La Motte Village Extension Roberts River Assessment

A requirement in terms of Section 21 of the National Water Act

September 2016

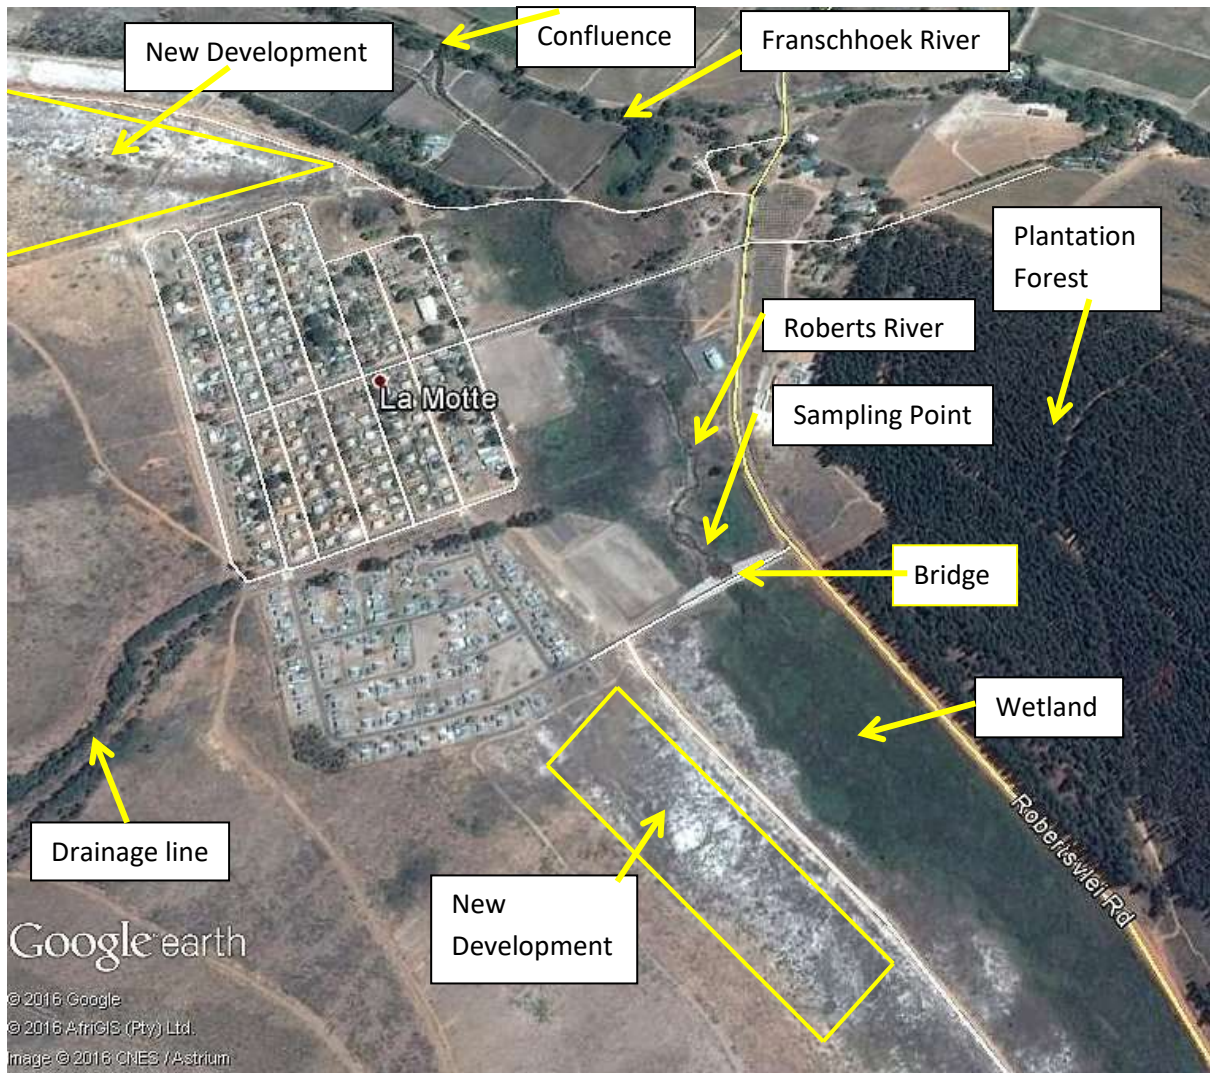
Figure 1 Location of the sampling point

The sampling point (Figure 1 & 2) was chosen downstream of the bridge on the access road to the La Motte village.

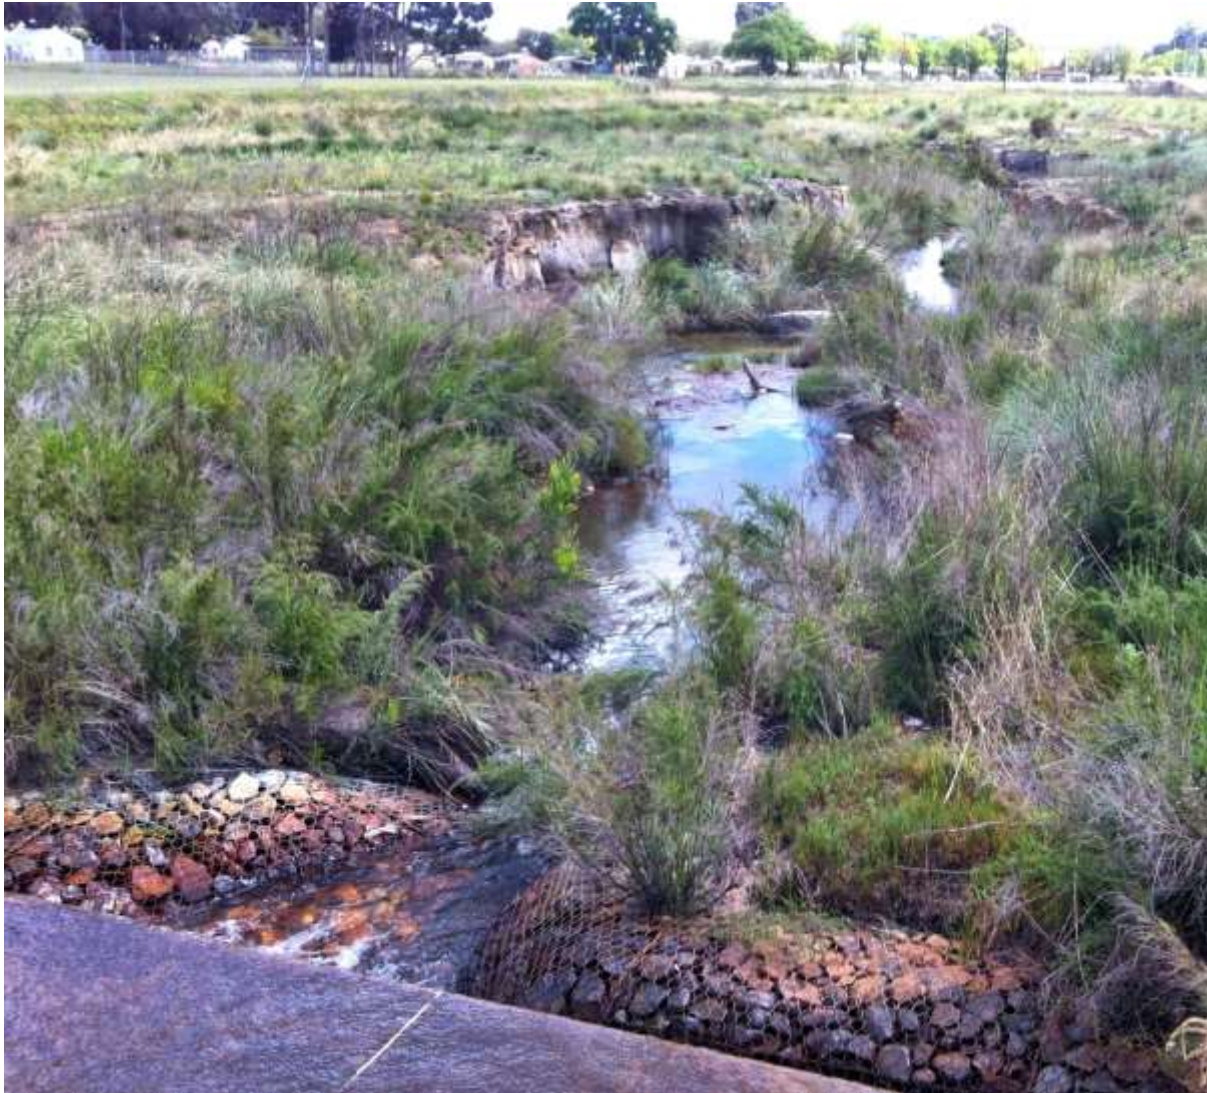
Figure 2 Sampling Point

The habitat for aquatic organisms is adequate with riffles, rapids, pools, stones in and out of current, bedrock, sandy bottom and emerging vegetation. The river varied from 1 meter to 5 meters wide and from a few centimetres to 1.5 meter deep.

During sampling the water was clear and fast running.

Reportedly the river at the sampling point stops flowing during summer. Evidently the period during which the river flowed was substantially shortened because of upstream water abstraction.

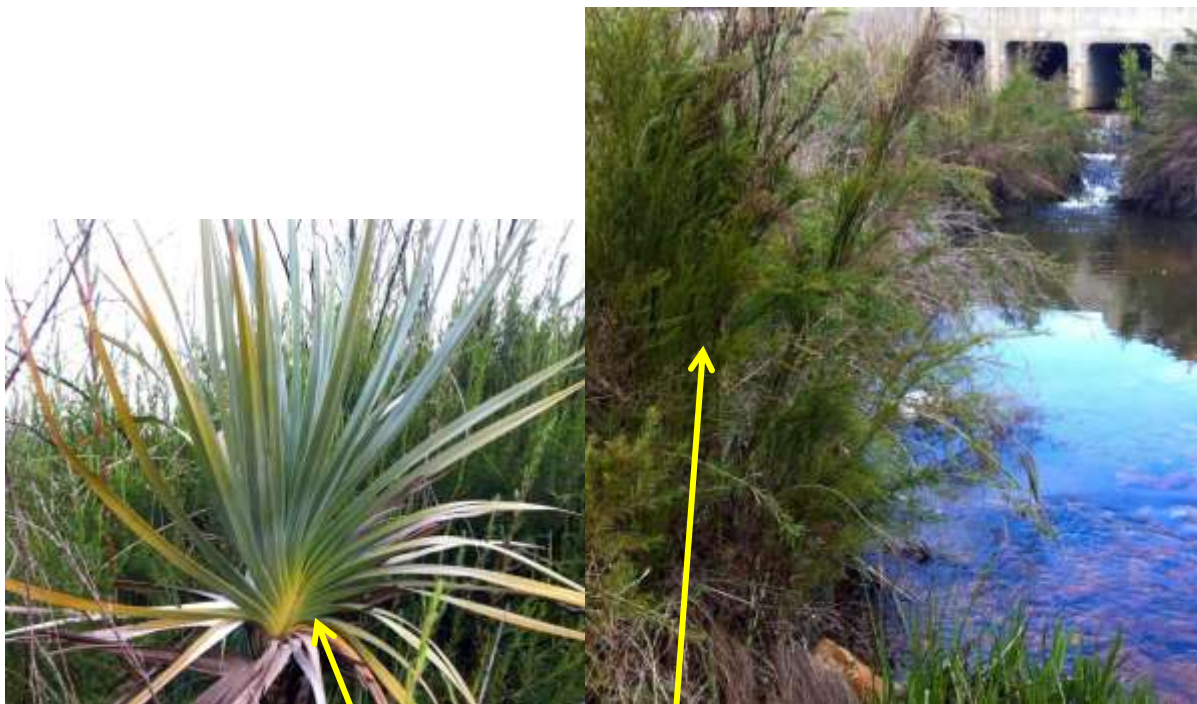
Figure 3 Palmiet *Prionium serratum* and *Restio paniculatus*

A single palmiet *Prionium serratum* (Figure 3) was still present, high above the river bed, which indicated that the river must have been overgrown prior to human impact, as dense stands of palmiet was the hallmark of Western Cape streams before human impact. The riverside *Restio paniculatus* (Figure 3), a wetland indicator, grows in abundance right next to the water's edge along the river bed, but was absent higher up the banks.

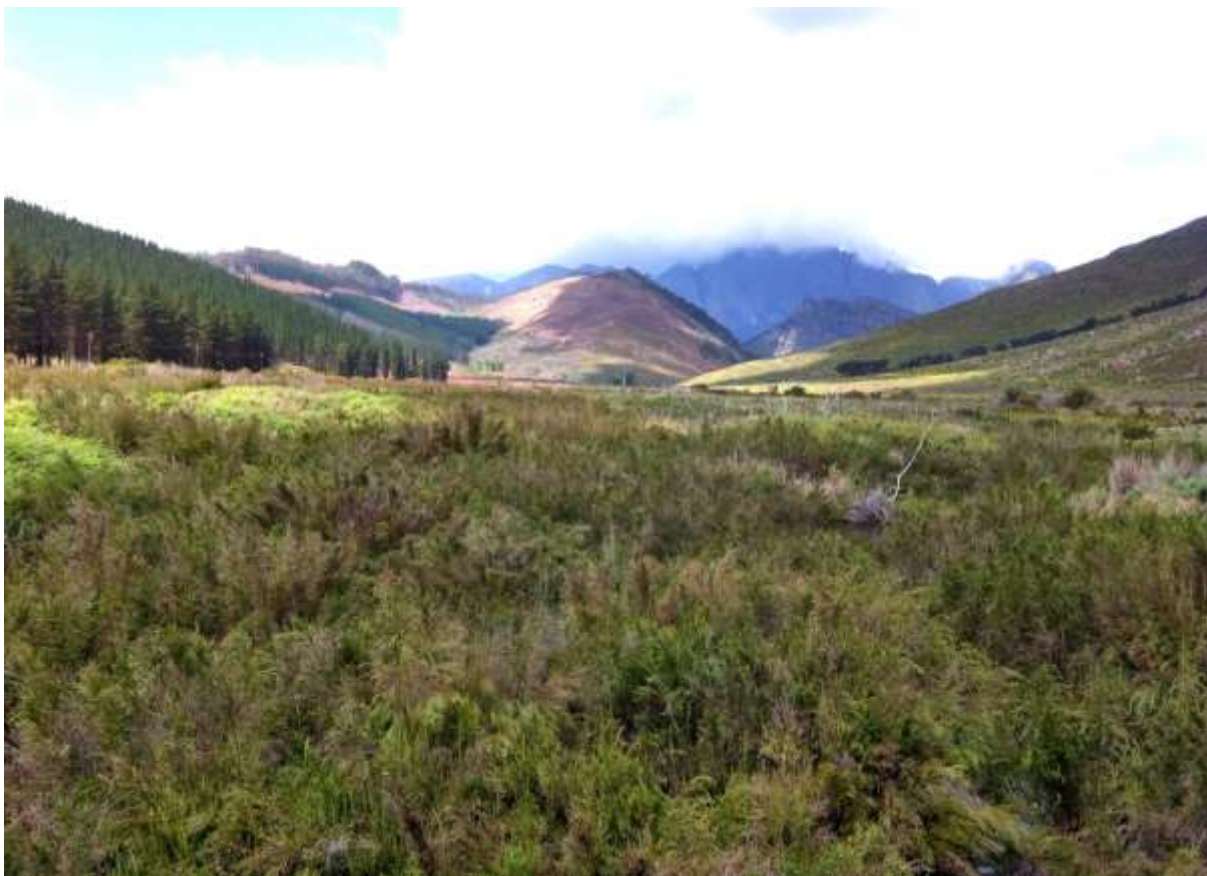
Figure 4 Vegetation upstream of sampling point

Further upstream is an extensive wetland abundant with wetland vegetation (Figure 4). This wetland comes to an abrupt stop where the vineyards start.

The stretch of river upstream of the bridge to where the vineyards start in the upper catchment, as well as it's associated riparian zone and wetlands should be conserved at all costs. Storm water and pollution by accidental sewage spills should be channelled to a point downstream of the bridge.

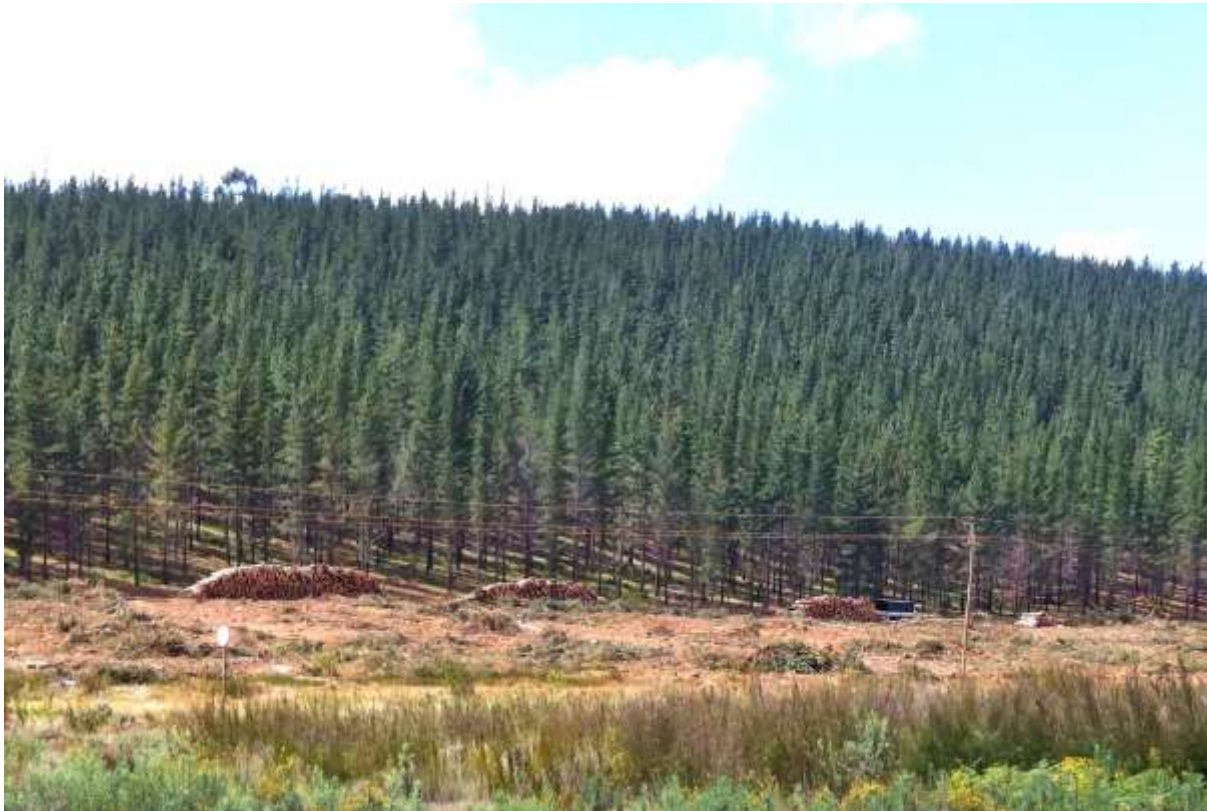
Figure 5 Forest harvesting

The La Motte MTO forest is being harvested at the moment (Figure 5). This process will continue in the years to come. The pines are being cut down. As a result the evapotranspiration of ground water diminishes and the cleared mountains sides become hydrologically active again. Subsequently emerging ground water lower down the mountain slopes is likely to sustain the existing wetland and perhaps add some more wetland area.

It was noted that blue gum saplings have been eradicated with herbicide during follow-up operations.
