## 2018 ENVIRONMENTAL COMPLIANCE RATING SCORECARD: Dasberg Dam\_10 Dec 2018

# ECO CONSTRUCTION SITE ENVIRONMENTAL INSPECTION REPORT

**Project Name:** Dasberg Dam

**Report no** 2 (Consolidated  
report of last 4  
site visits)

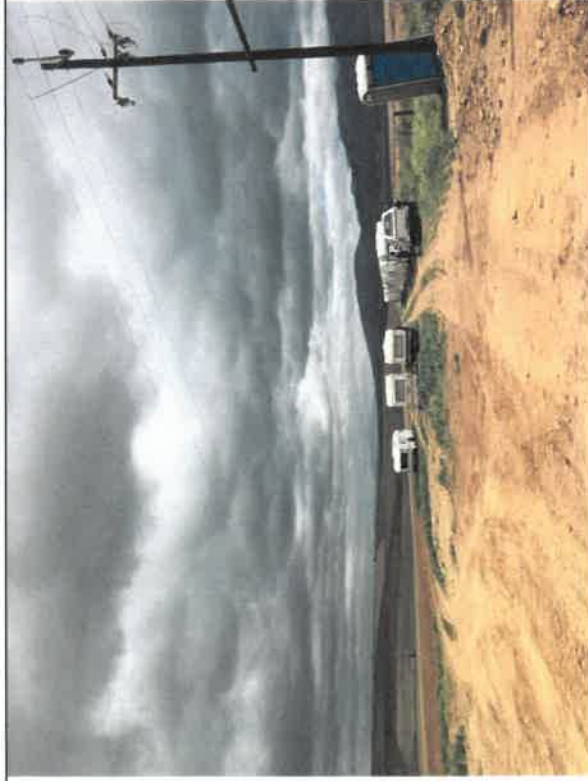
Figure 1: Neat and tidy labourers camp

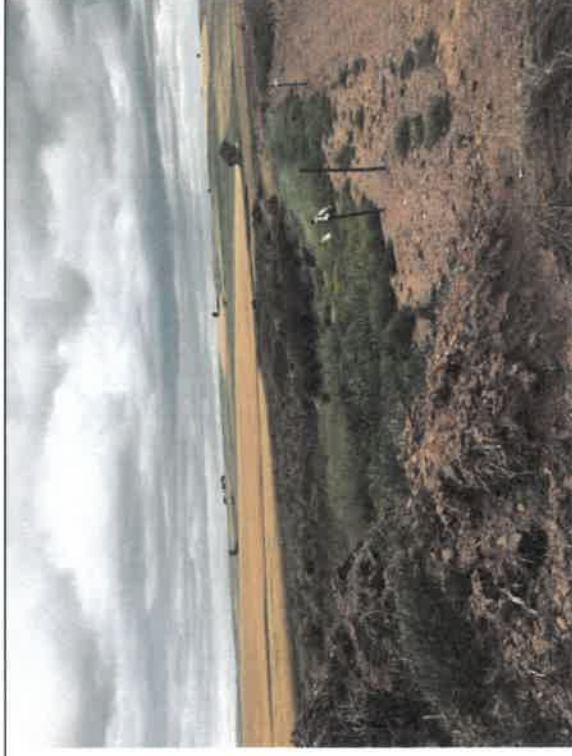
Figure 2: No-go area demarcation correct as request

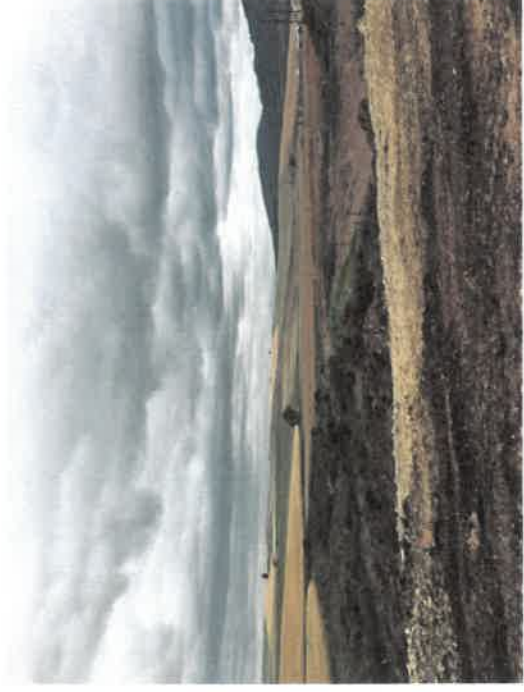
Figure 3: Demarcated No-go area standing on the dam wall

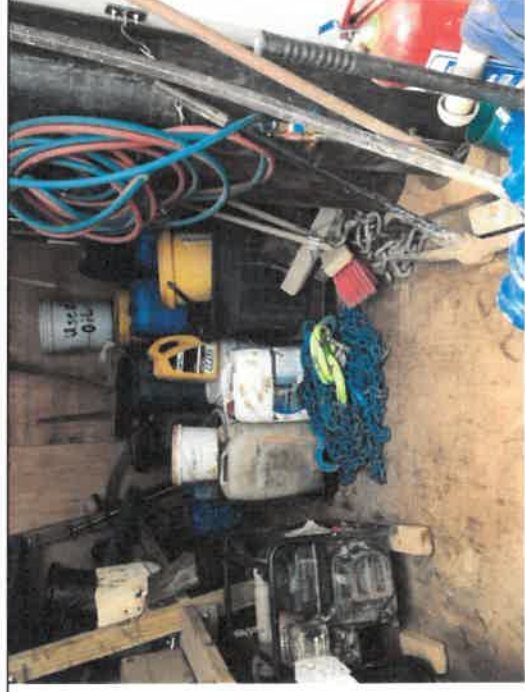
Figure 4: Clean store room

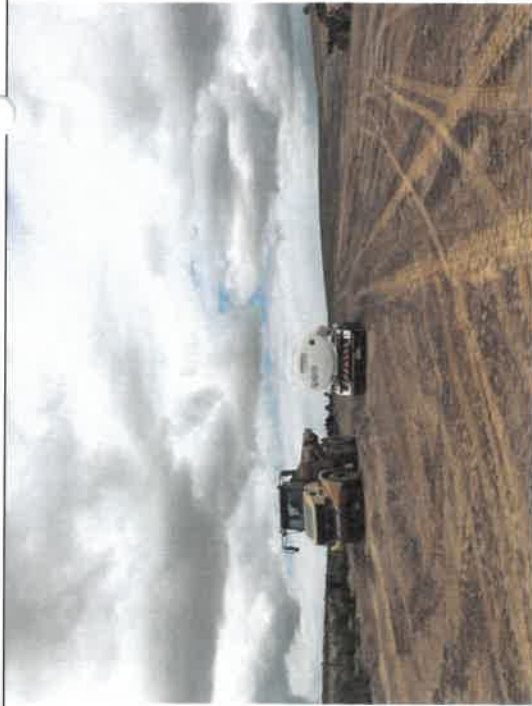
*Figure 5: Drip trays placed under stationary vehicles*

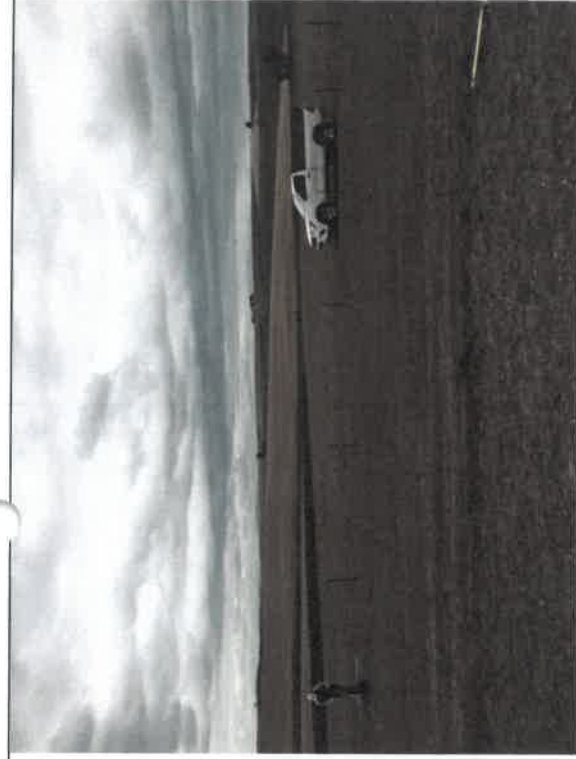
*Figure 6: Start of pump house site demarcation and pegging of out of the footprint*

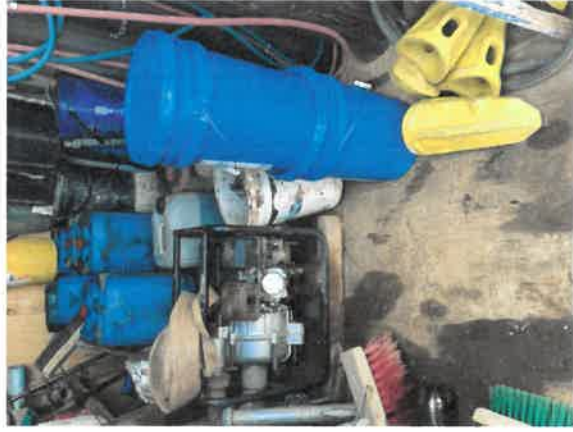
Figure 1: Oil spills in site storage office

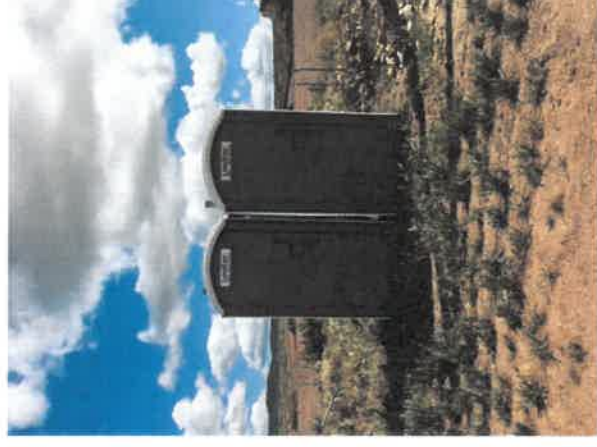
Figure 2: Extra toilet was placed on site to accommodate extra workers

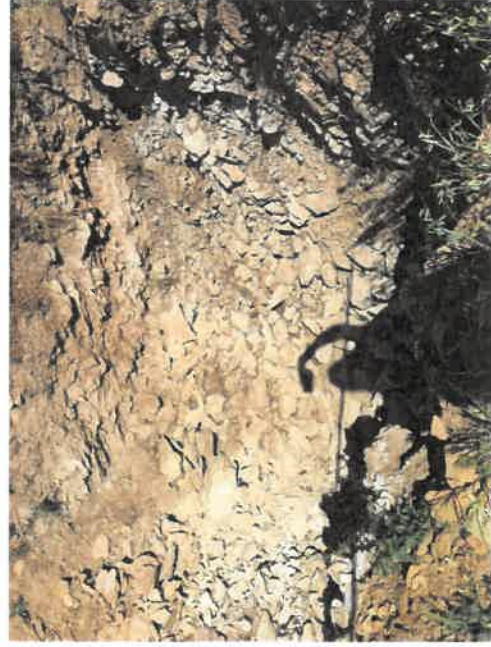
Figure 3: Lime in trench drains to prevent odour

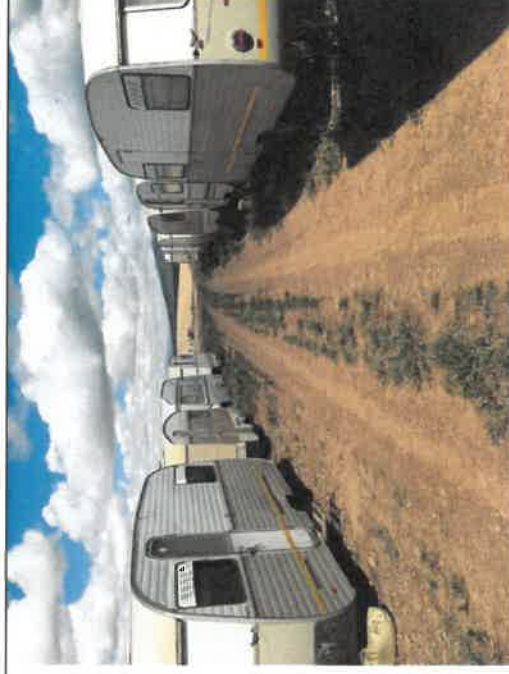
Figure 4: Tidy labourers camp

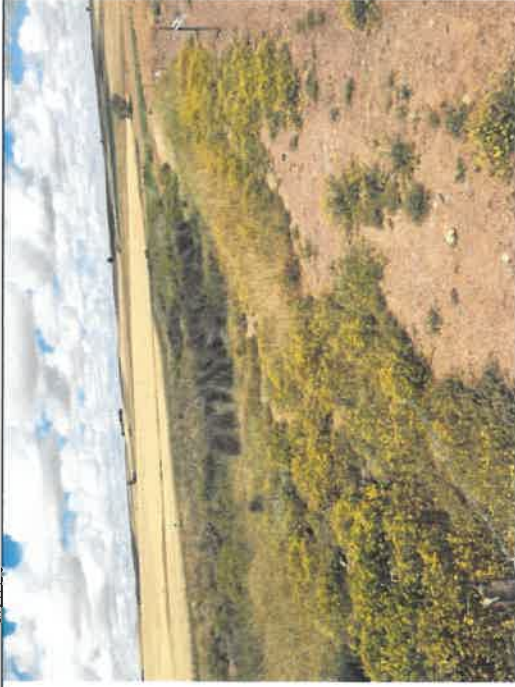
*Figure 5: No-go area correctly demarcated as requested*

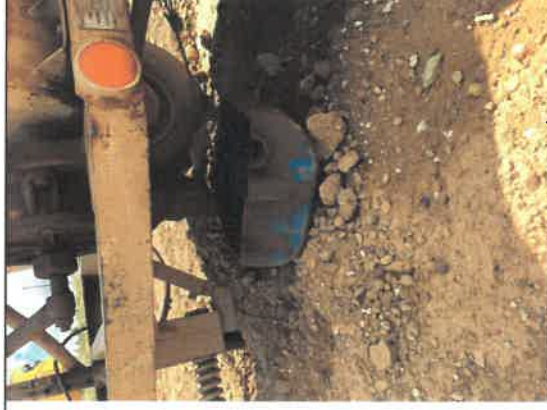
*Figure 6: Drip tray under refueler*

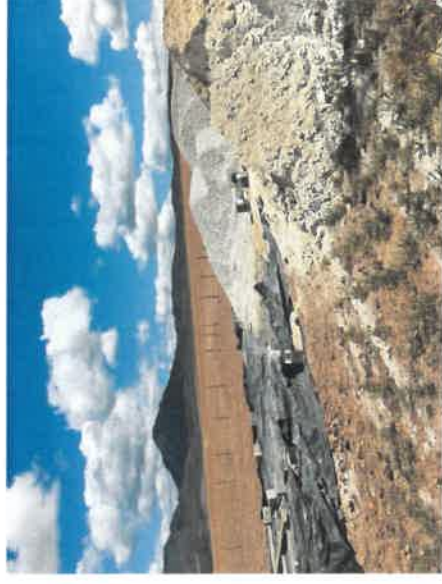
Figure 2: Building rubble placed on micron liner as requested

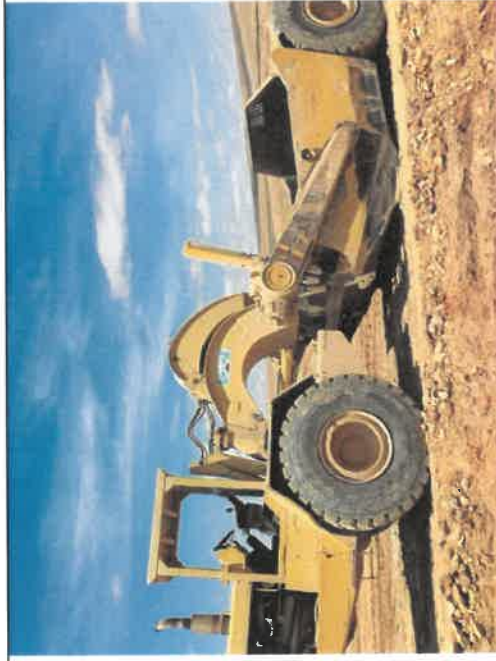
Figure 1: Stationary Wabco machine with no drip trays

<b>ECO/ESO RESPONSE TO INCIDENT AND RECOMMENDATIONS:</b>			
<ul style="list-style-type: none"> <li>- Ensure machines are checked for leaks. Machines need to be serviced and maintained to prevent spills</li> <li>- Ensure greasing equipment is stored away</li> <li>- Clean up and dispose of Diesel spill ensure drip trays placed at all times</li> <li>- Drip trays on site at all times!</li> </ul>			
<b>IS THIS INCIDENT A:</b> <input type="checkbox"/> FIRST OFFENCE <input type="checkbox"/> SECOND OFFENCE <input type="checkbox"/> THIRD OFFENCE			
SIGNATURE OF SITE AGENT: _____		DATE _____	
SIGNATURE OF ECO/ESO

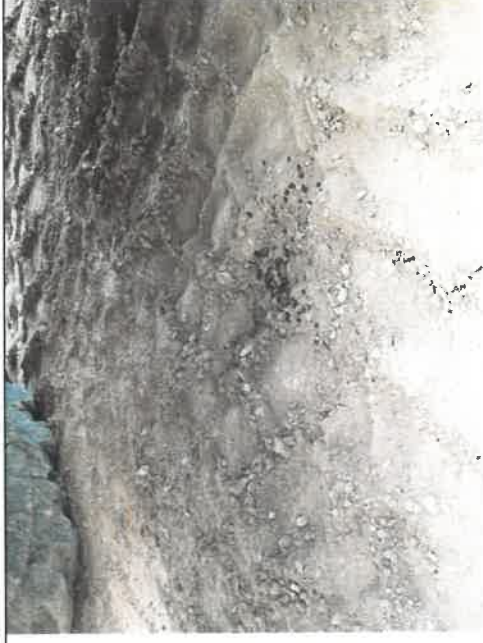
Figure 2: Oil spills from stationary Wabco machines on site. No drip trays under stationary machines

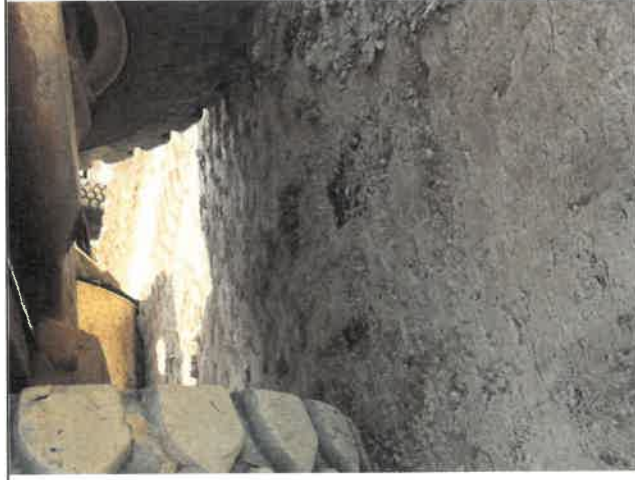
Figure 3: Stationary machine on site with no drip tray and visible oil leaks

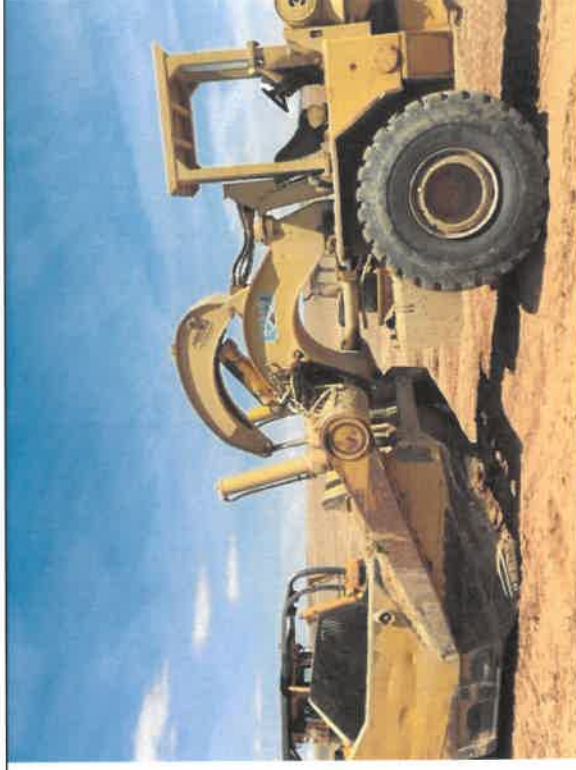
Figure 4: Second stationary Wabco machine with no drip trays

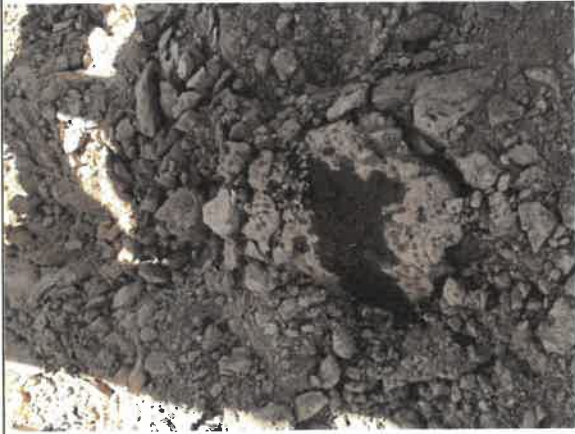
Figure 5: Oil spills from secondary stationary Wabco machines on site. No drip trays under stationary machines

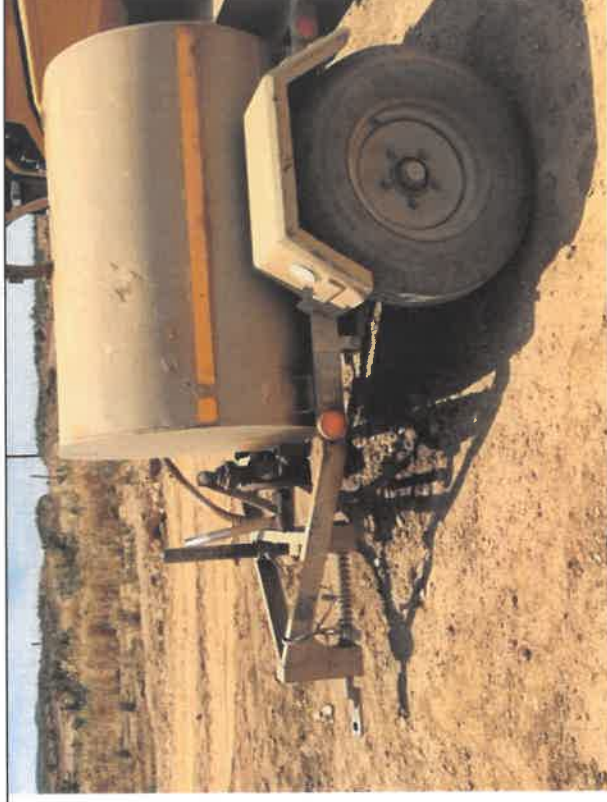
Figure 6: No drip tray under mobile refueler

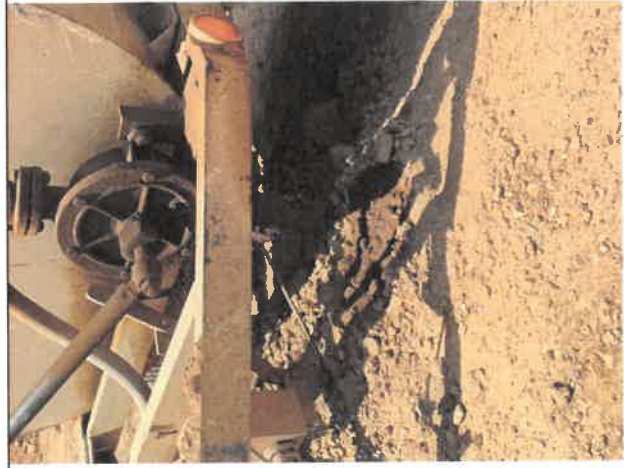
Figure 7: Visible Diesel spill under mobile refueler

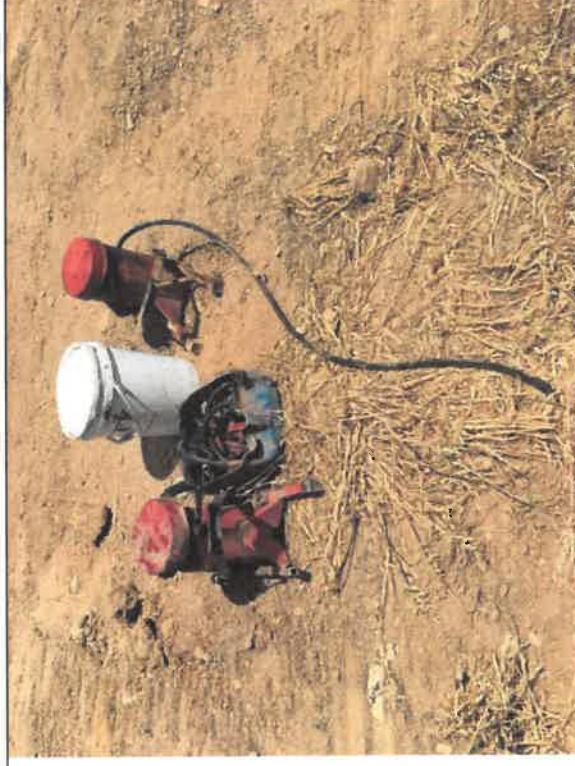
Figure 8: Greasing equipment left on site after use, not on impermeable surface

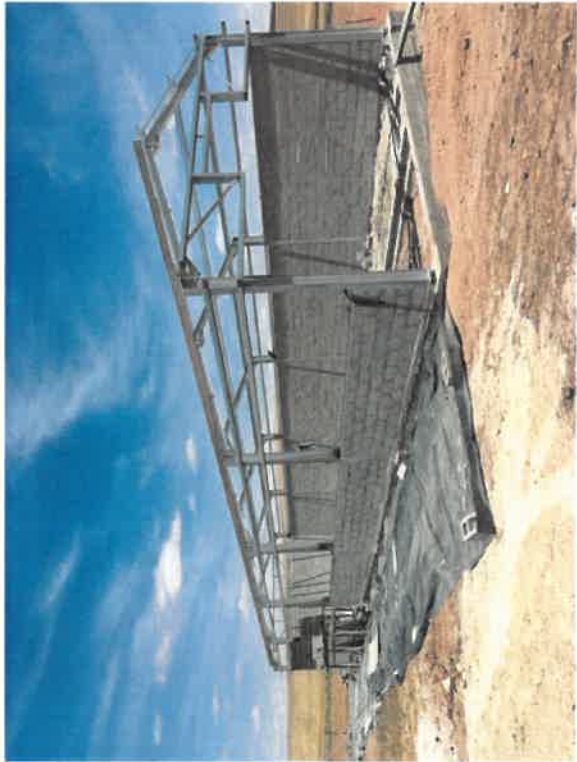
Figure 1: Dasberg Dam Pump house progress. Protective sheet placed for working with cement for protection

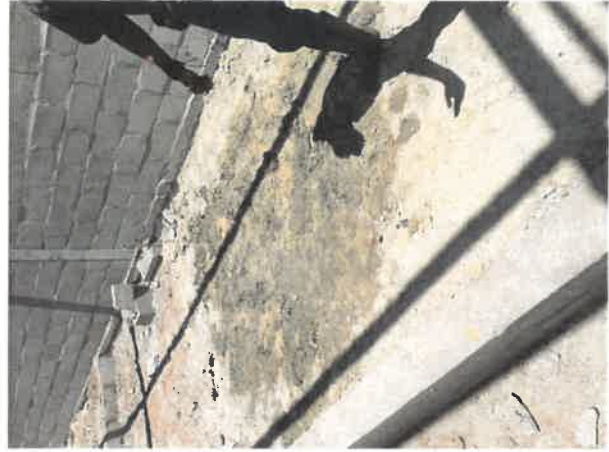
Figure 2: Cement mixing taking place within the pumphouse footprint

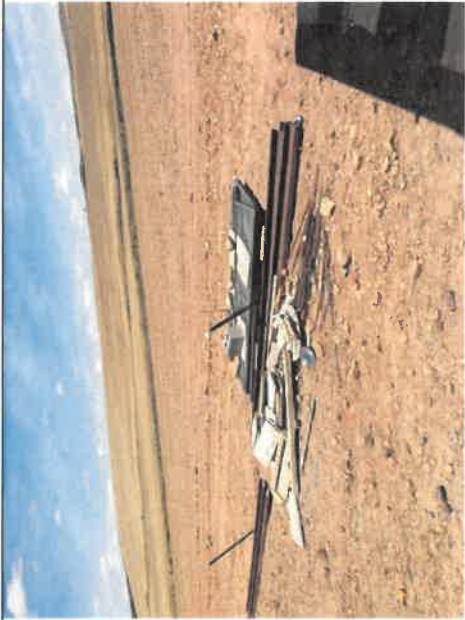
Figure 3: Building material outside the construction footprint (to be removed)

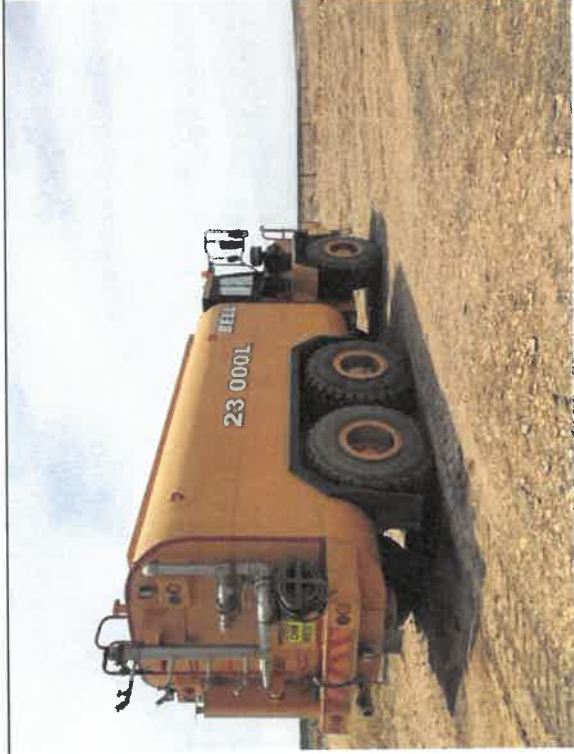
Figure 1: Stationary water tank truck with drip tray but visible spills

<ul style="list-style-type: none"> <li>- Machines need to be serviced and maintained to prevent future spills</li> <li>- Drip trays on site at all times!</li> </ul>			
<b>IS THIS INCIDENT A:</b> <input checked="" type="checkbox"/> FIRST OFFENCE <input type="checkbox"/> SECOND OFFENCE <input type="checkbox"/> THIRD OFFENCE			
SIGNATURE OF SITE AGENT:		DATE	
SIGNATURE OF ECO/ESO		DATE

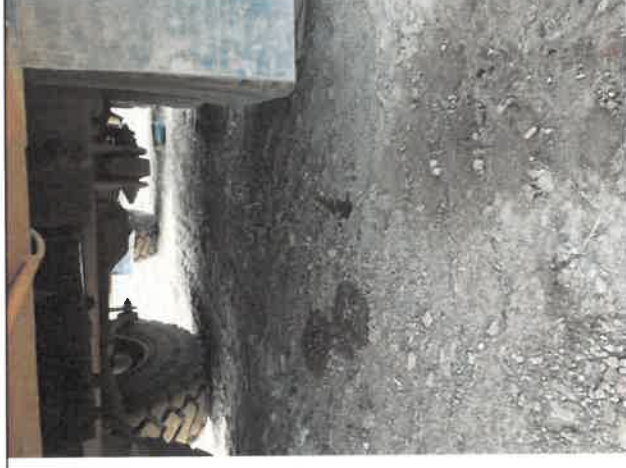
Figure 2: Oil spills from stationary water tank truck on site.

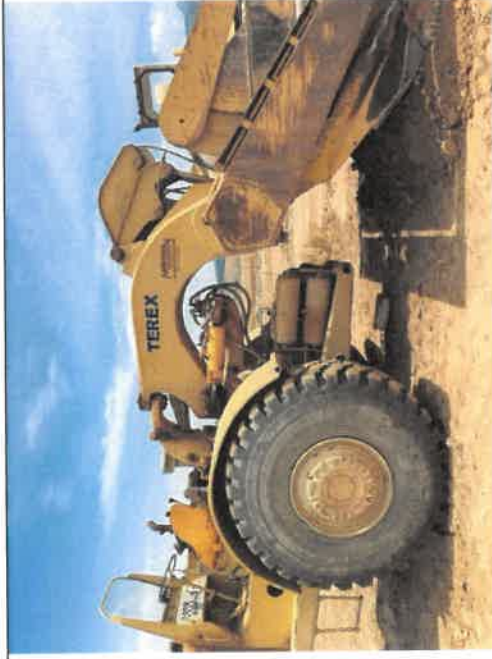
Figure 3: Stationary Terex machine with drip tray, although oil spills were still prominent

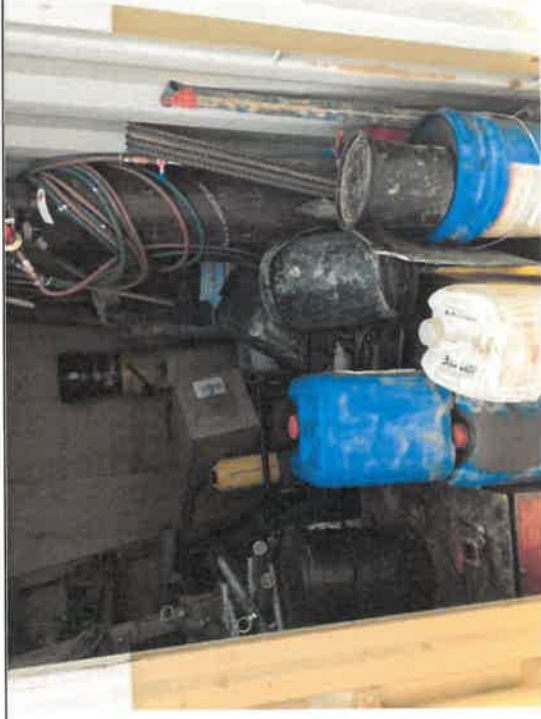
Figure 4: Site store room untidy

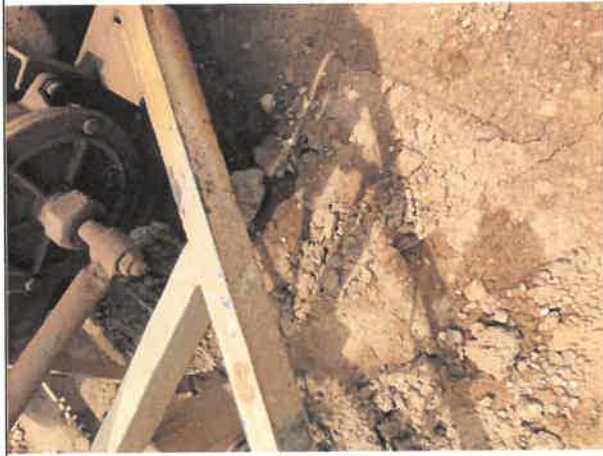
Figure 5: Previous Diesel spill under mobile refueler not cleaned up since last site visit (16 Nov) and still no drip tray placed.
