2019 ENVIRONMENTAL COMPLIANCE RATING SCORECARD: Dasberg Dam_9 February 2019

ECO CONSTRUCTION SITE ENVIRONMENTAL INSPECTION REPORT

Project Name: Dasberg Dam

Report no 3 (closure report)

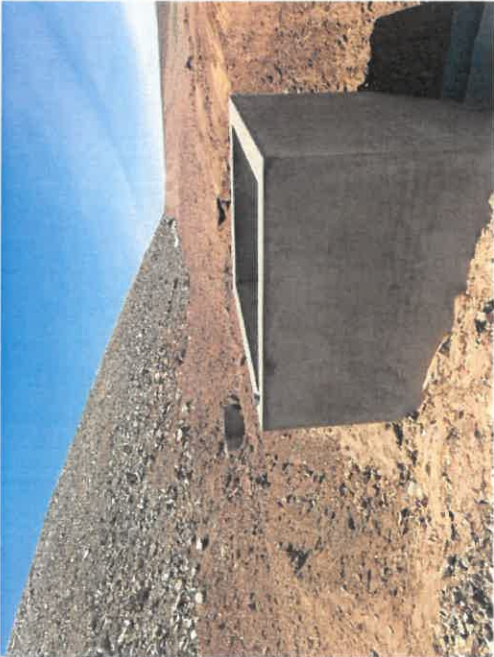
The valve chamber was constructed as per the agreed upon method statement. Please refer to Appendix B for photos and layout of the pipeline from the valve chamber to the pumphouse.

<p>A photograph of a large, rectangular concrete structure, identified as the Dasberg Valve Chamber, situated in a dry, rocky landscape under a clear blue sky.</p>

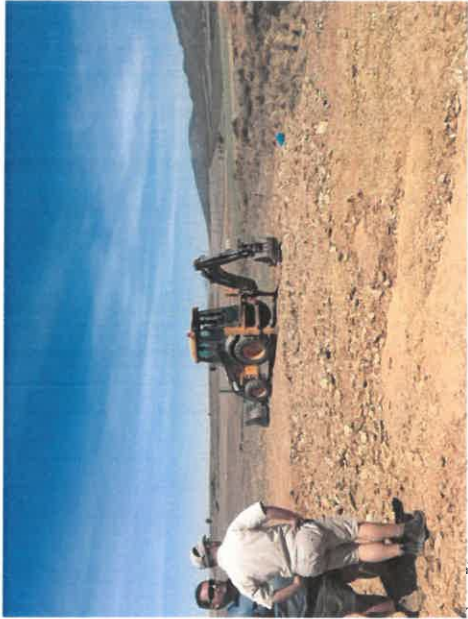
13. CONSTRUCTION VEHICLE MAINTENANCE Construction vehicles must be in good working order and well maintained to prevent oil and fuel leakages and to reduce noise levels.	3	No spills observed. However, a drip tray was not observed with the one excavator that was used for construction of the pipeline.

<p>A photograph showing an excavator working on a dirt site. Two people are standing in the foreground, looking towards the excavator. The background shows a clear blue sky and distant hills.</p> <p><i>Figure 2: Excavator in site for construction of the pipeline</i></p>

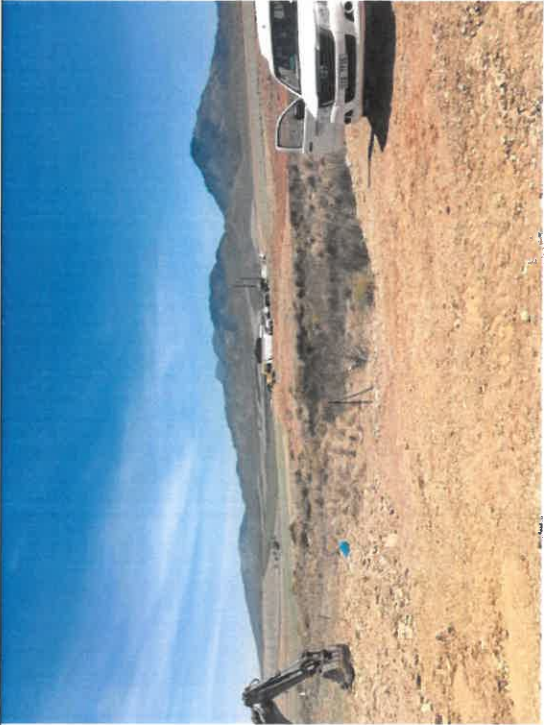
<p>A photograph of a white vehicle parked on a dirt road. In the background, there is a large, dark, rocky structure, likely the dam, and a clear blue sky.</p> <p><i>Figure 3: Discharge pipeline, no- go area still being maintained as no-go area</i></p>

The discharge pipe (as seen in the photo records) must be monitored for erosion in the unlikely event that water is discharged from the dam into the natural stream.

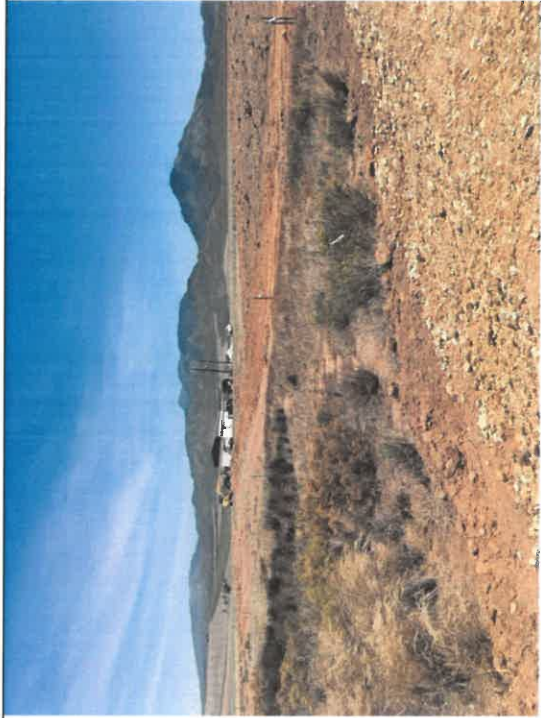
<p>A photograph showing a wide, flat, dry landscape with sparse vegetation. In the distance, a small structure (the pumphouse) is visible near the base of a large, dark, rocky structure (the dam). The sky is clear and blue.</p> <p><i>Figure 4: Demarcated no-go area with Dasberg dam pumphouse in the background</i></p>

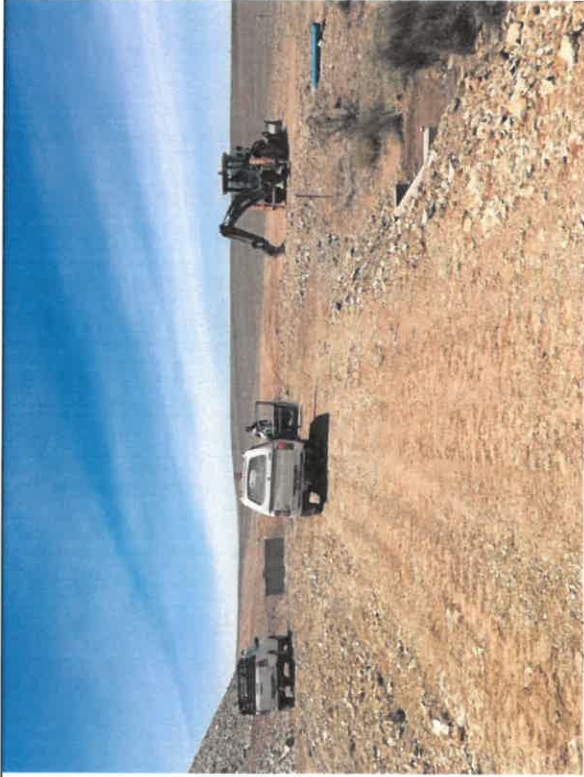
Figure 5: Photo indicating the culvert constructed for seepage water

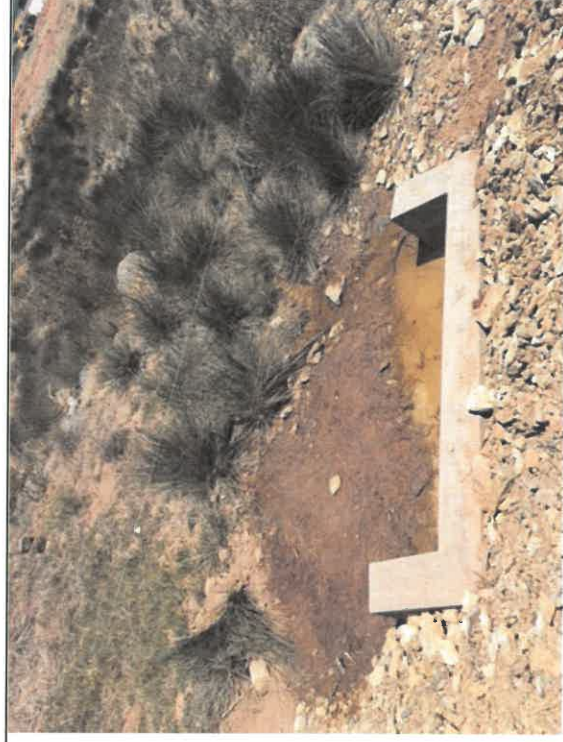
Figure 6: Culvert for seepage water to flow into the natural stream

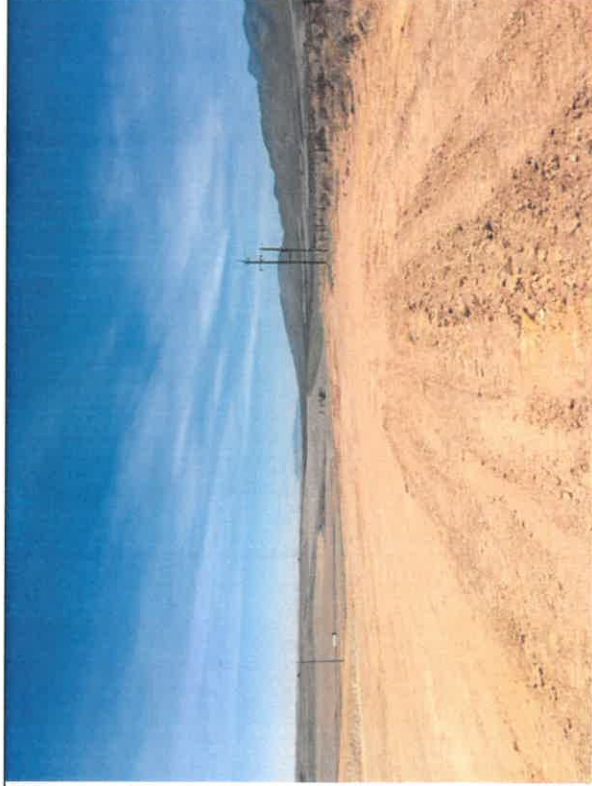
Figure 7: Photo taken from the north eastern boundary of the site, showing that the maintenance yard, construction camp and labourers facility was rehabilitated as per the method statement.

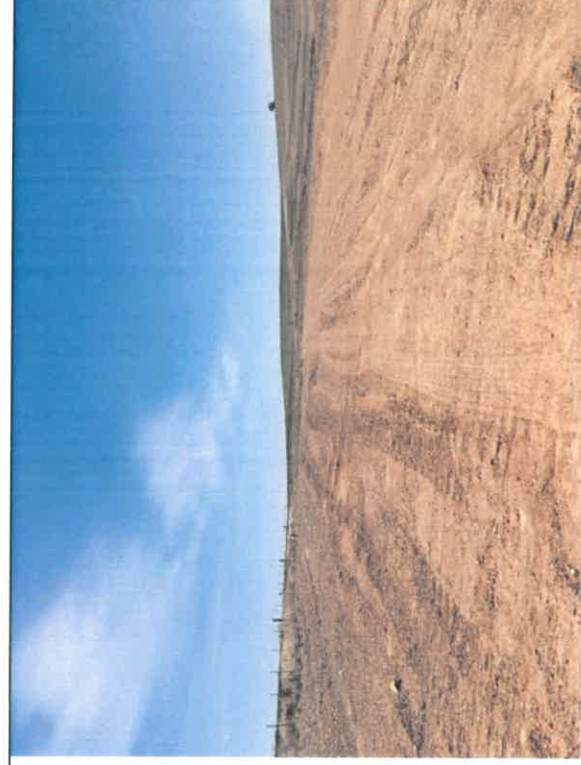
Figure 8: Photo taken from the north western boundary of the site, showing that the maintenance yard, construction camp and labourers facility was rehabilitated as per the method statement

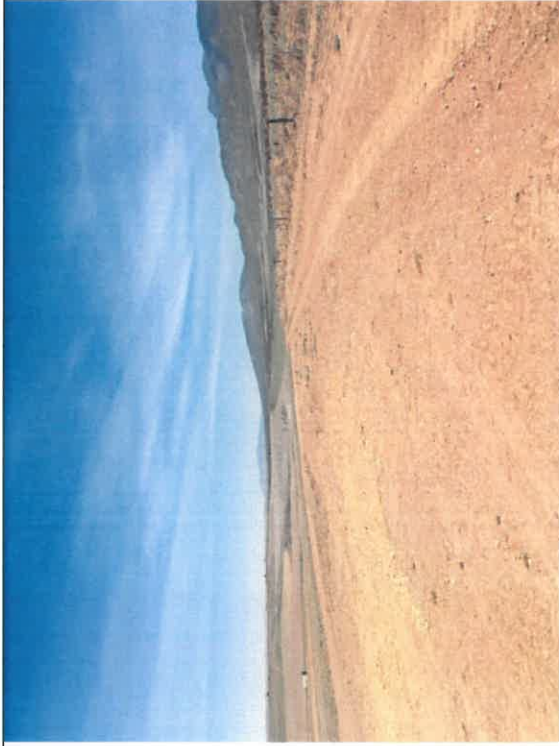
Figure 9: Photo indicating that the labours' facility area was rehabilitated

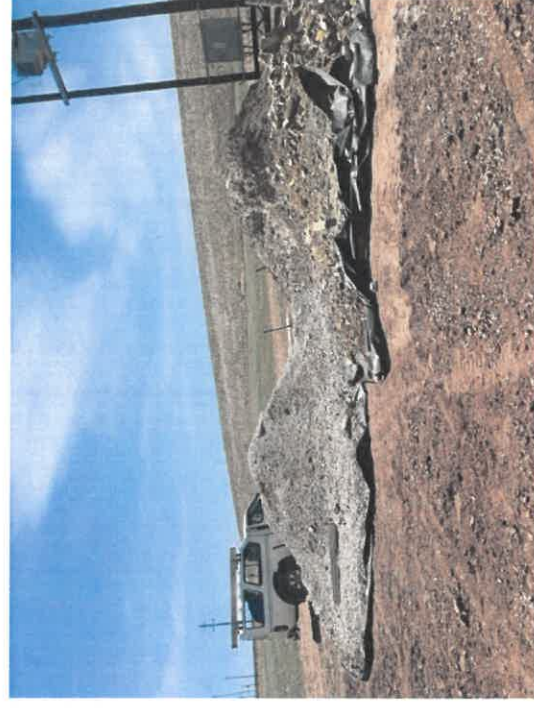
Figure 2: Stockpiles at the Dasberg Pumpphouse being maintained

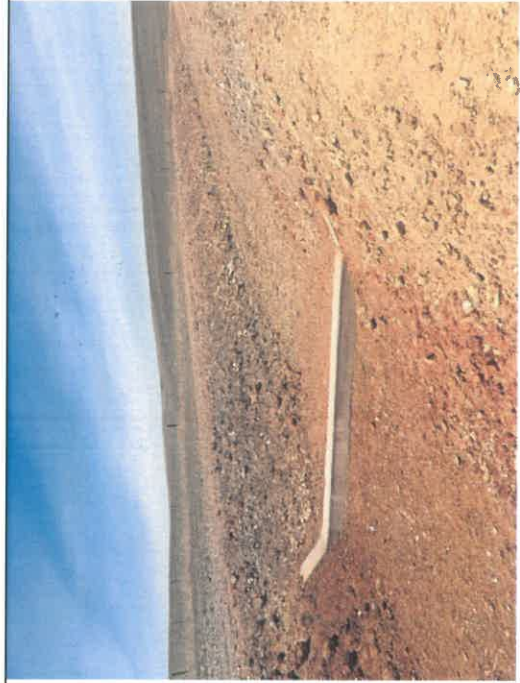
The Spillway was constructed as per the agreed upon method statements. Please refer to Appendix B for photos and layout.

Figure 23: Site visit 21 January 2019, Dasberg dam spillway as per the agreed upon method statement

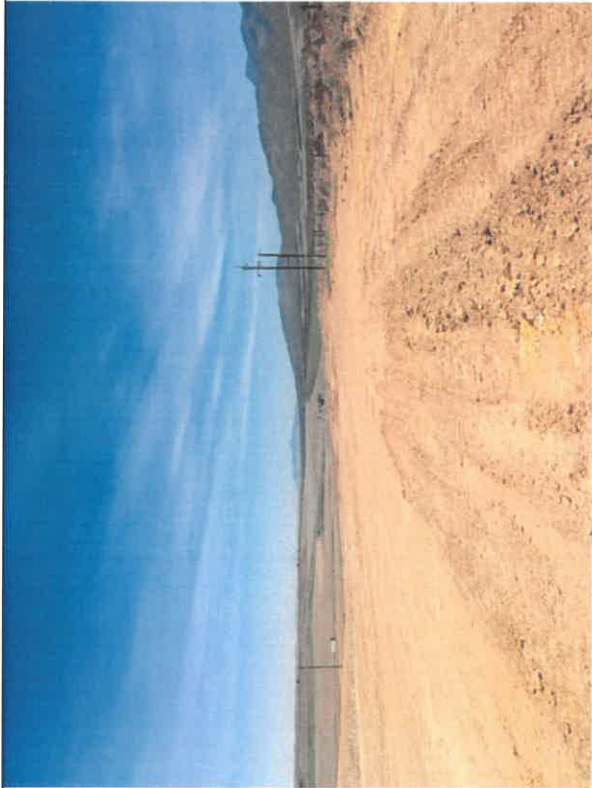
Figure 24: Photo taken from the north eastern boundary of the site, during 21 January 2019, showing that the maintenance yard, construction camp and labourers facility was rehabilitated as per the method statement.

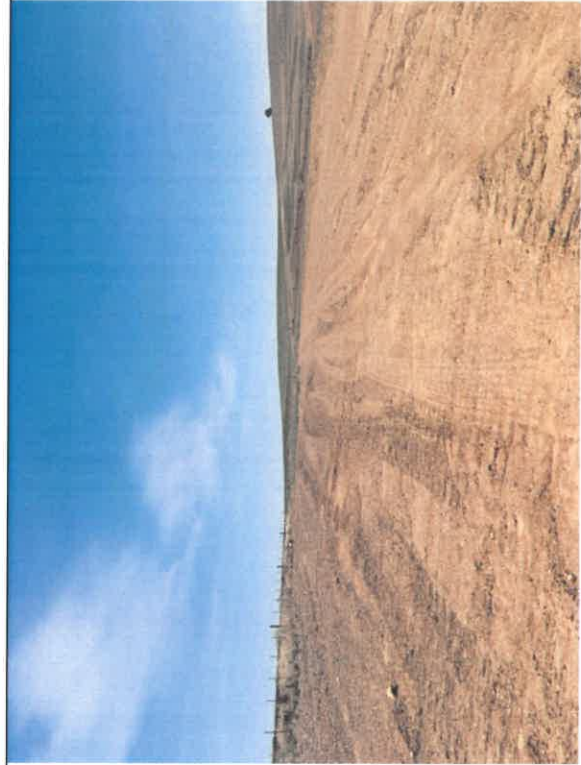
Figure 25: Photo taken from the north western boundary of the site, showing that the maintenance yard, construction camp and labourers facility was rehabilitated as per the method statement

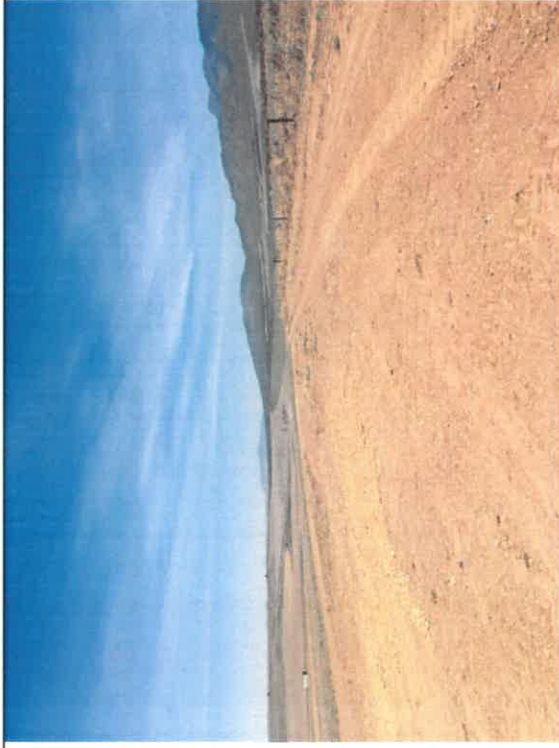
Figure 26: Photo indicating that the labours' facility area was rehabilitated

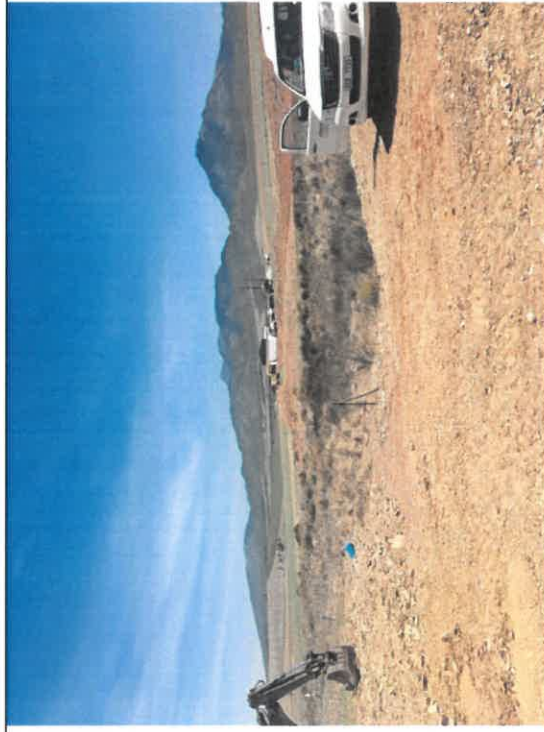
Figure 28: Discharge pipeline, no-go area still being maintained as no-go area

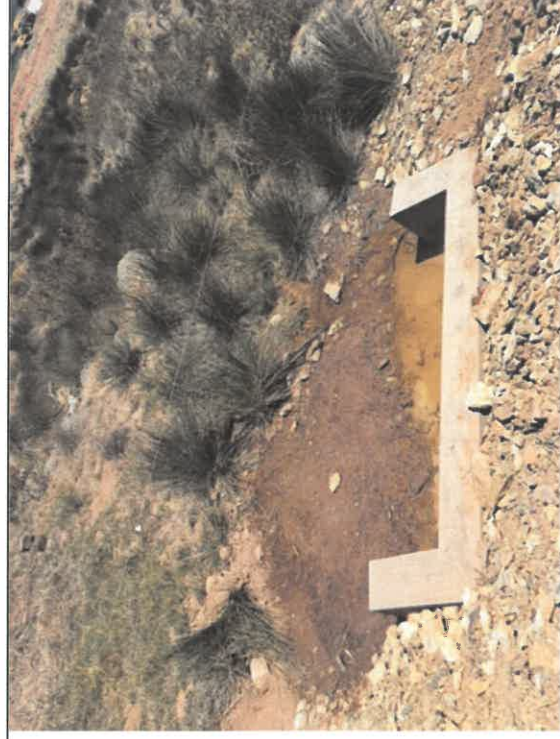
Figure 29: : Culvert for seepage water to flow into the natural stream
