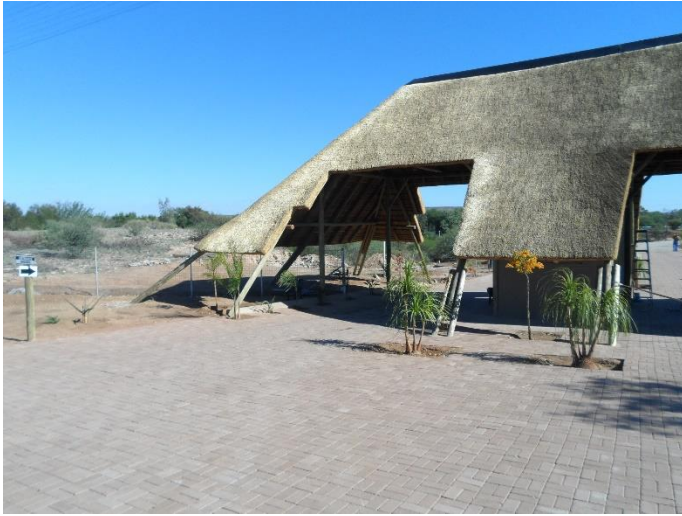
Photo 1: Newly constructed thatched roof at the Property entrance (taken from position 1)

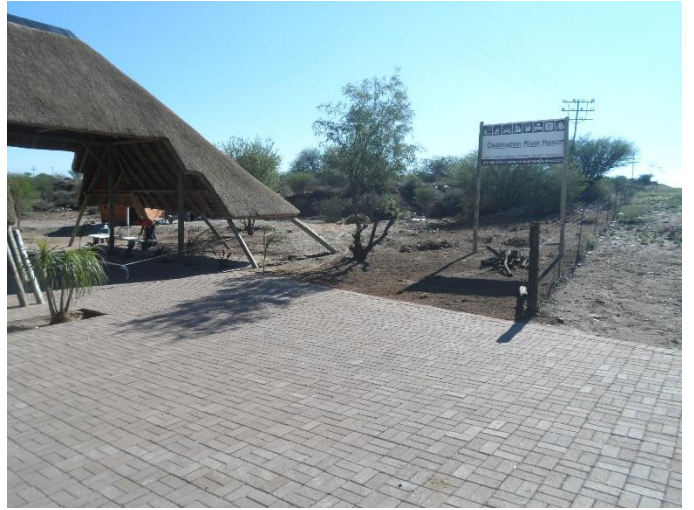
Photo 2: Newly constructed thatched roof at the Property entrance (taken from position 1)

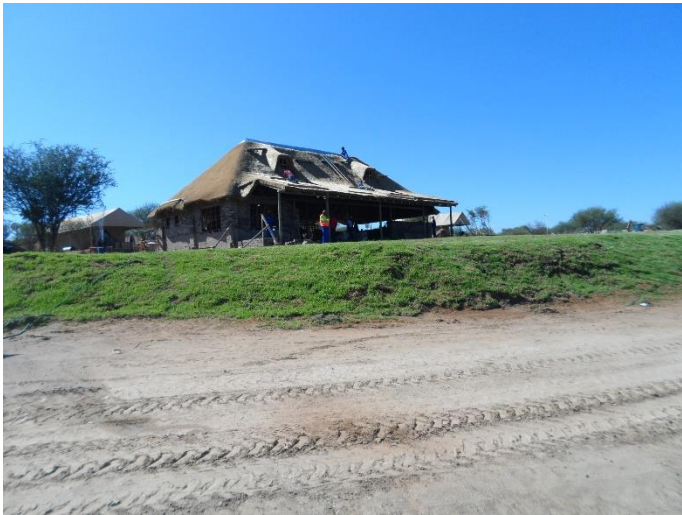
Photo 3: Construction of the Main area/restaurant (taken from position 2)

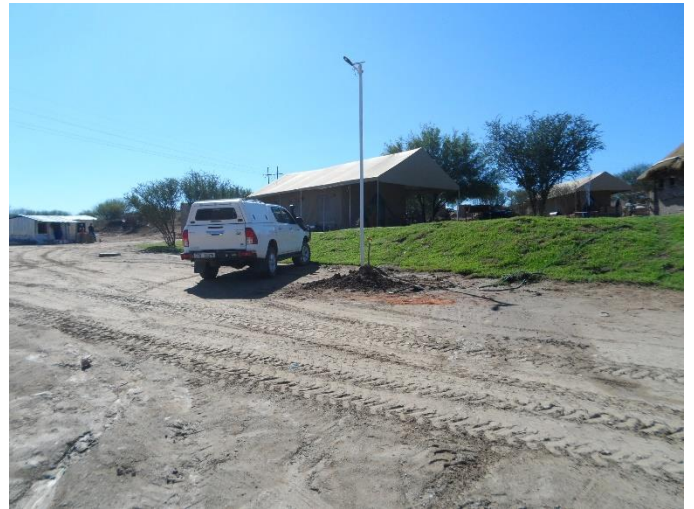
Photo 4: Entrance road and completed units (taken from position 2)

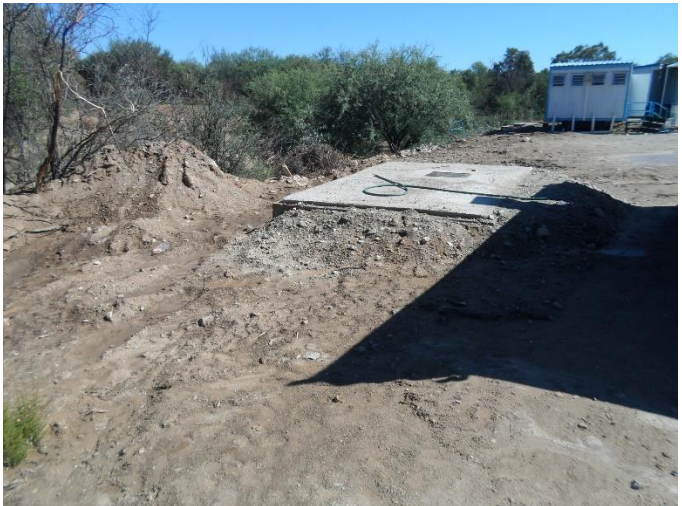
Photo 5: Conservancy tank near completed units (taken from position 2)

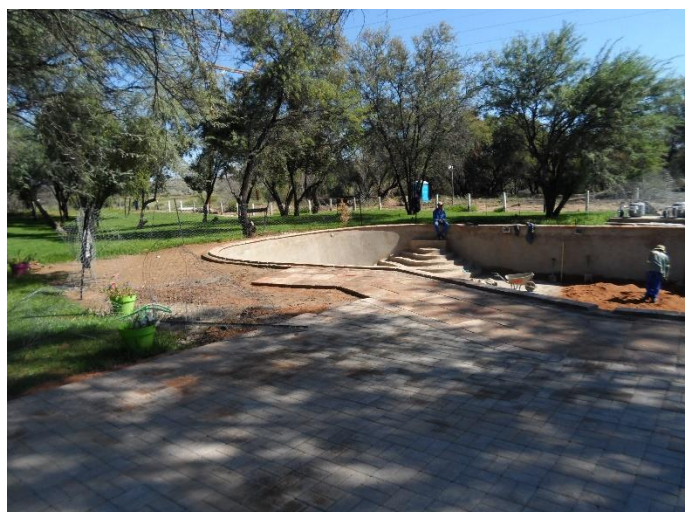
Photo 6: Swimming Pool (taken from position 3)

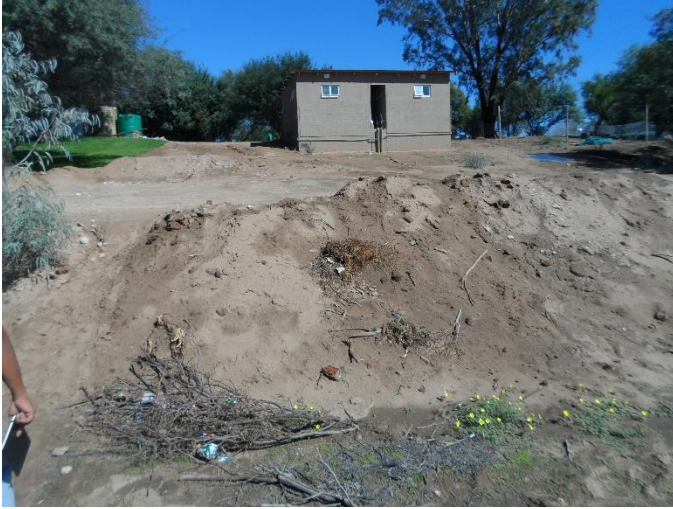
Photo 7: Ablution facility with conservancy tank (taken at location 4)

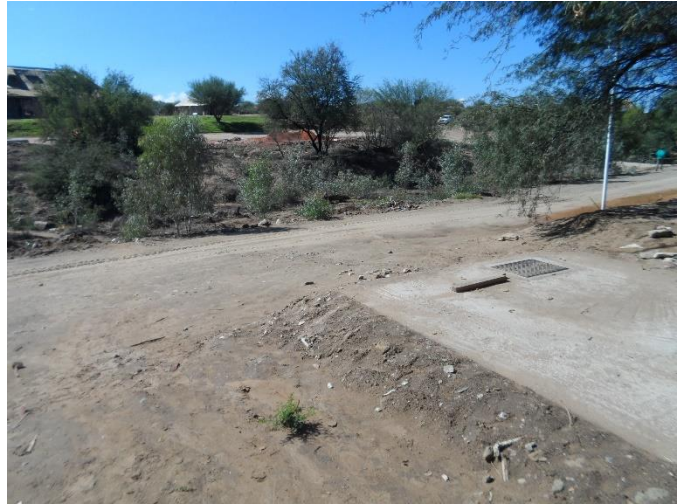
Photo 8: Small drainage line running through the site. Ablution facility conservancy tank can be seen in foreground (taken from position 5)

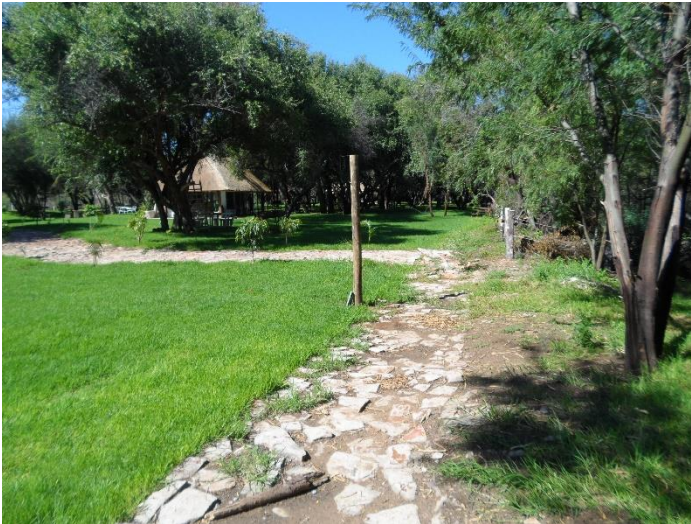
Photo 9: General camp ground (taken from position 6)

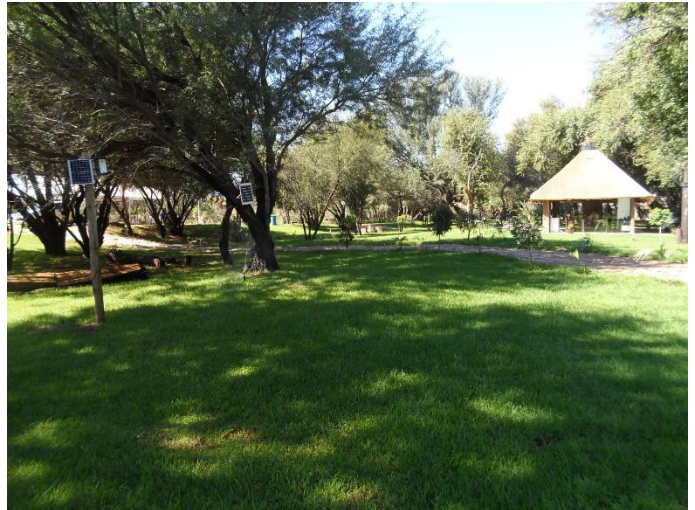
Photo 10: General camp ground (taken from position 6)

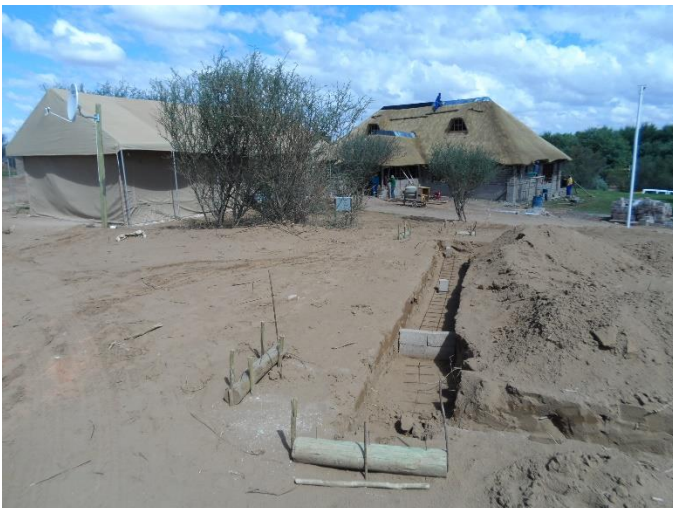
Photo 11: Main area and some accommodation units under construction (taken from location 7)

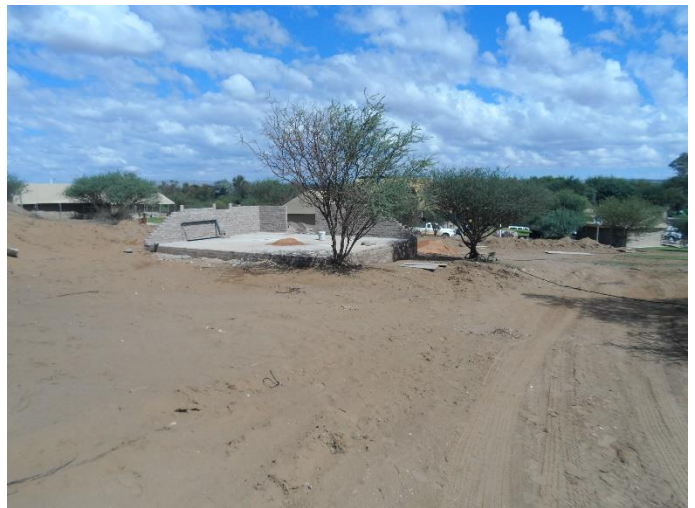
Photo 12: Main area and some accommodation units under construction (taken from location 7)

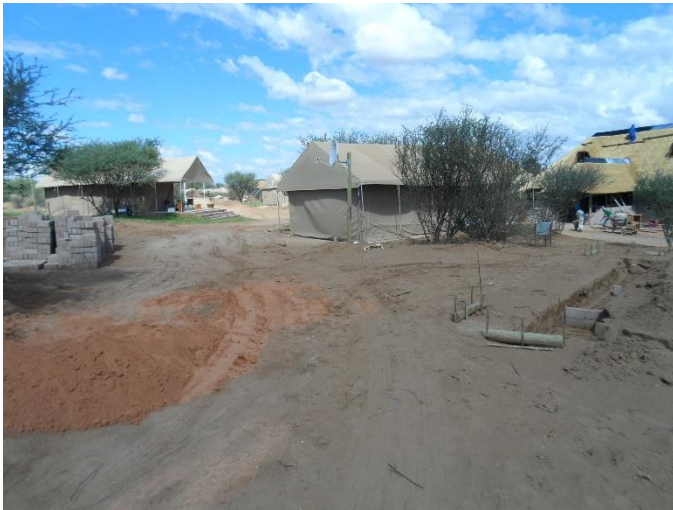
Photo 13: Main area and some accommodation units under construction (taken from location 7)

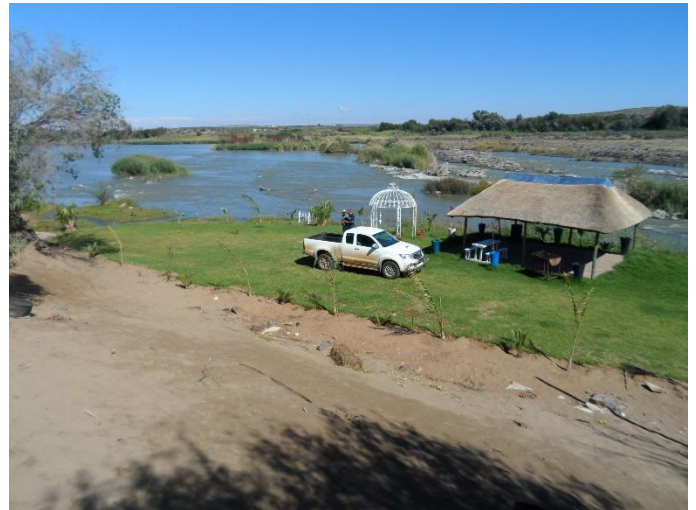
Photo 14: Thatched gazebo constructed on river bank (taken from location 8)

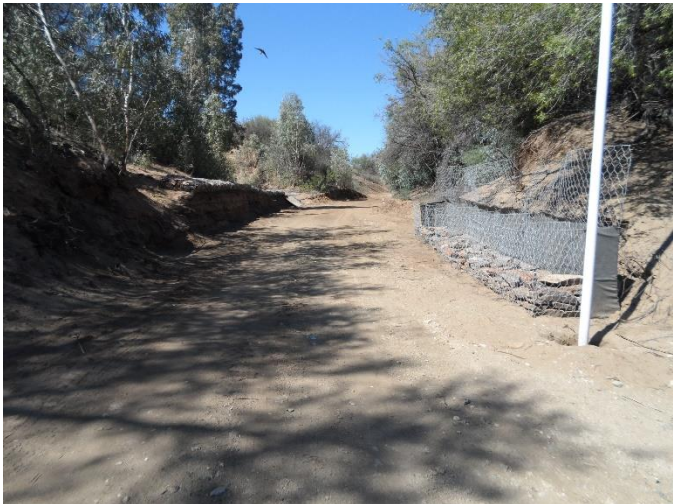
Photo 15: Road constructed within drainage line (taken from position 9, looking south)
