Geophysical survey for a subsurface foundation assessment for the expansion of an existing dam on Zwartfontein, southwest of Hermon, Western Cape

GEOSS Report No: 2020/03-29

13 March 2020

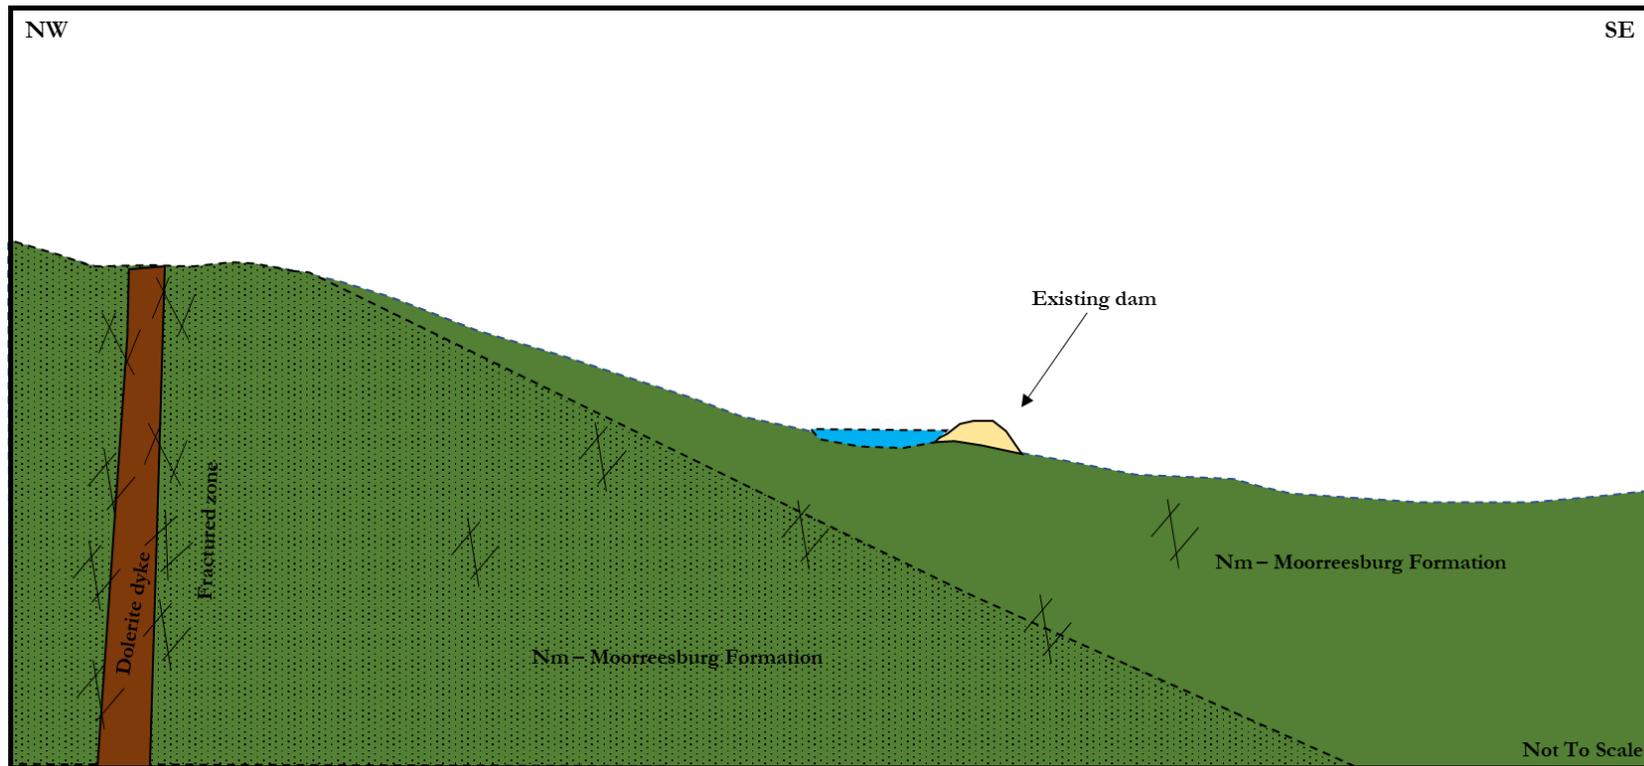
There is a mapped faulted contact between the Moorreesburg and Klipplaat Formation towards the far east of the property. These fault structures are mapped as dipping towards the east. Fault structures are often associated with large discontinuities in the rock, hence fractured bedrock.

Figure 3: Geological cross-section (as shown on Figure 2) across the dam site.

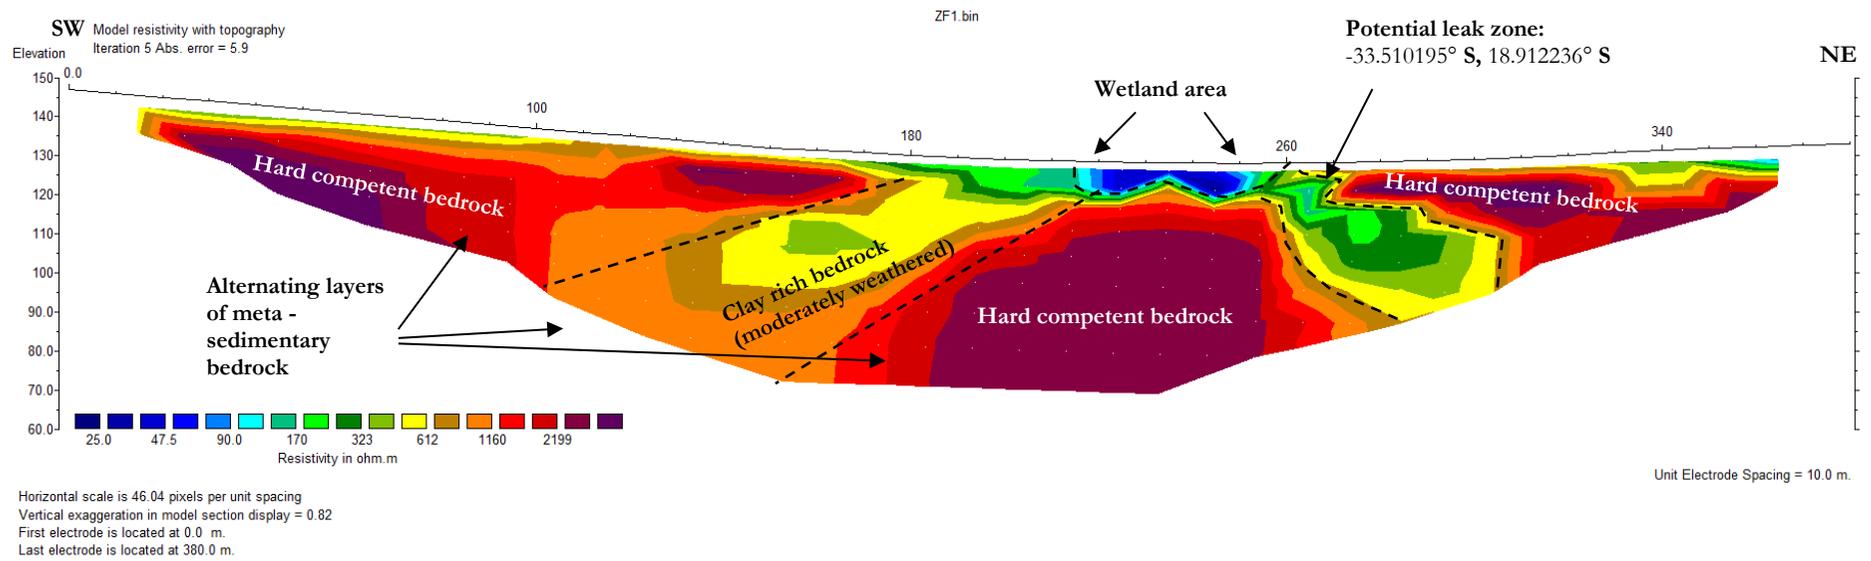
Figure 5: Inverted resistivity profile Res_Line_1 showing investigation depth as elevation (mamsl)

- Dark blue to light blue contour (25 - 90 ohm.m) values at shallow depth is likely indicative of semi water saturated alluvial material just below the existing dam wall (stations 210 – 260). This correlates well with the dam outlet and a drainage area.

- Light green to dark green contour (91 – 323 ohm.m) values at shallow depth is likely indicative of unconsolidated clay rich material and weathered bedrock. At depths >20 mbgl this is likely indicative of moderately weathered shale bedrock. Around stations 255 – 290 this zone extends up to depth of 30 mbgl which is likely indicative of less competent weathered bedrock with signs of fracturing. At shallow depth around stations 250 – 260 this is likely indicative of bedrock with signs of fracturing.

- Yellow to orange contour (324 – 1160 ohm.m) values at shallow depth is likely indicative of weathered bedrock, grading into competent bedrock with depth.

- Red to purple contour (1161 – 2200 ohm.m) values is likely indicative competent bedrock extending from shallow depth to the full depth of investigation.

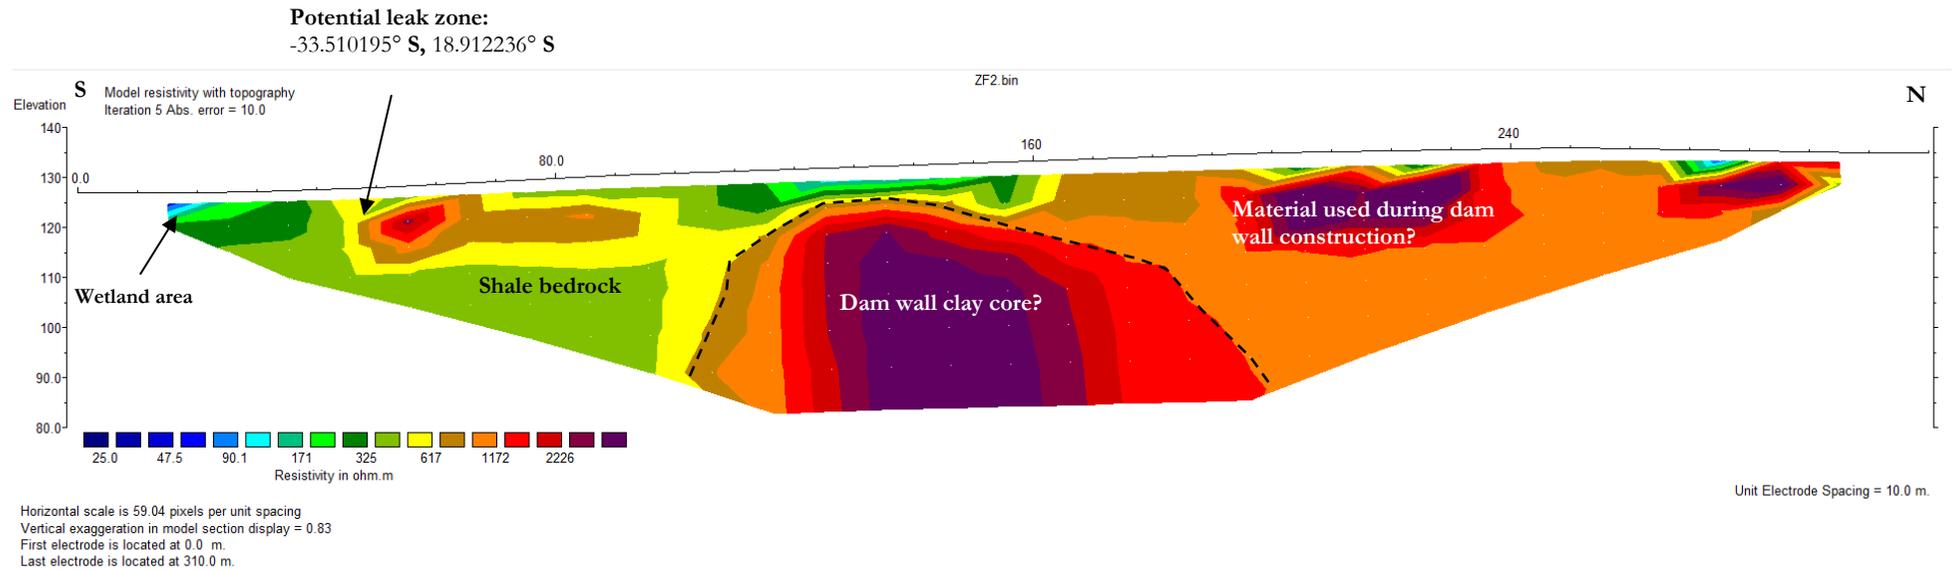
Figure 6: Inverted resistivity profile *Res_Line_2* showing investigation depth as elevation (mamsl).

- Dark blue to light blue contour (25 - 90 ohm.m) values at shallow depth is likely indicative of clay rich unconsolidated material and or clay rich material used during the dam wall construction Around stations 0 – 30 this correlates well with the dam outlet and a drainage area (this correlates well with the data from Res_Line_1).

- Light green to dark green contour (**91 – 323 ohm.m**) values at shallow depth is likely indicative of unconsolidated clay rich material and weathered bedrock. At depths >20 mbgl this is likely indicative of slightly weathered shale bedrock.
- Yellow to orange contour (**324 – 1160 ohm.m**) values at shallow depth is likely indicative of material used during the construction of the dam wall (stations 120 – 160). At depths >20 meters this is likely indicative of shale bedrock.
- Red to purple contour (**1161 – 2200 ohm.m**) values is likely indicative of material used during the construction of the dam wall, grading into bedrock with depth.

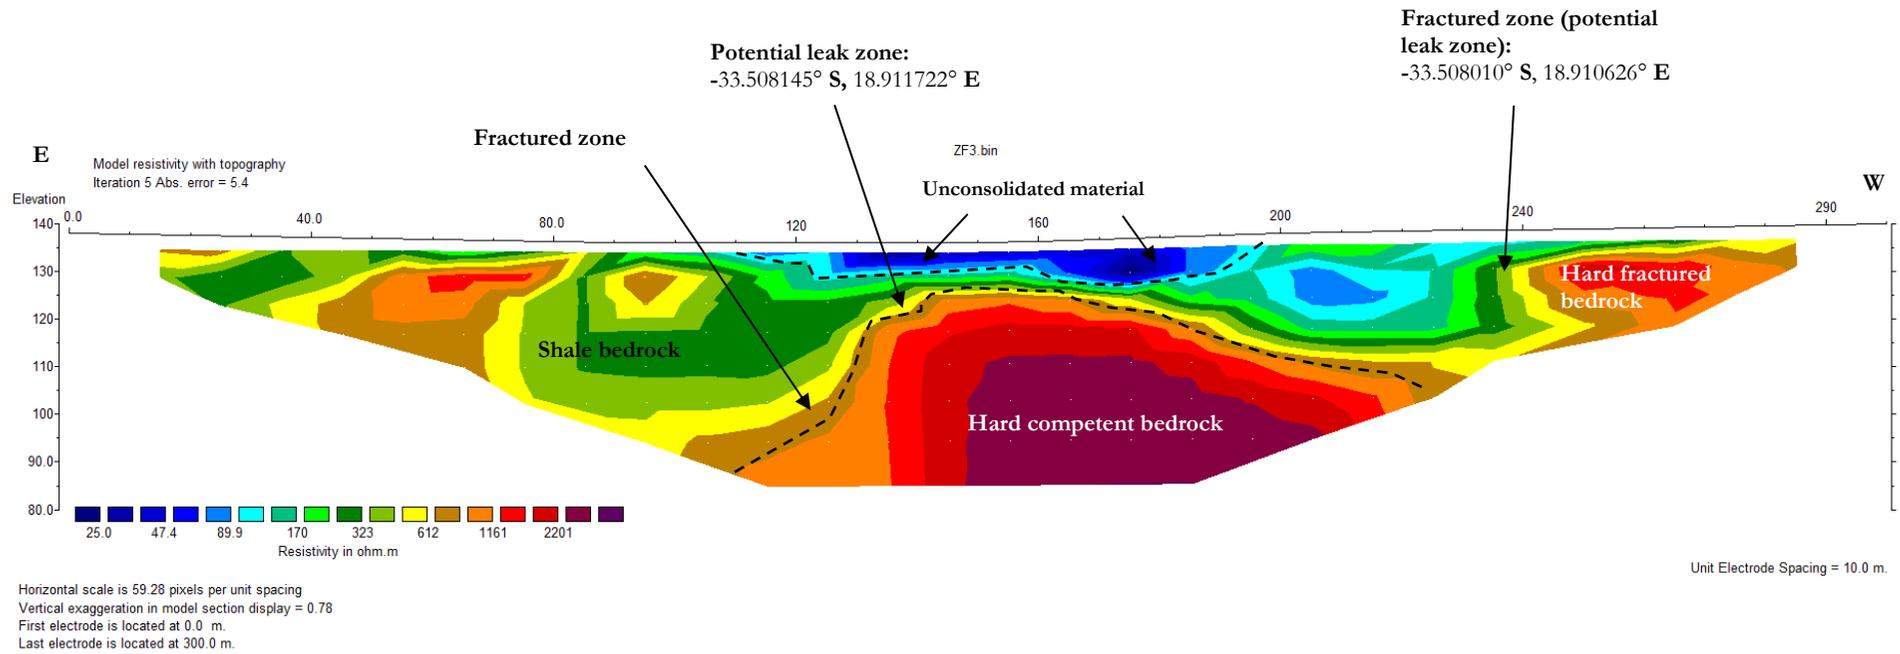
Figure 7: Inverted resistivity profile Res_Line_3 showing investigation depth as elevation (mamsl).

- Dark blue to light blue contour (**25 - 90 ohm.m**) values at shallow depth is likely indicative of moist clay rich unconsolidated material. The degree of water saturation is anticipated to increase with depth. This extends to depths of 25 mbgl around stations 160 – 240. This is likely semi water saturated as a result of regular irrigation of orchards upgradient of ERT traverse.

- Light green to dark green contour (**91 – 323 ohm.m**) values at shallow depth is likely indicative of unconsolidated clay rich material and weathered bedrock. At depths >20 mbgl this is likely indicative of moderately weathered clay rich bedrock. Around stations 0 – 130 this is anticipated to be clay rich unconsolidated material and moderately weathered bedrock at depths >10 meters, grading into competent bedrock. Around stations 230 – 250 this is anticipated to be competent fractured bedrock (this correlates well with profiles of TP_8B, showing fractured bedrock).

- Yellow to orange contour (**324 – 1160 ohm.m**) values at shallow depth is likely indicative of bedrock with signs of weathering. Degree of weathering is anticipated to decrease with an increase in depth.

- Red to purple contour (**1161 – 2200 ohm.m**) values is likely indicative competent bedrock extending from shallow depth to the full depth of investigation. Around stations 110 – 190 this can be associated with hard competent bedrock.

The data from all of the ERT traverses completed shows a relatively shallow depth to bedrock and the area would require fairly shallow excavations to reach hard bedrock. From the ERT survey conducted and field observations, potential leakage is expected through fractured zones in the shallow bedrock. Leakage is expected to decrease over time with silt and clay build up. Several areas were identified where the bedrock is expected to be fractured, correlating with fractured bedrock in the trial pits dug during a previous investigation, which may act as preferential flow paths for water. Several areas have been identified with a high risk for leakage through fractured bedrock. The data from Res_Line_1 indicates that there is a potential existing leak zone below the dam wall due to fractured bedrock (around stations 250 – 270). Where two anomalies have been delineated from the data of Res_Line_3 (around stations 130 – 140 and 230 – 240) that have a high risk of leakage due to shallow unconfined fractured bedrock.

For the structural integrity of the dam wall it is recommended that excavations are made to a depth where competent bedrock is intersected.
