Google Earth image of the photograph positions. Photographs taken on 19 May 2020

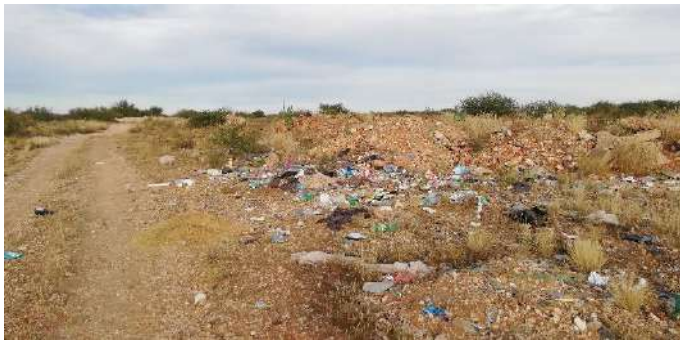
Photo 3: Taken from point 1, looking west over the site. Notice extensive dumping on the site.

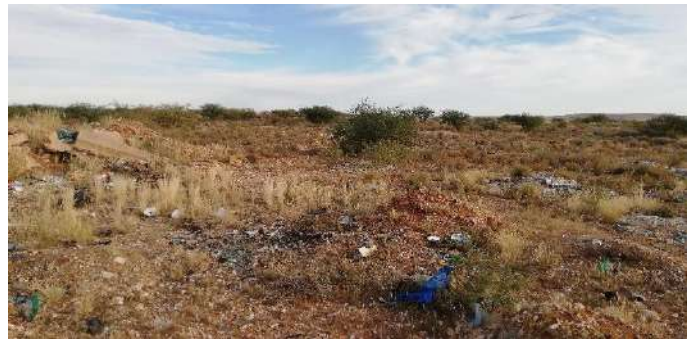
Photo 4: Taken from point 1, looking north-west over the site. Notice extensive dumping on the site.

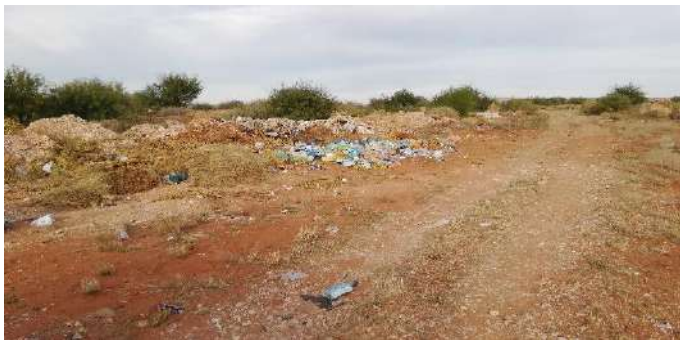
Photo 5: Taken from point 2. The extensive dumping on this part of the site is clearly visible.

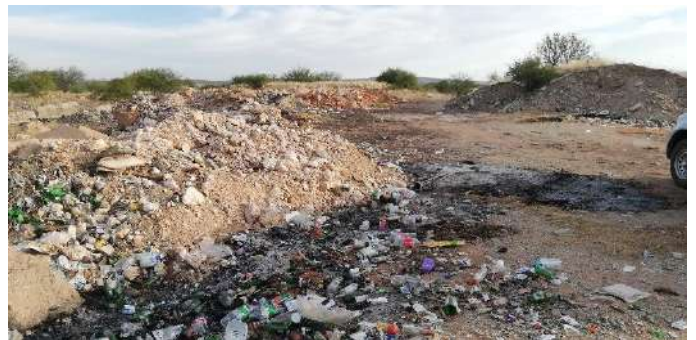
Photo 6: Taken from point 2. The extensive dumping on this part of the site is clearly visible.

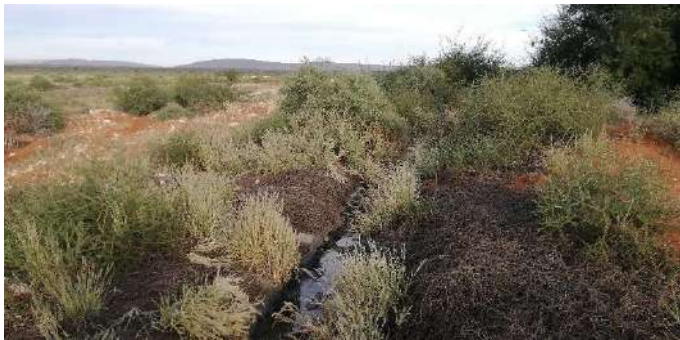
Photo 11: Taken from point 4, looking west. The raw sewage flowing in an open trench is visible in this image.

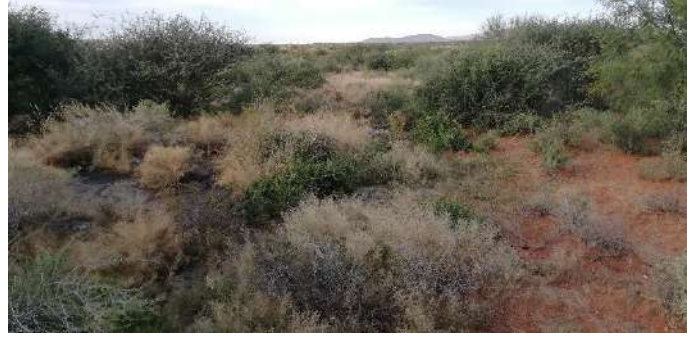
Photo 12: Taken from point 5, where the raw sewage is overflowing from the trench onto the open ground. This flow is clearly visible from the Google Earth image
