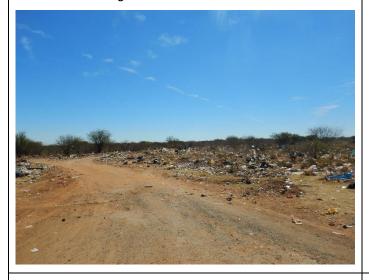
Photo 4: Taken from point 2, looking north from Camelia Str over the Site. The large amounts of illegal dumping is evident in this image.

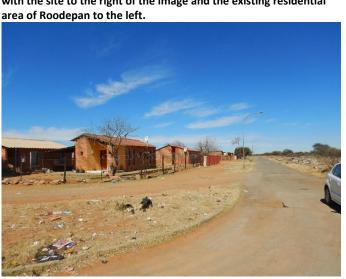
Photo 5: Taken from point 2, looking south-west down Camelia Str, with the site to the right of the image and the existing residential

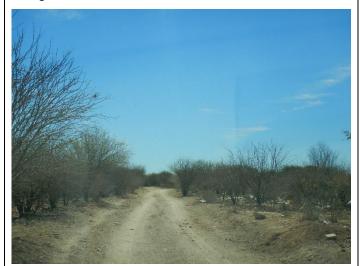
Photo 9: Taken from point 5, looking north-west over the site.

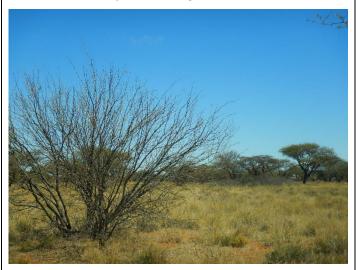
Photo 11: Taken from point 6, looking south-west. The degraded nature of the site and illegal waste dumping is evident closer to the boundary of the site.

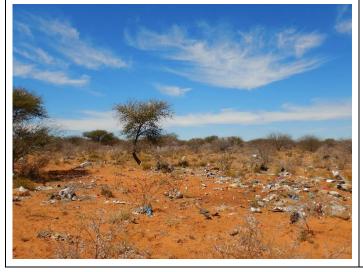
Photo 8: Taken from point 4, at the existing livestock pens to the north of the site.

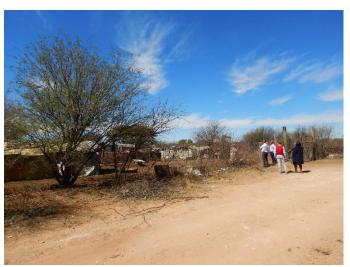
Photo 10: Taken from point 5, looking south over the site.

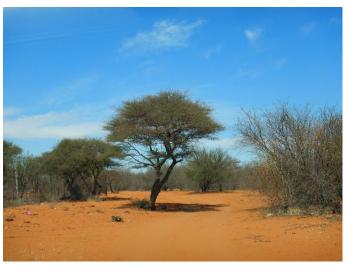
Photo 12: Taken from point 6, looking south-east. The degraded nature of the site and illegal waste dumping is evident closer to the boundary of the site.

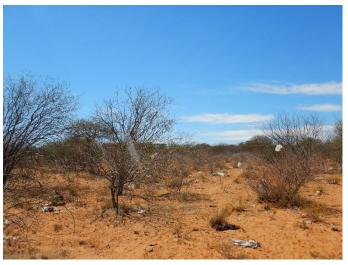
Photo 13: Taken from point 7, looking north-west. The site (Erf 15089 can be seen to the right of the image, and the existing informal residences to the left.

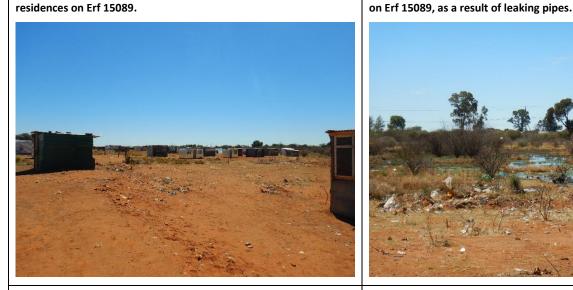
Photo 10: Taken from point 7, looking north-east at the wet area

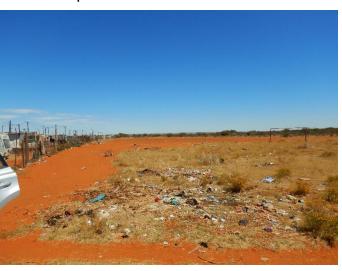
Photo 11: Taken from point 8, looking west. The site (Rem. Farm 70) can be seen to the right of the image. The area is currently used as an informal sports field.

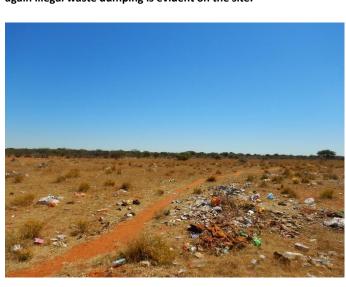
Photo 12: Taken from point 8, looking north over the site. Once again illegal waste dumping is evident on the site.
