Appendix C_Site Photos

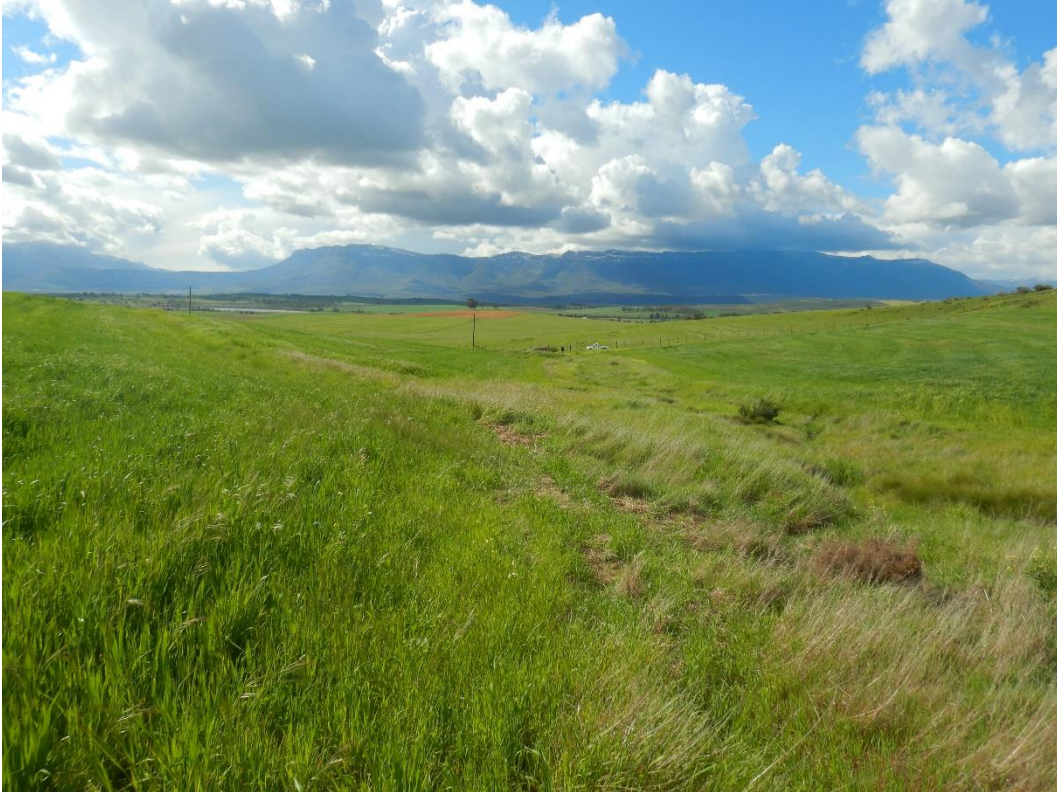
Figure 1: Photo taken standing in the proximity of the dam toe locality, facing North towards the locality of the dam wall. Drainage line visible in the photo

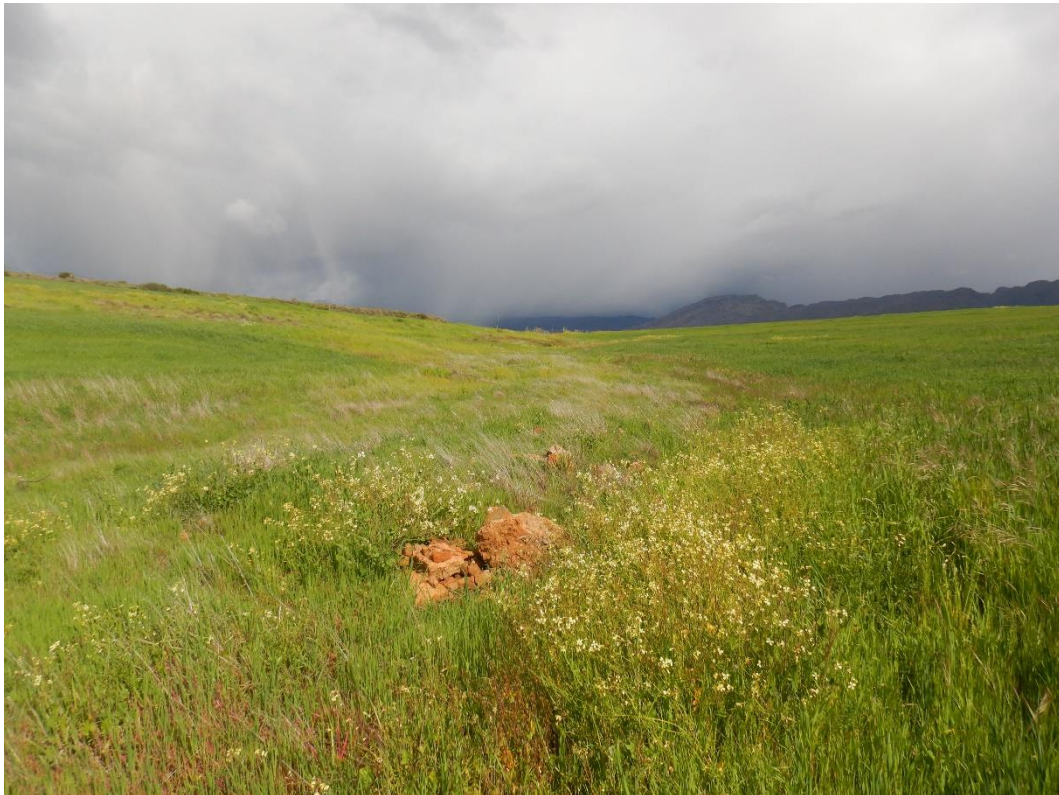
Figure 6: Photo taken facing South. Drainage line visible
