CALITZDORP ROADS UPGRADE DR1688 & DR1699

PROPOSED UPGRADE OF THE DR1688 AND DR1699, BETWEEN CALITZDORP AND OUDTSHOORN, WESTERN CAPE PROVINCE

COMPLIANCE AUDIT REPORT (REVISION 2)

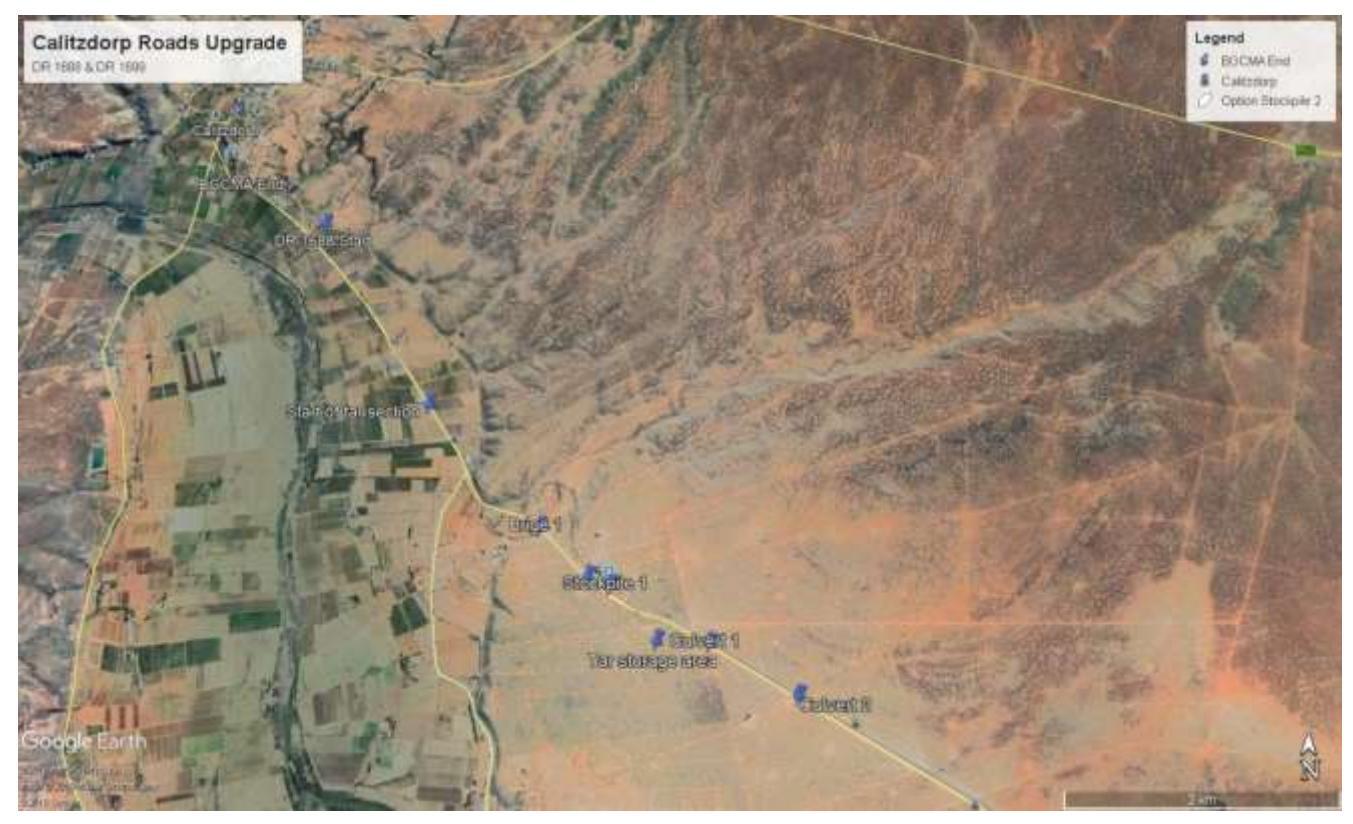
Figure 1: An overview of the DR 1699, showing the first section of the road in progress

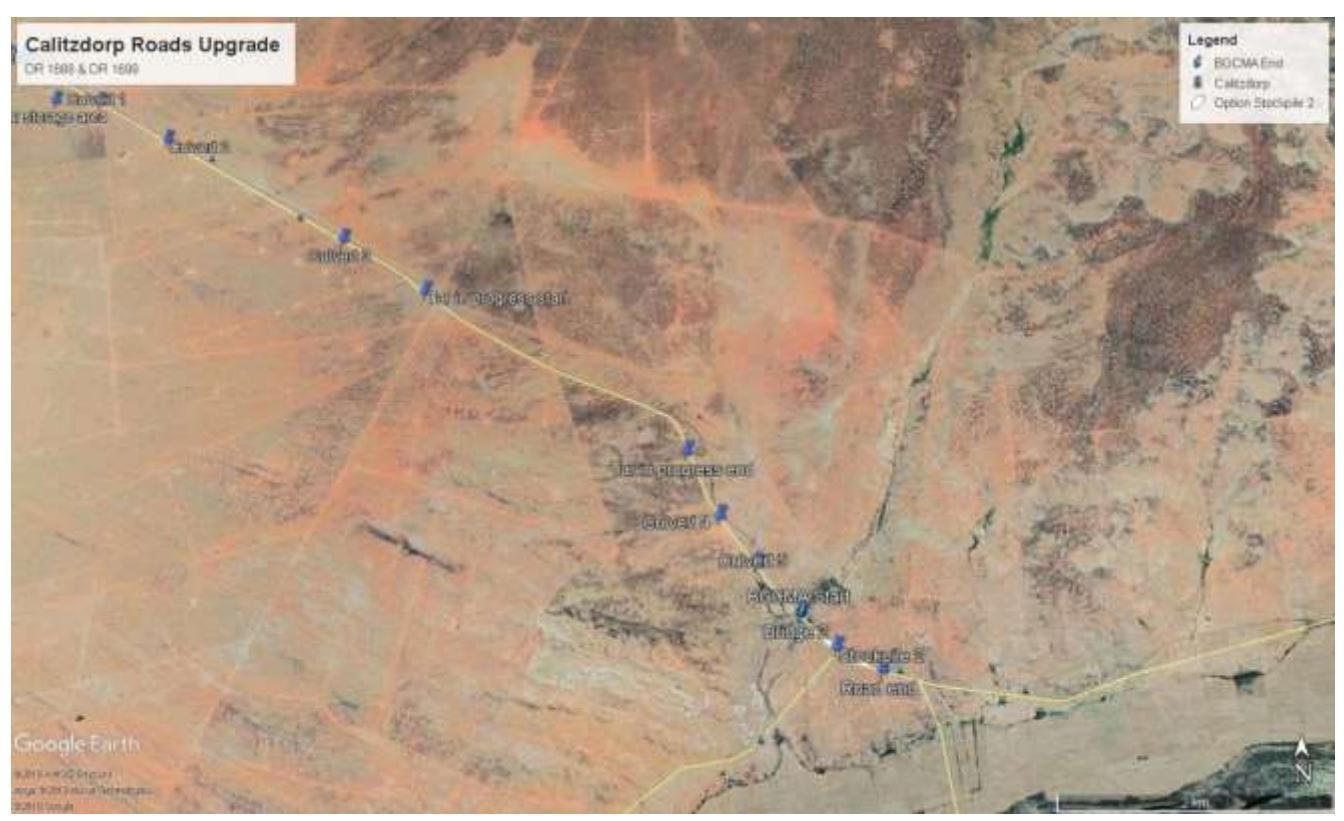
Figure 2: An overview of the DR 1699, showing the second section of the road in progress (15km mark)

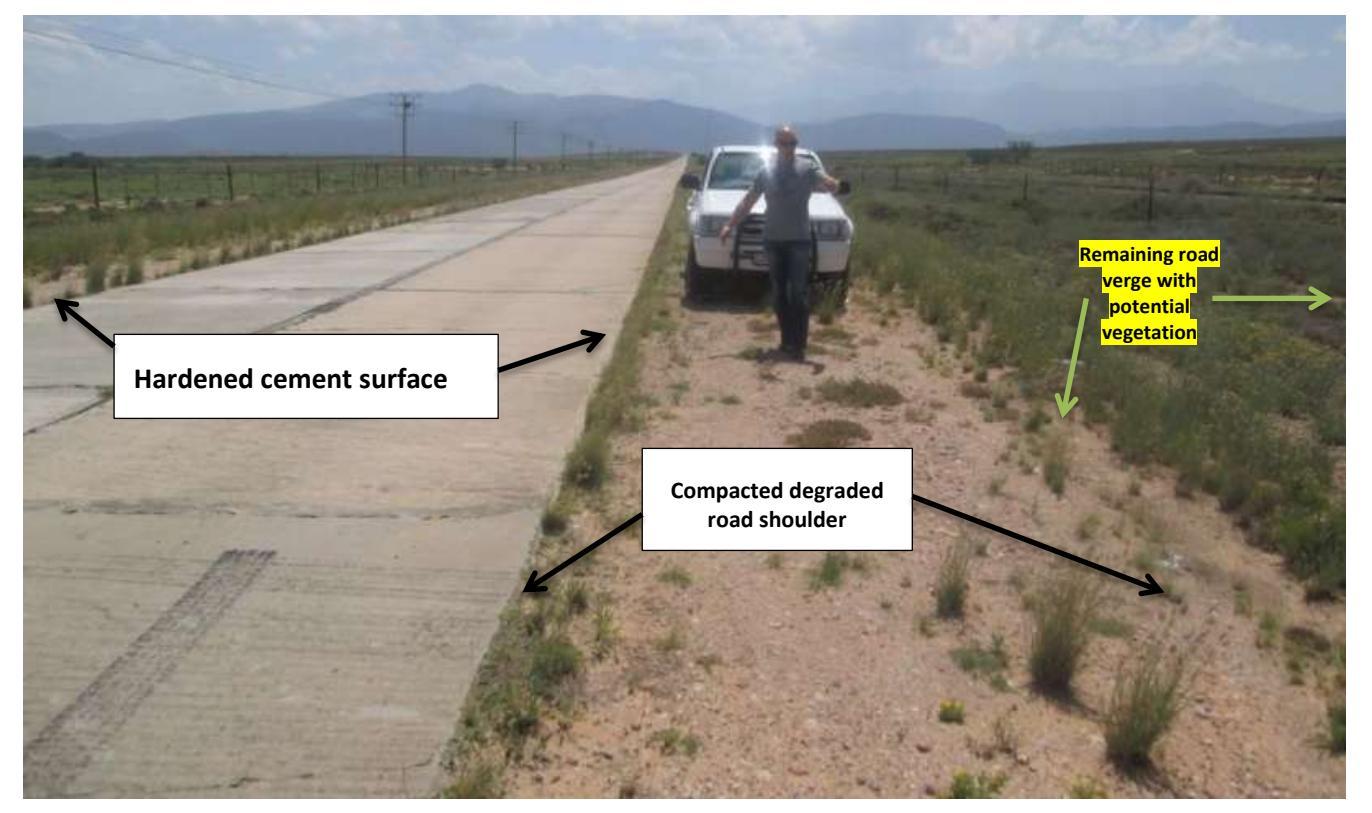
Photo 1: The DR1688 road reserve (photo taken from the EMP, Figure 1 within the EMP)

Both the EMP and the Botanical reports recommended the protection of any remaining natural veld that is encountered between the hardened road shoulder and the road reserve boundary fence (Refer to Photo 1 in this report). From the ECO reports and on-site verification this was clearly not a viable option in terms of the current construction method.
