Appendix 3 - Site Photos

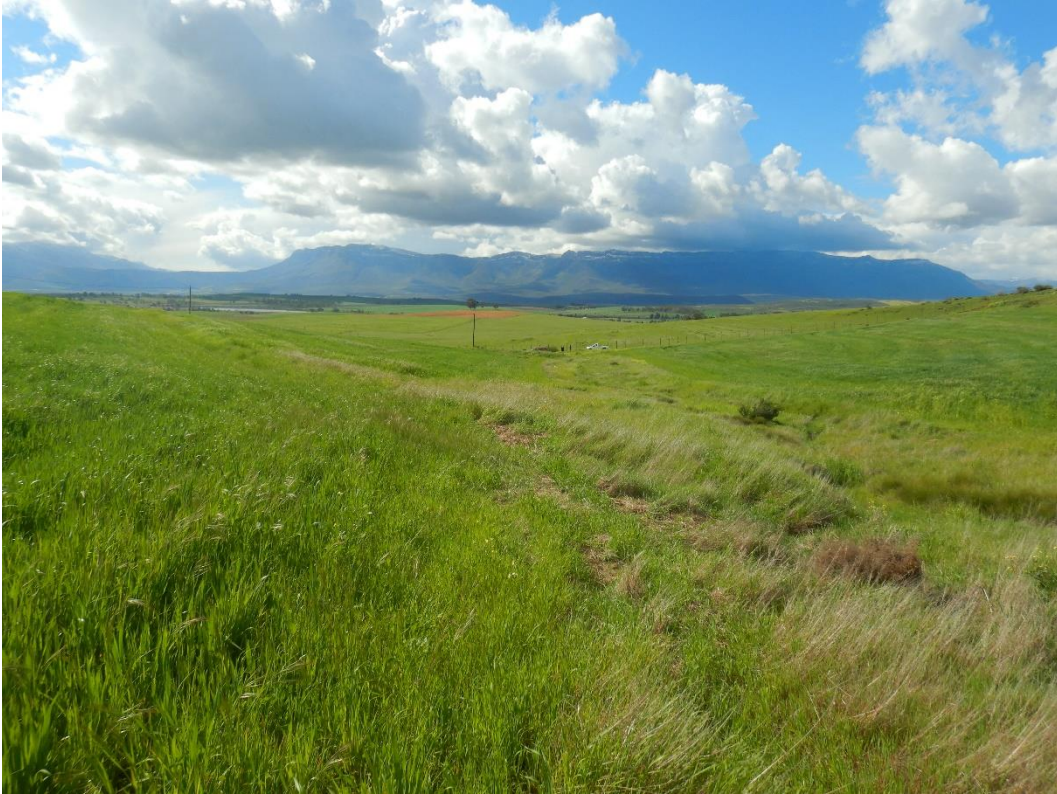
*Figure 1: Photo taken standing in the proximity of the dam toe locality, facing North towards the locality of the dam wall.
The drainage line visible in the photo*

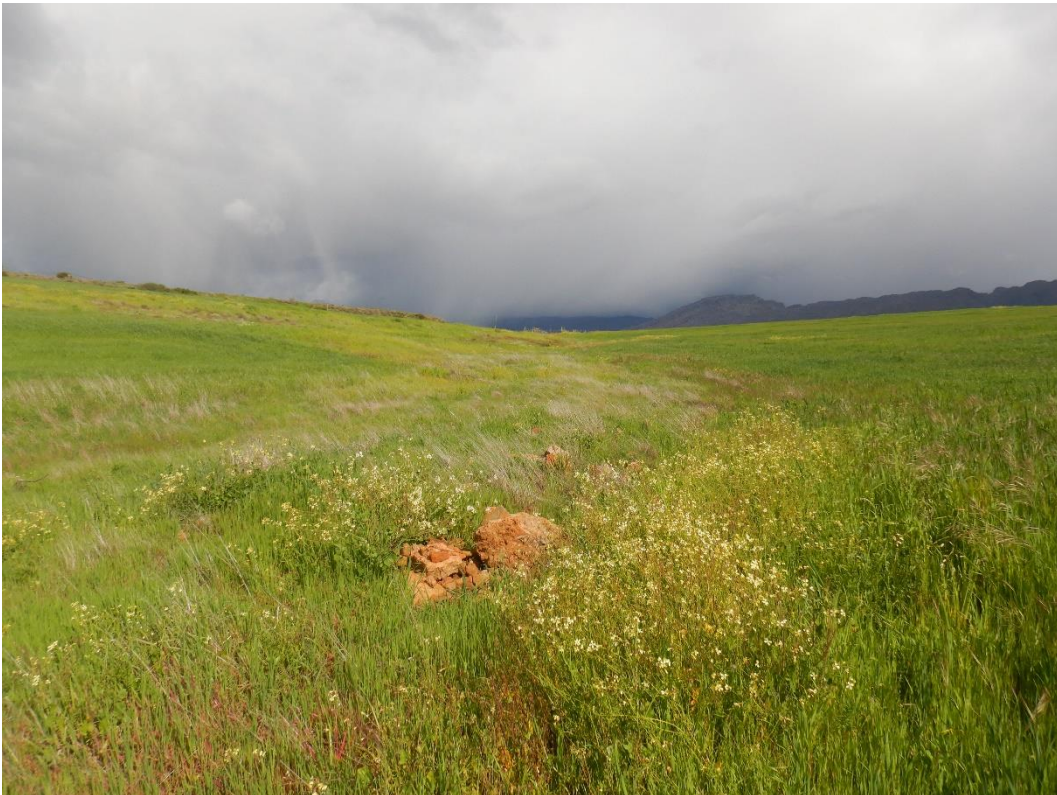
Figure 6: Photo taken facing South. Drainage line visible
