CONSERVATION INTELLIGENCE: LANDSCAPE CENTRAL

RE: Proposed construction of a 2.5km pipeline on Erven 1886 & 1887, including a section through Wittebrug Nature Reserve – Draft Basic Assessment Report.

DEA&DP Ref: 16/3/3/6/7/1/B5/2/1524/22

Annexure A: Photographs from site visit

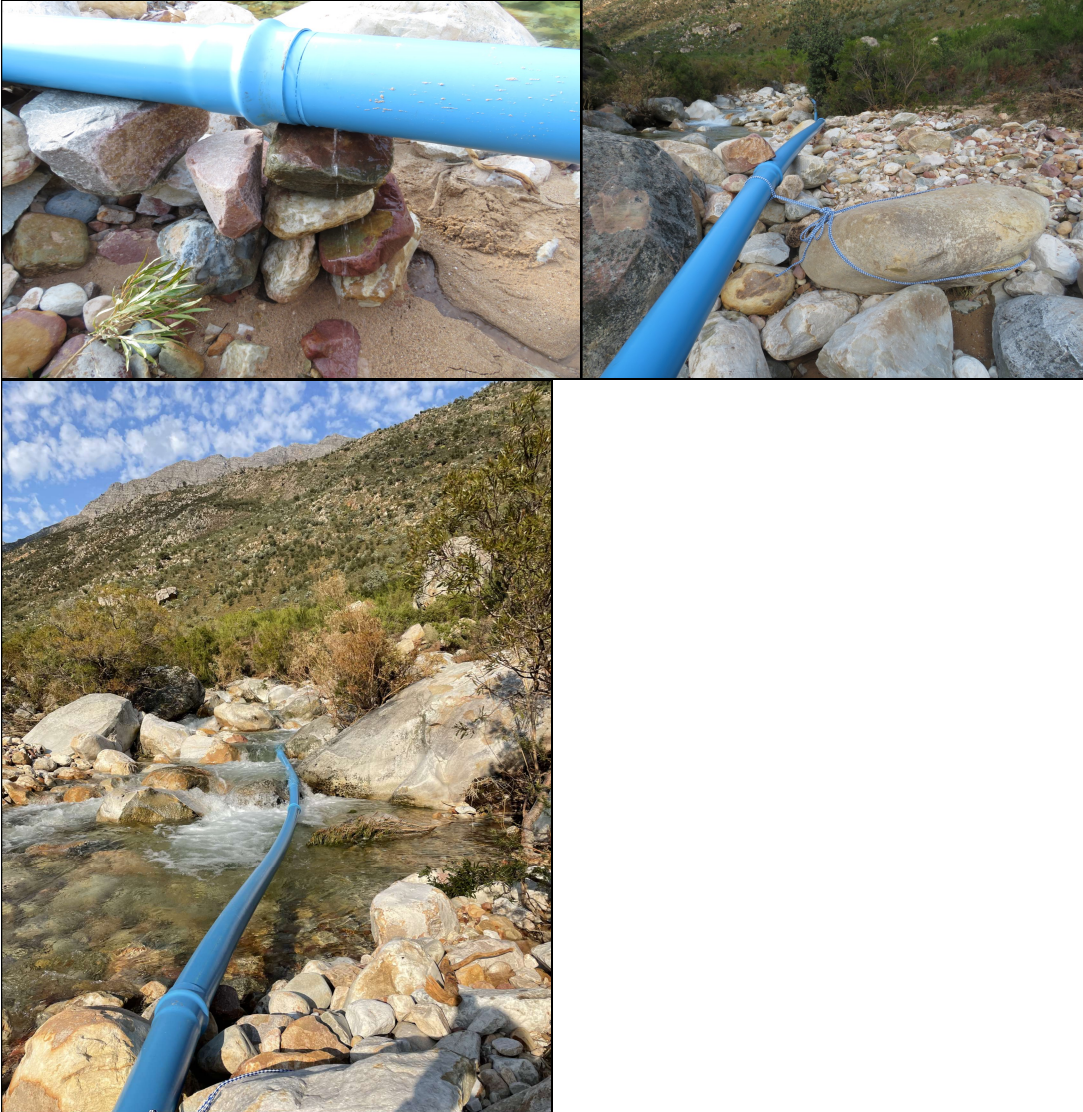
Plates 1a, 1b and 1c: Photographs near weir of blue plastic pipe which is precariously placed and needs to be replaced with a pipeline that blends into the environment. It is not clear when this blue pipeline was installed.

- We strongly agree that the new pipeline must blend into the environment where it is above ground. The current section of blue HDPE pipeline placed along a section from the weir is not acceptable.

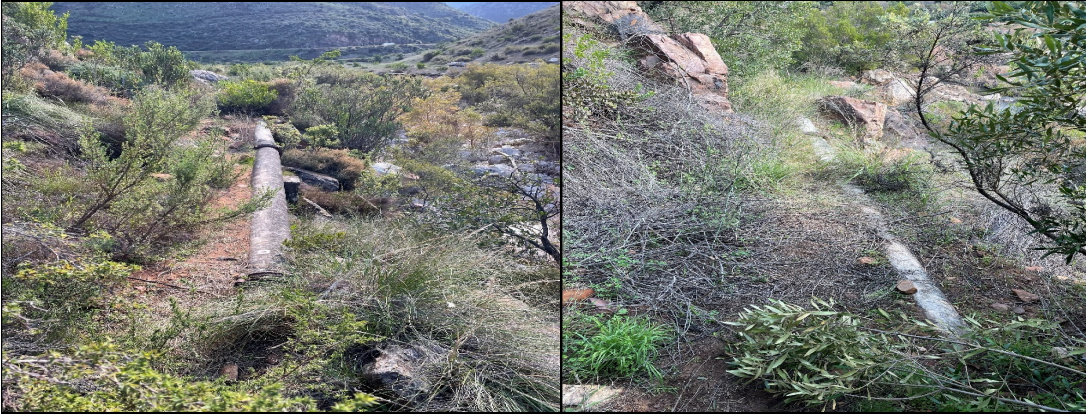
Plates 2a and 2b: Where the existing pipeline is buried or partly buried such as in these sites it should be left in place to prevent erosion.

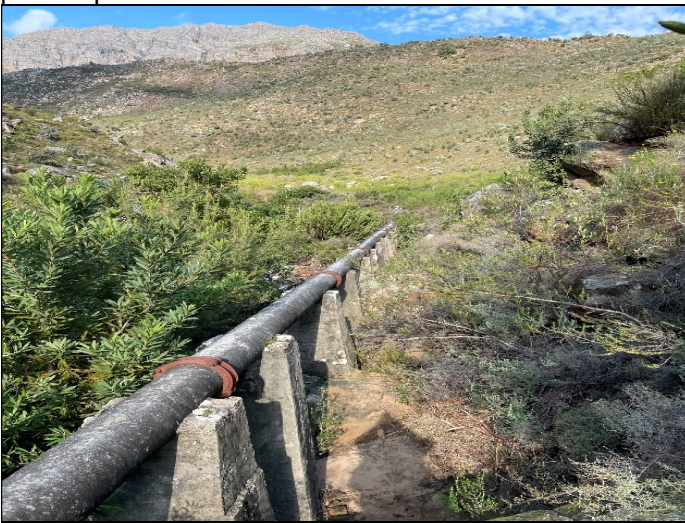
Plate 3: The existing support structures are quite substantial and should be reused if possible to minimise disturbance and reduce rubble that has to be removed from site. No additional structure should be built on the river side of the existing structures.

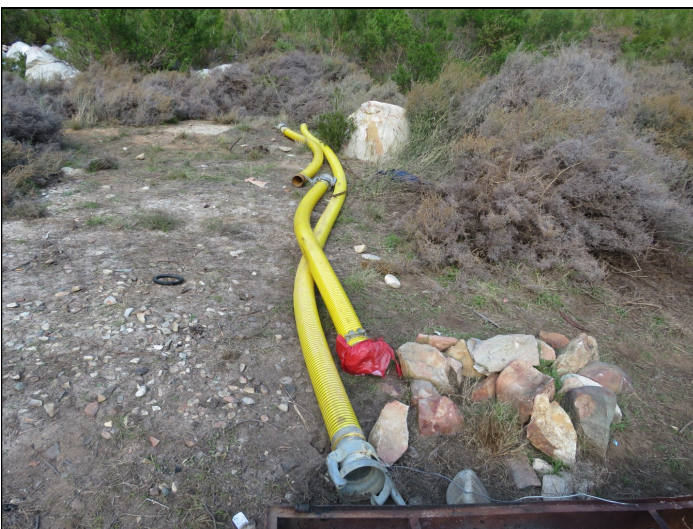
Plate 4: Discarded pipes and “braai” observed near the weir. Broken pieces of cement/asbestos pipe were also observed along the trail.

14. Broken structures, pipelines (plastic and asbestos/cement) and other equipment must be completely removed.
