**Botanical Assessment
for a proposed dam at
Van der Watts Kraal 399 Portion 5,
near Riviersonderend, Overberg,
Western Cape Province**

Prepared for EnviroAfrica

October 2017

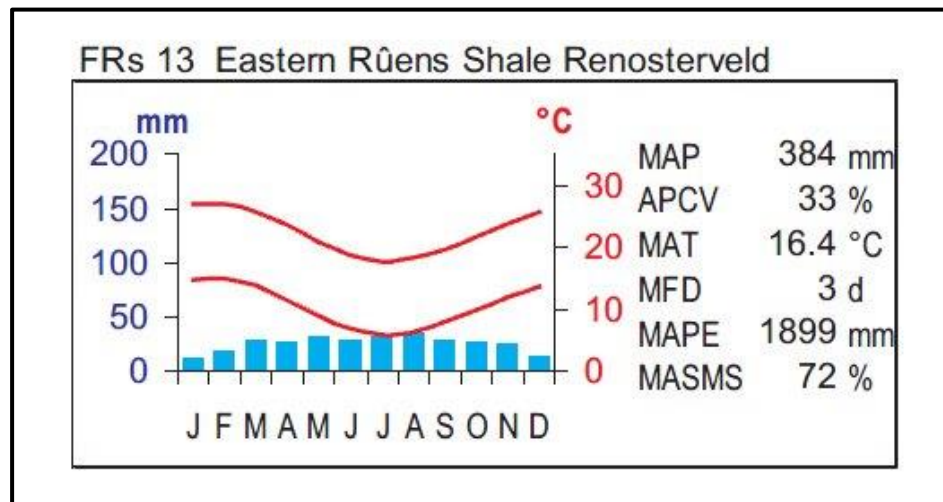
Figure 6. Climate diagram for Eastern Rûens Shale Renosterveld (from Rebelo et al. 2006 in Mucina & Rutherford, 2006) showing MAP – Mean Annual Precipitation; APCV = Annual Precipitation Coefficient of Variance; MAT = Mean Annual Temperature; MFD = Mean Frost Days; MAPE = Mean Annual Potential Evaporation; MASMA = Mean Annual Soil Moisture Stress.

Van der Watts Kraal (Dasberg) lies within a climate zone which is transitional between the winter-rainfall region of the extreme Western Cape and the non-seasonal rainfall region in the east. The climate of Van der Watts Kraal is similar to that of Bredasdorp for which rainfall (Figure 4) and temperature (Figure 5) information is available. Rain occurs in the winter months when westerly winds associated with cold fronts sweep across the southern Cape. During spring and autumn cold onshore winds that blow over the warm Agulhas Current draw moisture which is deposited over the land. Mean annual precipitation is in the order of 400 mm *per annum* (Figure 6).

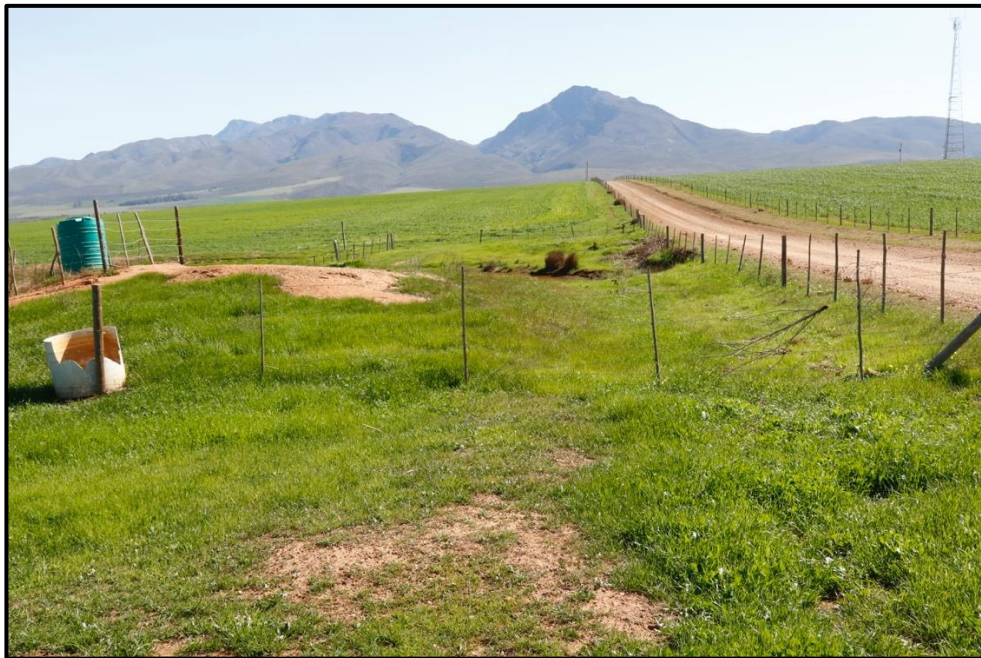
Figure 8. The access point at the farm road above the existing two small farm dams and upslope from the study site. The vegetation is completely transformed here.

This waypoint was at the main access road in the dam catchment from where the site was accessed. This would be the point from which construction would be initiated but does not fall within the dam inundation area. This area is completely transformed, with two small dams on the water-course. The vegetation is all exotic herbaceous species.

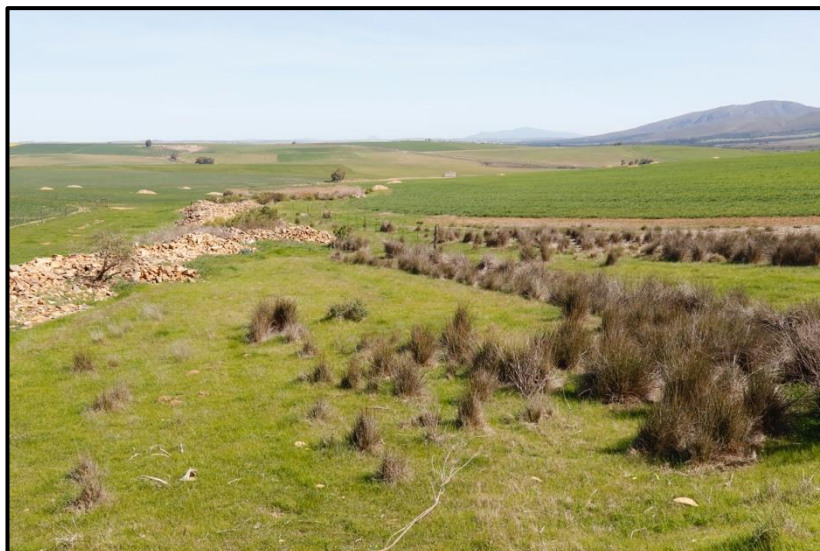
Figure 10. View westwards over the study area. Note the rush (*Juncus cf. kraussii*) in the foreground and the piles of rock adjacent to the drainage line.

The waypoint was recorded on the dam wall of the lower existing small dam. Figure 10 shows the view westwards from the dam wall following the line of the stream or water-course. The natural vegetation has mostly been lost at this waypoint (which would not fall within the inundation area). The main vegetation is a grassy sward that is grazed. The water channel is lined with *Juncus cf. kraussii*. Other plant species recorded here include *Asparagus capensis*, *Berkheya rigidus*, *Conyza scabrida*, *Cynodon dactylon*, *Moraea cf. flaccida*, *Oxalis pes-caprae*, *Oxalis purpurea* and *Searsia pallens*. Piles of shale rock are on the edge of the wheat-land, having been ploughed out during cultivation (Figure 11).

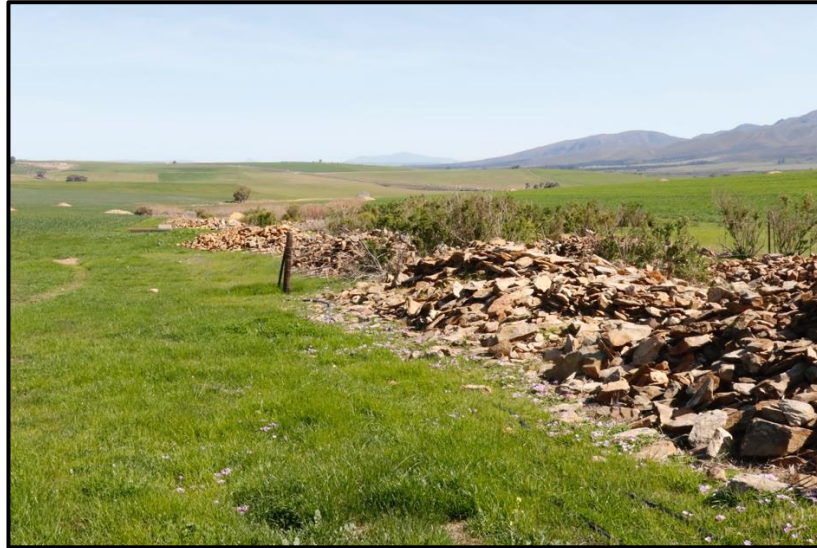
Figure 11. Piles of shale rock removed from the ploughed fields, placed between the field and the drainage line (stream).

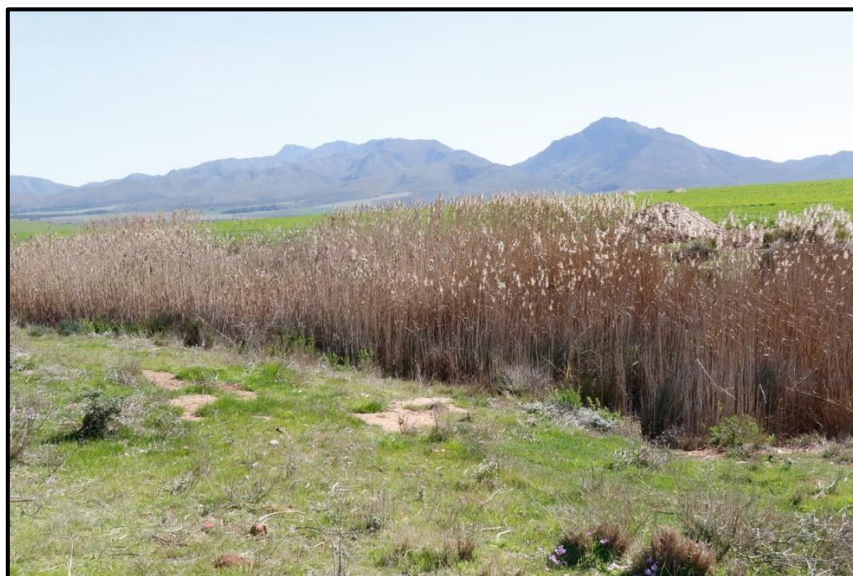
Figure 12. Common reed (*Phragmites australis*) in the stream-bed.

This waypoint is at a soil pit (Figure 13) near the main drainage channel (stream). At this point the stream is dominated by *Phragmites australis* (common reed) (Figure 12) but *Juncus* cf. *kraussii* (rush) is also present. Other plant species recorded at this waypoint include *Arctotheca calendula*, *Asparagus capensis*, *Conyza scabrida*, *Galenia africana*, *Helichrysum crispum*, *Lycium cinereum*, *Oxalis purpurea*, *Oxalis* sp. (red), *Pteronia* sp., *Ruschia* sp. and *Senecio* sp.

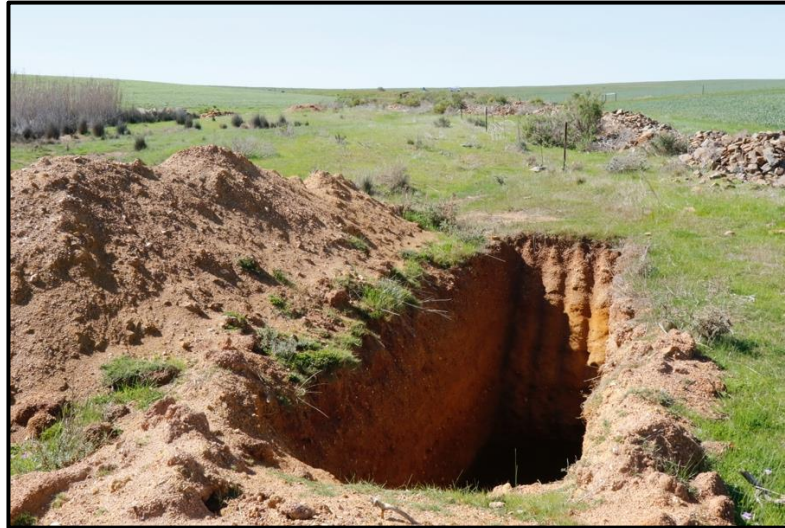
Figure 13. Soil pit at waypoint VDW3. This area would be within the inundation zone.

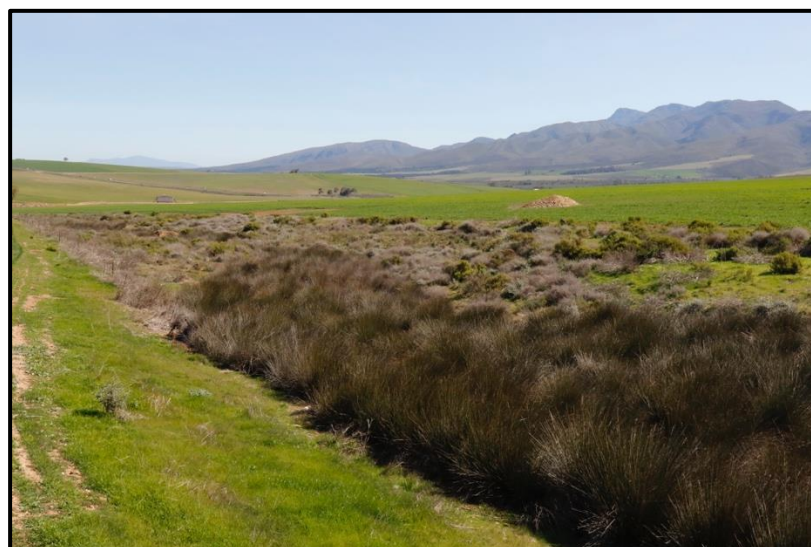
Figure 14. *Juncus* cf. *kraussii* in the foreground with the remnant Central Rûens Shale Renosterveld further west (greyish vegetation).

Waypoint VDW 4 is at a patch of remnant renosterveld that is rich in species (Figures 14 & 15). This location would be within the area inundated by the dam. Plant species recorded include *Arctotis acaulis*, *Asparagus capensis*, *Babiana* sp., *Brunsvigia* cf. *orientalis*, *Chrysocoma* sp., *Cotula turbinata*, *Cyphia* cf. *digitata*, *Drosanthemum* sp., *Galenia africana*, *Gladiolus gracilis*, *Helichrysum crispum*, *Linum cinereum*, *Microloma sagittatum*, *Moraea ciliata*, *Oxalis purpurea*, *Oxalis* sp. (red), *Polygala garcinii*, *Romulea flava*, *Sparaxis* sp., *Syringodea longituba*, *Tenaxia stricta*, *Trachyandra* sp., *Trichodiadema* sp., *Tulbaghia alliacea* and *Indigofera heterophylla*. (Some of the plant species encountered are illustrated below).

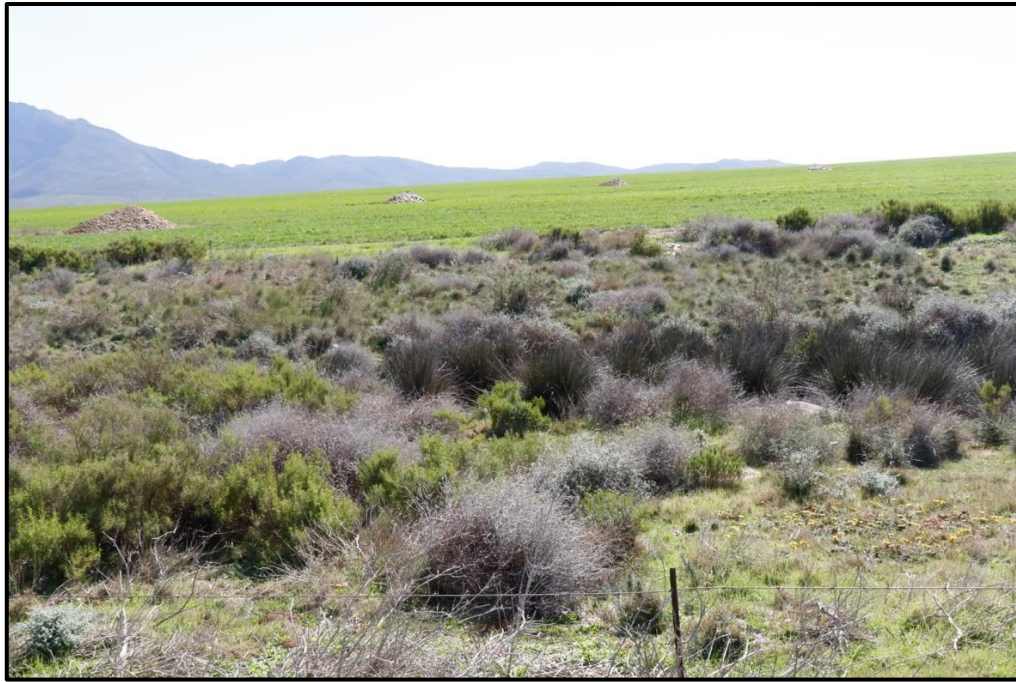
Figure 15. Remnant Central Rûens Shale Renosterveld in vicinity of waypoint VDW 4.

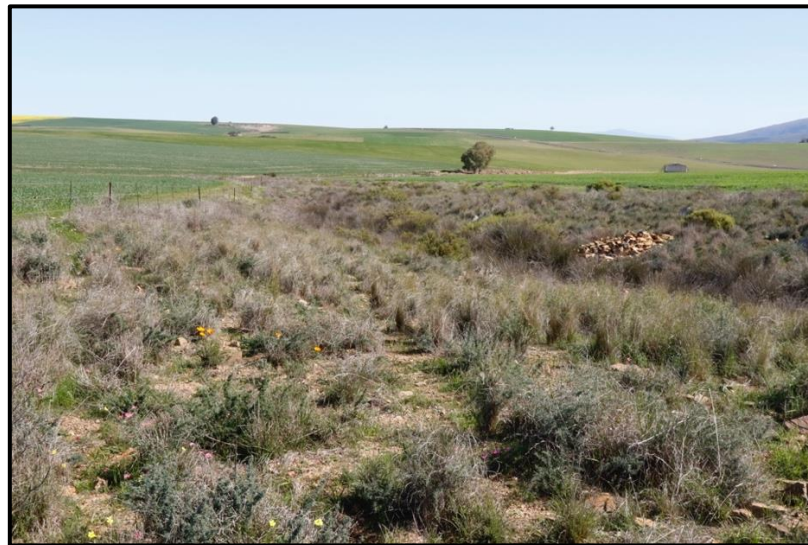
Figure 16. The area of the Central Rûens Shale Renosterveld around waypoint VDW 5 that would be affected by the dam. The area to the west can act as a receptor area for relocated plants.

It is recommended that the area below the dam wall (west of waypoint VDW 5) (Figures 16 & 17) should be a receptor area for plants that are rescued from the area of the dam (wall and inundation area). [See below under 'Mitigation']. Note the rocky nature of the terrain in Figure 17, providing many niches for various plant species.

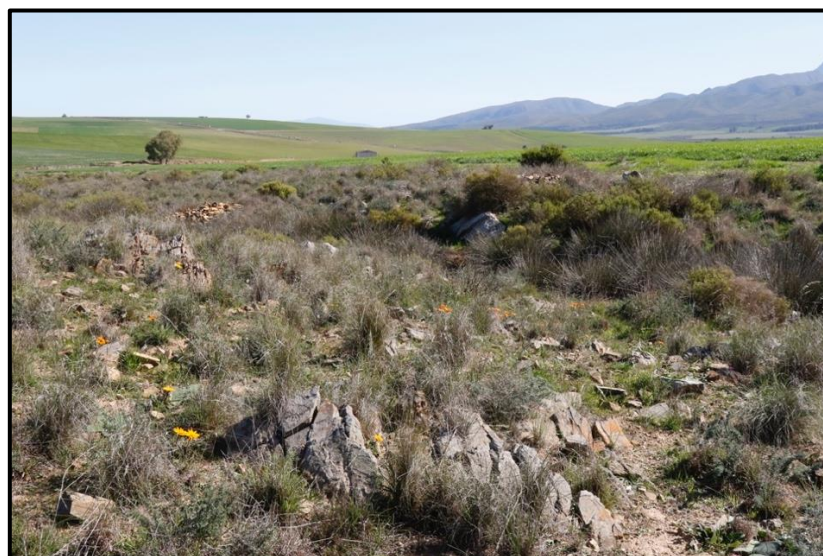
Figure 17. The area of the Central Rûens Shale Renosterveld around waypoint VDW 5 is notably rocky, creating numerous niches for plants. These plants should be rescued before the dam wall is constructed.

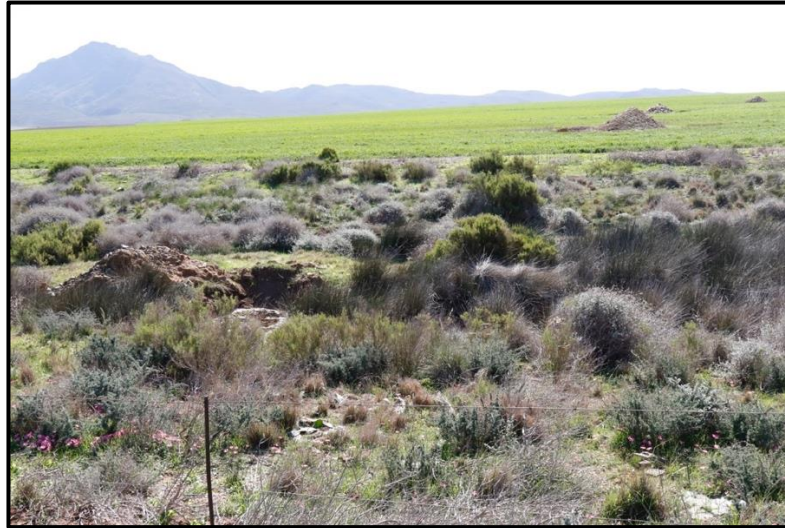
Figure 18. A soil pit within the remnant the Central Rûens Shale Renosterveld around waypoint VDW 6 at the position of the proposed dam wall. Other soil pits can be seen in the cultivated field in the background.

This waypoint is at the position (on the line) of a series of soil pits. The image in Figure 18 shows a soil-pit in the immediate foreground (in the remnant renosterveld) and a series of soil pits to the north in the cultivated field which would fall within the inundated area.

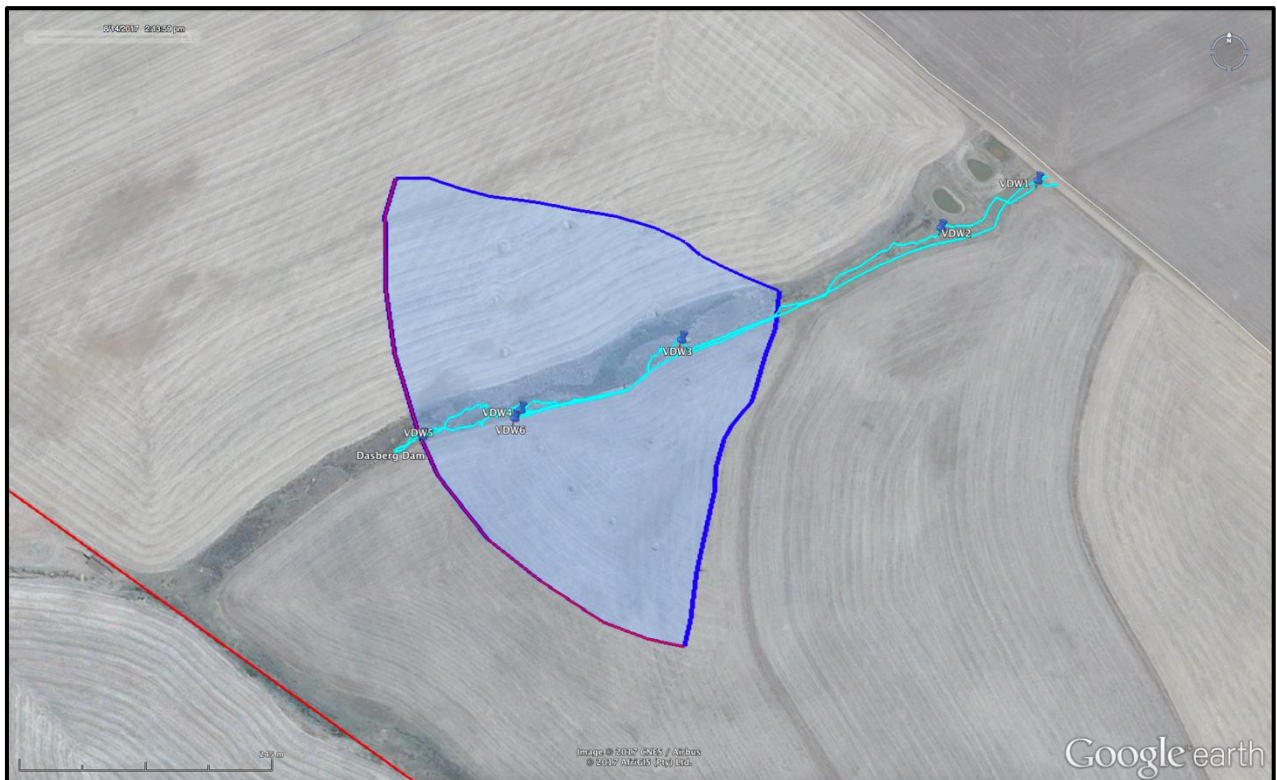
Figure 20. Magnified aerial image of the area of the proposed Dasberg Dam (blue shading) with the

The proposed dam would have an earth wall that would be orientated in a roughly north-west – south-east direction. The dam wall would extend in a shallow arc from cultivated fields to the north of the stream, across the stream to cultivated fields south of the stream. The anticipated inundation by the dam at full supply level is shown in Figure 20 and would cover approximately 8.8 ha.
