Heritage Impact Assessment, Hakskeen Pan, in the Dawid Kruiper Local Municipality, Northern Cape, in relation to tourism and event-related development: Final Report (Revised)

> David Morris (Order OR-002815: Supplier E4234) 15 December 2016

Prepared by: Prof David Morris, Head of Archaeology, McGregor Museum P.O. Box 316, Kimberley, 8300 dmorriskby@gmail.com

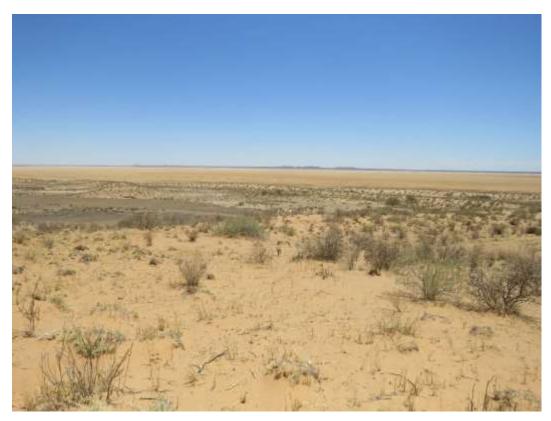
Figure 2. View from the dunes at the east in a south westerly direction

Hakskeenpan is a mud and salt pan situated between the Towns of Mier and Rietfontein in the Kalahari Desert in the Northern Cape Province, South Africa. It is one of the largest isolated or closed pans ((depressions) in the South African Kalaharilt, with an area of approximately 140 km<sup>2</sup>, at an elevation of about 800 m above sea level. A number of farms converge across or around the edges of the pan, while the R31 main road from Mier to Rietfontein crosses the northern-most section of it. An older road had traversed the pan a little south of the new road. There are no major buildings or other features, except an MTN mast beside the tarred road at the north-western side of the pan, an existing 'Speed Week Camp', and Speed Week Track and other infrastructure at the eastern side of the pan. A farm worker's dwelling is situated next to the old road as it descends into the pan at the north eastern part of the pan. The pan as a whole and its sides make for significant vistas (Fig. 2).

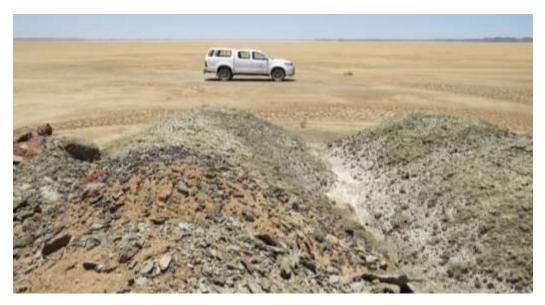
Piles of stone that was cleared from the track were inspected for any indication of heritage traces that may have existed on the pan floor. Much of this material was found to be rock that is sedimentary and not in any way archaeological in nature. A second component consists of small quartzite and other pebbles, many of them rounded, possibly derived from Dwyka tillite known to occur in the wider landscape. A very few of these latter had been flaked or consisted of flakes, constituting an extremely ephemeral archaeological trace on the pan floor. Their very small number indicates a near to zero impact on archaeological traces by any of the proposed developments on the pan surface itself including in the vicinity of the MNT tower and the proposed fuel depots. While traversing the pan not a single such artefact was found *in situ*.

Two such piles were documented at  $26^{\circ}46'39.9'' \ 20^{\circ}12'18.2''$  (Figs 4-6) and at  $26^{\circ}50'13.1'' \ 20^{\circ}13'22.4''$  (Fig 7)

Figure 4. Pile of rock recovered from the Pan floor situated adjacent to the old road / causeway traversing the northern end of the pan.

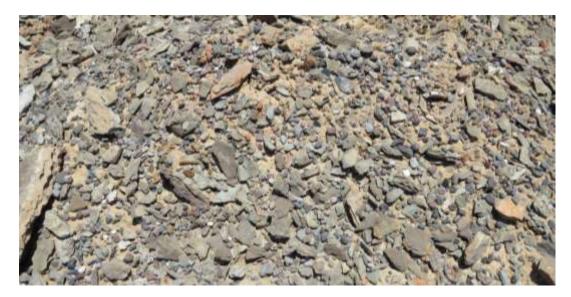
Figures 5 (above) & 6 (below). View of a heap containing generally smaller non-sedimentary rocks (i.e. suitable for flaking). A minute component of these stone showed signs of flaking (below)

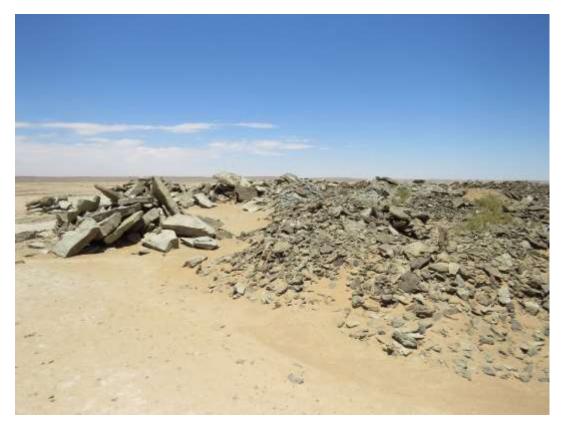
Figure 7. A further heap of stone material piled up from clearance of one of the rocky parts of the Pan floor. No artefacts were found here at all.

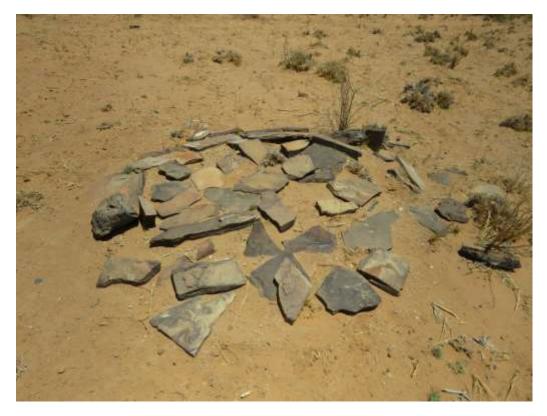
An unmarked grave, elliptical in shape and capped by flat stones, was recorded at  $26^{\circ}46'00.6'' \ 20^{\circ}13'50.0''$  (Fig 8). This was thought by local farm workers to be a "Bushman Grave". The presence of head and foot stones indicates that it is not of precolonial context but rather reflects Christian influence. It is impossible from the form of the grave and its situation to say anything about the identity of the buried individual. It may be significant that it is situated not far from the old road crossing the pan. The stones used for packing onto the cairn are derived from exposed rock beds a few hundred metres south of the grave. Isolated pieces of ostrich eggshell were noted but could not be linked with the grave (see similar observations below).

Figure 8. Grave on side of dune near old road.

The above evaluation of the significance of impacts indicates that in all pan and pan-side settings, with the exception of the grave site, the significance of impact is likely to be low. The grave site is of high sensitivity and it is recommended that it be a no-go area. A mitigation strategy for all other areas, especially with respect to secondary facilities (i.e. subsidiary infrastructure such as accommodation, workshops, media centre, eateries, roads, car parks etc), is recommended to be in the form of a heritage management plan as part of the EMP (3.8 below).

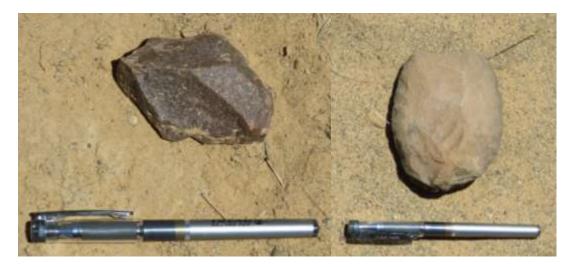
Figures 10 & 11. Flaked quartzite and handaxe.

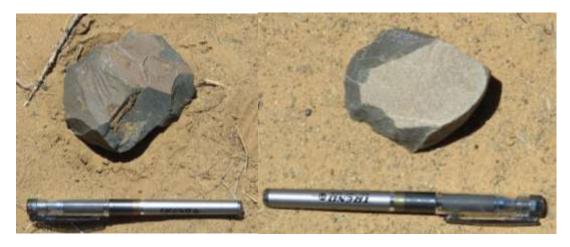
Figures 12 & 13. Chert core and large quartzite scraper

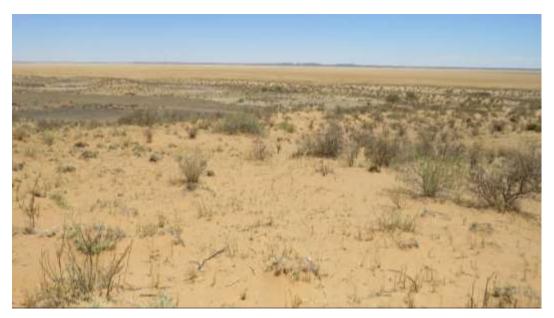
Figures 15 (above) & 16 (below). Landscape setting showing dunes on the east side of the pan adjacent to the 'Landside'/'Speedweek' infrastructure development

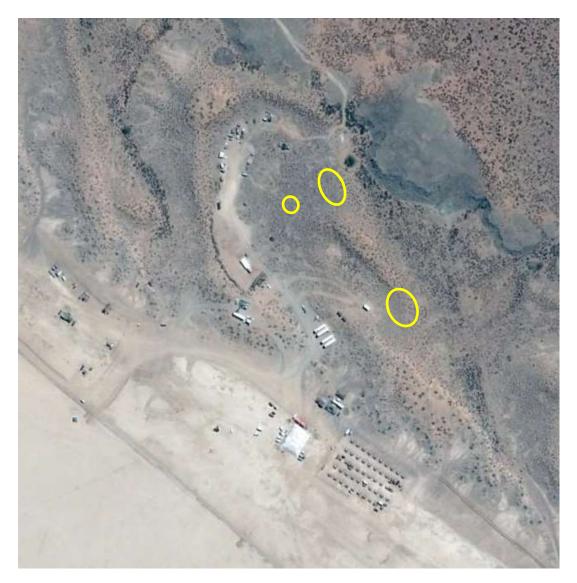
Figure 17a. 'Landside'/'Speedweek' secondary infrastructure area showing location of clusters of isolated Stone Age traces (with GPS plots 15b, below).

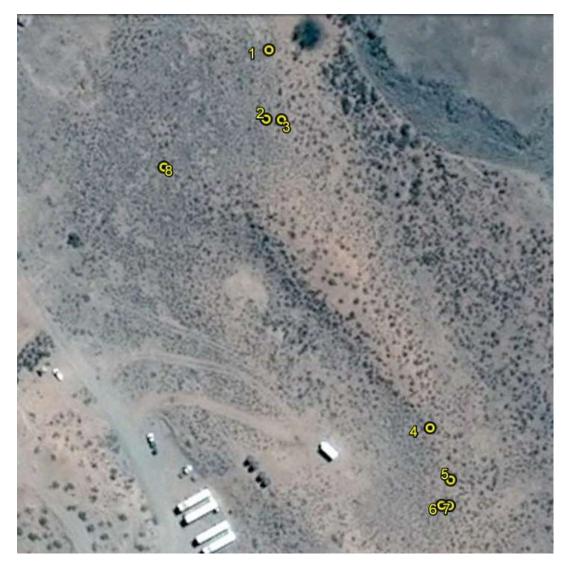
Observation	Co-ordinates	Observation	Figure
HSP-	26°46'46.4"	Large quartzite flake	10
Landside	20°14'38.3″		
Dune			
1			
2	26°46'47.2″	Handaxe	11
	20°14'38.3″		
3	26°46′47.5″	Core	12
	20°14′38.5″		
4	26°46'50.7"	Later Stone Age flake	
	20°14'40.6"		
5	26°46′51.3″	Large flake scraper	13
	20°14'40.9″		
6	26°46′51.6″	Later Stone Age flake	
	20°14′40.9″		
7	26°46'51.6"	Large ?Lockshoek/Oakhurst	14
	20°14'40.8″	flake/scraper	
	<b>a</b> a <sup>0</sup> + a' + a "		
8	26°46'47.8"	Cluster of ostrich eggshell pieces	
	20°14'37.0"	over area of about 5x5 m (possibly	
		remains of a single eggshell flask)

Figure 17b. 'Landside'/'Speedweek' secondary infrastructure area showing GPS plots for individual Stone Age artefacts as tabulated in Table 3.4.1.

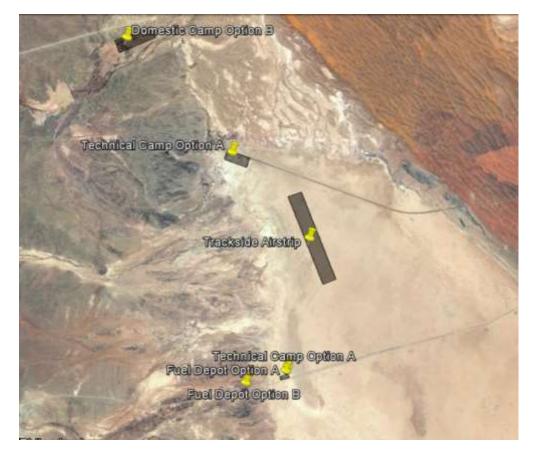
The area indicated for Fuel Depot Option A and Technical Camp Option A is situated on the pan surface on the west side of the pan alongside the old Rietfontein road. This area was traversed on foot, revealing between zero and an extremely low number of flakes stone pieces, very widely scattered. This observation is consistent with observations made above for the pan floor in general.

This once again represents an extremely ephemeral archaeological trace on the pan floor where the proposed possible development would constitute a near to zero impact on archaeological traces.

Figure 18. Map of north western end of Hakskeen Pan indicating the Fuel Depot Options, Technical Camp Options, Trackside Airstrip and Domestic Camp Option at Loubos.

The proposed site of Fuel Depot Option B (see Fig 18) is upslope, i.e. westwards, from Option A, also alongside and just north of the old Rietfontein road. It is on the gently sloping ground rising westwards from the pan and on a surface strewn with Dwyka tillite-derived cobbles and, and amongst them, much flaked Stone Age material.

These areas of potential development are both situated on the pan floor at the north western end of the pan, south of the new (tarred) R31 between Mier and Rietfontein (see Fig. 18). These locales have the same characteristics of other pan floor settings described above, with zero or near zero archaeological traces. There would be no heritage impact by any infrastructure development in these areas.

This Option B is situated just to the south of the existing village of Loubos (Fig. 18) which is about 4 km (as the crow flies) north west of the north-western corner of Hakskeen Pan. Much of the area is today infested with mesquite (*Prosopis*): if development of the camp would include clearance of infestations of alien vegetation this could represent a useful contribution to the ecological health of the area. The terrain is mantled by silt below which, and exposed in some parts of the area, there is a Dwyka-strewn surface similar to that noted at Fuel Depot Option B. Once again in these exposed areas there are cobbles of stone and, amongst them, much flaked material, principally Middle Stone Age but possibly containing some Acheulean (Earlier Stone Age) as well. As at Fuel Depot Option B, the archaeological component lacks stratigraphy and contextual features that would make it meaningful.

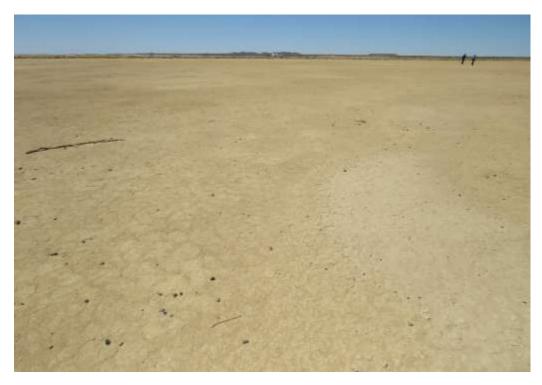
Figure 19. Pan floor at Fuel Depot Option A.

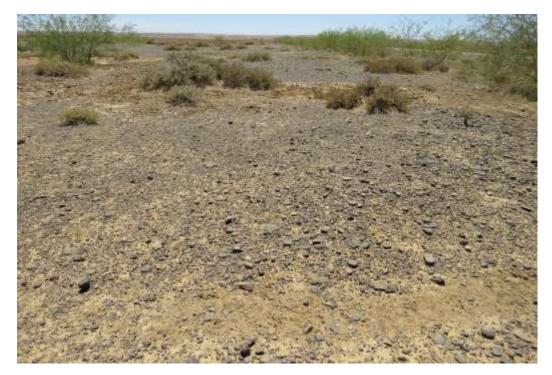
Figure 21. Stony surface at Fuel Depot Option B which includes many flaked stone artefacts, mainly Middle Stone Age.

Although this locale is rich in stone tools, these are probably a lag deposit, i.e. not in primary context, and hence lacking in archaeological integrity: no stratigraphy; no organic preservation; limited opportunities of characterising the material in any meaningful way. Almost all spreads of Dwyka tillite in the region display similar artefactual content, and this was found to be the case at Loubos as well (see below).

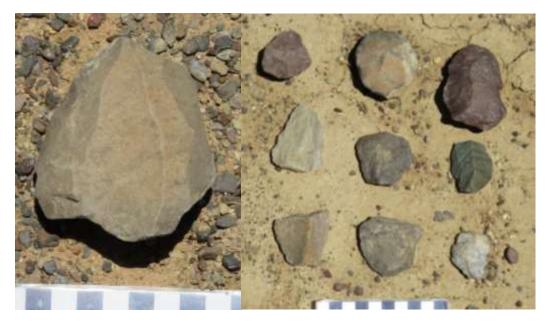
Figure 22 a & b Stone artefacts including classic Middle Stone pieces at Fuel Depot option B.

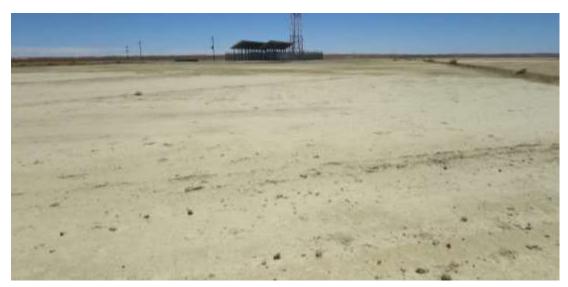
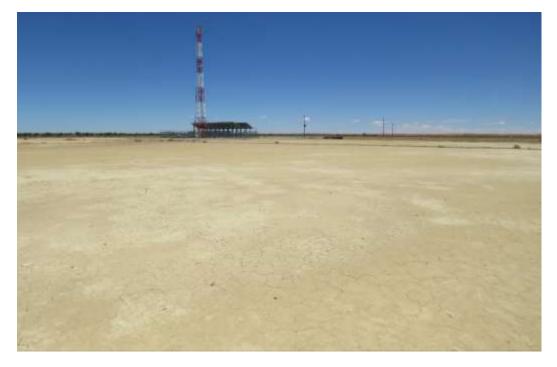
Figure 23 (above) and Figure 24 (below) show pan surfaces around the MTN tower at the north western end of the pan, scheduled as possible Technical Camp Option A at the north western end of the pan: no artefacts were noted here at all.

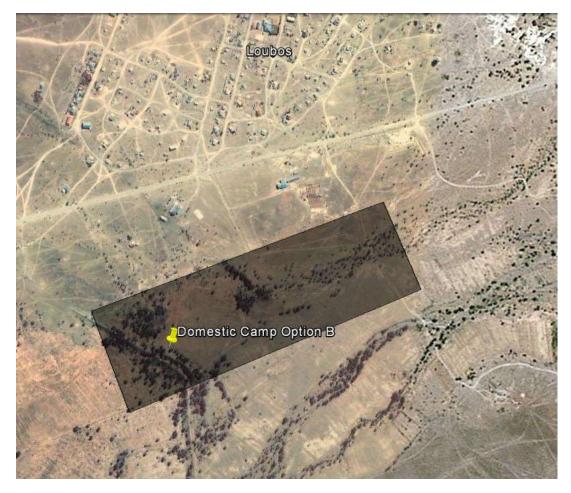
Figure 25. Google Earth image showing proposed potential location of Domestic Camp Option B south of Loubos.

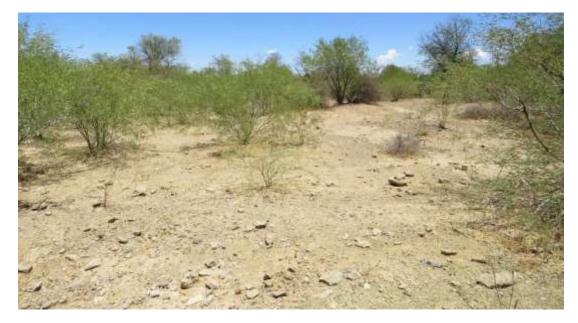
Figure 26. Silt and stony ground south of Loubos: possible Domestic Camp Option B.

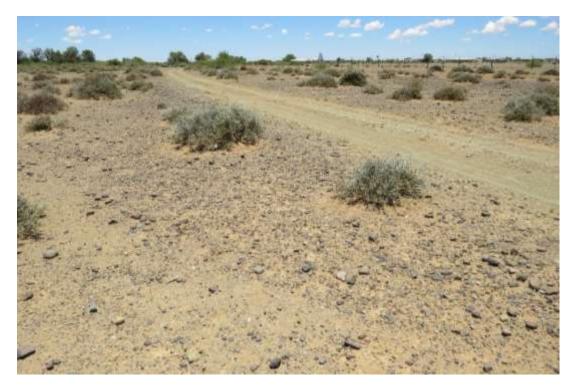
Figure 27. Exposures of tillite-strewn surfaces south of Loubos.

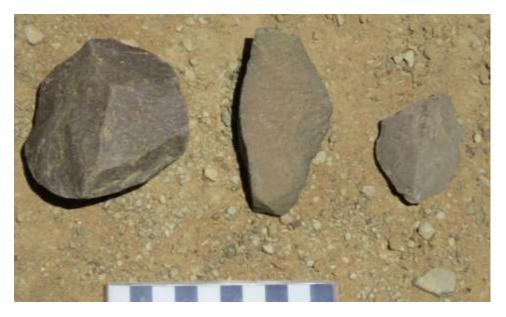
Figure 28. Stone artefacts made on quartzite derived from the Dwyka tillite.
