***HERITAGE IMPACT ASSESSMENT***

**PROPOSED ENLARGEMENT OF THE DRIEFONTEIN DAM,  
PORTION 33 OF THE FARM RIETVALLEY NO. 364, CERES  
WESTERN CAPE**

**MAY  
2018**

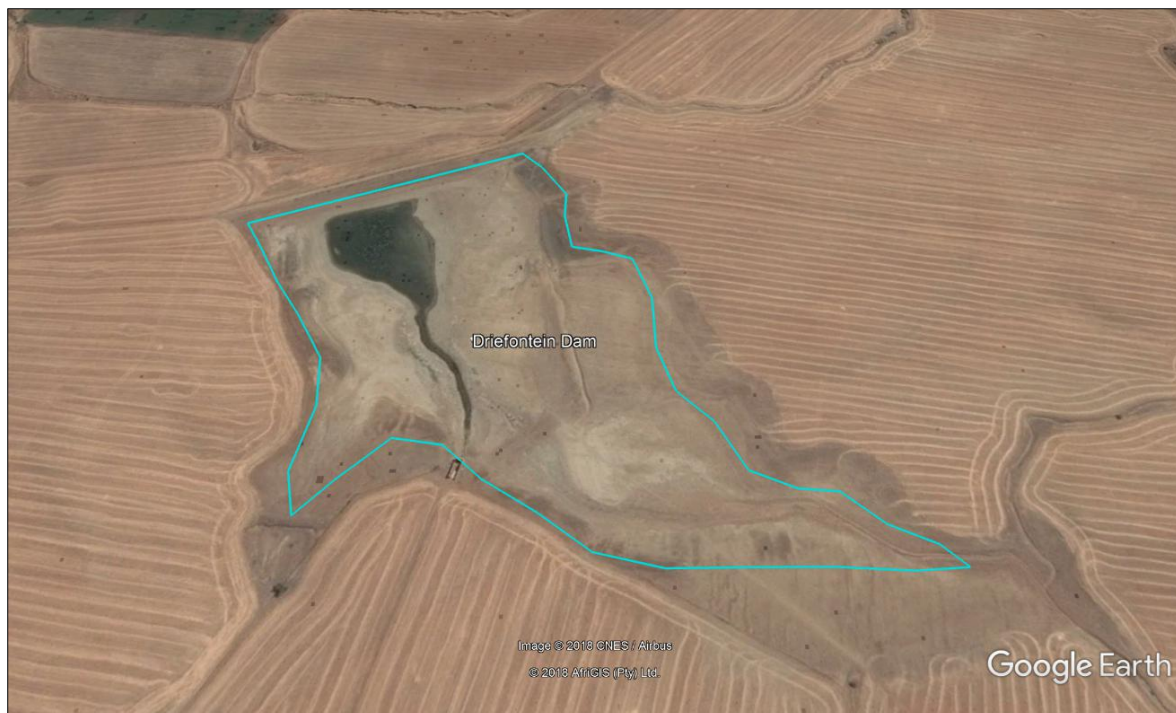
Figure 4. Driefontein Dam and the receiving environment. The blue polygon in the full supply level. Note the surrounding transformed landscape

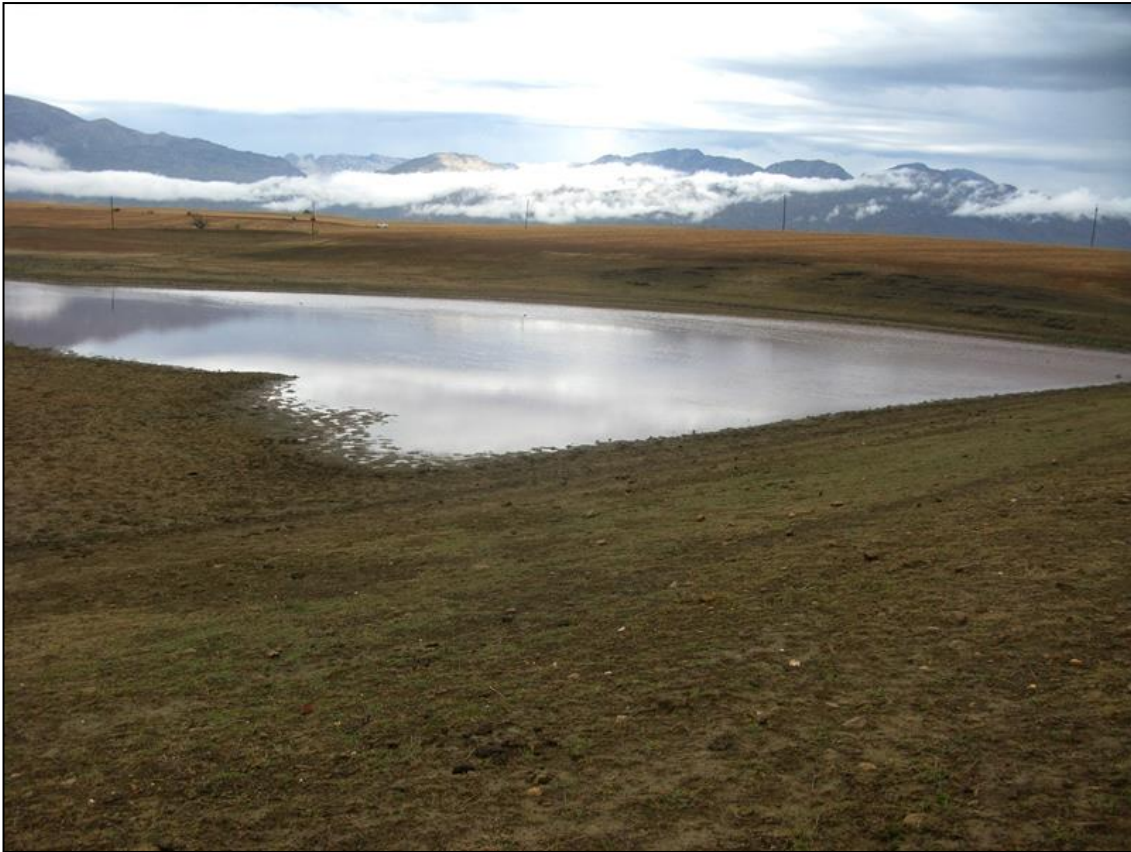
Figure 5. View southwards across the existing Driefontein Dam from the dam wall towards the Hex River Mountains. Low exposures of Bokkeveld Group bedrocks are visible along the north western edge of the dam (source Almond, 2018)

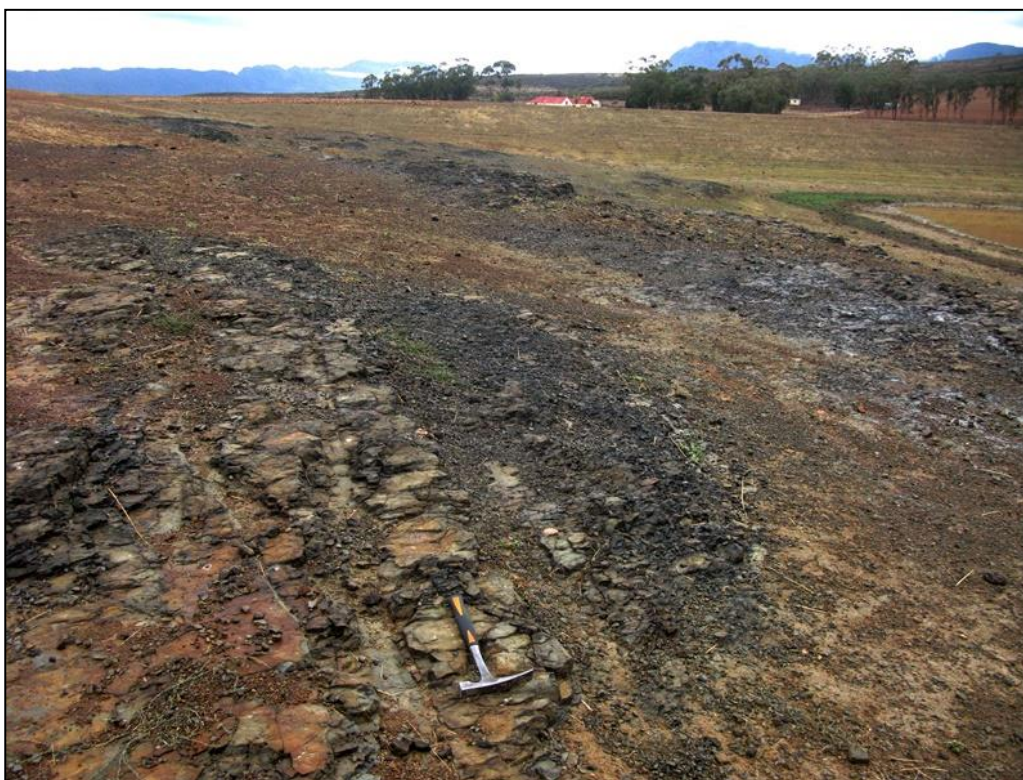
Figure 6. Low exposures of gently-dipping Voorstehoek Formation mudrocks & wackes along the north-western margins of the Driefontein Dam (dam wall in the background) Hammer = 30 cm (Source Almond 2018).

According to Almond (2018), Bokkeveld Group bedrock exposure in the study area is largely confined to small outcrops of gently - to steeply-dipping beds of dark grey, grey-green, blueish-green, rusty-brown to khaki, massive to laminated siltstone and wacke. These sediments crop out around the north-western and north-eastern margins of the existing dam as well as in the walls of a short pipeline trench leading from a small concrete reservoir on the southern side of the dam (Figures 6 & 7). The bedrocks are highly-weathered, and fractured with very little bedding plane exposure. They are locally impregnated with secondary iron and manganese minerals, including small ferruginous nodules. Soft-sediment loading of wacke units is locally developed and the succession is cut by several small-scale faults. Mottling of some horizons indicates high levels of bioturbation.

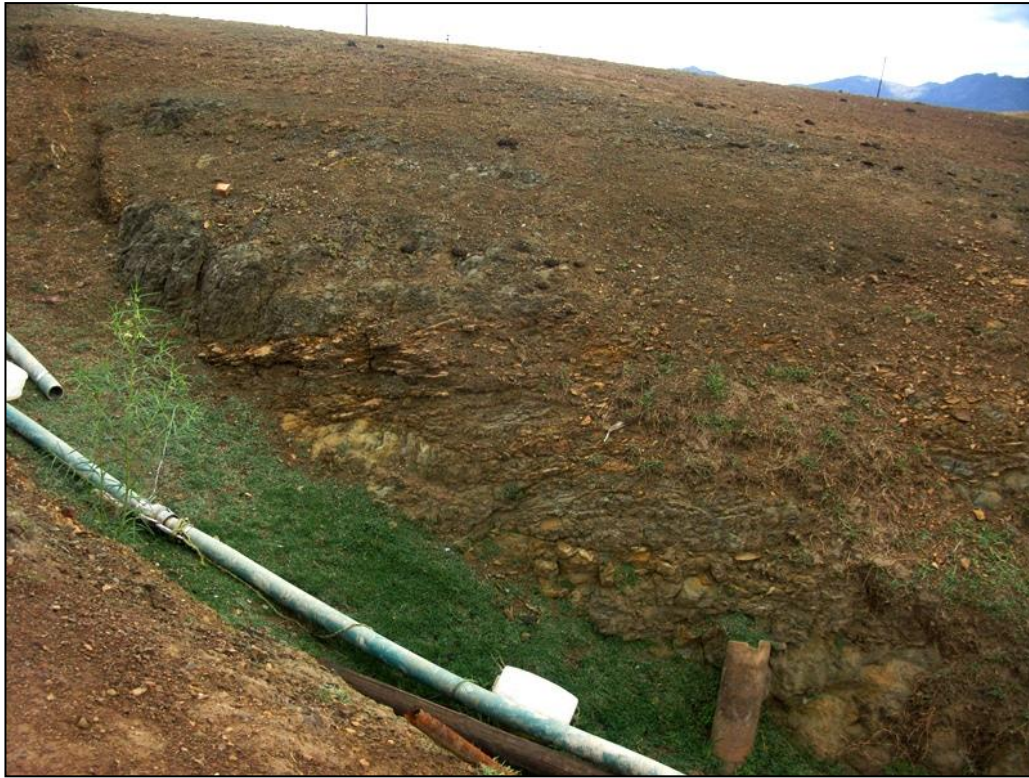
Figure 7. Highly fractured, faulted & weathered Voorstehoek Formation bedrocks exposed in a short pipeline trench on the southern edge of the existing dam (Source Almond, 2018).

The Voorstehoek Formation bedrocks in the Driefontein Dam study area are generally highly weathered, fractured and locally secondarily mineralised, compromising preservation of scientifically-useful fossil remains. The only fossils recorded during the site visit were internal moulds of an orthocone nautiloid (Figure 10) and an incomplete juvenile homalonotid trilobite (Figure 11). Nautiloids are comparatively rare in existing Bokkeveld Group fossil collections. The specimen here is unfortunately poorly preserved, while homalonotid trilobites are a very common element within Voorstehoek invertebrate biotas.

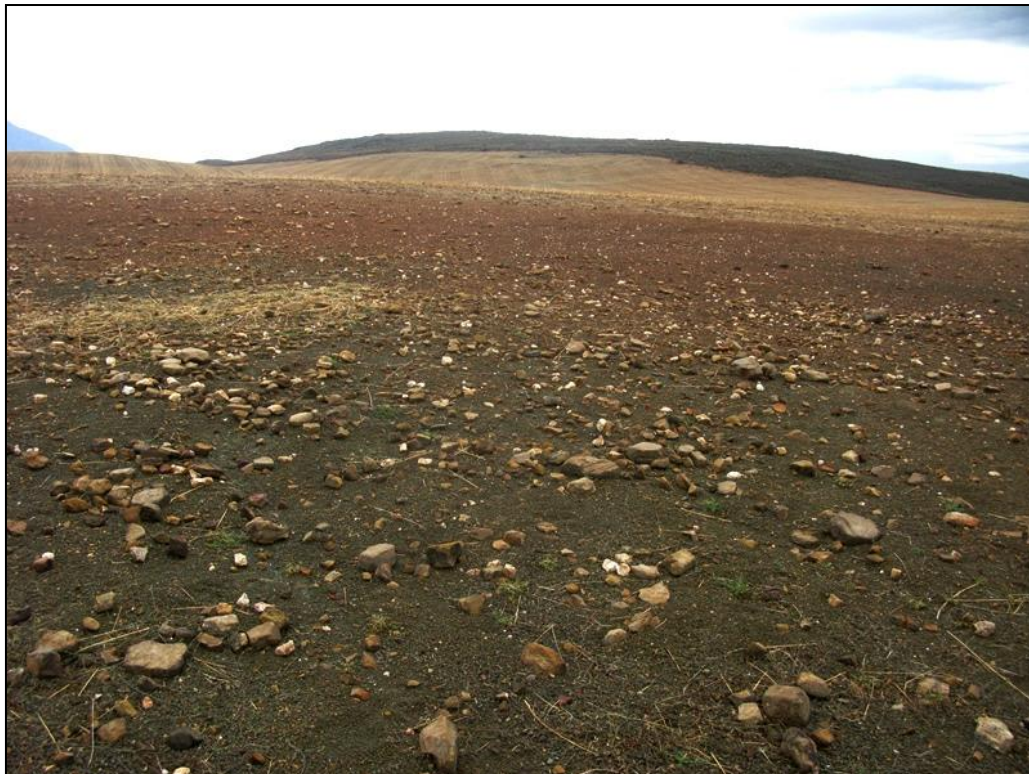
Figure 8. Dense scatter of downwasted angular clasts of quartzite, wacke and vein quartz along the eastern margins of the dam (Source Almond, 2018).

The bedrocks are overlain by fairly thick, sparsely gravelly, loamy to clay-rich soils of mixed alluvial and colluvial origin. A zone of downwasted coarse gravels along the eastern side of the dam includes angular to occasionally well-rounded clasts of pale quartzite, sandstone (often ferruginised), wacke and vein quartz (Figure 8). The surface gravels also include sparse crudely-flaked Early Stone Age (ESA) quartzite bifaces (Figure 9).

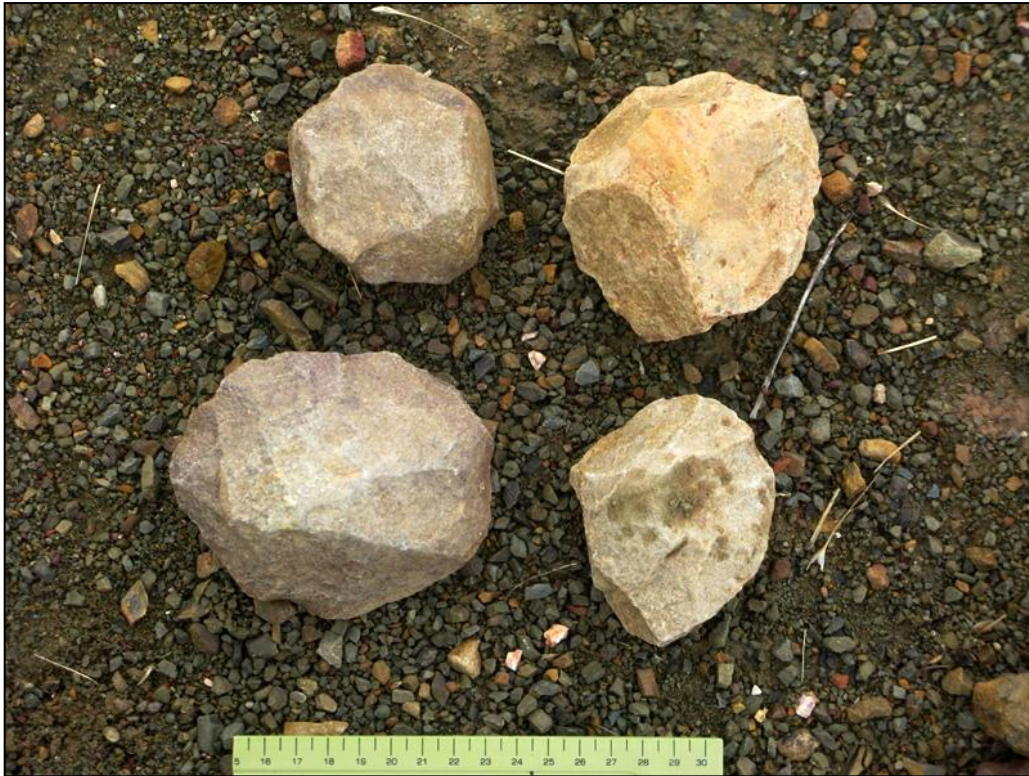
Figure 9. Examples of sparse bifacially-flaked ESA quartzite artefacts scattered within the gravel-rich area illustrated above (Source Almond, 2018).

No fossils were recorded from the overlying soils and downwasted gravels. The presence of sparse ESA quartzite artefacts in a disturbed context is noted. Comparable stone artefact assemblages have been reported elsewhere in the Warm Bokkeveld region by Kaplan (2007a, 2007b, 2009, 2010).

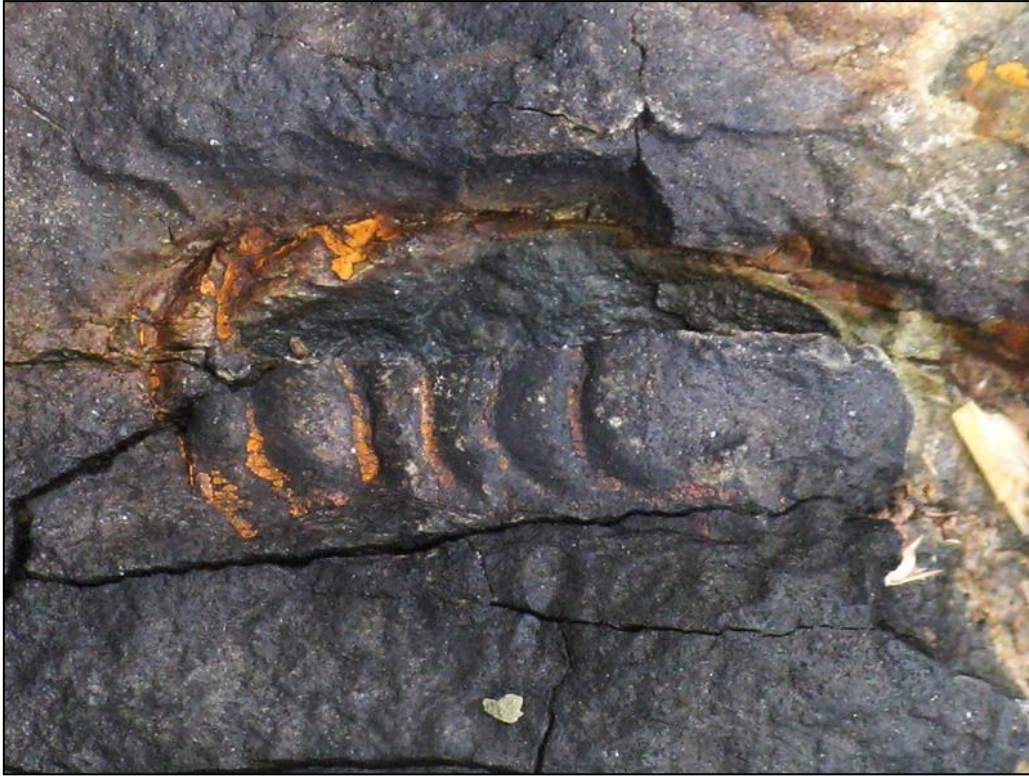
According to Almond (2018:12), neither of these fossils is considered to be of high scientific or conservation value, and have been rated as having *low* (Grade IIIC) significance.

Figure 10. Poorly-preserved internal mould of an orthocone nautiloid showing nested series of lens-shaped, biconvex casts of the shell chambers preserved within massive dark siltstone (Specimen is c. 3 cm long) (33 21 12.4 S, 19 24 19.1 E) (Source Almond, 2018).

1. In the case of any significant new fossil finds exposed during dam construction (e.g. concentrations of well-preserved fossil shells such as “starfish beds”), these should be safeguarded - preferably *in situ* - and reported by the ECO as soon as possible to Heritage Western Cape (Att: Mr Andrew September 021 483 9543).

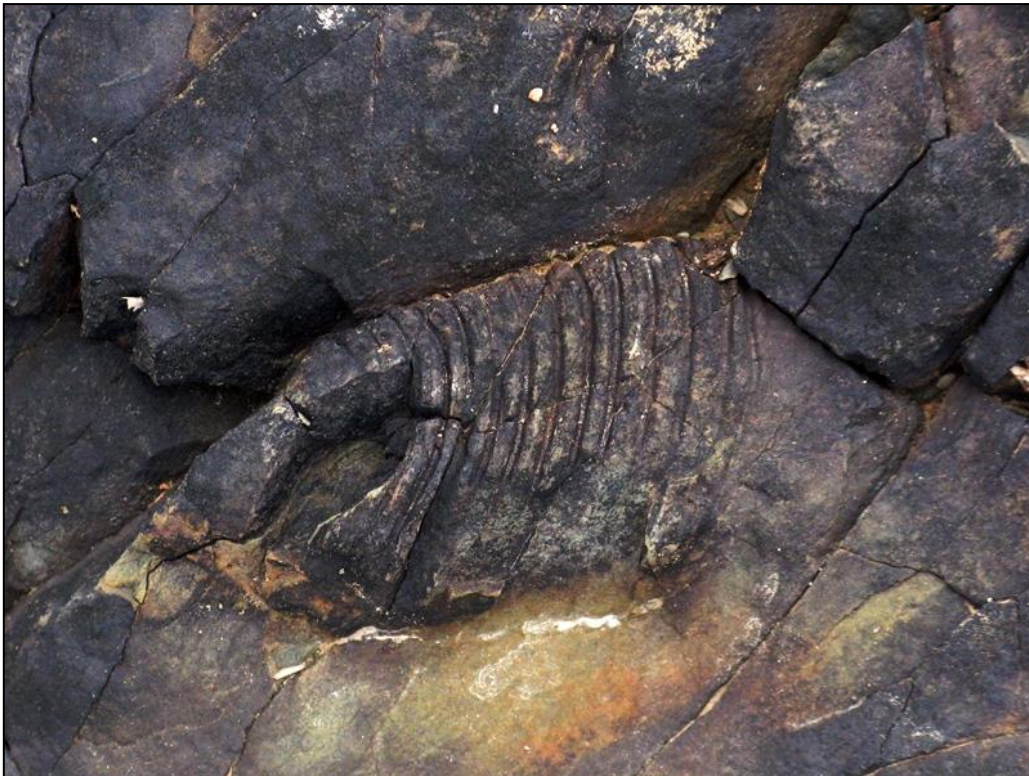
Figure 11. Internal mould of the posterior trunk and pygidium of a small (probably juvenile) homalonotid trilobite (*Burmeisteria*) preserved within massive dark siltstone (Specimen is c. 5.5 cm long) (33 21 12.4 S, 19 24 19.1 E) (Source Almond 2018)
