**Wagenboomrivier  
Irrigation Board**

**PROPOSED WATER OFFTAKE WEIR  
on  
PORTION 2 OF THE FARM SNELRIVIER 602, WORCESTER**

**PRELIMINARY TECHNICAL REPORT V1.2  
WATER USE LICENSE APPLICATION**

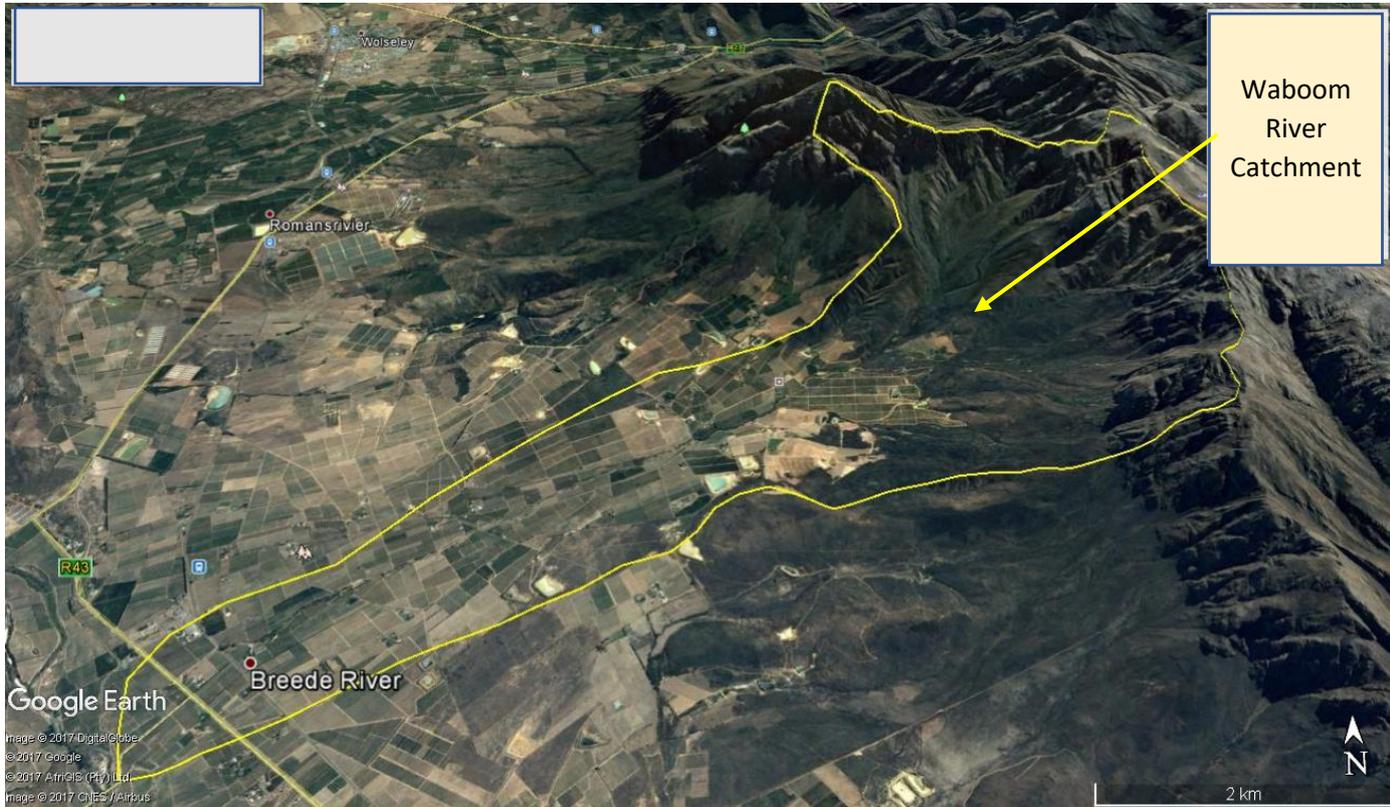
**Figure 2** Waboom River Catchment

The upper catchment is wedged into a deep bowl in the mountains of the Matroosberg Mountain Catchment (Figure 2). The distance from the top of the catchment to the confluence with the Breede River is only 11km, following ground contours. The circumference is 32 km surface area is 37 km<sup>2</sup>. It is by all measures a small sub-catchment and is one of many along the Breede River.

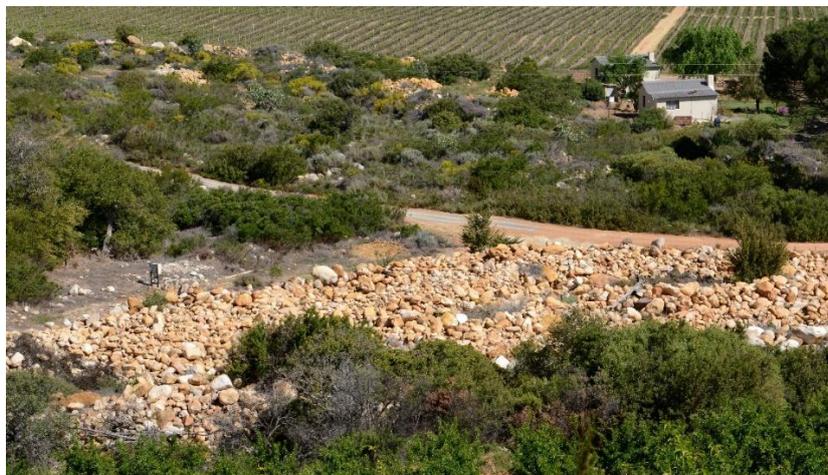
**Figure 4** Berms of Cobbles

The natural environment is heavily impacted upon. The Cape Fynbos is still evident up against the high mountain slopes, but down in the valley just about all of it has made way for large-scale farming. Likewise, the aquatic environment is largely affected over-abstraction. The river has been straightened and deepened to decrease flow resistance. The banks have been lined with berms of cobbles (Figure 4). This was done to prevent flooding of the vineyards and orchards. The river is not allowed to meander naturally.

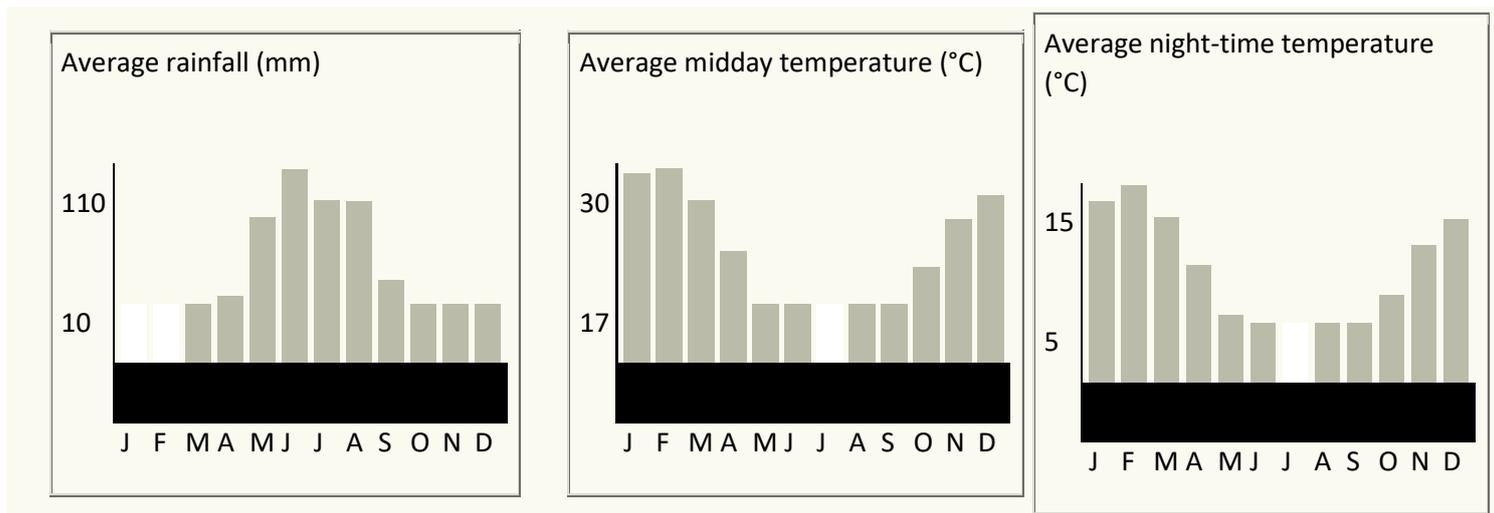
**Figure 5 Climate**

Wolseley normally receives about 575mm of rain per year and because it receives most of its rainfall during winter it has a Mediterranean climate. Figure 5 shows the average rainfall values for Wolseley per month. It receives the lowest rainfall (10mm) in January and the highest (107mm) in June. The monthly distribution of average daily maximum temperatures (centre chart below) shows that the average midday temperatures for Wolseley range from 16.7°C in July to 29.7°C in February. The region is the coldest during July when the mercury drops to 4.7°C on average during the night. Consult the chart below (lower right) for an indication of the monthly variation of average minimum daily temperatures.

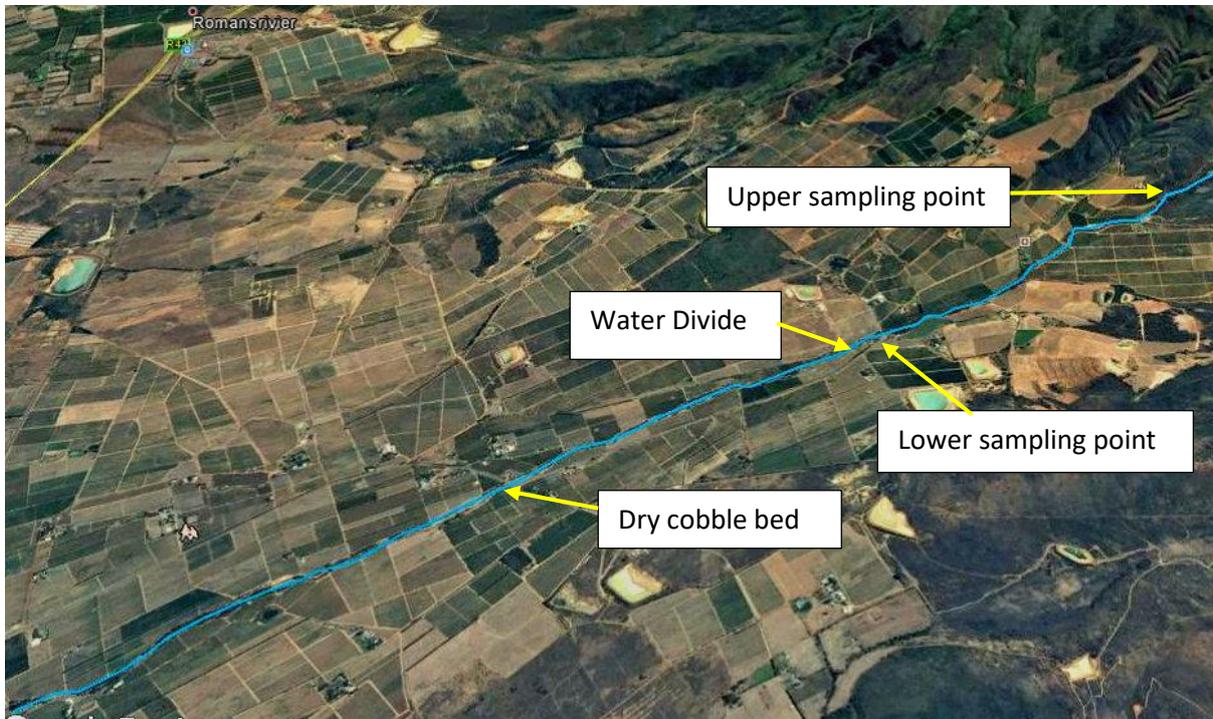
**Figure 6** Sampling Points

The location of the sampling points is depicted in Figure 6 and the coordinates and elevation is given in Table 2.

Sampling point	Latitude	Longitude	Elevation masl
Upper	33°29' 52.46"	19°16'48.18"	541
Lower	33°30' 34.03"	19°15'27.40"	391
Cobble bed	33°31' 09.28"	19°14'07.53"	308

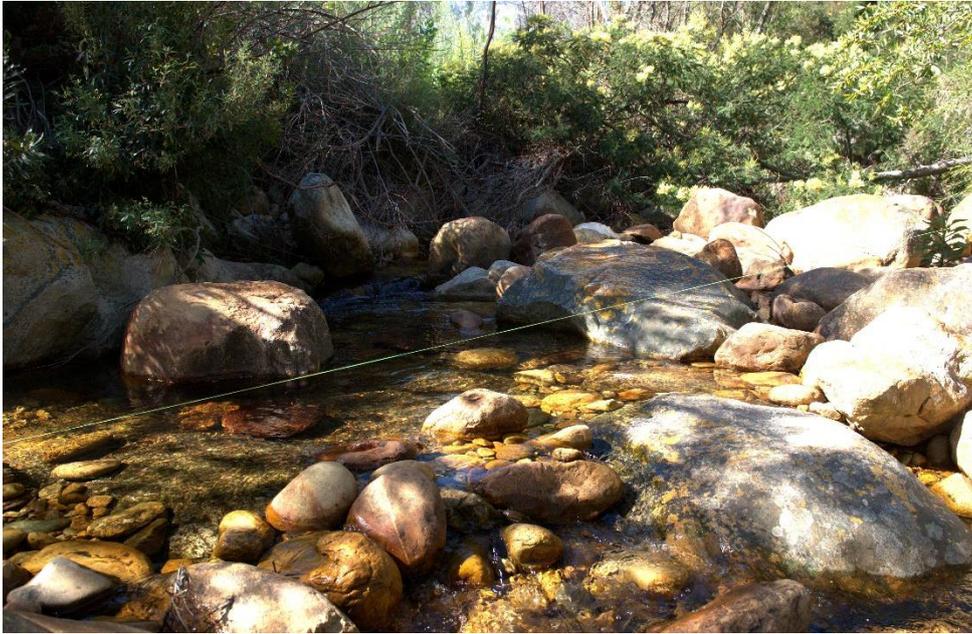
**Figure 7** Upper sampling point

The upper mountain stream is a cobble bed up against the mountain side with fast flowing water. The water was clear and does not have the vegetation-stained brown colour that is so typical of waters in the mountain Fynbos. The incline is steep, with sandstone bedrock, stones in and out of current and a small pool with turbulent water. The vegetation consisted of a few patches of moss and one small patch of threat-like algae.

The stream was approximately 5m wide. The depth varied from a couple of centimetres in the riffles to a meter in the pool. There was only a little gravel on the bottom next to the one side of the stream.

Adjacent and downstream of the sampling point is a one-track bridge (Figure 8). Inside the sampling point was a take-off point for irrigation. This was a 100mm pipe fitted with filter to keep out debris.

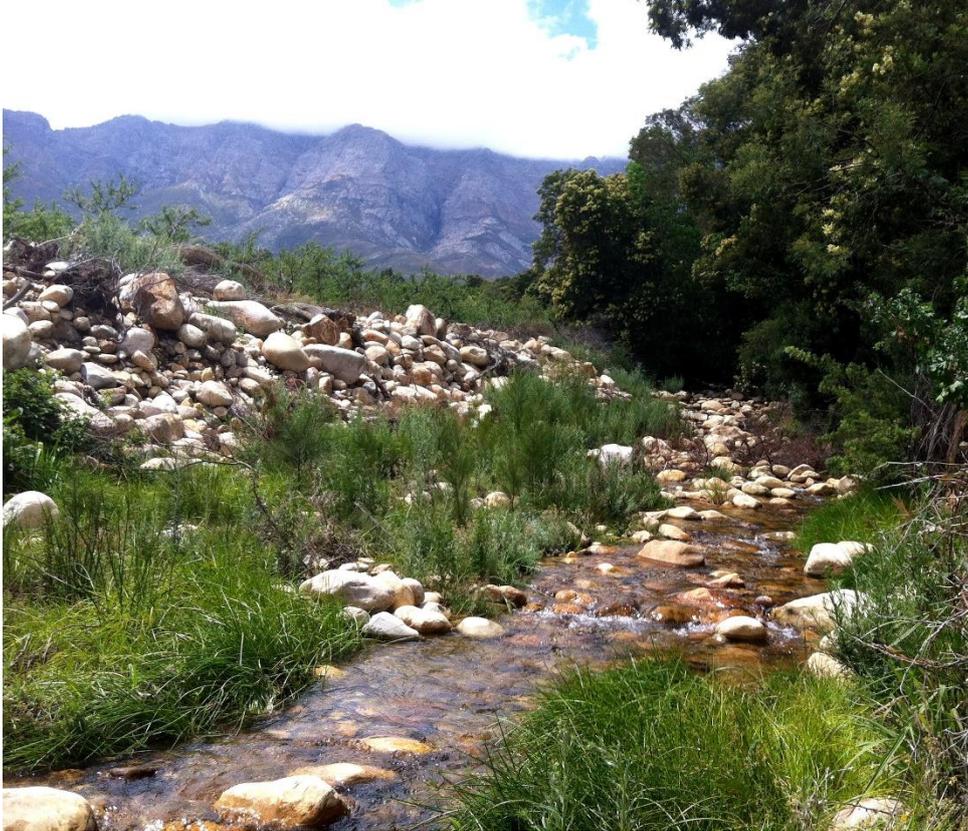
**Figure 10** Lower sampling point

The lower sampling point can be typified as a fast-flowing lower mountain stream of approximately 5m wide. The incline more gradual than up the mountain. The water was clear. The extensive cobble bed had some large rocks that can go through as bedrock, in and out of the current. There was much emerging vegetation (sedge *Cyperus denudatus*) growing right into the stream. The depth varied from a few centimetres to about 10cm in the deeper parts of the cobble bed. There was a patch of gravel of less than a m<sup>2</sup>.

The riparian zone was much degraded, with the sides banked up with cobbles to form berms along much of the stream. The stream was straightened out since the start of farming in the area for literally a hundred years and more to allow for formal agriculture. The vineyards and orchards were right up to the banks of the stream. Much of the banks were taken over by black wattle, interspersed by the indigenous taaibos trees (*Searsia* species).

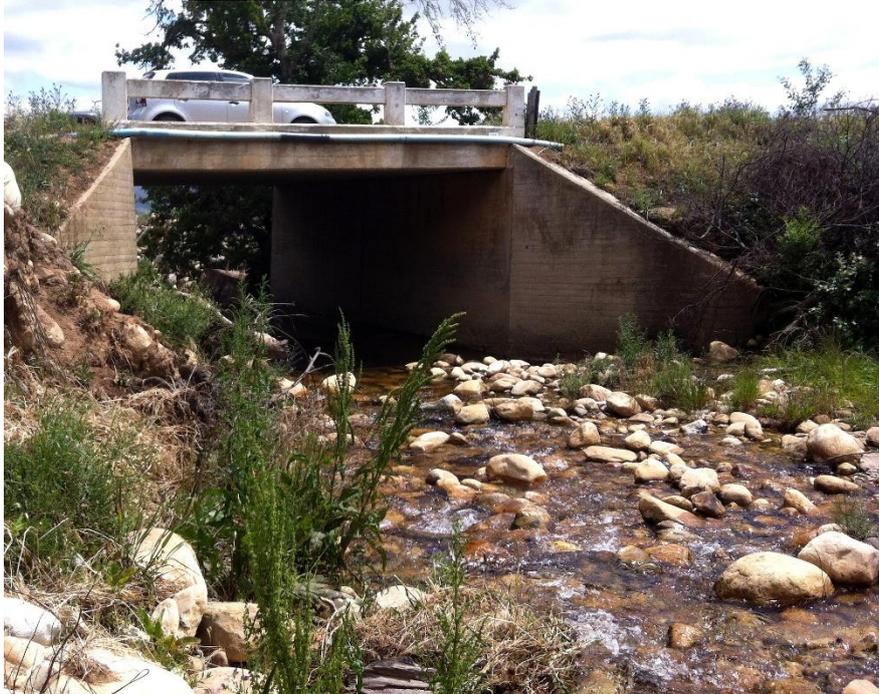
**Figure 11** Bridge downstream of lower sampling point

Downstream and adjacent to the sampling point was a road bridge with ample concrete foundations (Figure 11).

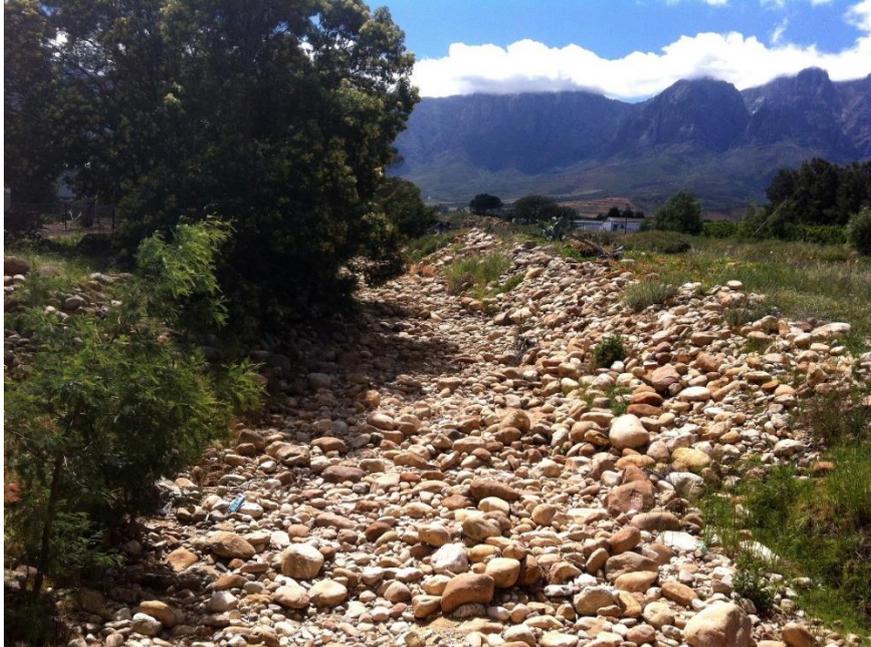
**Figure 12** Cobble bed

Downstream from the lower sampling point, where a road crosses the Wabooms River, there is no water at all in the river. It is just a dry cobble bed (Figure 12). All of the water is abstracted for agricultural purposes and none is left in the river.

The very lower sampling point was a dry cobble bed devoid of aquatic macroinvertebrates and no SASS5 score at all, as the available water was abstracted for irrigation and none was left for the river.

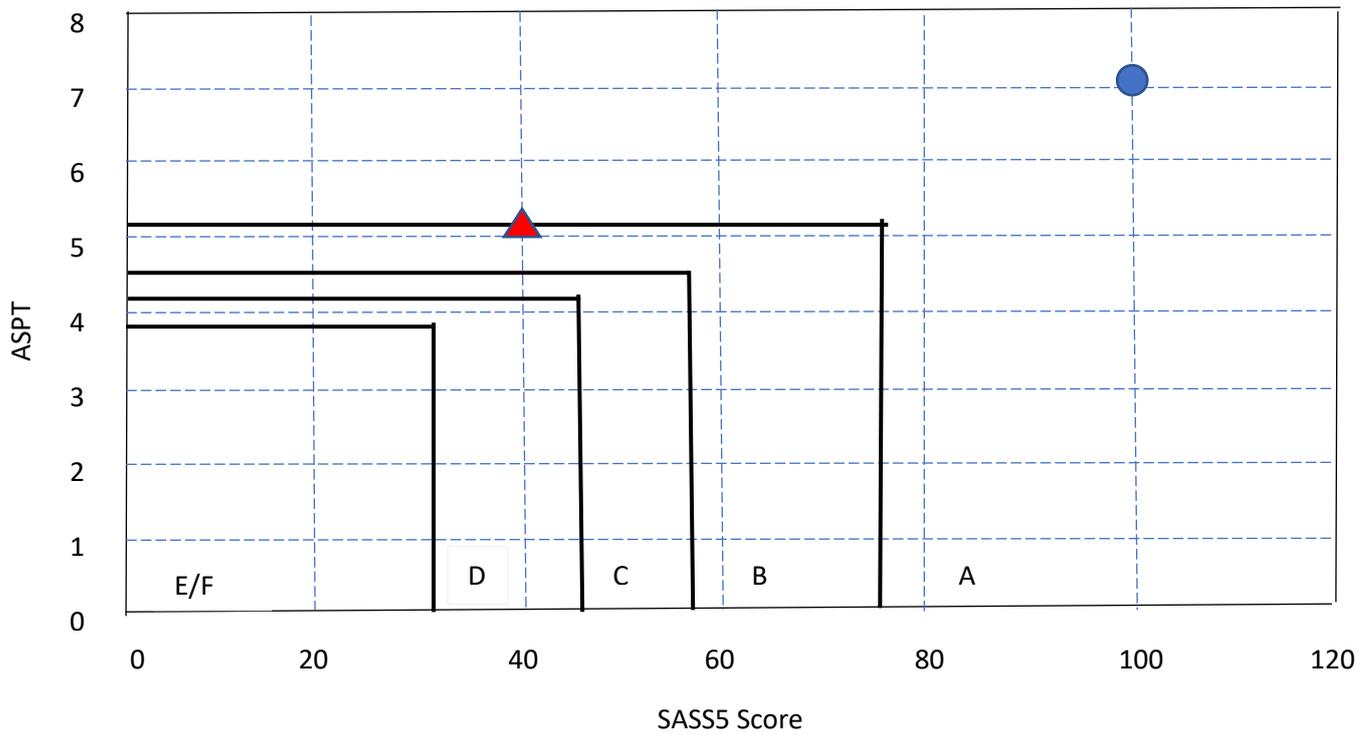
**Figure 13** Biomonitoring Results

The data of Table 3 is illustrated in a graph format (Figure 13) that is often used to evaluate biomonitoring results. The data carried over from the SASS5 score sheets in the appendix.

Parameter	Upper	Lower
SASS5 Score	100	40
Number of Taxa	14	7
ASPT	7.1	5.7

Integrity Class	Description
A	Pristine; not impacted
B	Very Good; slightly impacted
C	Good; measurably impacted with most ecological functioning intact
D	Fair; impacted with some loss of ecological functioning
E	Poor; loss of most ecological function
F	Very Poor; loss of all ecological function

At the upper sampling point the Snel River is a small mountain stream that lacks the wide variety of habitats of a larger stream in similar environments where biomonitoring scores can be very high. Hence the score of 100 indicated a healthy aquatic environment with an excellent biodiversity for such a small stream. At the upper sampling point was already some human impact, with a house higher up the mountain and more water take-off points. According the high SAS5 score this impact was limited.

There is a marked drop in the SASS5 score as well as in the ASPT from the upper to the lower sampling station. This is despite the lower sampling station having a good flow of water and a wider variety of habitat during the site visit.

According to Figure 1 the biodiversity at the upper sampling station is excellent with little if any human impact (class A). The biodiversity at the lower sampling station is good, but with some impact (class B). Without agriculture it would most likely be excellent as well at the lower sampling point.

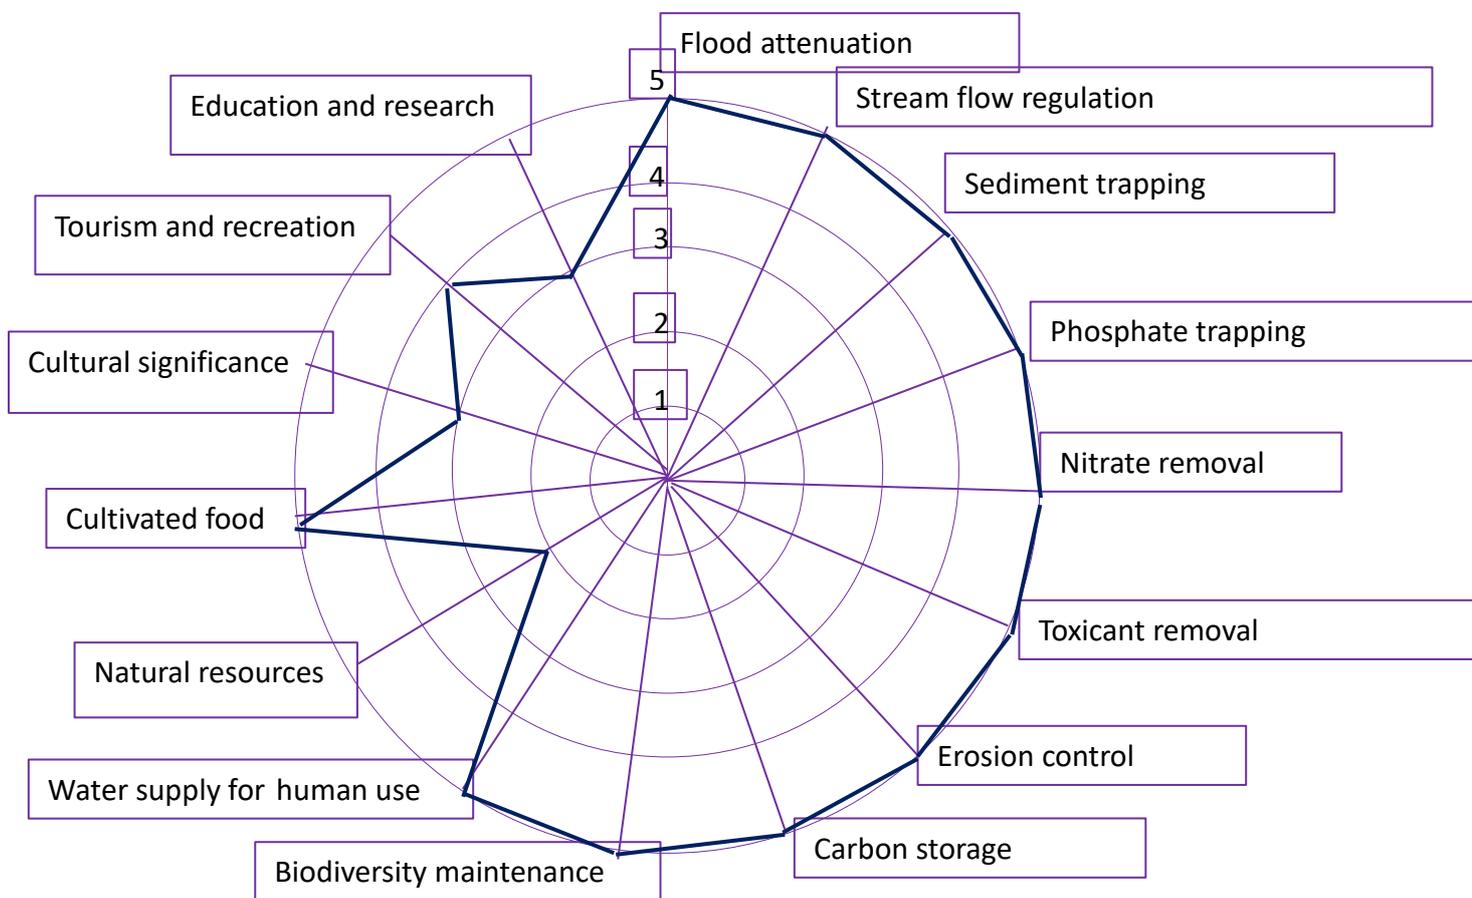
**Figure 14.** Resource Economics Footprint of the Waboom River

The diagram (Figure 14) is an accepted manner to visually illustrate the resource economic footprint the river.

Goods & Services	Score
Flood attenuation	5
Stream flow regulation	5
Sediment trapping	5
Phosphate trapping	5
Nitrate removal	5
Toxicant removal	5
Erosion control	5
Carbon storage	5
Biodiversity maintenance	5
Water supply for human use	5
Natural resources	2
Cultivated food	5
Cultural significance	3
Tourism and recreation	4
Education and research	3

The star shape of Figure 1 is large and will probably catch the eyes of the decision-makers. The aspects on the right-hand side of the star get full marks. The reason that the left-hand side has been somewhat marked down is that a small river up against a mountain side is probably of less importance to the tourism and recreation industry than the major attractions in the Western Cape.

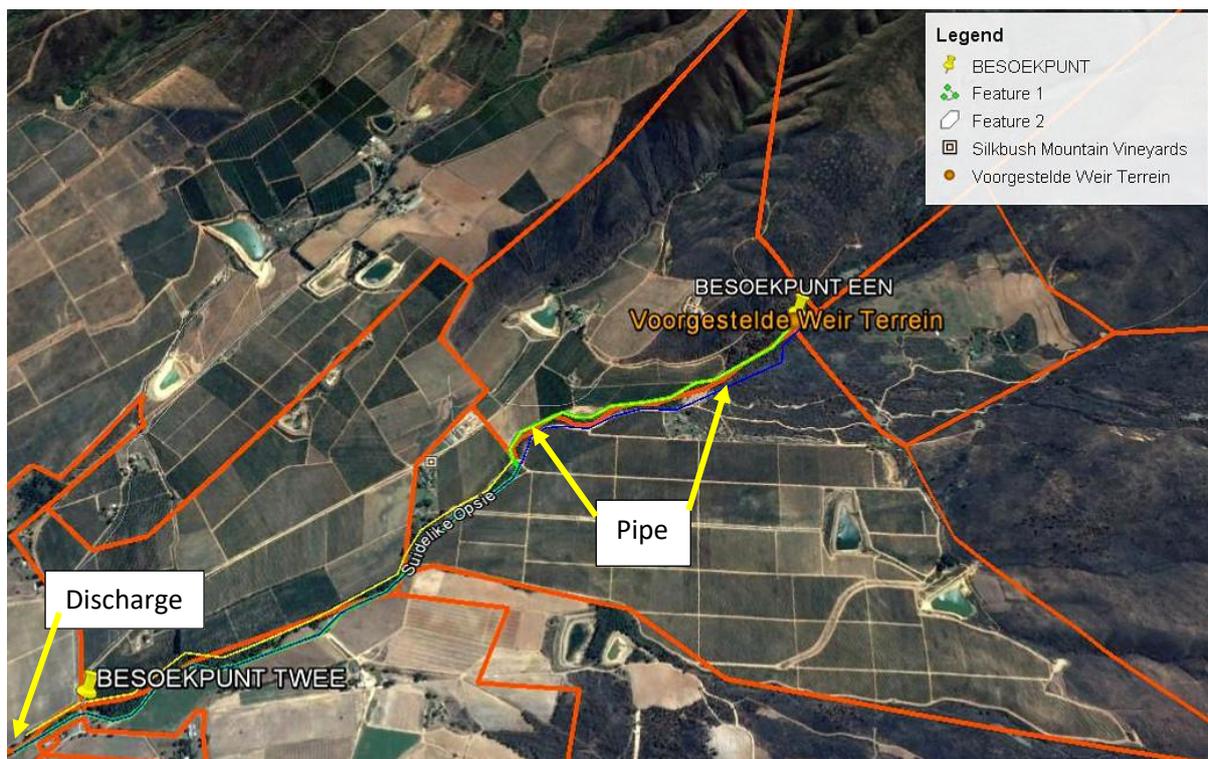
**Figure 15 Pipe**

A pipe will convey the water from the weir downhill to another instream division structure (Figure 15).

There are two options for the pipe as well. This is because of land owners that do not wish to have a pipe on their land. Accessibility to land for the pipe must still be negotiated and finalised. Now, a pipe on the northern bank or on the southern bank of the Snel River must be considered (the blue and yellow lines on Figure 15). Where land is not available at all, the pipe will have to be constructed right in the bed of the river. This is through a short section below the envisaged weir.

Likewise, the two options for the position of the pipeline have similar impacts. The riparian zone on both banks of the river is denaturalised. The construction and the presence of a pipe would not bring about further and unacceptable deterioration. The pipe will be above the ground and supported by pedestals, where required. Where it crosses the river, the supporting pedestals will have to be outside of the river bed.

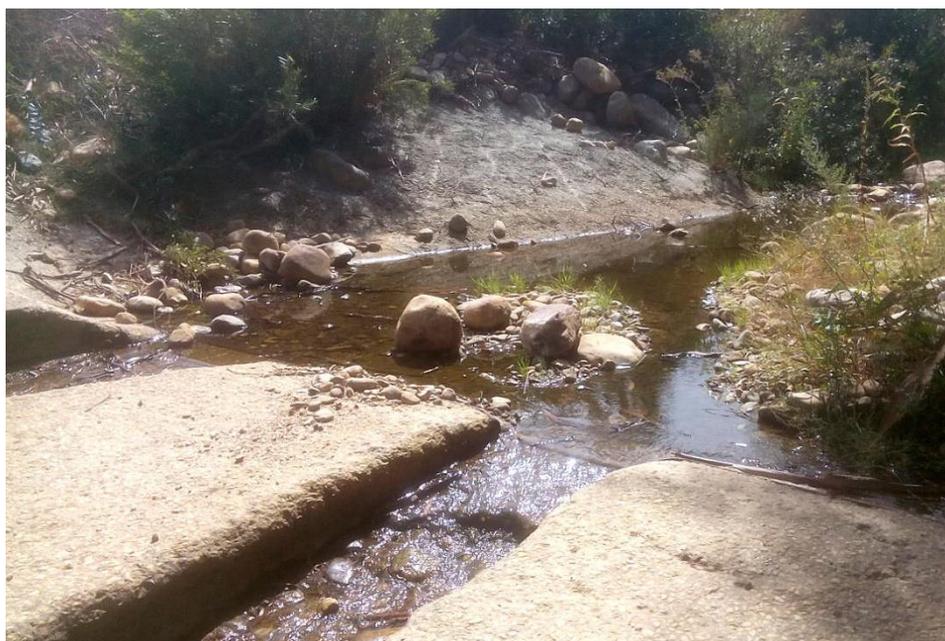
**Figure 16** Dividing Structure (Image Steven le Roux)

The structure is located just downstream of the lower sampling station (Figure 6, p12).

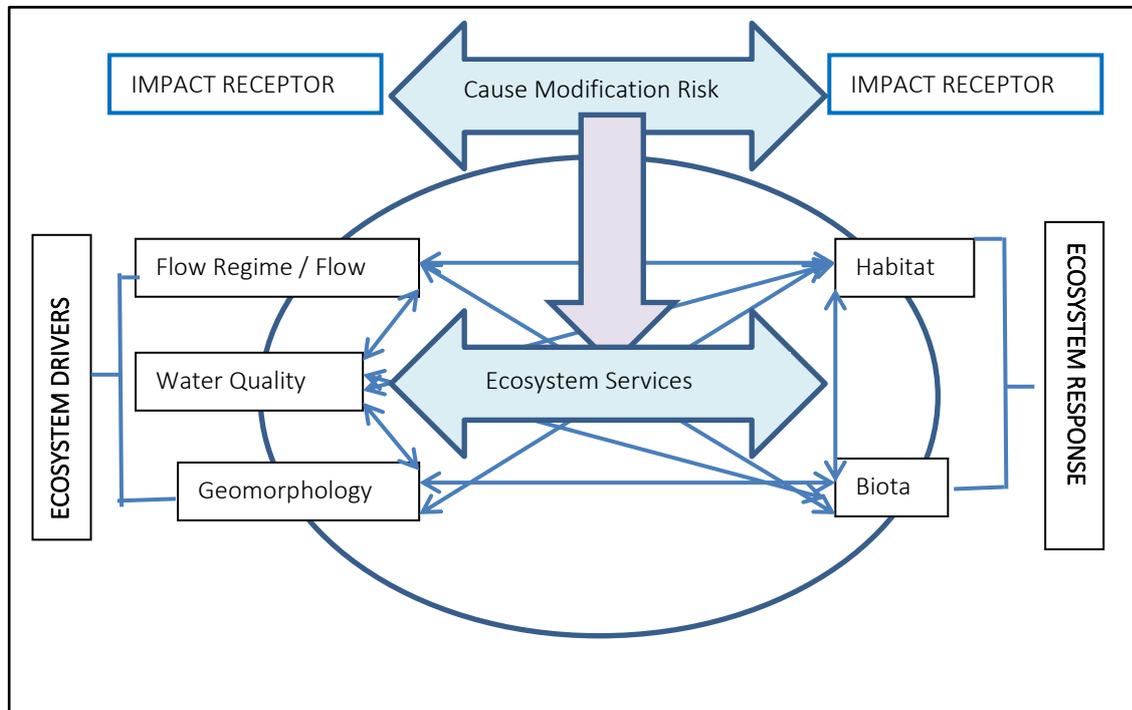
**Figure 17** Minimum Requirements for a S21(c) and (i) Application

Figure 17 has been adapted from one of the most recent DWS policy documents.

An anthropogenic activity can impact on any of the ecosystem drivers or responses and this can have a knock-on effect on all of the other drivers and responses. This, in turn, will predictably impact on the ecosystem services. The WULA and the EAI must provide mitigation measured for these impacts.

The conclusions can be structured along the outline that is provided by Figure 17.
