**Report to CK Rumboll & Partners on a Geotechnical Investigation carried out for the Louw's Bos South RE/502, Cemetery Site, Stellenbosch, Western Cape**

**Project No.: 18-820R02**

**Date Issued: June 2019**

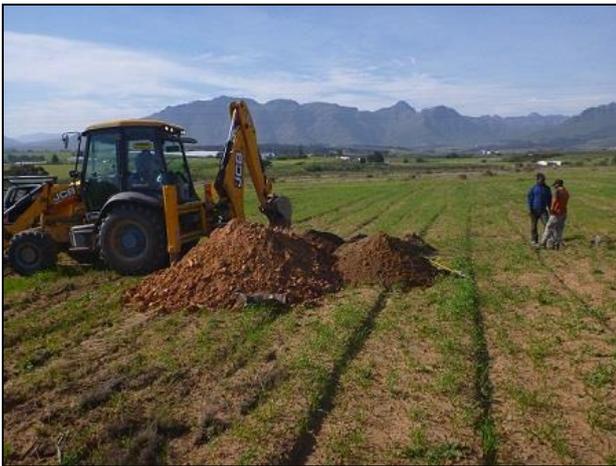
Plate 1: Site viewed towards the east at TP6

The site slopes down towards the Bonterivier in the north. The slope is gentle in the south steepening up closer to the river. The slope on the east side of the site slopes towards the east and includes an area which slopes at >6°. The remainder of the site slopes at between 4.7% and 6%. (Figure 2). Vegetation on the site consists of a vineyard, planted pastures or fallow agricultural land. The fallow agricultural land is covered in weeds and small bushes.

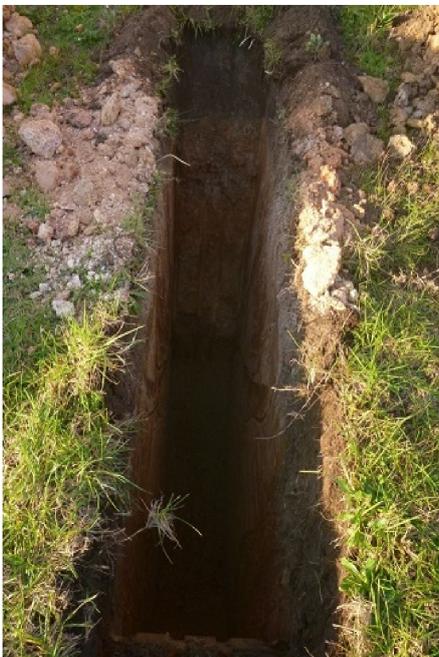
0.40 Moist cream to cream brown to red brown stiff to soft intact silty CLAY. Residual Granite.

- 1) Final depth at 3.40m. TLB limit.
- 2) No groundwater seepage.
- 3) No sidewall collapse.
- 4) No samples taken.

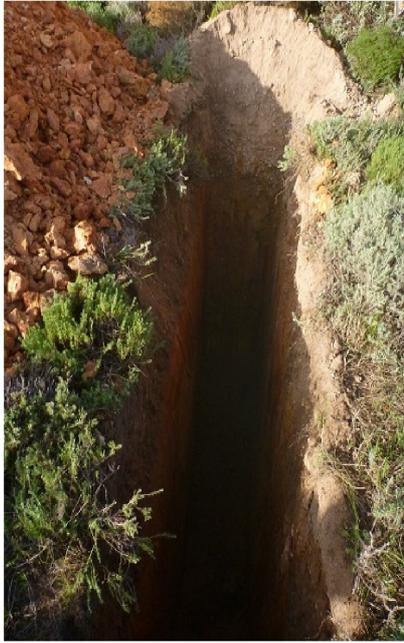
- 1) Final depth at 3.00m. TLB limit.
- 2) No groundwater seepage.
- 3) No sidewall collapse.
- 4) Samples taken :  
S1 0.60--3.00m

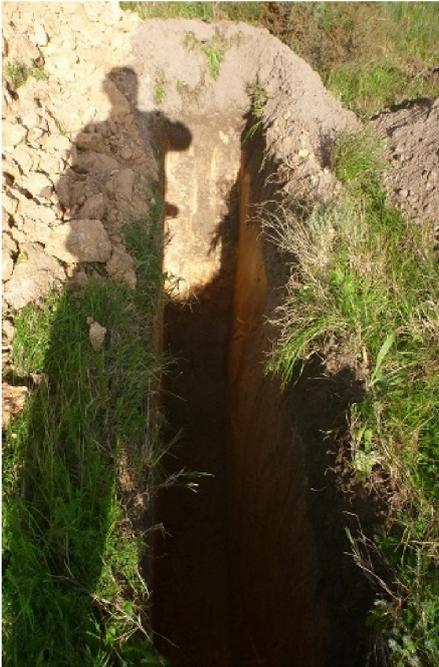
- NOTES**
- 1) Final depth at 3.20m. TLB limit.
  - 2) No groundwater seepage.
  - 3) No sidewall collapse.
  - 4) Samples taken :  
S1 0.30--3.20m

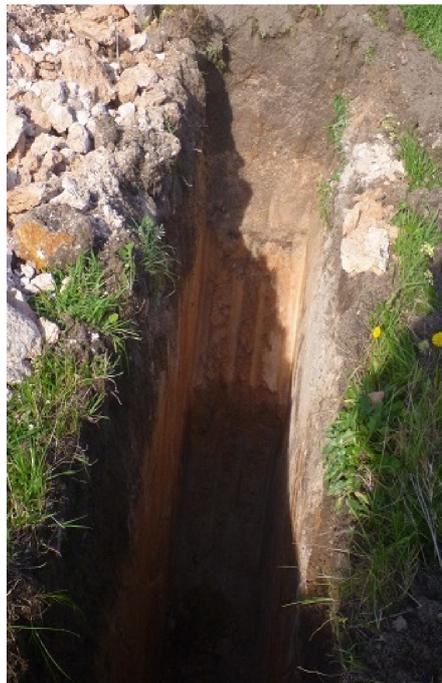
- 1) Final depth at 3.40m. TLB limit.
- 2) No groundwater seepage.
- 3) No sidewall collapse.
- 4) No samples taken.

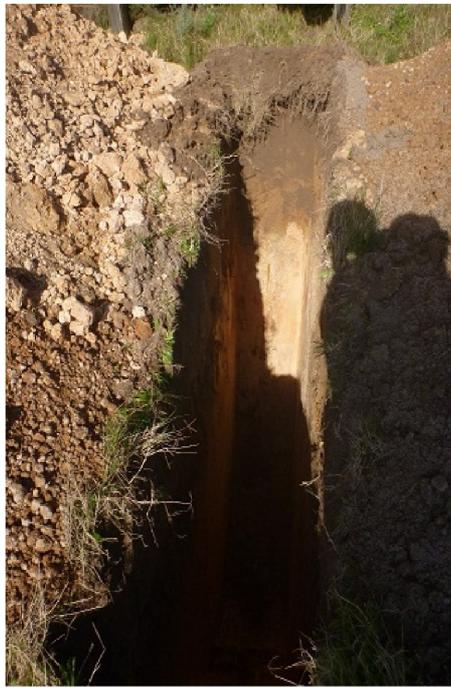
- 1) Final depth at 3.10m. TLB limit.
- 2) No groundwater seepage.
- 3) No sidewall collapse.
- 4) Samples taken :  
 S1 0.00--0.60m  
 S2 0.60--1.00m

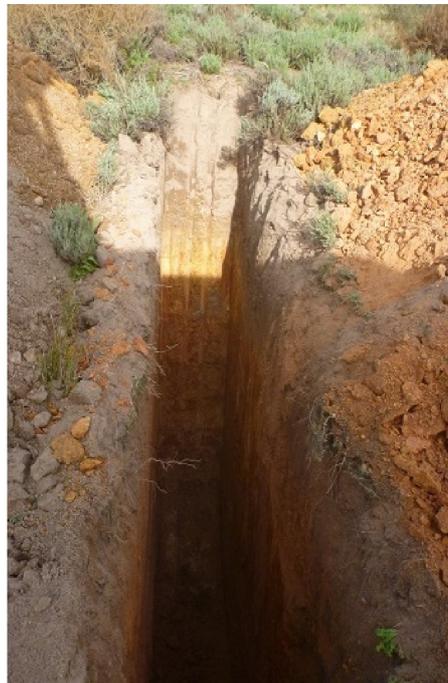
- 1) Final depth at 3.10m. TLB limit.
- 2) No groundwater seepage.
- 3) No sidewall collapse.
- 4) No samples taken.

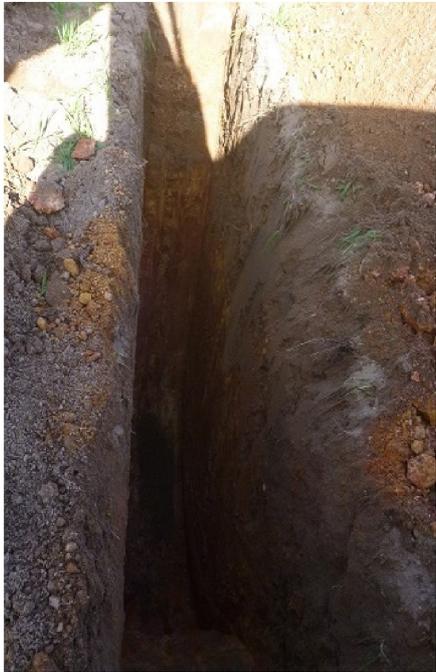
- 1) Final depth at 3.10m. TLB limit.
- 2) No groundwater seepage.
- 3) No sidewall collapse.
- 4) Samples taken :  
 S1 0.60--1.00m  
 S2 1.00--3.10m

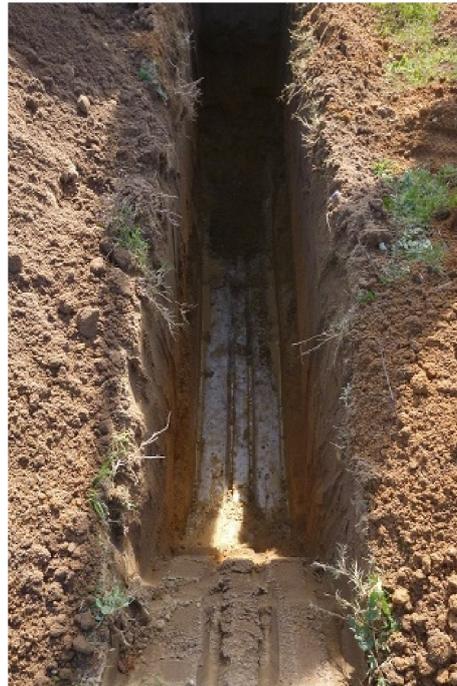
Seeping groundwater was only encountered in TP8 at a depth of 1.50m. This is consistent with the shallow bedrock in this area which was encountered at 2m and resulted in refusal of the TLB excavator. Similarly, groundwater can be expected to occur above the bedrock, however, this depth is largely well below the depth to which grave excavations will be dug.

- 1) Final depth at 2.00m. Refusal.
- 2) Groundwater seepage at 1.50m.
- 3) Sidewall collapse in gravel.
- 4) No samples taken.

Furthermore, sidewall collapse was only observed in TP8 which is outside the proposed cemetery site boundary. No sidewall collapse was observed in any of the other trial pits put down and it is therefore assumed that grave excavations will stay open for a reasonable length of time. It must be noted that when the soils are wet by precipitation or otherwise, sidewall collapse is possible. The recommended stand-up time for open grave sidewalls is maximum 24 hours, however, wet periods will have a significant effect on the stability of the open graves and should be assessed individually.

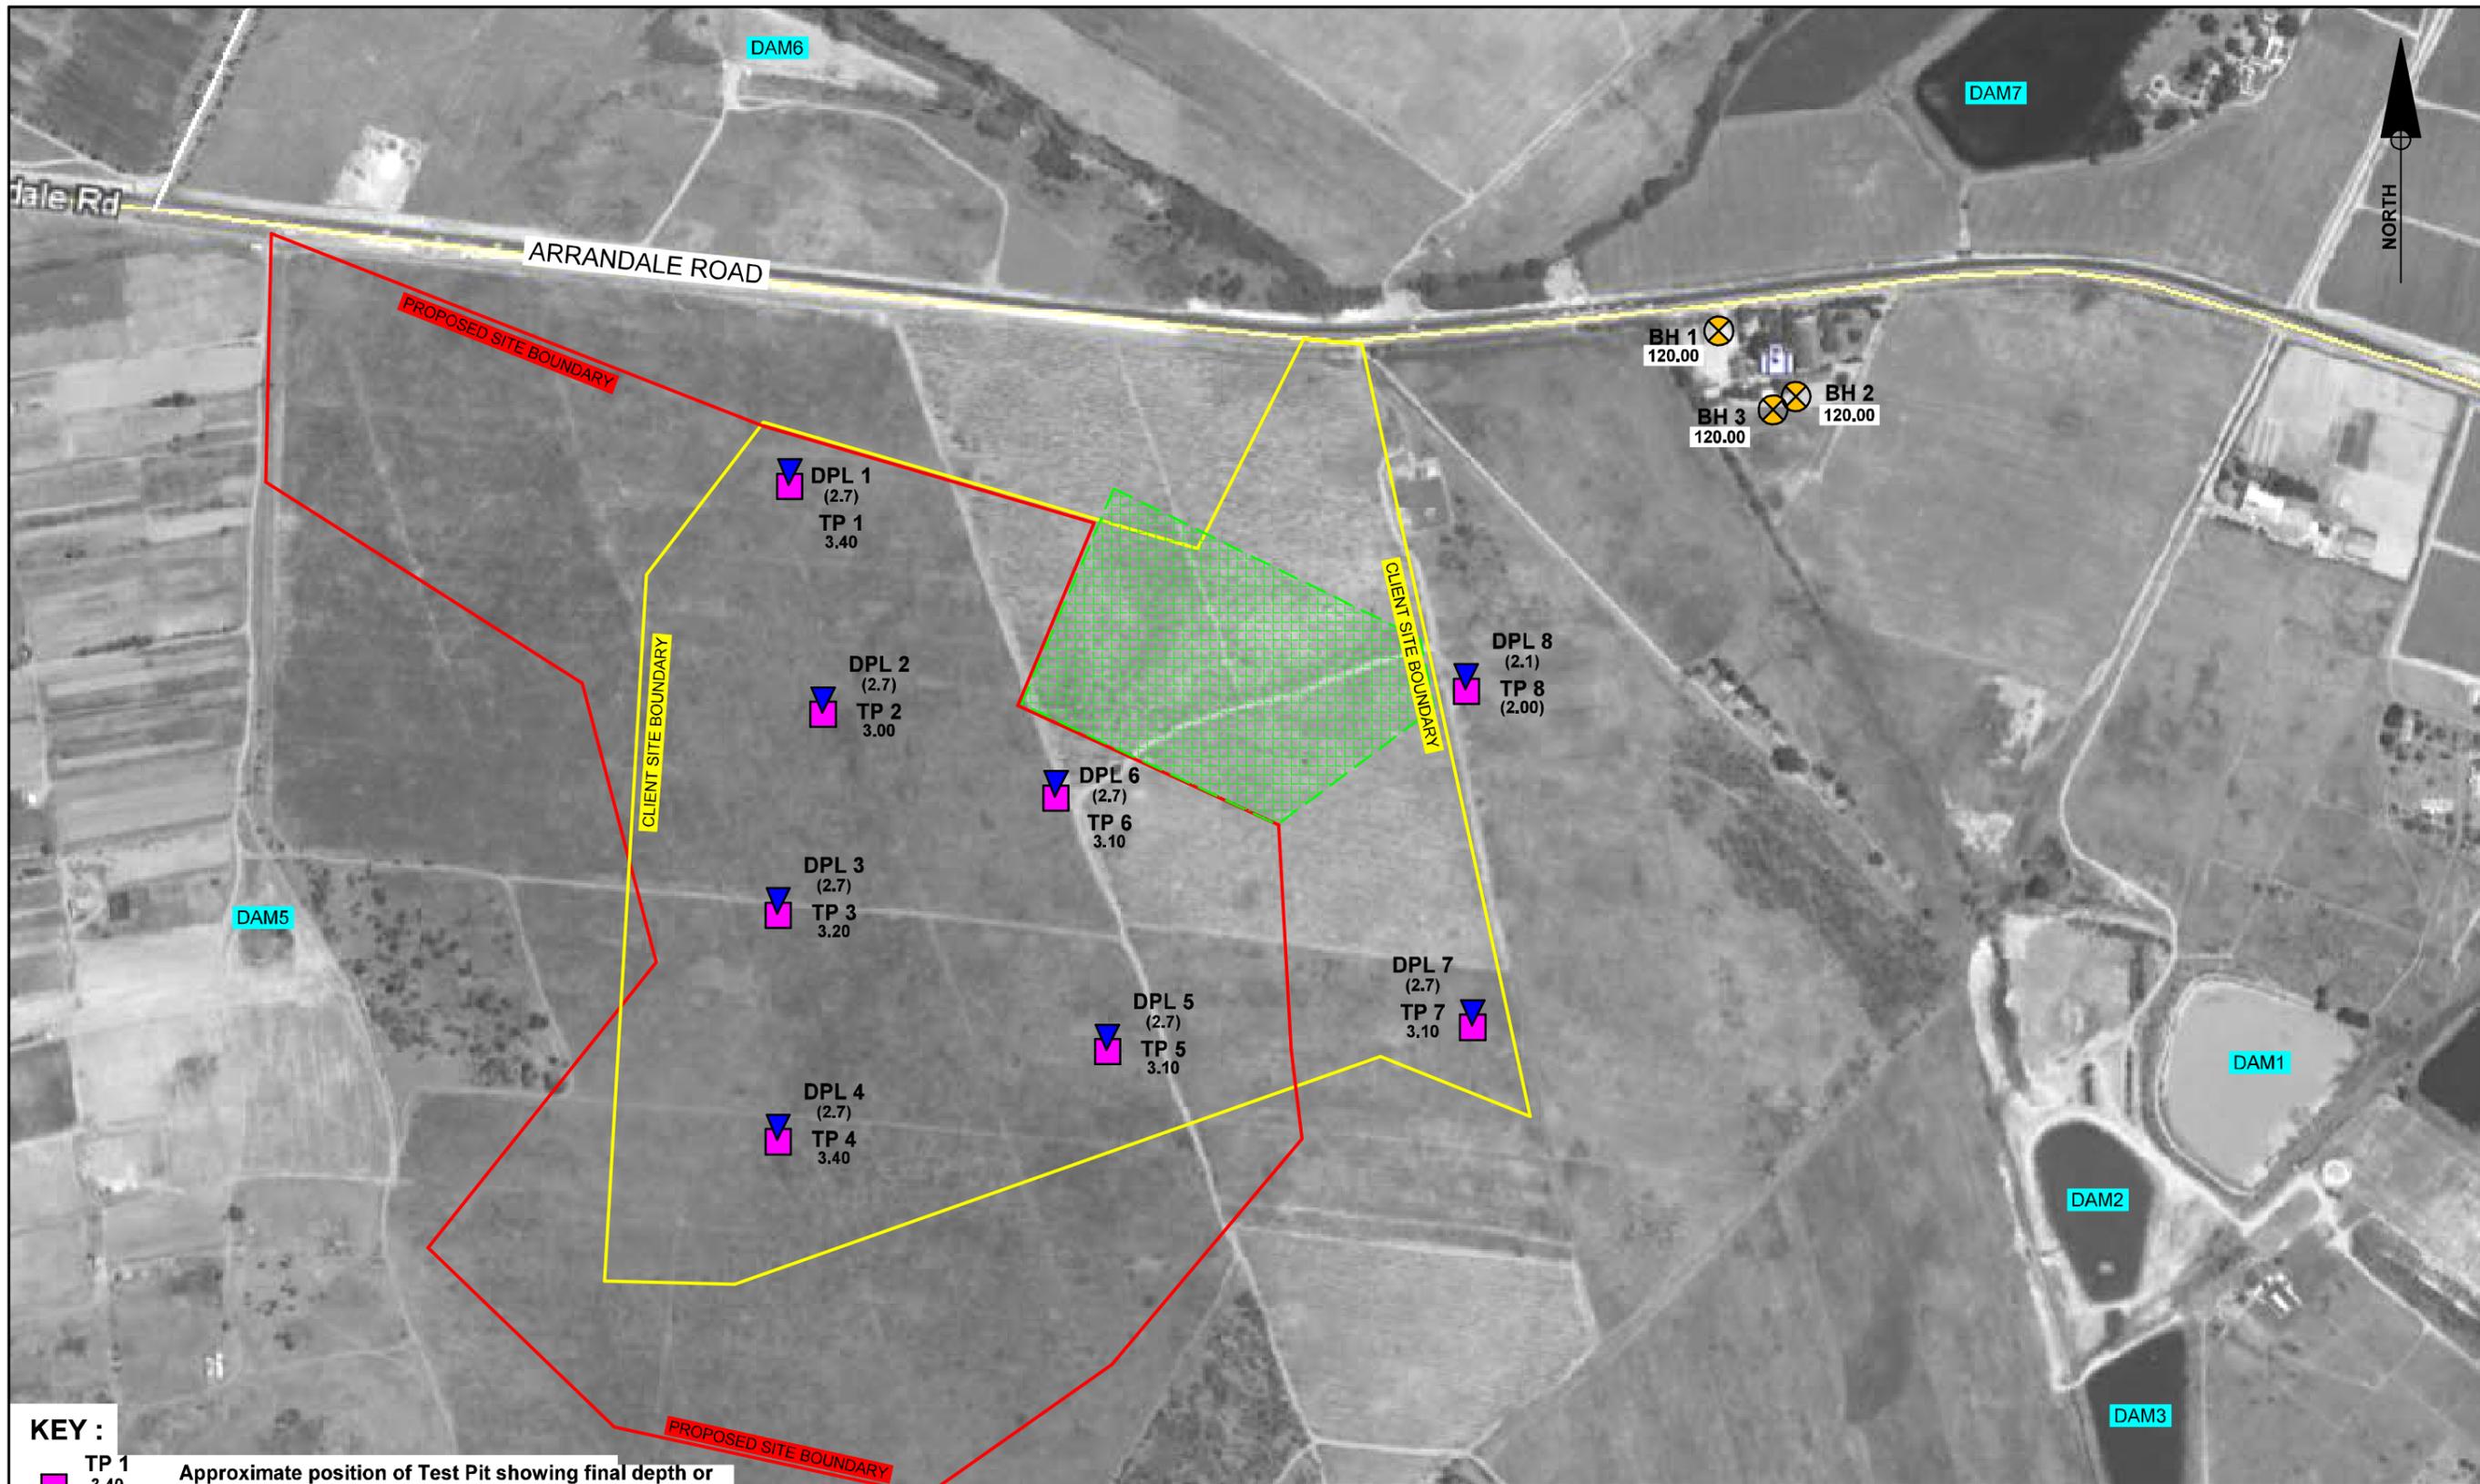
<b>DATE</b> 26/07/2018	
<b>DRAWN</b> A.S.	
<b>CHECK</b> M.V.R.	
<b>REFERENCE No.</b> 18 - 820	
<b>FIGURE No.</b> 2	<b>REV.</b> 0

The site is bounded on the northern side by Annandale Road and cultivated farm land and on the south, east and west sides side by municipal land, some of which is cultivated (Figure 2).

Eight trial pits, designated TP1 through TP8 were put down at the location as shown in Figure 2 at the site. TP1 to TP7 were terminated in clay at a depth of between 3.1m and 3.4m below existing ground level. TP8 refused on granite at a depth of 2.00m.

- TP 1  
3.40  
(2.00)     **Approximate position of Test Pit showing final depth or depth to refusal ( ) in metres below existing ground level.**
- DPL 1  
(2.7)     **Approximate position of Dynamic Cone Penetrometer Test (Light) showing depth to refusal in metres below existing ground level.**
- BH 1  
120.00     **Approximate position of Borehole showing final depth in metres below existing ground level.**
- Area where slopes are >6%**

DWS requirements with regards to the siting of cemeteries are that the following areas<sup>8</sup> should be avoided. The area recommended for the siting of a cemetery is shown in Figure 2.

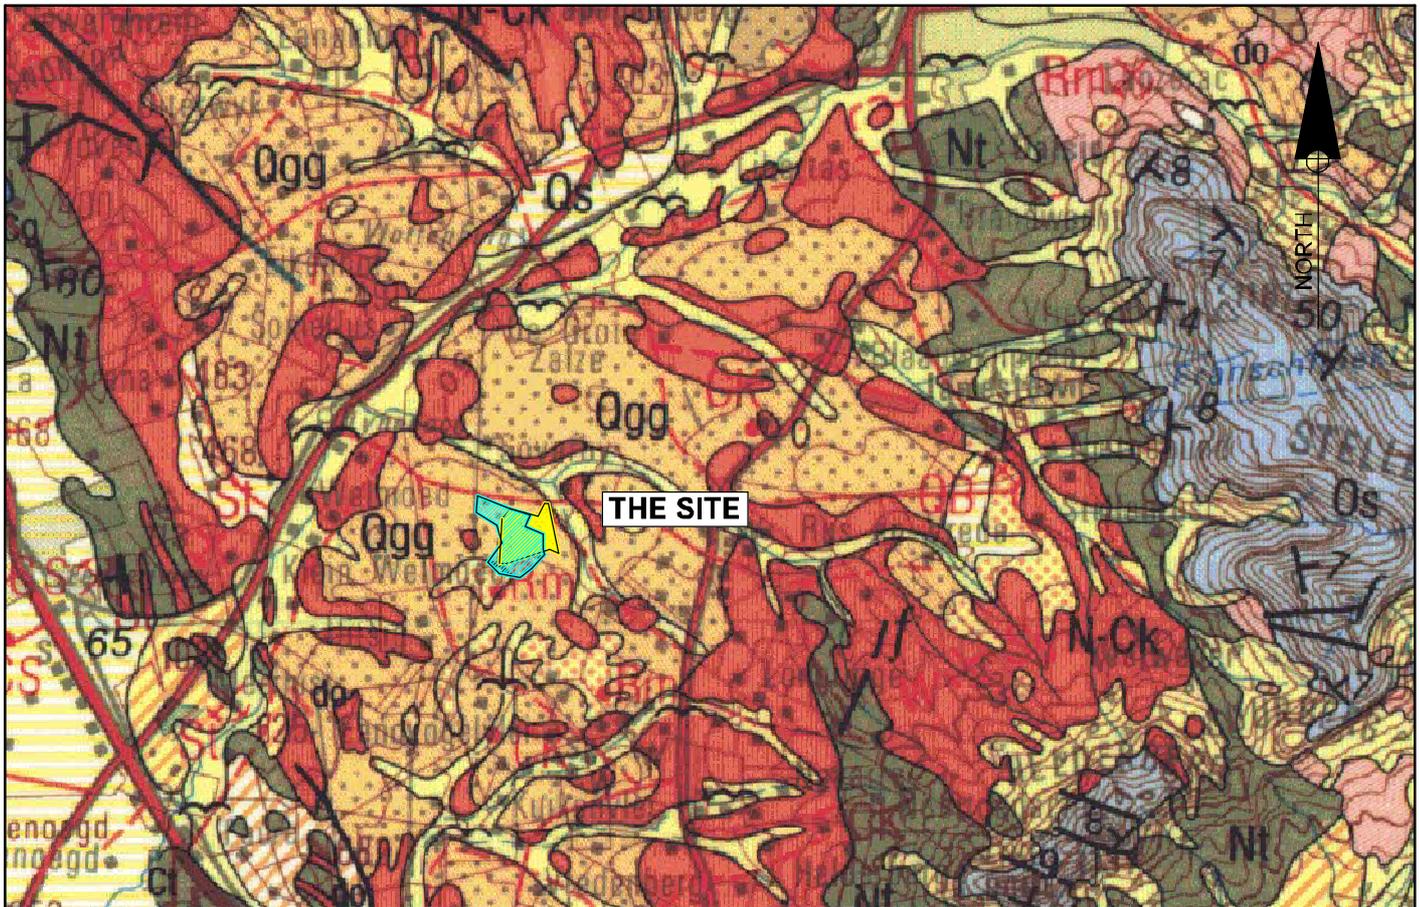
The regional geology of the area is shown in the extract presented in Figure 3 and taken from the 1:250 000 Cape Town 3318 geological map prepared by the Council for Geosciences. The regional geology consists of:

- Gravelly clay loam, Quaternary, overlying
- Granite Plutons comprising mainly coarse grained porphyritic with porphyritic biotite, fine grained leucocratic, hybridic and medium grained tourmaline-bearing variants of the Cape Granite Suite, outcrop around the site.
