**PROPOSED DEVELOPMENT OF A DAM AND
ASSOCIATED INFRASTRUCTURE LOCATED ON
PORTION 3 AND PORTION 5 OF THE
FARM VAN DER WATTSKRAAL 394,
NEAR RIVIERSONDEREND WITHIN THE WESTERN
CAPE PROVINCE**

FRESHWATER ASSESSMENT

Date: June 2017

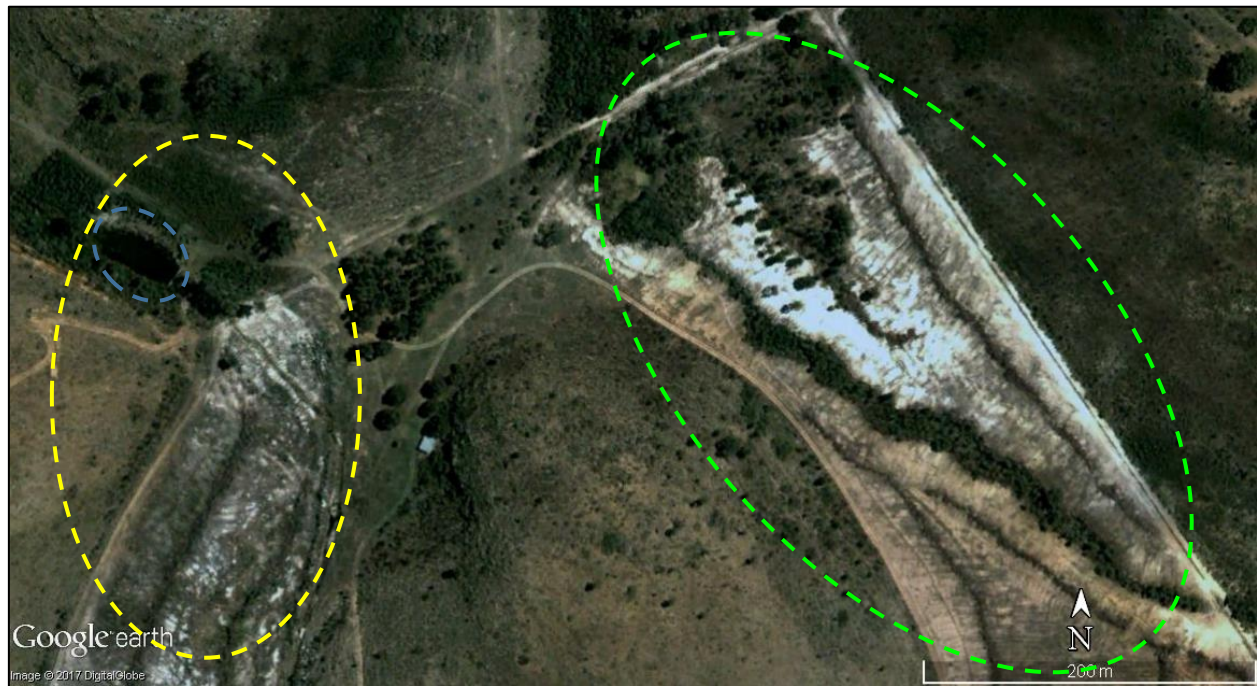
Figure 8: Historical imagery dated 2003 (Google Earth Pro, 2016). Disturbance at watercourse 1 indicated with yellow and disturbance at watercourse 2 indicated with green. The impoundment of surface water upstream of the original weir is also evident indicated with blue.

Personal communication with Mr. N. Jonker confirmed the extent to which watercourse 1 and watercourse 2 as well as the immediate surrounding areas have been disturbed in previous years. The most severe disturbance at watercourse 1 is considered to be the channelling and straightening of the watercourse following the flood event that also destroyed the weir. In addition, a road has been developed immediately downstream of the area where the weir was positioned. Alien vegetation encroachment is also considered significant within this portion of the watercourse. The main anthropogenic activities that resulted in disturbance of watercourse 2 are considered to be crop cultivation which has taken place for a considerable number of years on both sides of the channel.

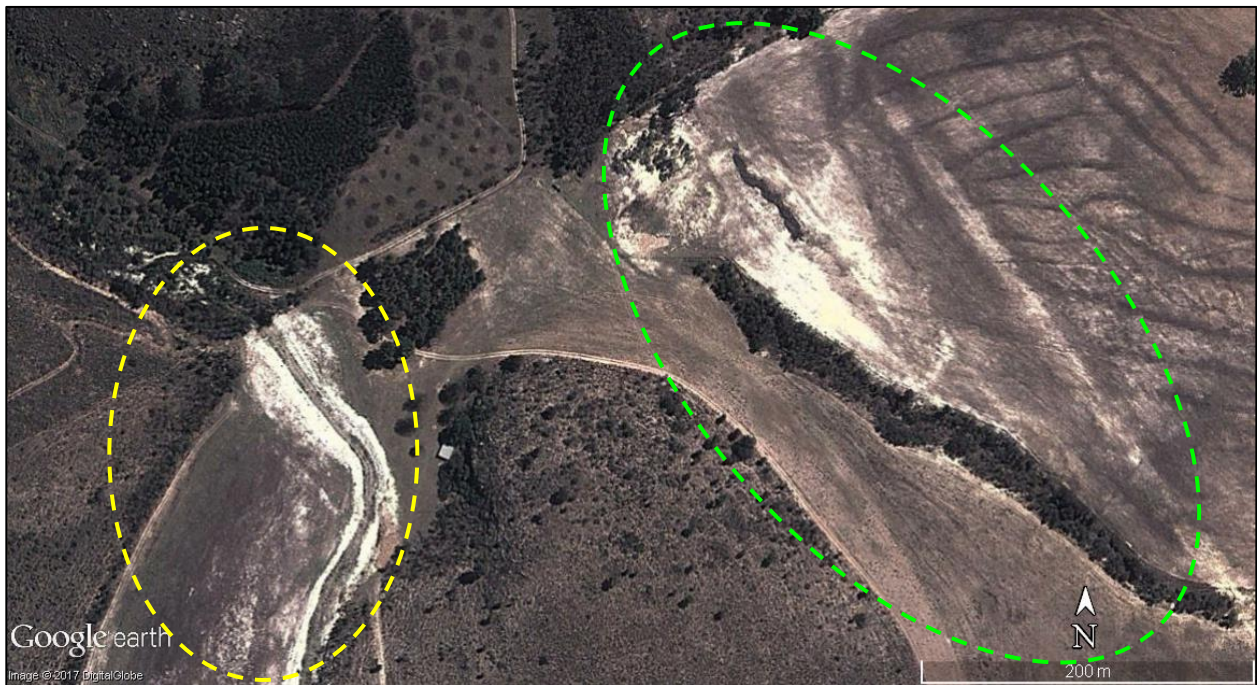
Figure 9: Historical imagery dated 2011 (Google Earth Pro, 2016). Disturbance at watercourse 1 indicated with yellow and disturbance at watercourse 2 indicated with green.

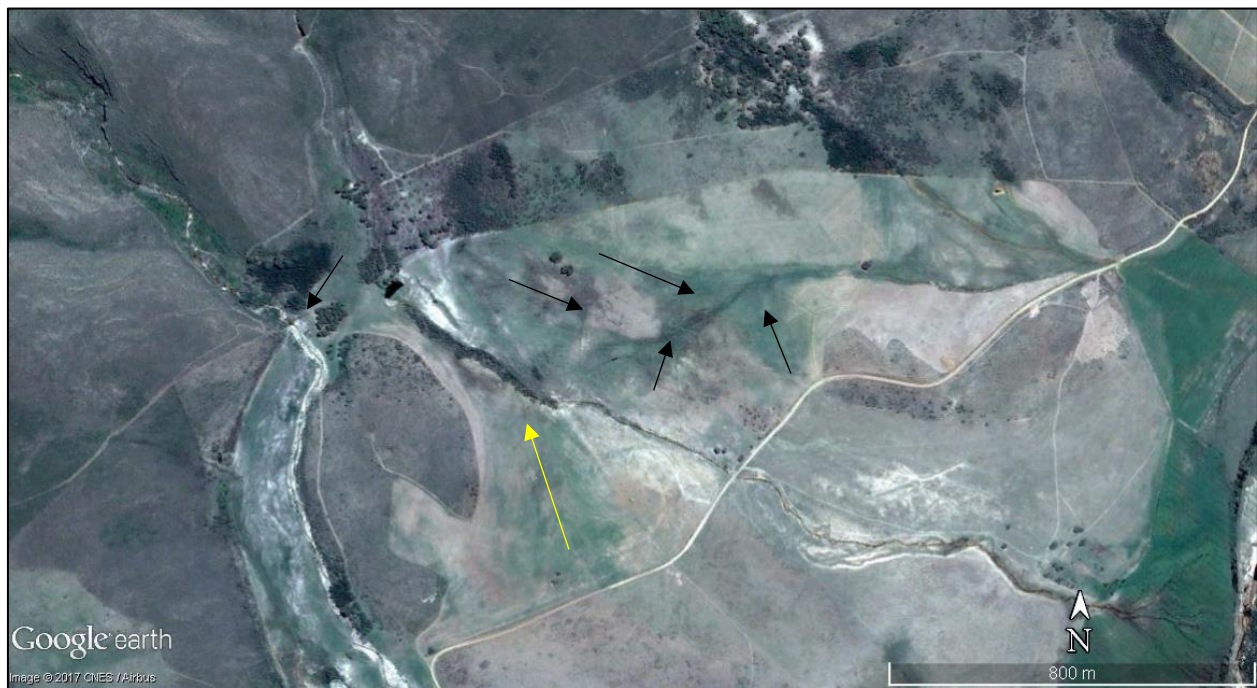
Figure 10: Historical imagery dated 2011 (Google Earth Pro, 2016) indicating the continued interflow of water despite disturbance taking place. General direction of subsurface flow indicated with black arrows.

Historical imagery taken after sufficient rainfall (Figure 10) indicates the presence of substantial interflow despite the degree of disturbance. The area south-west of watercourse 2 also show signs of potential interflow (indicated by yellow arrow in figure below), however this area is currently cultivated and no wetland indicators were encountered at the time of the field survey. It is however considered possible that wetland habitat may be more defined following sufficient rainfall. In the event of this happening, interflow will intercept watercourse 2 to the south of the area earmarked for the dam wall, and would therefore continue to augment watercourse 2 regardless of the presence of the dam. This potential wetland seep was therefore not assessed in detail as part of this report.

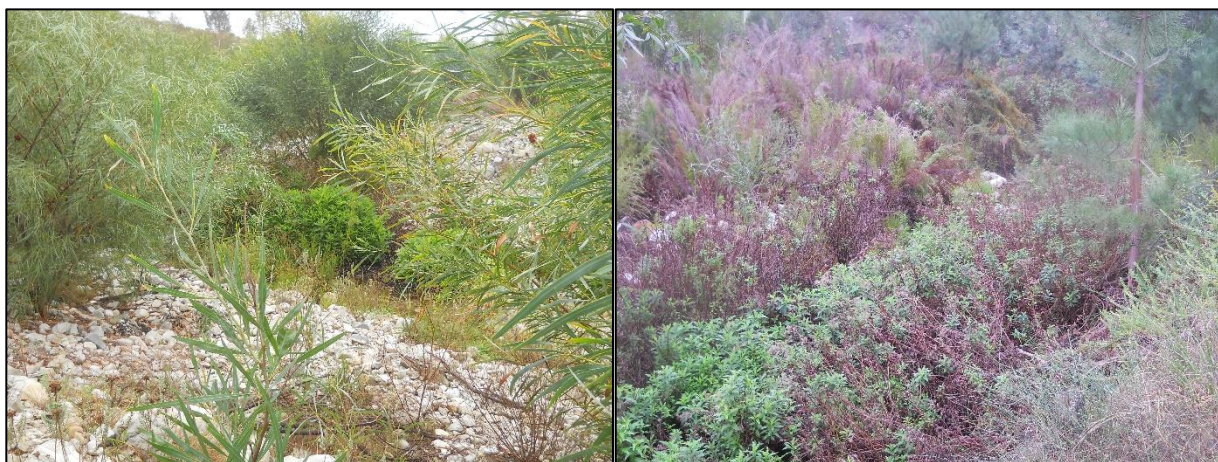
Figure 11: Portion of the watercourse in the vicinity of the weir.

Alien vegetation encroachment within the watercourse in which the weir repair is proposed was considered severe at the time of the field survey. Lack of vegetation with good soil binding capability has also resulted in erosion of the banks. The indigenous vegetation abundance does increase approximately 100m upstream of the area earmarked for the weir, however alien vegetation abundance increases substantially downstream.

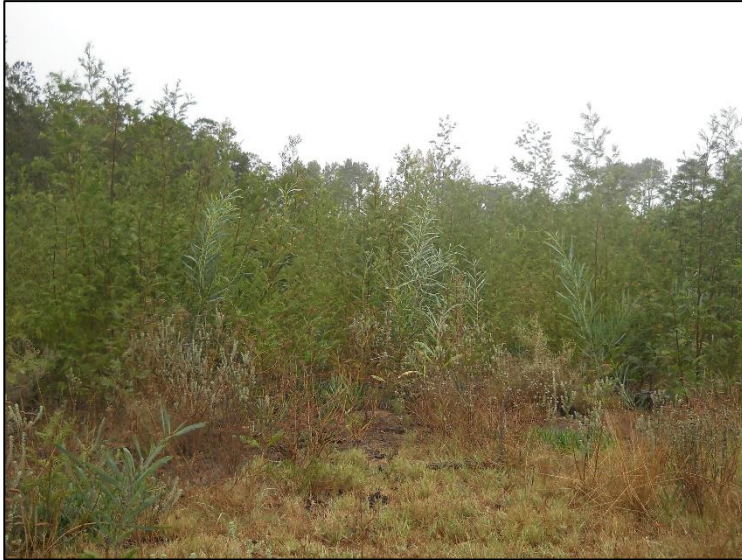
Figure 12: Wetland seep identified to the north of the proposed pipeline route.

The proposed route for the pipeline will traverse already disturbed areas, currently dominated by invasive grass species. Only one wetland seepage area was identified directly to the north of the northern portion of the route. This wetland seepage area is currently dominated by a combination of *Acacia mearnsii* and invasive grass species and the wetland indicators as defined by DWAF (2008) are considered to be ill-defined at present, most likely due to the volume of water utilised by alien vegetation in combination of the ongoing drought. The pipeline route is located approximately 50m from the wetland temporary zone and as

a result it was considered highly unlikely that the development of the pipeline will result in an impact on the wetland seep. This wetland feature was therefore not assessed in detail in the sections that follow.

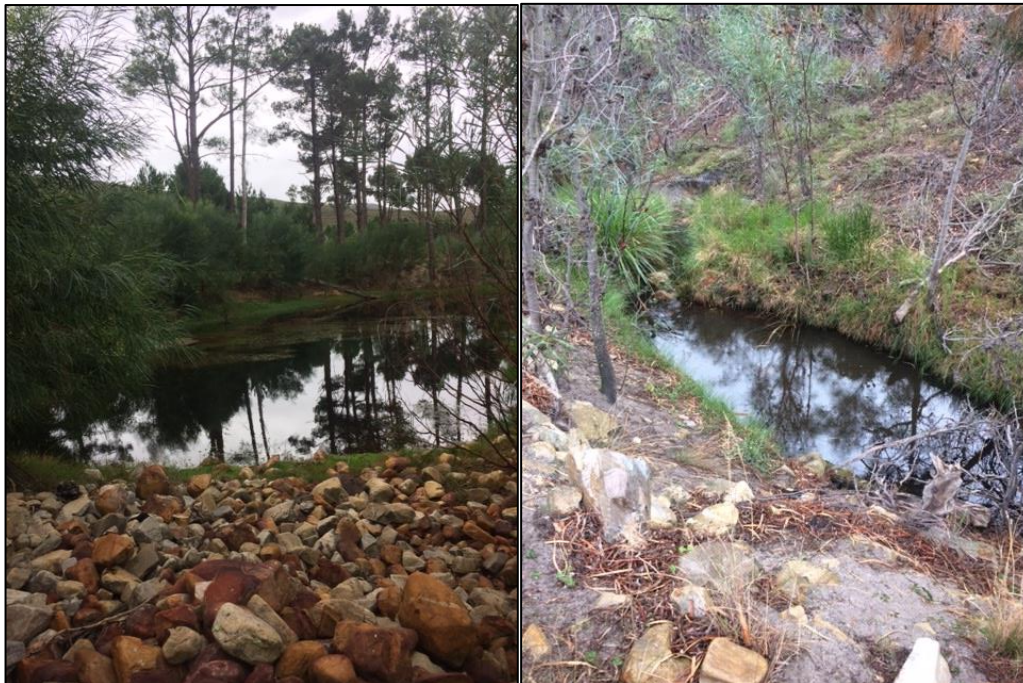
Figure 13: Impoundment approximately 100m upstream of the area that will be flooded if the Hut Dam is authorised (left) and a representative photograph of the watercourse in the vicinity of the proposed dam wall (right).

The watercourse wherein the construction of the Hut Dam is proposed (watercourse 2) has been subjected to an array of disturbances for decades. Watercourse 2 has been impounded at three locations upstream of the area earmarked for the dam. The area directly to the east of the watercourse was cultivated in the past and the area to the west is still under cultivation. The vegetation community along the watercourse itself is characterised by a combination of alien trees and invasive grasses, with indigenous wetland vegetation mainly restricted to the permanently saturated zone. The watercourse is also partially augmented by wetland seepages originating in the higher lying areas to the east.

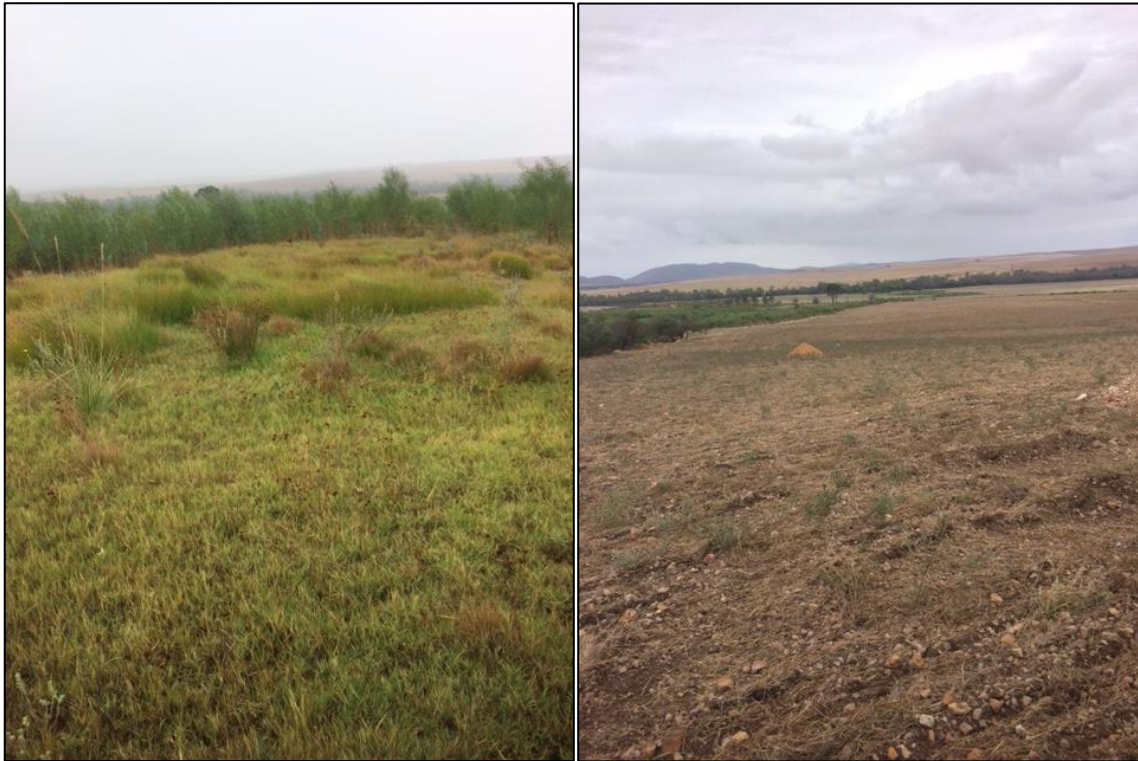
Figure 14: Alien vegetation dominating the areas to the east of the watercourse and ongoing cultivation within the area to the west of the watercourse.

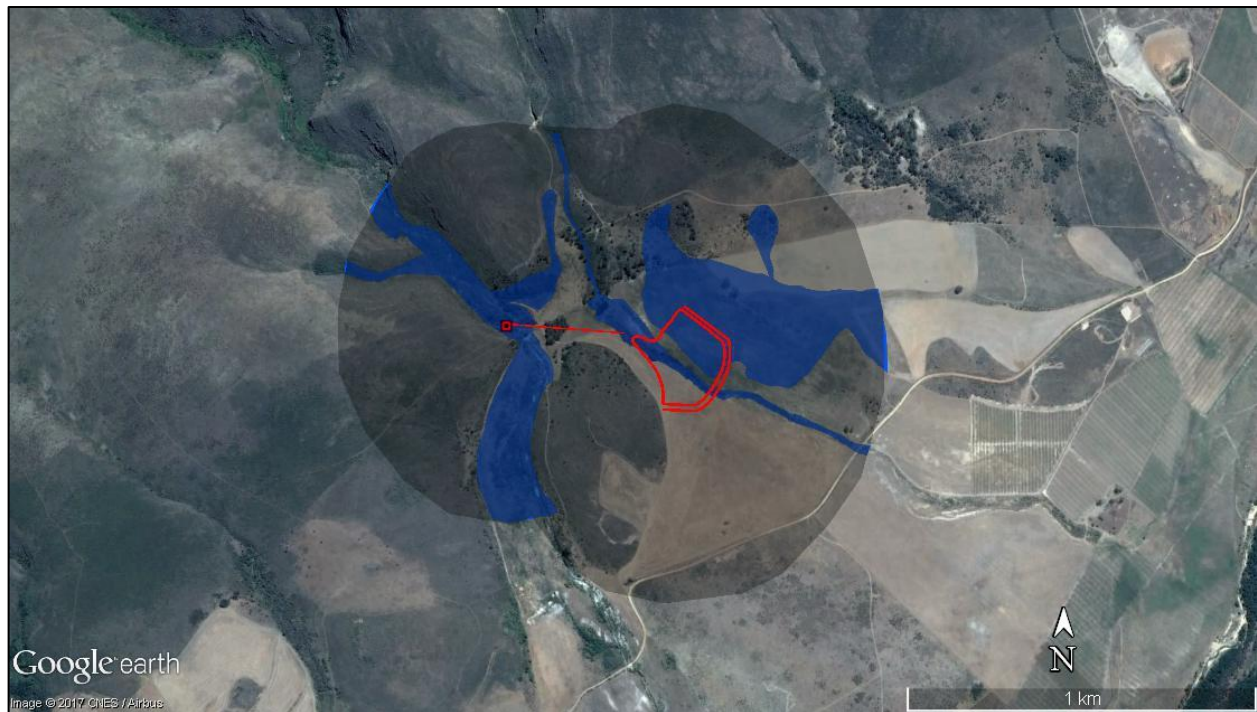
Figure 16: Wetland habitat (indicated in blue) identified within the 500m regulatory area (indicated in grey) of the proposed dam, weir and pipeline (indicated in red).

All wetlands within 500m of the proposed activities were identified with the use of Topo-Cadastral maps, WCBSP (2017), NFEPA (2011) and aerial imagery, presented in Figure 16 below. Portion 3 and 5 of the farm Van der Watskraal 394 is located on the foot slope of a mountainous area. Therefore, the gradient starts to decline (from north to south) and mountain streams and seepages tend to change into larger rivers or valley bottom wetlands. This is considered an accurate reflection of the watercourses encountered within 500m of the areas investigated. All the identified watercourses were considered and either assessed in detail if any impact relating to the proposed activities is anticipated or excluded from the detailed assessment if no impact is anticipated.

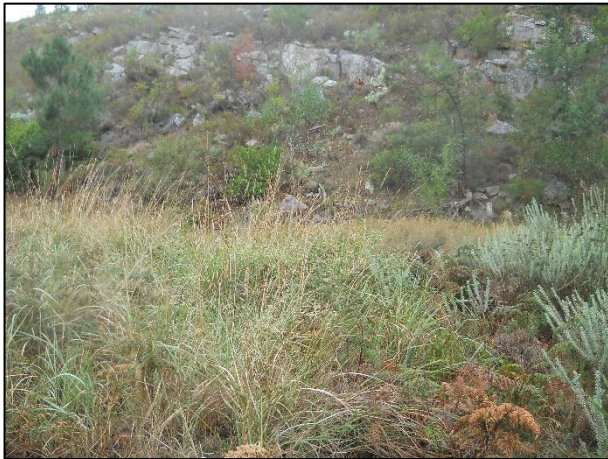
Figure 17: Watercourse 1. Wetland habitat dominated by *Pennisetum macrourum*, *Cyperus texilis* and in some areas *Searsia angustifolia* (left) adjacent to the channel and Gleying of soils evident at eroded areas of the channel.

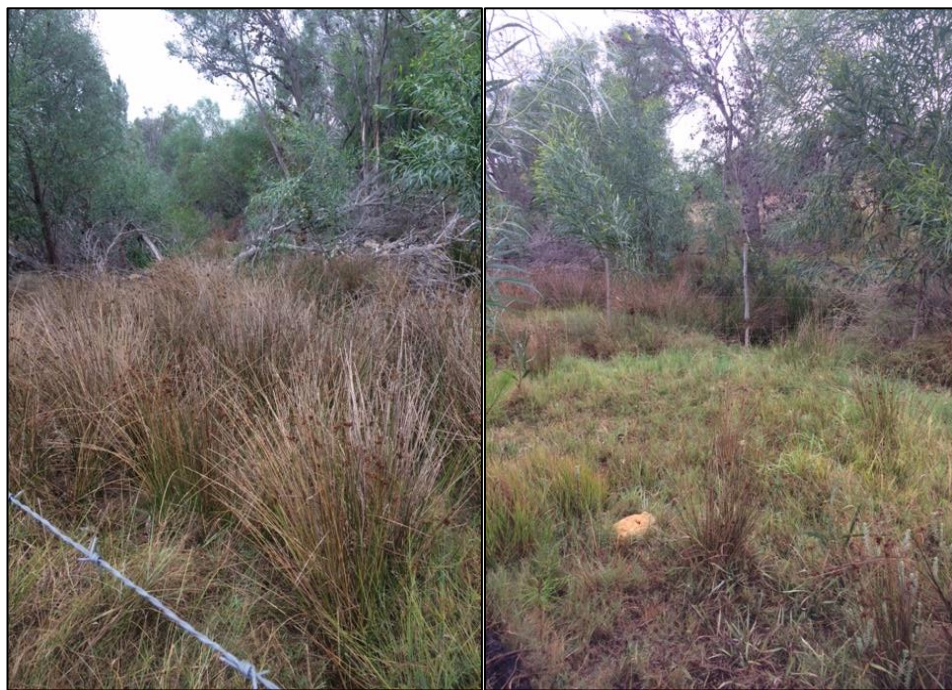
Figure 18: Watercourse 2. *Juncus* sp. communities upstream of the existing ground weir (left) and *Acacia saligna* dominating the banks of the channel.

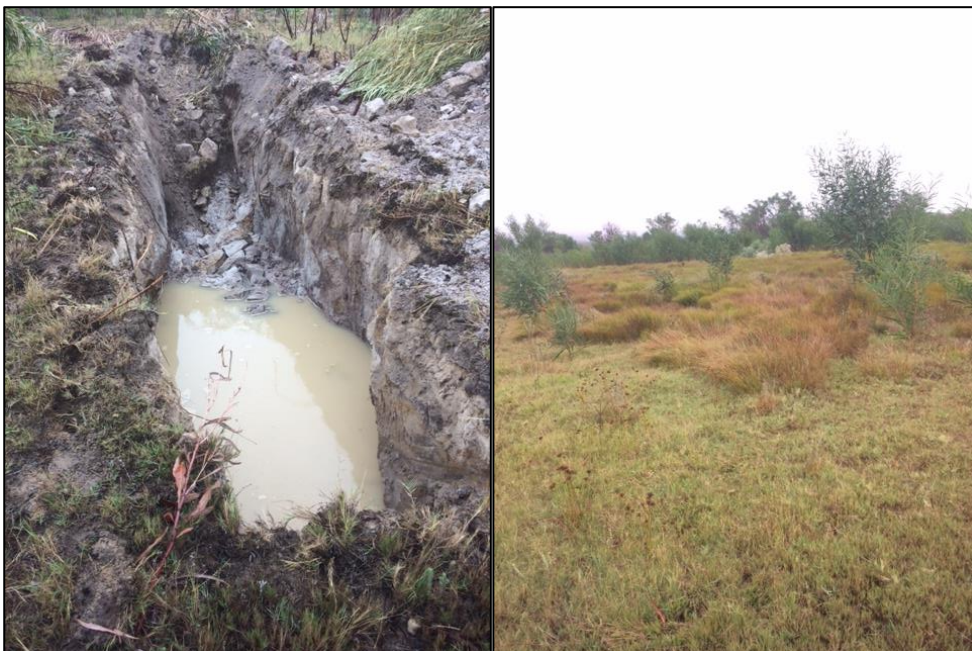
Table 7: Wetland seepages. Hydromorphic soils (10YR 2/1 and GLEY 1 3/N)¹⁵ (left) and communities of *Imperata cylindrica* (right).

The onsite delineation of the wetland seep was undertaken with the use of hydromorphic soils¹³ and facultative¹⁴ vegetation (*Imperata cylindrica* and *Cyperus* sp.). Due to the preceding dry conditions which could result in the potential underestimation of the size of wetland habitat the delineation was supplemented with the use of aerial imagery (Google Earth Pro, 2016).

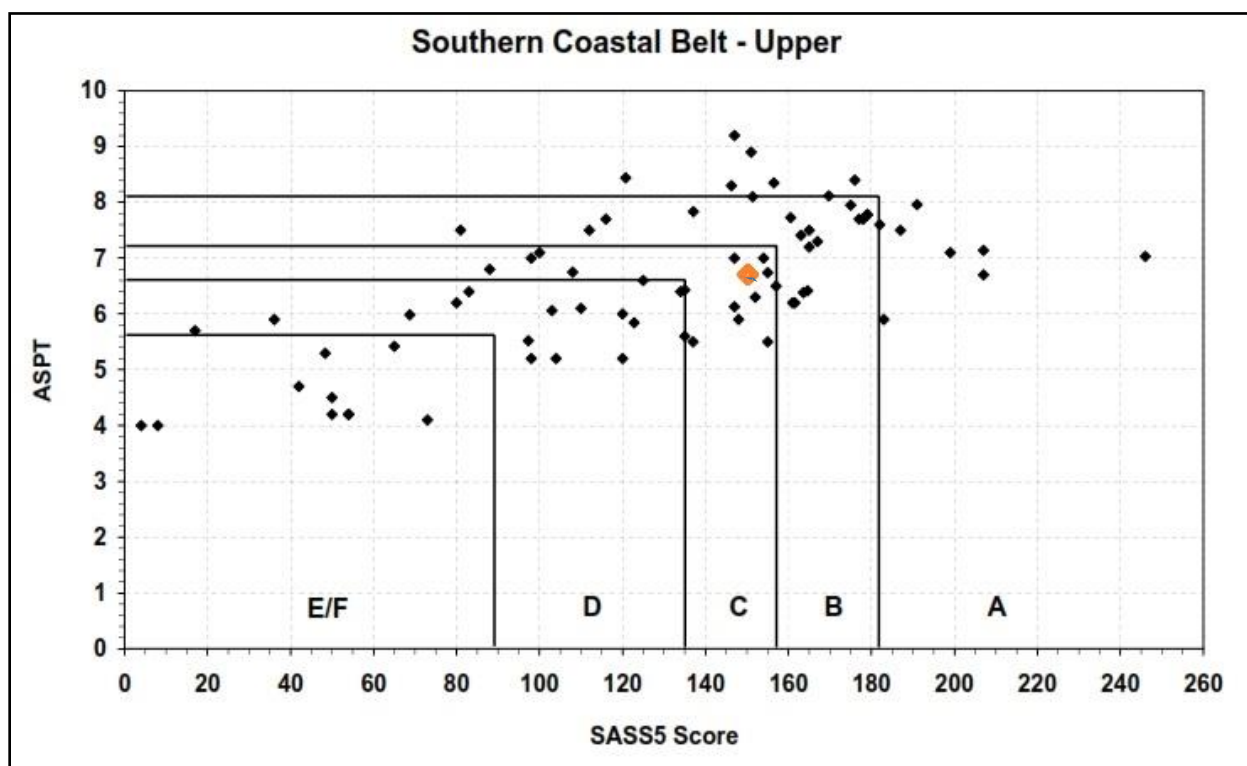
Figure 20: The biological bands for the Southern Coastal Belt-Upper Zone.

The site falls within Southern Coastal ecoregion and Figure 20 shows the biological bands assigned to the upper zone of the ecoregion plotted against the SASS5 score and the ASPT (according to the SASS5 interpretation guidelines of Dallas, 2007). The figure indicates that the site falls within Category C of the Biological Band/Ecological Category, indicating a moderately modified condition.

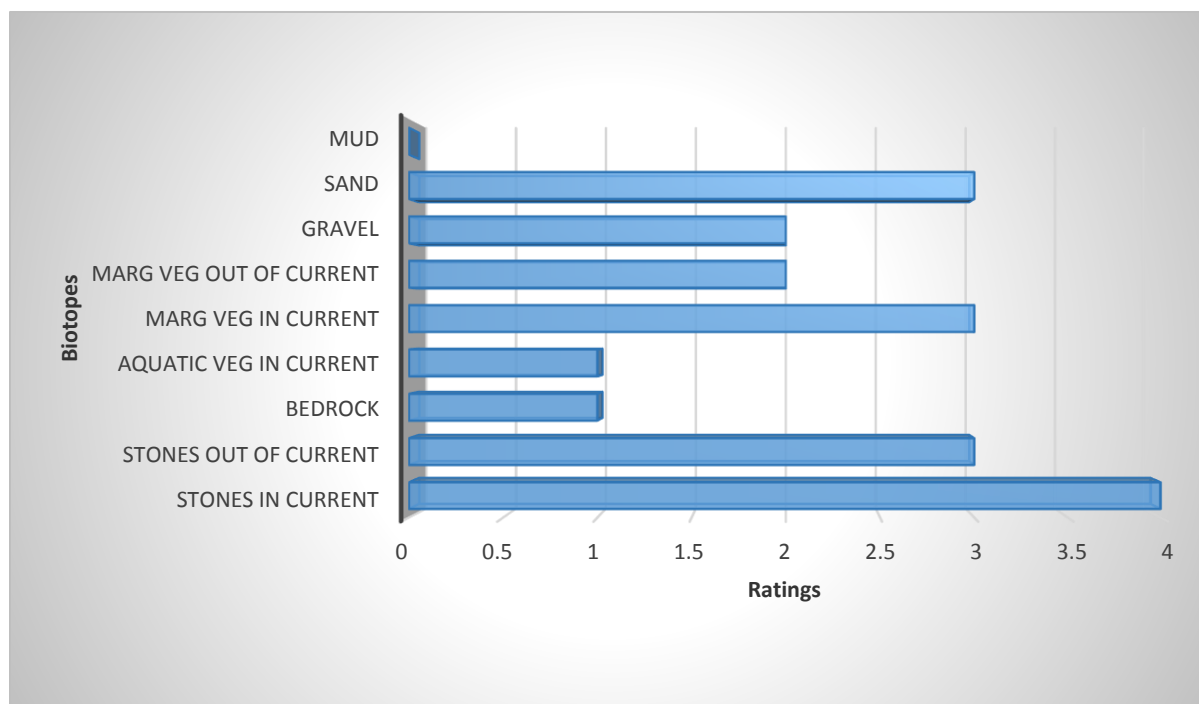
Figure 21: Biotope ratings, showing the score for Stones, Vegetation and Gravel Sand and Mud biotopes in relation to one another.

The rating of each biotope sampled is indicated on Figure 21. A biotope rated as 1 indicates very poor (limited diversity) and a biotope rated as 5 indicates highly suitable (wide diversity). The results suggest that the section of the river had moderately high diversity and availability of stones (stones in current) and very limited diversity of aquatic vegetation, bedrock and mud. Invertebrate habitat (diversity and availability)

is modified by modifications on the stream including channel morphological alteration e.g. bank degradation and bank modification and alien vegetation. These results help to explain that that habitat quality (diversity and availability) are important drivers in supporting invertebrate community diversity and abundance.
