BOTANICAL STATEMENT

DRIEFONTEIN DAM

**PROPOSED ENLARGEMENT OF AN EXISTING DAM ON PORTION 33 OF THE FARM RIETVALLEY
NO. 367, NEAR CERES, WITZENBERG LOCAL MUNICIPALITY, WESTERN CAPE PROVINCE.**

3 September 2018

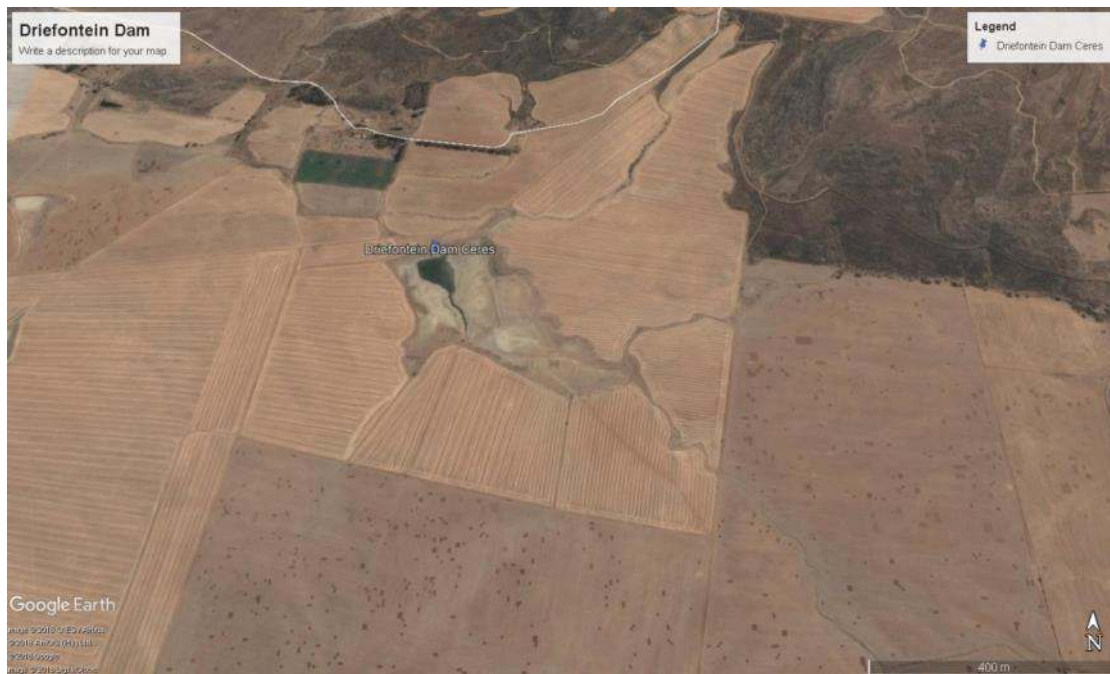
Desktop studies supported by the 2013-14 national land-cover dataset indicated that the site and its immediate surroundings were most likely transformed as a result of cultivation (Refer to Figure 4 & 5). This was confirmed by the site visit.

Figure 5: Google image, showing the existing dam and cultivated land surrounding the dam (note the narrow, uncultivated areas associated with the small valley bottom seasonal drainage lines)

- Ideally ecological support areas should be established along the small streams (similar to those already implemented – Refer to Figure 5). As a potential off-set the re-establishment and protection (fencing them off) of a more natural riparian vegetation along these streams should be considered. But this will be difficult as the area has been subject to intensive agriculture over a long period of time.

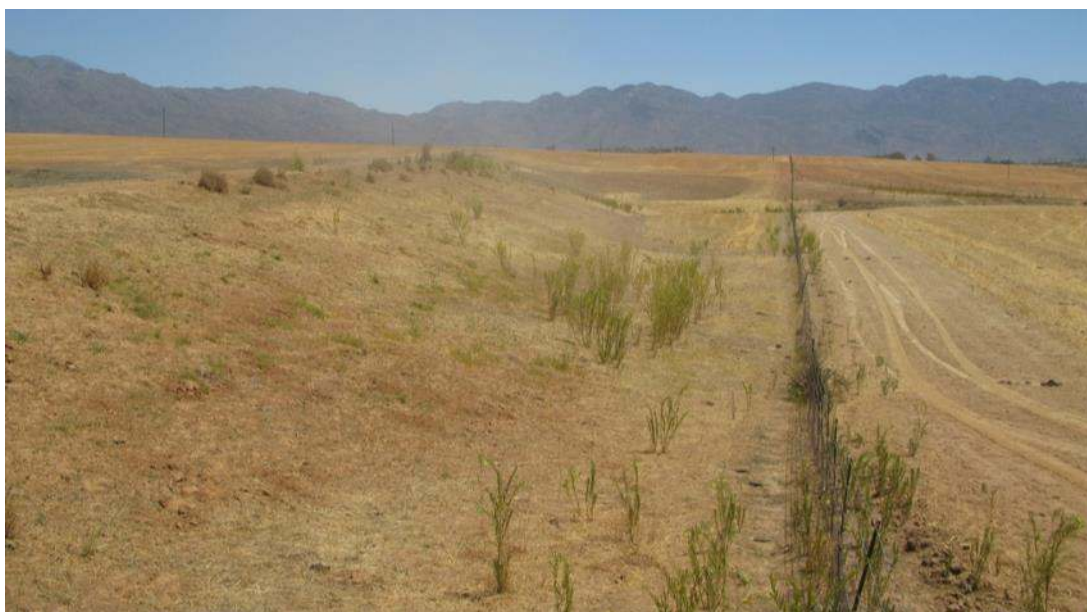
No natural vegetation was encountered on the site or its immediate surroundings, apart from a few hardy (and mostly weedy) species on or just below the dam wall or within the uncultivated areas near the seasonal drainage lines. The most common plant encountered was the indigenous weed; *Gomphocarpus fruticosus* (associated with the dam and small drainage lines).

Photo 1: The dam wall showing its transformed status with only the weedy *Gomphocarpus fruticosus* remaining along its slopes

Photo 1 – 3 clearly show the transformed status of the area, with no natural veld remaining. It also clearly indicates that the site was subject to agriculture over a long period of time and as a result it would be highly unlikely for any natural vegetation to remain.

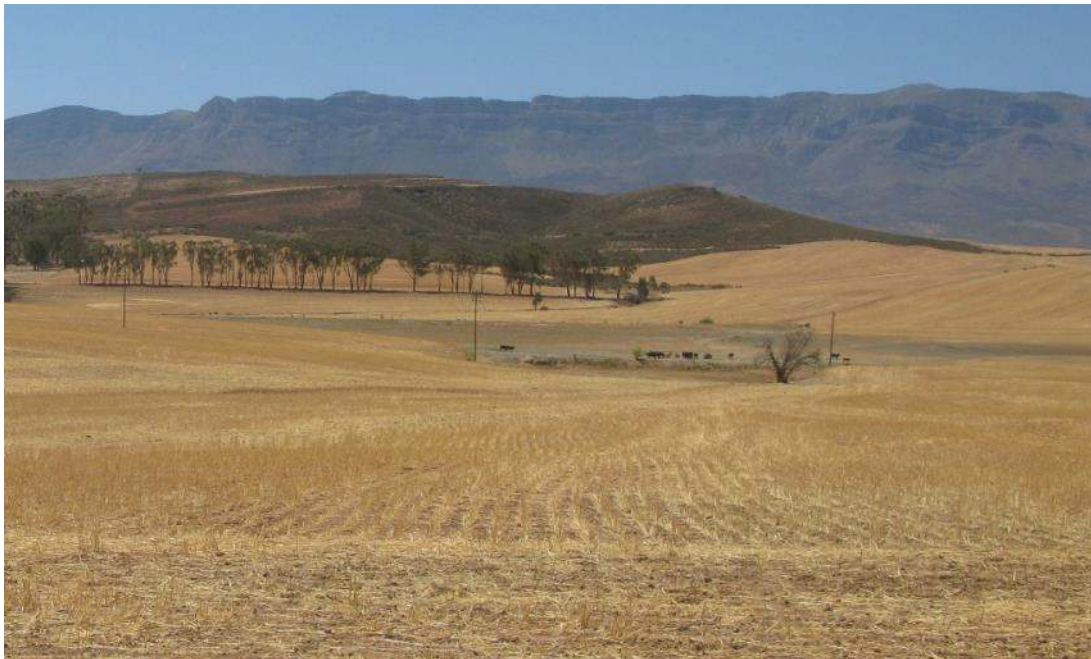
Photo 2: Looking over the existing dam from southwest to northeast

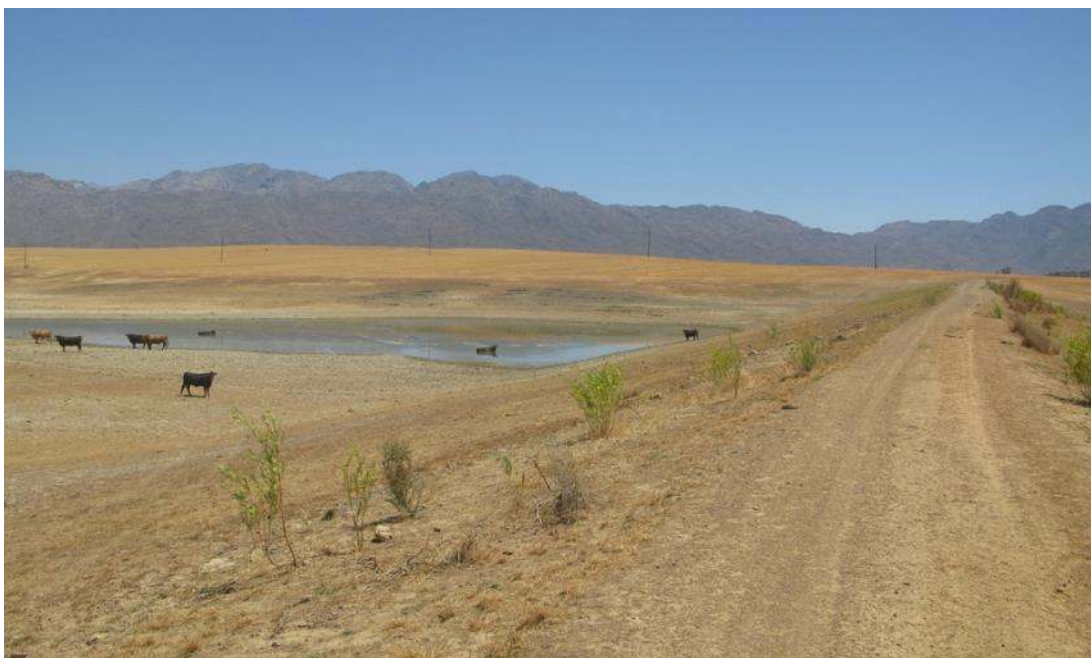
Photo 3: Looking over the existing dam from east to west

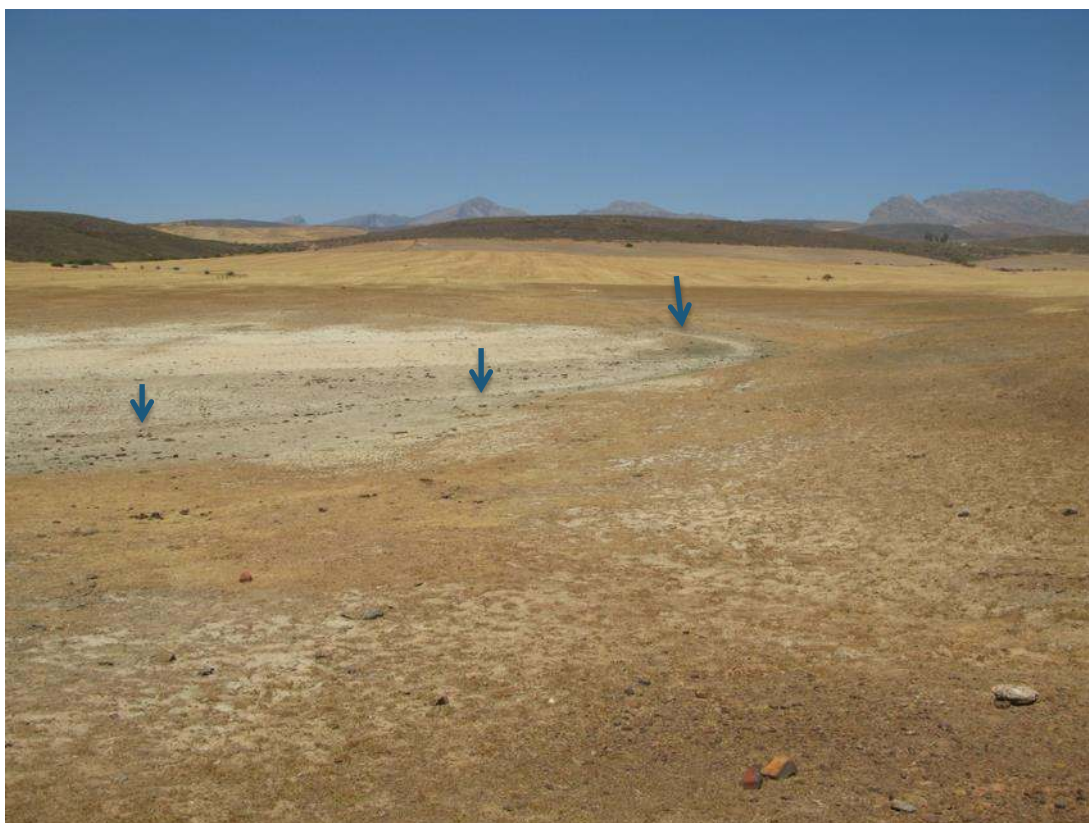
Photo 4 similarly shows the degraded status of the seasonal drainage lines (valley bottom wetlands) feeding into the dam. Ideally these drainage lines should be rehabilitated by trying to re-establish natural riparian vegetation along these streams and protecting them from grazing. In order for this to have a significant effect this should be supported by neighboring property owners as well.

Photo 4: Showing the status of the incoming seasonal drainage line (no riparian vegetation remaining)
