# AGTERFONTEIN BOERDERY (PTY) LTD

## PORTION 33 OF FARM RIETVALLEY 367, CERES

### DRIEFONTEIN DAM

#### TECHNICAL REPORT V2.1

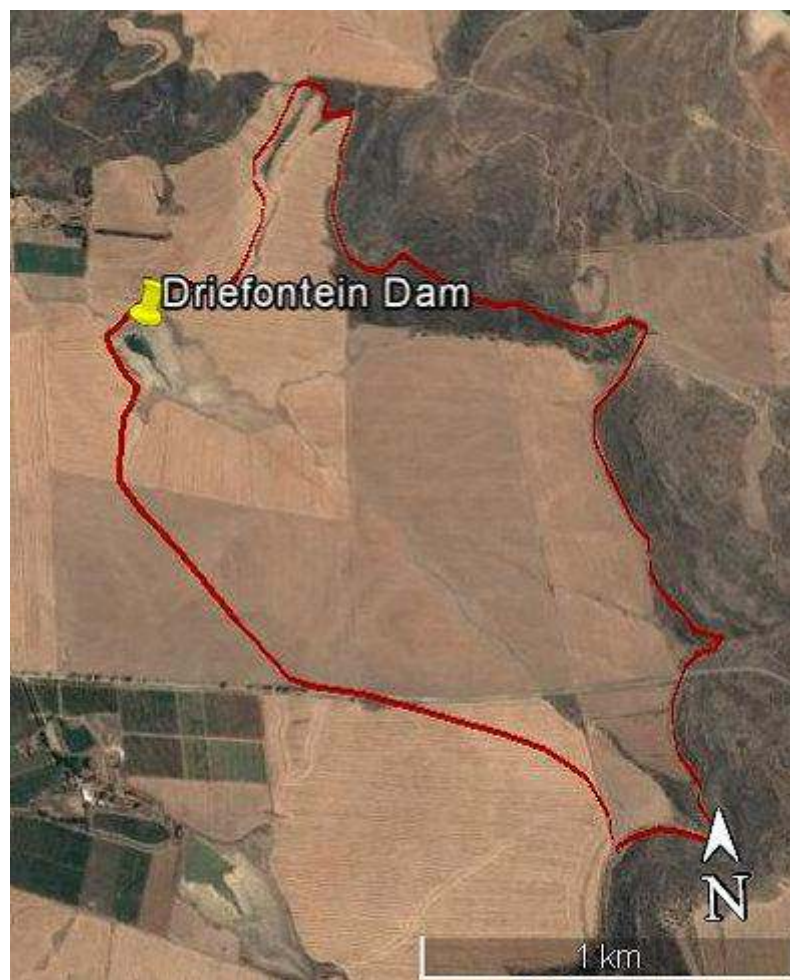
**Figure 2** Driefontein Dam Catchment Area

Of importance is that the Driefontein Dam, which is located approximately in the middle of the valley, is not naturally connected to any of the rivers that flow out of the surrounding mountains. It has, however, a small catchment of its own (Figure 2).

Originally this catchment was twice as large as it is today, as it has been divided in two portions by a canal from the Warm Bokkeveld Irrigation Scheme. The irrigation canals form the boundary of the sub-catchment on the western and northern sides.

Surface area	2.2 km
Annual rainfall	470mm
Annual runoff	230 000 m <sup>3</sup>

It is more than obvious that the runoff from the catchment is too little to fill the Driefontein Dam.

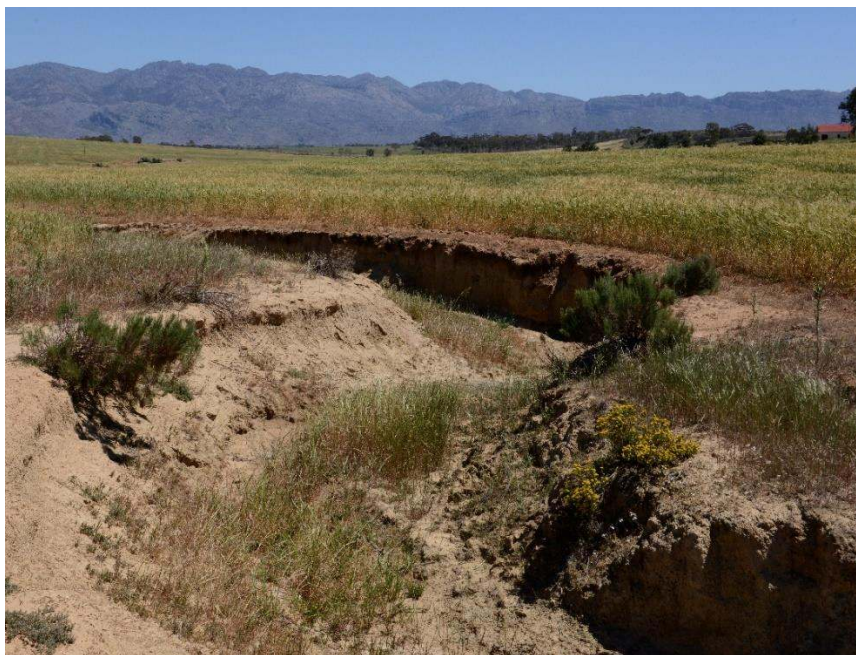
**Figure 5 Water course downstream of the Driefontein Dam**

Where the stream leaves the Driefontein Dam (Figure 5) it is highly impacted with literally nothing left of the original qualities of a natural stream. It is an incised furrow through a ploughed-over wheat field devoid of water, aquatic habitat or riparian zone. During the site visit there were mostly exotic grasses somewhat greener than the surrounding wheat fields (Figure 6).

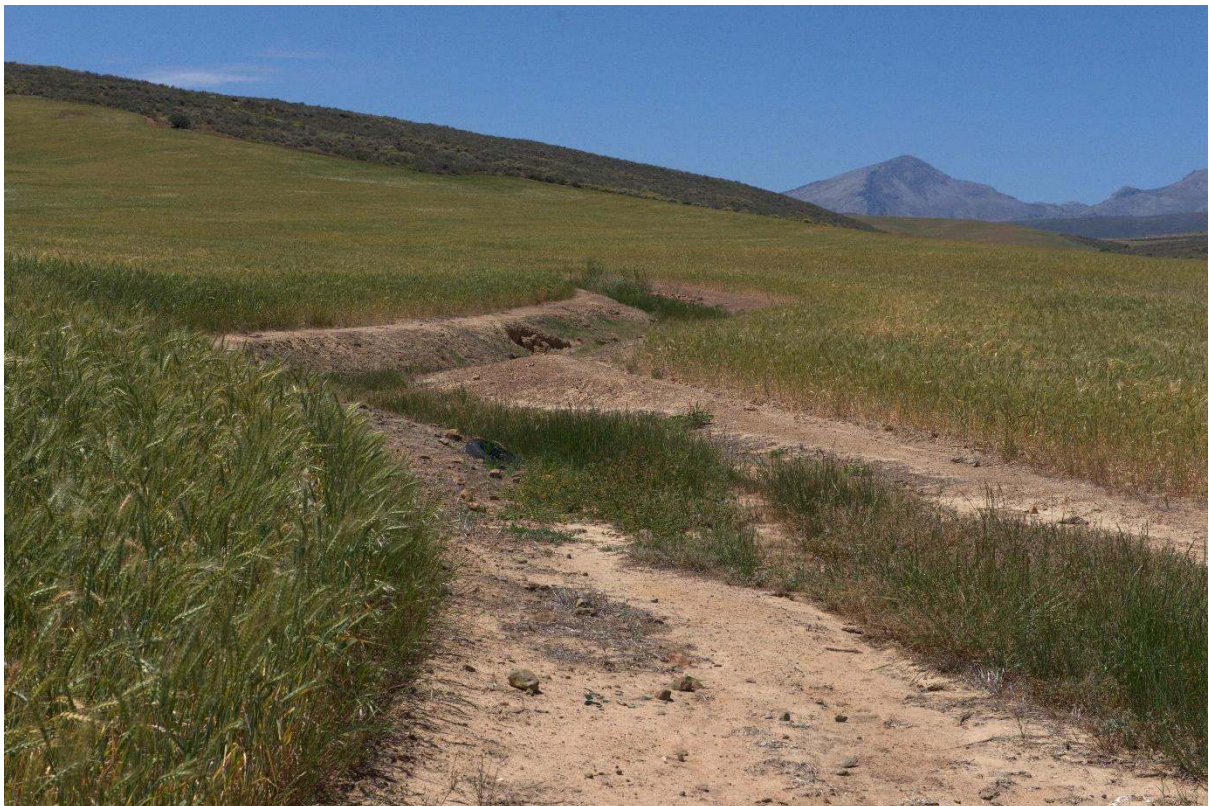
**Figure 7** Inflowing water course

The streams flowing into the Driefontein Dam are not any different (Figure 7). They are all most unnatural drainage lines through wheat fields.

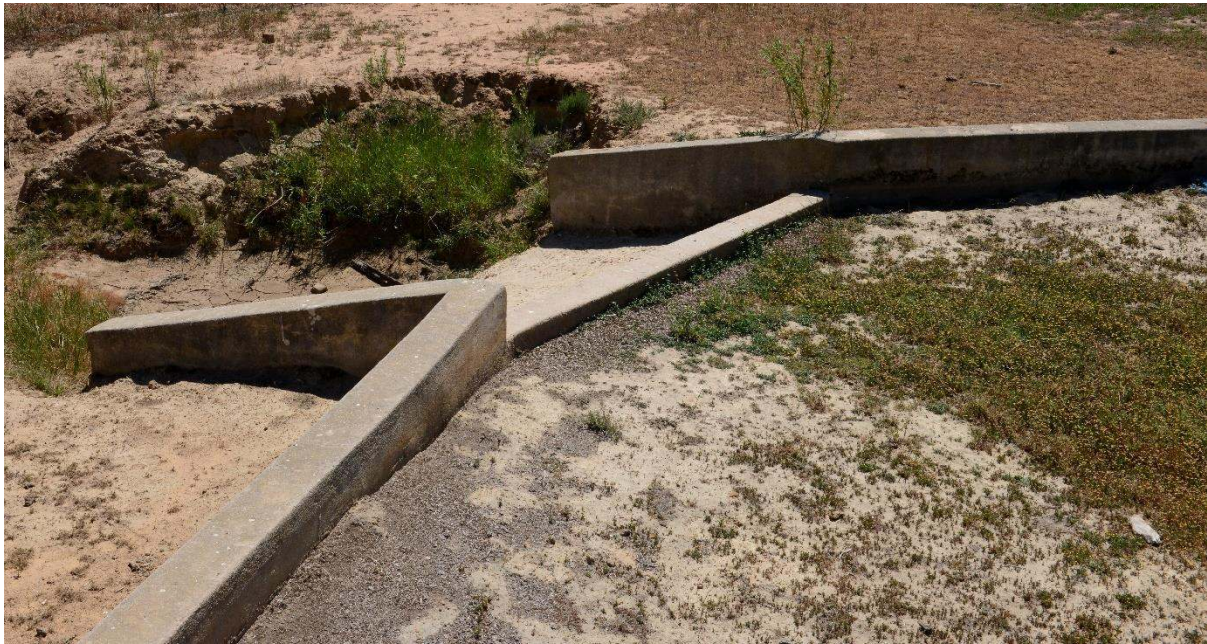
**Figure 8** Spillway

The spillway (Figure 8) is to be removed. A new one will be constructed over the reconstructed dam wall. The spillway will be raised with 1m.

The new spillway will be lined with natural stone rather than concrete. Again, no building material will be allowed to wash downstream under any circumstances.

The dam and the spillway should be not any higher than the dam's full capacity, after the 181 000m<sup>3</sup> has been added to the capacity of the dam. This would ensure that if the dam is at its design capacity, it would overflow during these exceptional very high rainfall events. This water would hardly benefit the highly impacted stream adjacent and below the Driefontein Dam. It would possibly be of benefit further downstream where there may still be ecological functioning left.

The possibility of any building rubble washing down the stream during the removal of the spillway can be prevented by applying standard work procedures, due diligence and limiting construction to the dry season.
