Biodiversity site inspection - ground-truthing of Western Cape Biodiversity Spatial Plan on Calcutta Farm No. 29

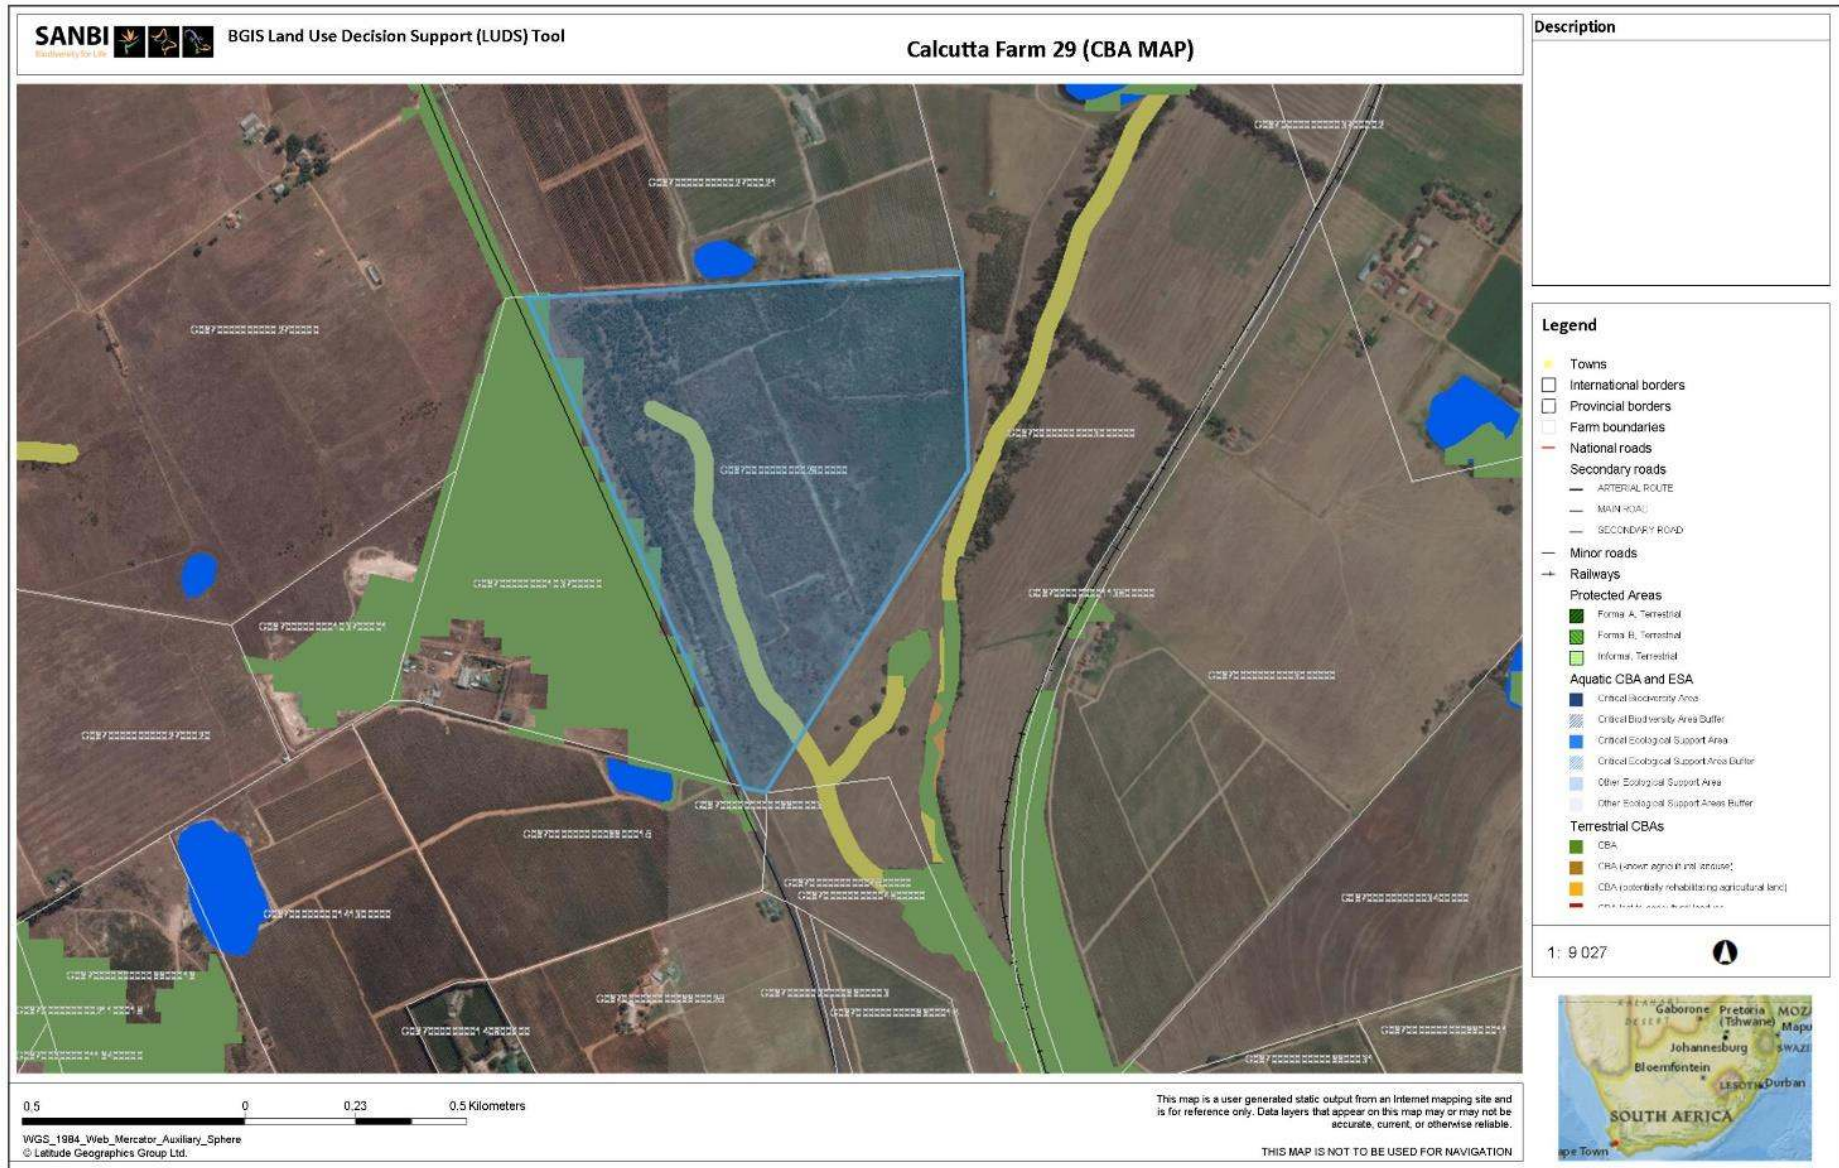
Figure 1: Critical Biodiversity Area (CBA) and Ecological Significant Area (ESA) Map of Calcutta Farm No. 29, Stellenbosch Municipality
 Critical Biodiversity Area 2 – degraded areas but with potential for rehabilitation indicated in brown. Ecological Significant Area 2 – aquatic ecological support areas indicated in yellow. Total property shaded light blue indicates that there are large areas of known degraded/alien infested land available for possible rehabilitation and development.

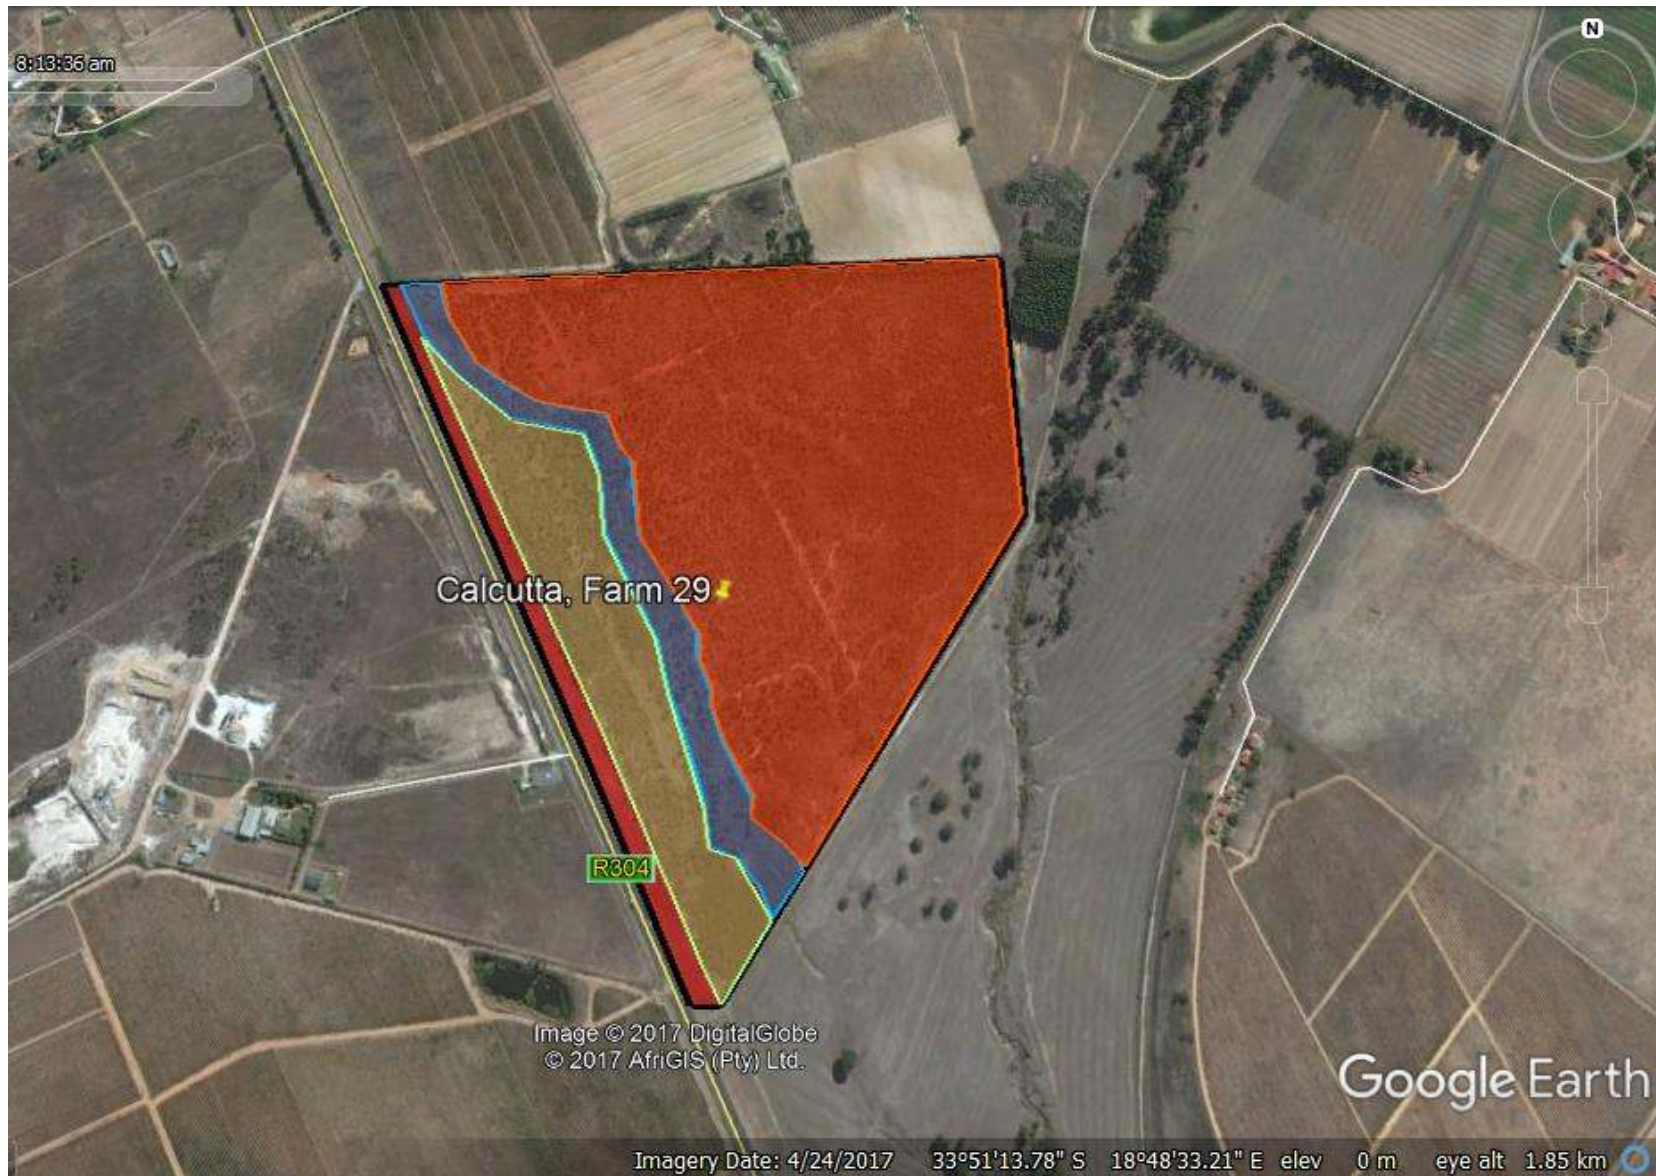
A physical site inspection showed that the whole of the property has been degraded as a result of dense stands of the alien tree *Eucalyptus*, but with *Acacia saligna* also prominent. Very few remaining natural plant species were observed but a small watercourse crosses the property from north to south along its western boundary. The area indicated in yellow above is also very degraded as a result of dense alien plant infestation but was marked separately because of its potential CBA status.
