**Report to CK Rumboll & Partners on a Geotechnical Investigation carried out for the Culcatta RE/29, Cemetery Site, Stellenbosch, Western Cape**

**Project No.: 18-811R01**

**Date Issued: May 2018**

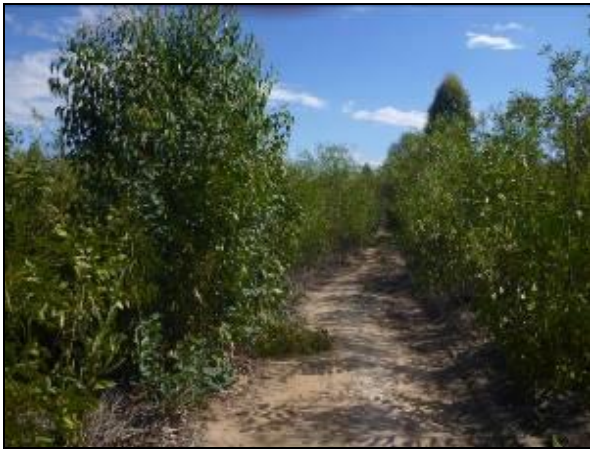
**Plate 1: Site viewed towards the east at TP4**

The site slopes gently towards the south west and south east and is thickly covered in Eucalyptus plantation regrowth and Port Jackson Willow trees, dead grass and weeds. The layout of the site is given in Figure 2.

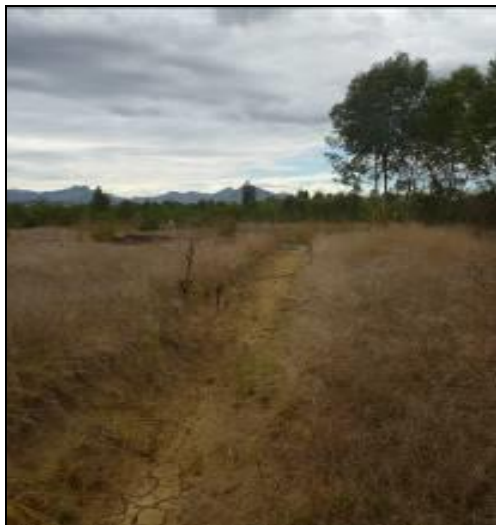
Plate 4: View towards the north along furrow

While there are small areas which could become vleis in wet years, notably in the north-west where a 140m furrow channels water from the neighbouring farmland in the north onto the site, (Plates 3 and 4), the bulk of the proposed area will comply if the area bounded by the drainage line in the west is avoided.

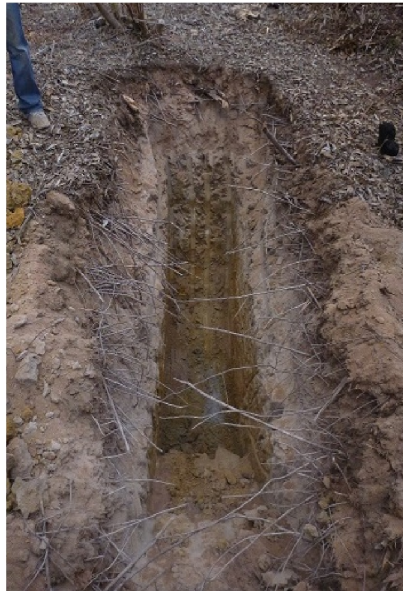
HOLE No: **TP1**

Dry light brown to cream brown loose intact fine grained calcareous SAND with tree roots over 0.40m. Colluvium.

Dry cream to grey brown medium dense to dense weakly cemented to cemented CALCRETE with orange brown staining on fracture surfaces. Pedicrete.

Slightly moist grey brown to light olive brown stiff to very stiff slightly shattered sandy CLAY. Colluvium.

Slightly moist olive brown stiff to very stiff slightly shattered sandy CLAY. Colluvium.

- 1) Refusal depth at 2.20m.
- 2) No groundwater seepage.
- 3) No sidewall collapse.
- 4) Samples taken :  
 S1 0.30--0.50m  
 S2 0.70--0.90m  
 S3 1.60--1.90m

Nine trial pits, designated TP1 through TP9 were put down at the location as shown in Figure 2 at the site. Trial pit TP1 refused on medium hard to hard rock sandstone, Trial Pits TP2, TP3, TP6, TP8 and TP9 terminated in clay at 3.10m, 3.40m, 3.00m, 3.20m and 3.30m respectively. Trial Pits TP4 and TP5 terminated in medium grained sand at a depth of 3.00m and 2.80m respectively, below existing ground level. Trial Pit TP7 refused in very dense ferricrete at 2.20m.

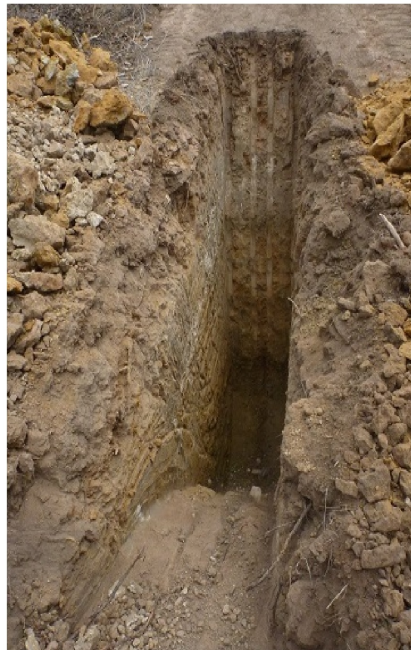
HOLE No: **TP2**

- 1) Final depth at 3.10m. TLB limit.
- 2) No groundwater seepage.
- 3) No sidewall collapse.
- 4) No samples taken.

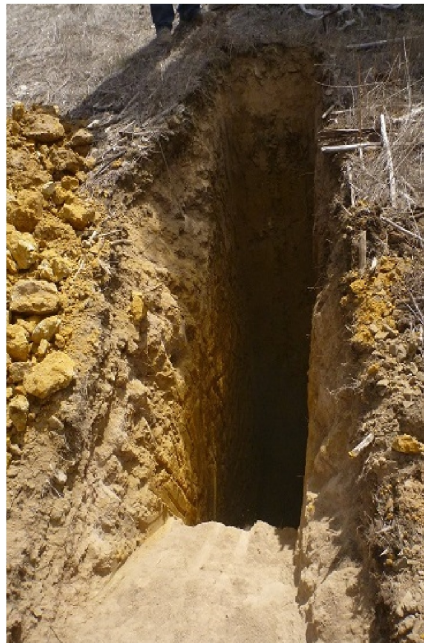
HOLE No: **TP3**

- 1) Final depth at 3.40m. TLB limit.
- 2) No groundwater seepage.
- 3) No sidewall collapse.
- 4) No samples taken.

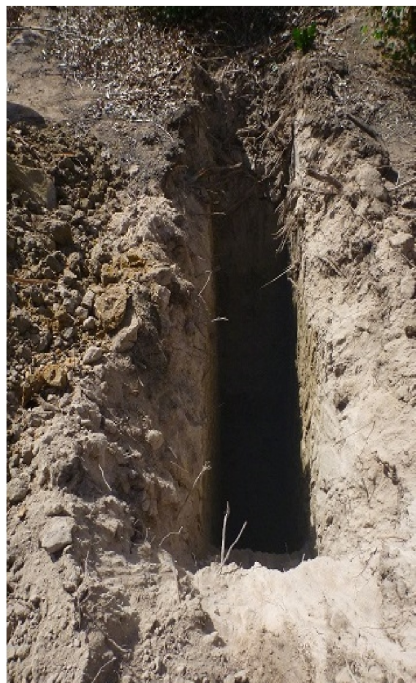
HOLE No: **TP4**

- 1) Final depth at 3.00m. TLB limit.
- 2) No groundwater seepage.
- 3) No sidewall collapse.
- 4) Samples taken :  
S1 0.60--2.40m

In the south, at trial pit TP4 the clay was underlain by olive brown medium dense to dense intact fine to medium grained SAND which was interpreted as being residual sandstone.

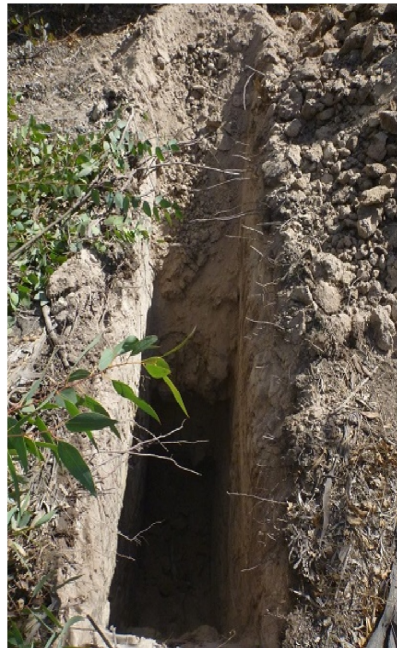
HOLE No: **TP5**

- 1) Final depth at 2.80m. TLB limit.
- 2) No groundwater seepage.
- 3) No sidewall collapse.
- 4) No samples taken.

In the east, at trial pit TP5 the site is overlain by light grey dense intact SAND with tree roots over the top 0.40m overlying;

- Light grey firm shattered sandy CLAY overlying
- Olive brown to grey brown to light grey to dark grey dense to very dense gravelly SAND.

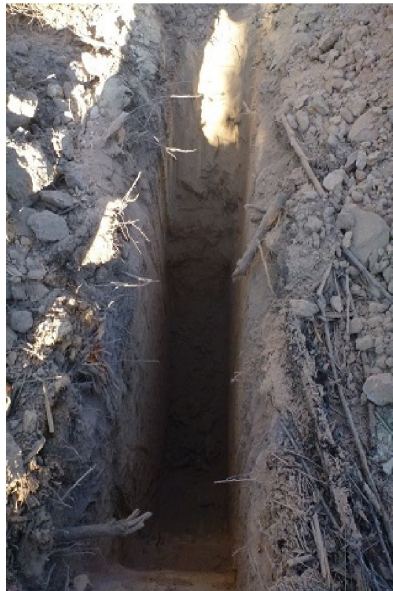
HOLE No: **TP6**

Dry light grey dense to very dense intact fine grained SAND with tree roots over top 0.40m. Colluvium.

Dry light cream grey mottled red grey near base very stiff intact silty CLAY. Colluvium.

- 1) Final depth at 3.00m. TLB limit.
- 2) No groundwater seepage.
- 3) No sidewall collapse.
- 4) No samples taken.

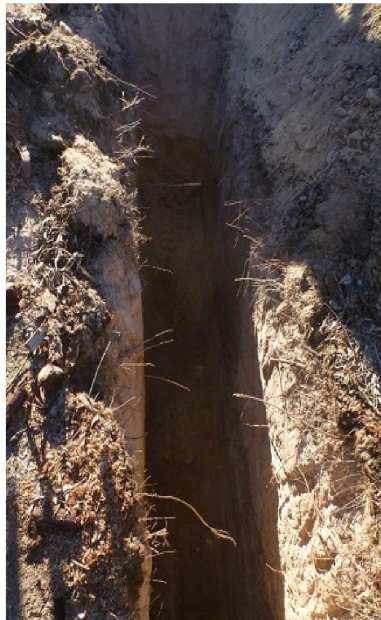
HOLE No: **TP7**

- 1) Refusal depth at 2.20m.
- 2) No groundwater seepage.
- 3) No sidewall collapse.
- 4) No samples taken.

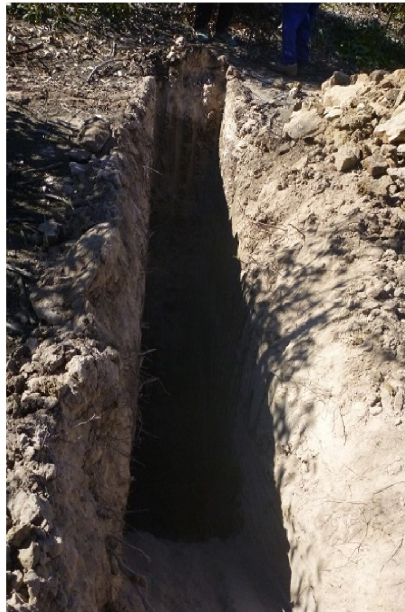
HOLE No: **TP8**

- 1) Final depth at 3.20m. TLB limit.
- 2) No groundwater seepage.
- 3) No sidewall collapse.
- 4) No samples taken.

- Light cream grey to light olive brown stiff to very stiff intact CLAY. Trial Pit TP8 had a narrow 0.20m layer of medium grained gravelly SAND within the clay profile.

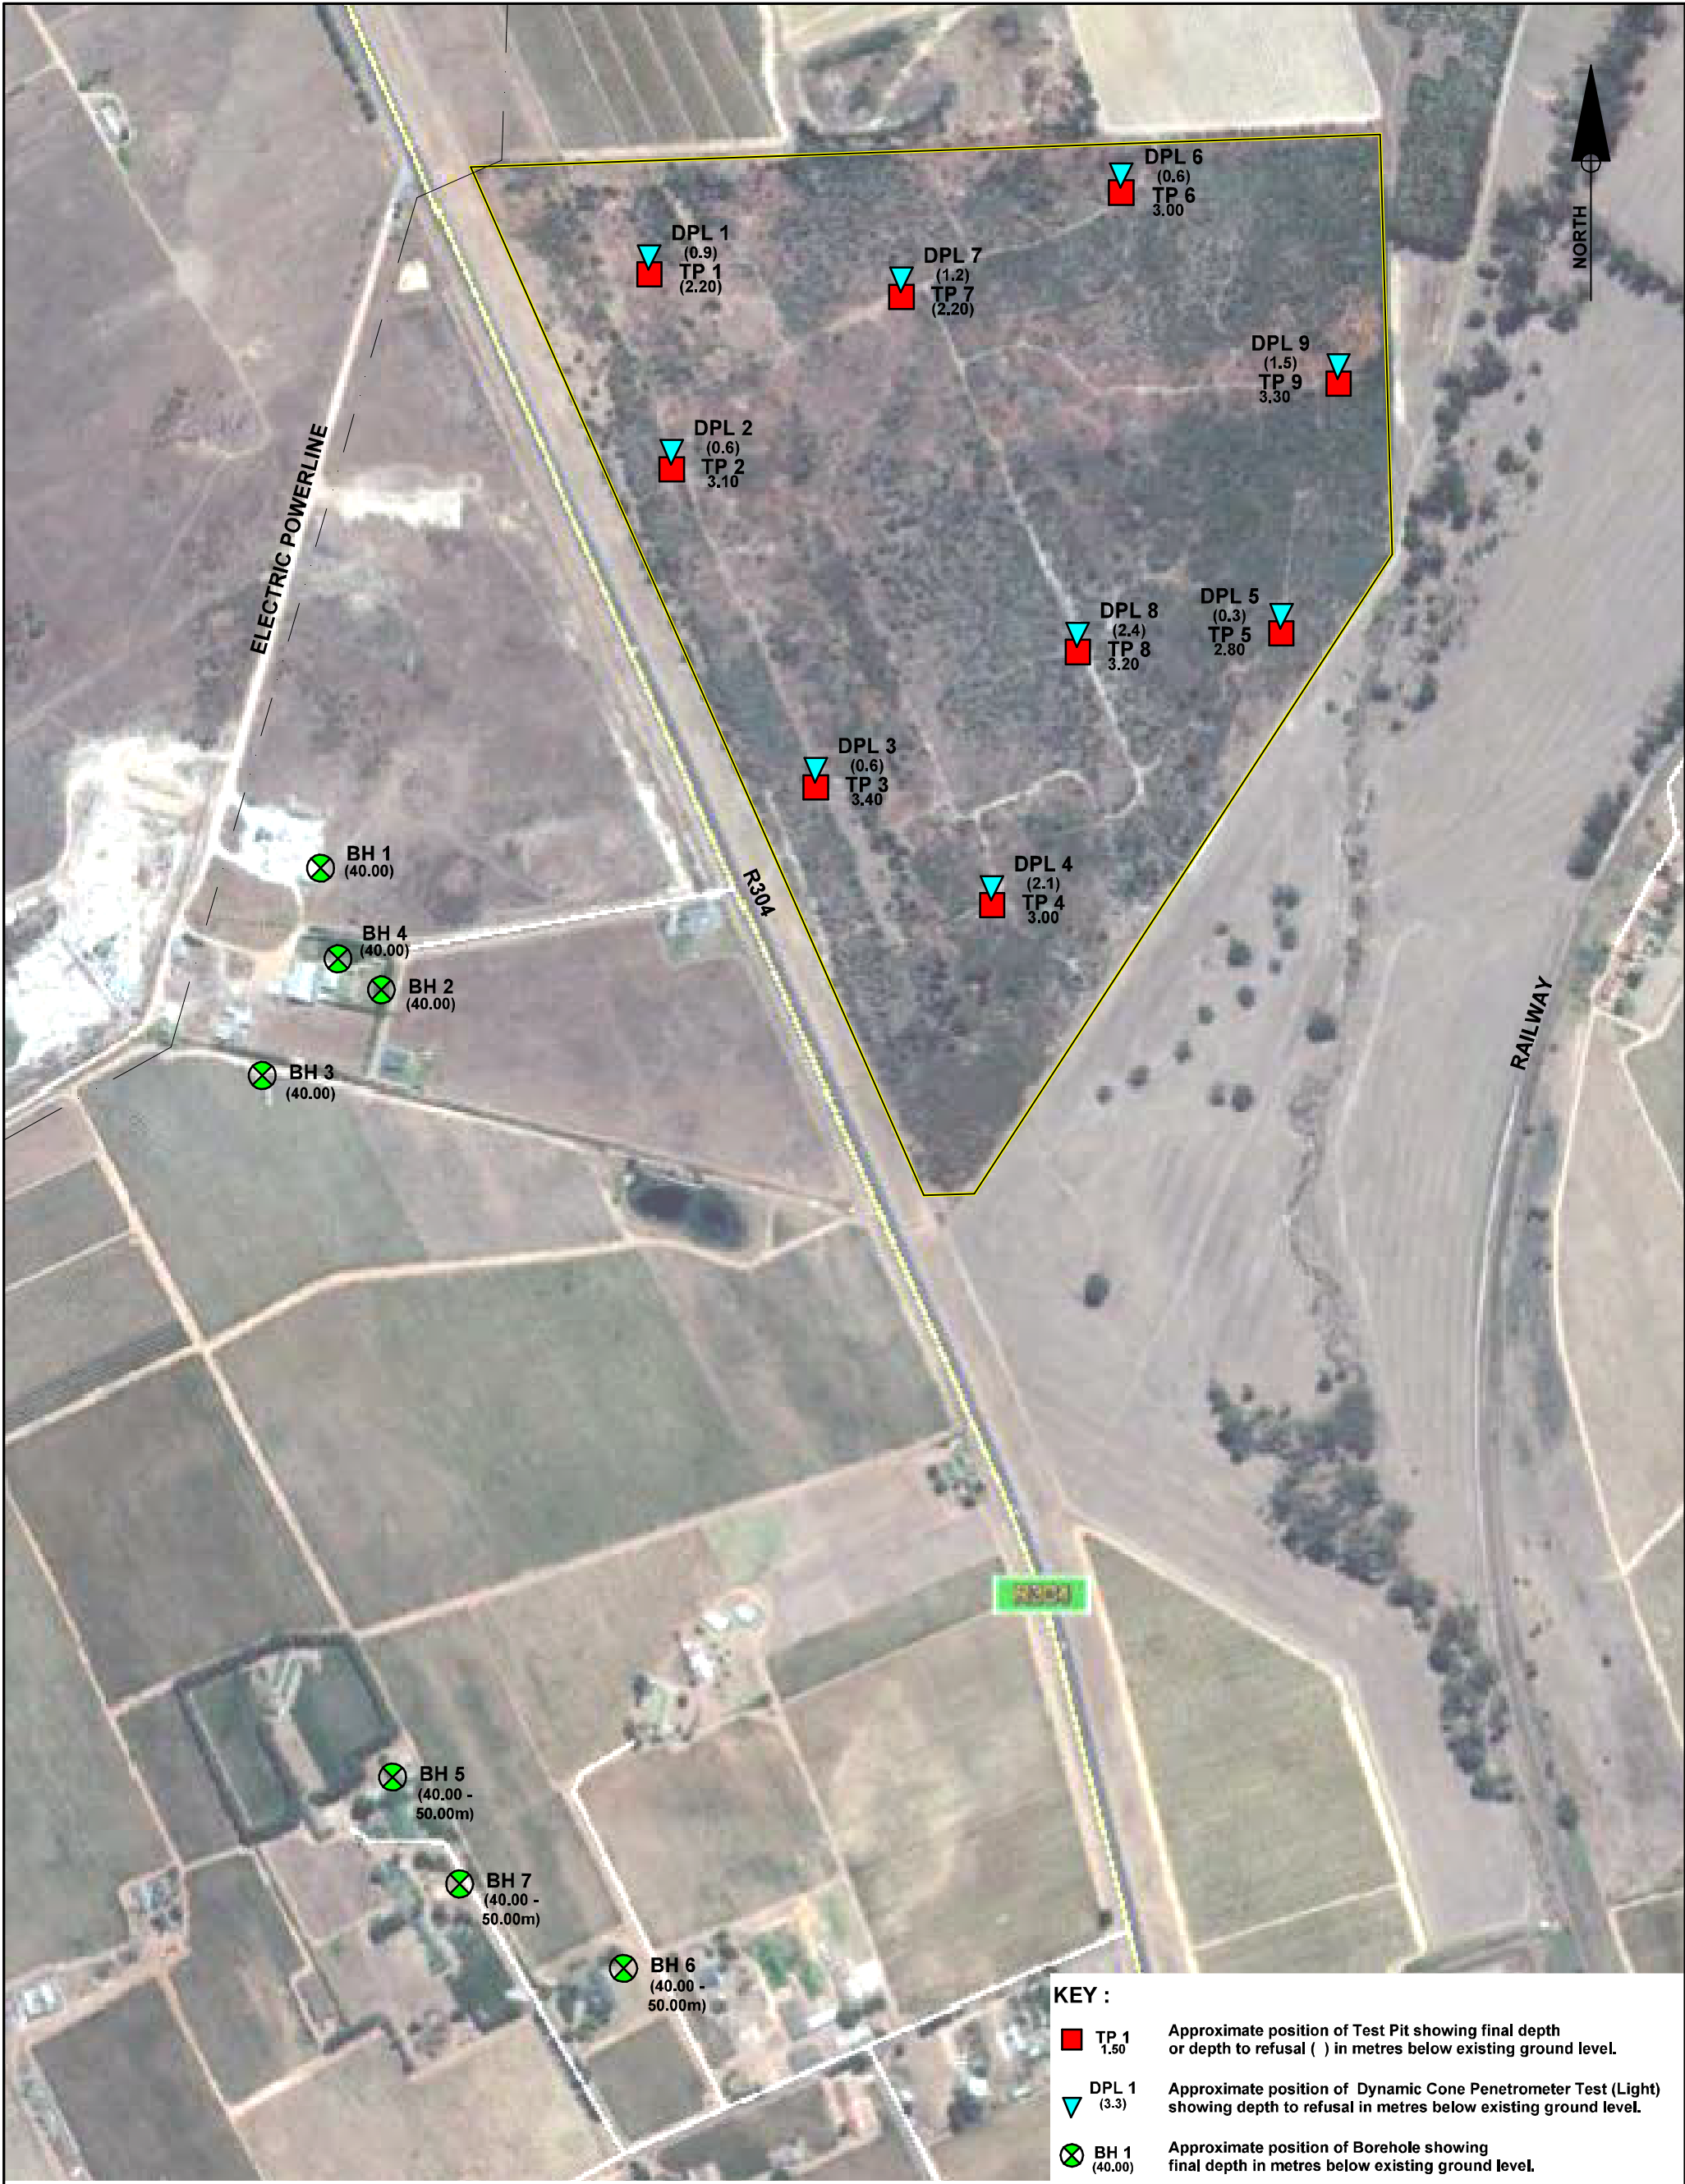
<b>KEY :</b>	
	TP 1 1.50
Approximate position of Test Pit showing final depth or depth to refusal ( ) in metres below existing ground level.	
	DPL 1 (3.3)
Approximate position of Dynamic Cone Penetrometer Test (Light) showing depth to refusal in metres below existing ground level.	
	BH 1 (40.00)
Approximate position of Borehole showing final depth in metres below existing ground level.
