Appendix G-5 – Geotechnical

Appendix G-5a – Geotechnical Preferred Site

Report to CK Rumboll & Partners on a Geotechnical Investigation carried out for the Louw's Bos South RE/502, Cemetery Site, Stellenbosch, Western Cape

Project No.: 18-820R01

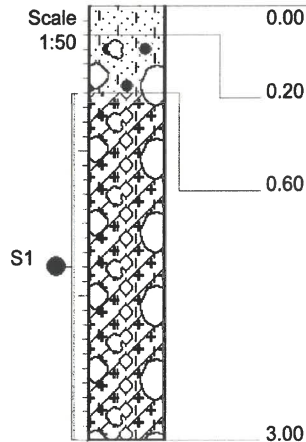
HOLE No: **TP1**

Slightly moist cream brown medium dense intact silty medium grained SAND. Colluvium.

Slightly moist cream brown dense intact silty medium grained SAND with abundant ferricrete pebbles and cobbles. Colluvium.

Slightly moist cream brown to red brown firm to very stiff intact silty CLAY with occasional cobbles of completely weathered granite. Residual Granite.

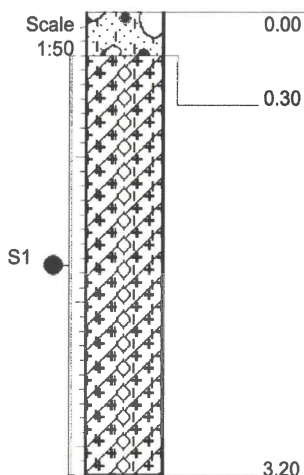
HOLE No: TP2

Slightly moist grey brown loose intact silty SAND with ferricrete pebbles and cobbles. Colluvium.

Slightly moist cream brown to red brown firm to stiff intact silty CLAY. Residual Granite.

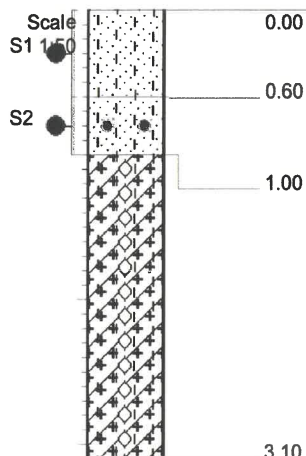
HOLE No: TP4

Slightly moist grey brown loose intact silty SAND. Colluvium.

Slightly moist grey brown medium dense intact silty SAND with abundant ferricrete nodules up to 30mm. Colluvium.

Slightly moist cream brown to pink brown soft to stiff intact silty CLAY. Residual Granite.

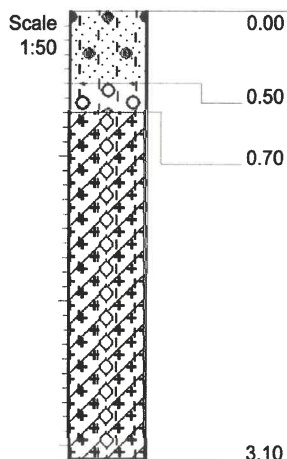
HOLE No: **TP5**

Slightly moist light grey brown very loose intact silty SAND with rare small ferricrete pebbles. Colluvium.

Slightly moist olive brown medium dense intact silty GRAVEL. Colluvium.

Slightly moist yellow brown to red brown to cream stiff to very stiff intact silty CLAY. Residual Granite.

- 1) Final depth at 3.10m. TLB limit.
- 2) No groundwater seepage.
- 3) No sidewall collapse.
- 4) No samples taken.

The silty gravel and silty sand in TP5 and TP7 are generally pervious to semi-pervious. The silty clay derived from residual granite in TP3 is semi-pervious to impervious. The silty sand at surface in TP6 and TP7 is found to be pervious as expected.

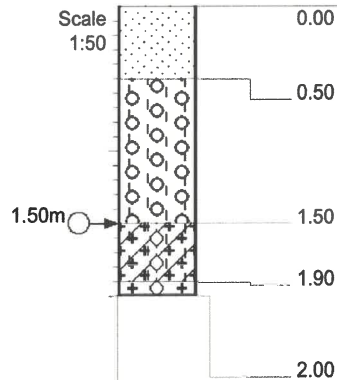
HOLE No: **TP7**

Slightly moist brown loose intact medium to coarse grained SAND. Colluvium.

Moist olive brown loose to medium dense intact silty GRAVEL. Colluvium.

Moist cream brown stiff to firm intact silty CLAY. Residual Granite.

- 1) Final depth at 2.00m. Refusal.
- 2) Groundwater seepage at 1.50m.
- 3) Sidewall collapse in gravel.
- 4) No samples taken.

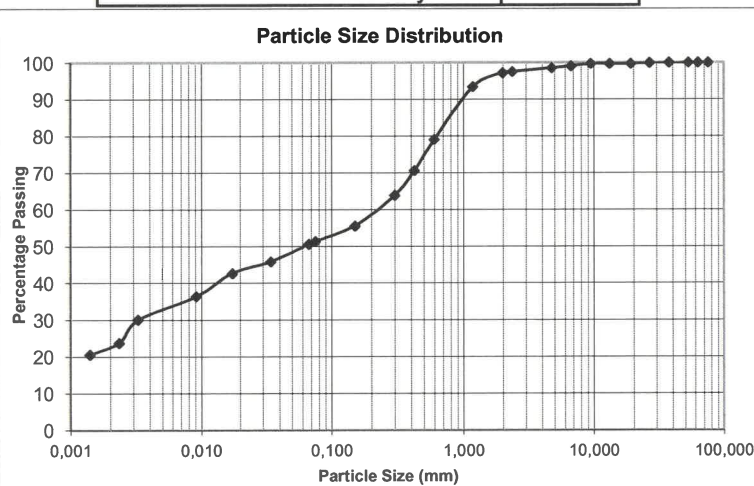
Tabulated Summary	Percentage
Gravel : Percentage - 4.75 mm	2
Sand : Percentage - 4.75mm and + 0.075mm	47
Silt : Percentage - 0.075mm and + 0.002mm	24
Clay : Percentage - 0.002mm	27

TP No.	Depth (m)	Description	Particle Size %				Atterberg Limits			GM	Classification
			Clay	Silt	Sand	Gravel	LL	PI	LS %		
TP2	0.60-3.00	Slightly moist cream brown to red brown firm to very stiff intact silty CLAY. Residual Granite.	27	24	47	2	31	14	7.0	0.81	A-6(4); ML; Medium heave; Type D Gravel Wearing Course
TP3	0.30-3.20	Slightly moist cream brown to red brown firm to stiff intact silty CLAY. Residual Granite.	34	30	36	0	32	14	7.0	0.56	A-6(7); ML; Medium heave; Type D Gravel Wearing Course
TP5	0.00-0.60	Slightly moist grey brown loose intact silty SAND. Colluvium.	7	3	86	4	-	NP	-	1.50	A-3(1); SW; Low heave; Type B Gravel Wearing Course
TP7	1.00-3.10	Slightly moist olive brown to red brown stiff to very stiff intact silty CLAY. Residual Granite.	26	23	50	1	32	15	7.0	0.89	A-4 (4); ML; Medium heave; Type D Gravel Wearing Course

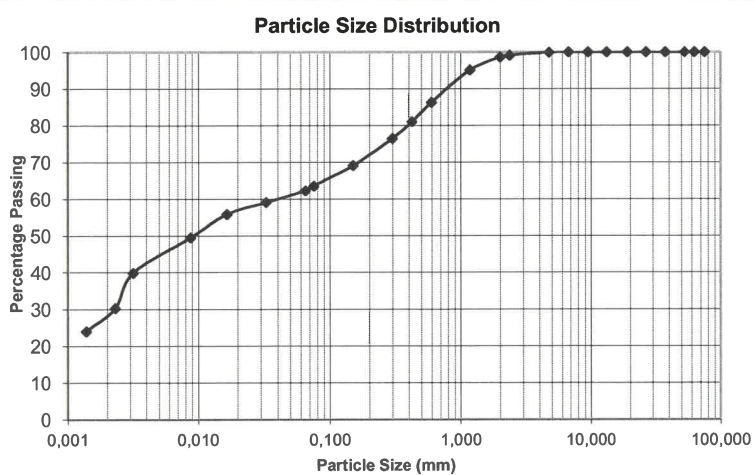
MOD AASHTO ; C.B.R. :	
MOD AASHTO (Kg/m³)	1756
O.M.C. (%)	16,2
C.B.R. @ 100% Comp.	
C.B.R. @ 98 % Comp.	
C.B.R. @ 95 % Comp.	
C.B.R. @ 93 % Comp.	
C.B.R. @ 90 % Comp.	
Swell (max) %

Tabulated Summary	Percentage
Gravel : Percentage - 4.75 mm	0
Sand : Percentage - 4.75mm and + 0.075mm	36
Silt : Percentage - 0.075mm and + 0.002mm	30
Clay : Percentage - 0.002mm	34

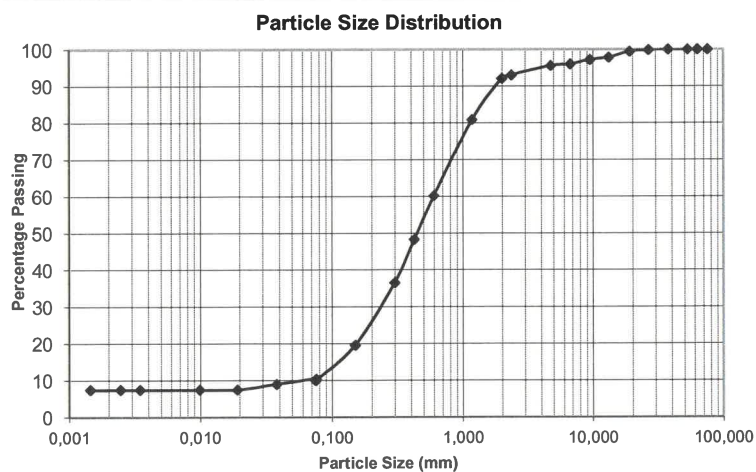
MOD AASHTO ; C.B.R. :	
MOD AASHTO (Kg/m ³)	1960
O.M.C. (%)	8,1
C.B.R. @ 100% Comp.	
C.B.R. @ 98 % Comp.	
C.B.R. @ 95 % Comp.	
C.B.R. @ 93 % Comp.	
C.B.R. @ 90 % Comp.	
Swell (max) %

Tabulated Summary	Percentage
Gravel : Percentage - 4.75 mm	4
Sand : Percentage - 4.75mm and + 0.075mm	86
Silt : Percentage - 0.075mm and + 0.002mm	3
Clay : Percentage - 0.002mm	7

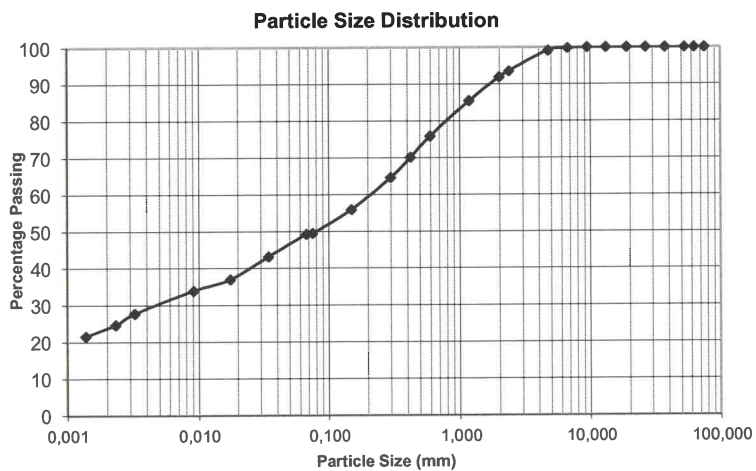
Tabulated Summary	Percentage
Gravel : Percentage - 4.75 mm	1
Sand : Percentage - 4.75mm and + 0.075mm	50
Silt : Percentage - 0.075mm and + 0.002mm	23
Clay : Percentage - 0.002mm	26

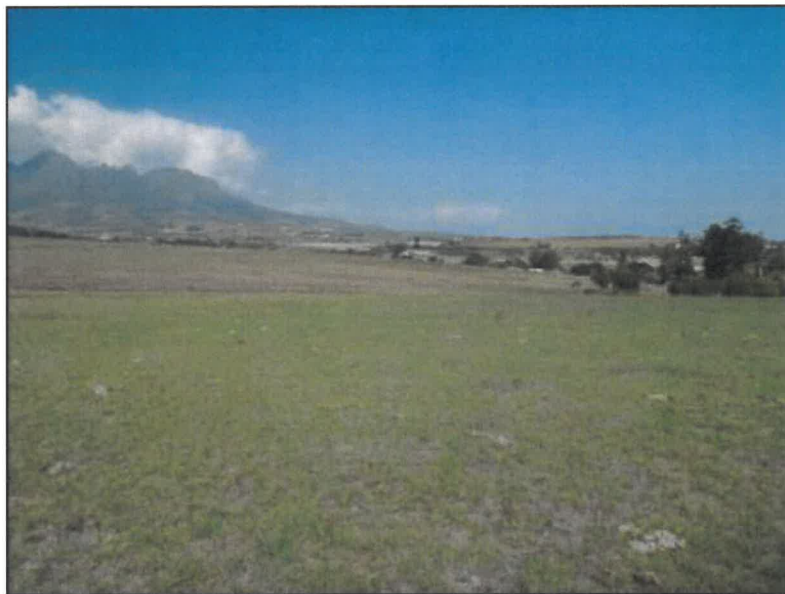
Plate 3: View towards the east from TP3. The brown area in the middle distance is the vlei

There is a small vlei area roughly in the centre of the site which was dry at the time of the investigation but which will become saturated in normal rainfall years. A small area in the extreme south east abuts onto the Bonterivier. If these areas are avoided the bulk of the proposed site will comply (Figure 4). The vlei area is depicted in Plate 3 below.

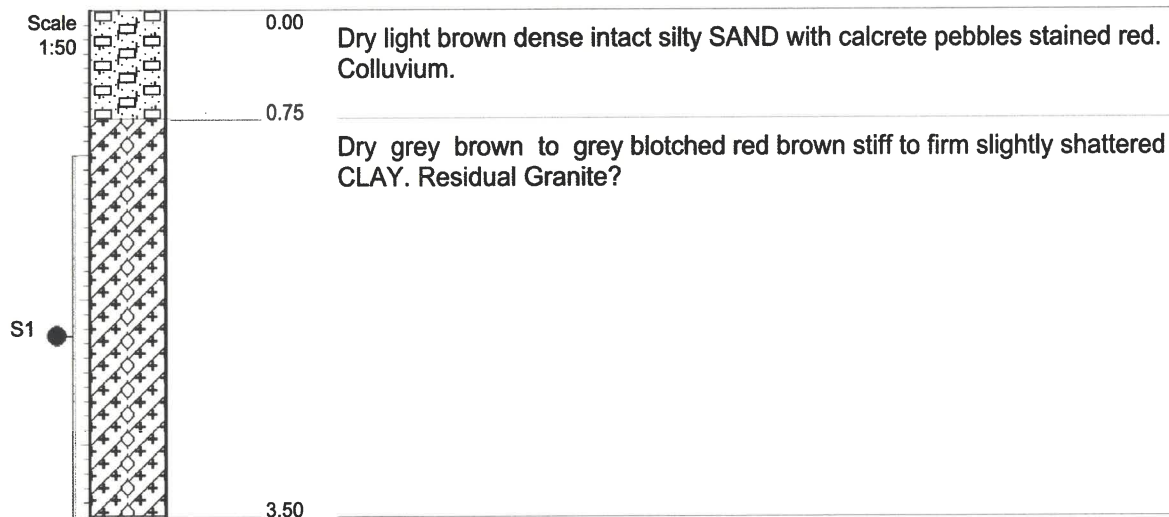
- 1) Final depth at 3.50m. TLB limit.
- 2) No groundwater seepage.
- 3) No sidewall collapse.
- 4) Samples taken :
S1 1.00--3.50m

TP No.	Depth (m)	Description	Particle Size %				Atterberg Limits			GM	Classification
			Clay	Silt	Sand	Gravel	LL	PI	LS %		
TP1	1.00-3.50	Dry grey brown to grey blotched red brown stiff to firm slightly shattered CLAY. Residual Granite	24	41	34	1	32	15	7.0	0.56	A-6(7); CL; Medium heave; Type D Gravel Wearing Course
TP2	2.20-3.00	Slightly moist cream grey stiff to firm intact gravelly CLAY. Residual Granite	31	29	38	1	25	11	6.0	0.81	A-6(4); CL; Medium heave; Type D Gravel Wearing Course

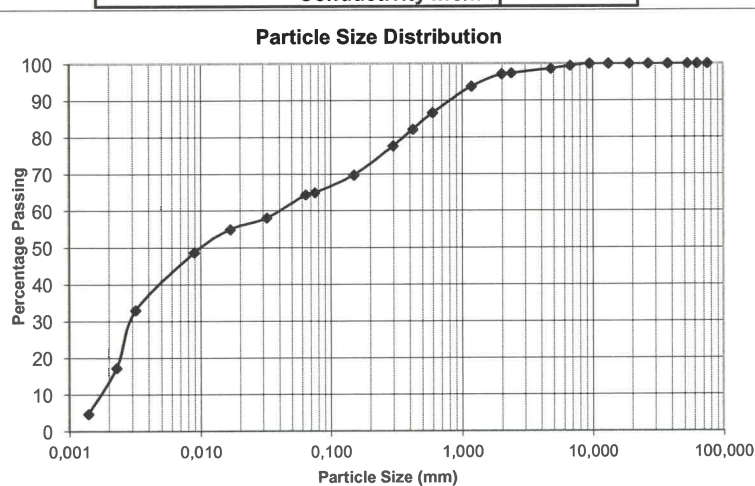
Tabulated Summary	Percentage
Gravel : Percentage - 4.75 mm	1
Sand : Percentage - 4.75mm and + 0.075mm	34
Silt : Percentage - 0.075mm and + 0.002mm	41
Clay : Percentage - 0.002mm	24

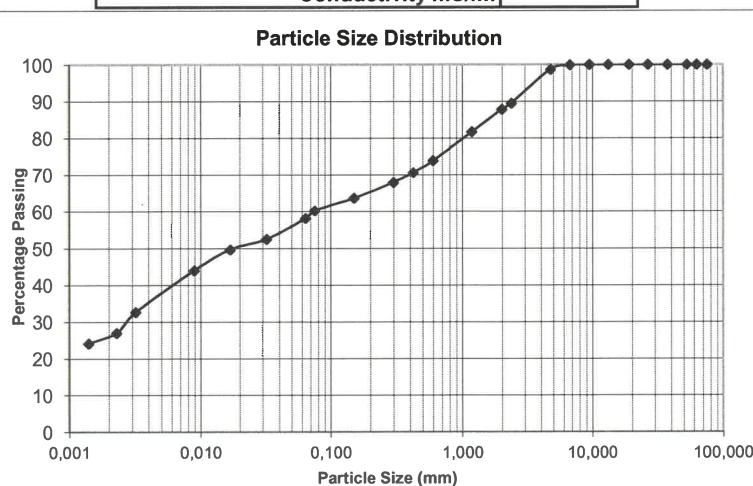
Tabulated Summary	Percentage
Gravel : Percentage - 4.75 mm	1
Sand : Percentage - 4.75mm and + 0.075mm	38
Silt : Percentage - 0.075mm and + 0.002mm	29
Clay : Percentage - 0.002mm	31
