FRESH WATER REPORT

for the construction of a proposed telecommunications mast on

FA 292/7, Jagersvlakte, Grabouw

January 2019

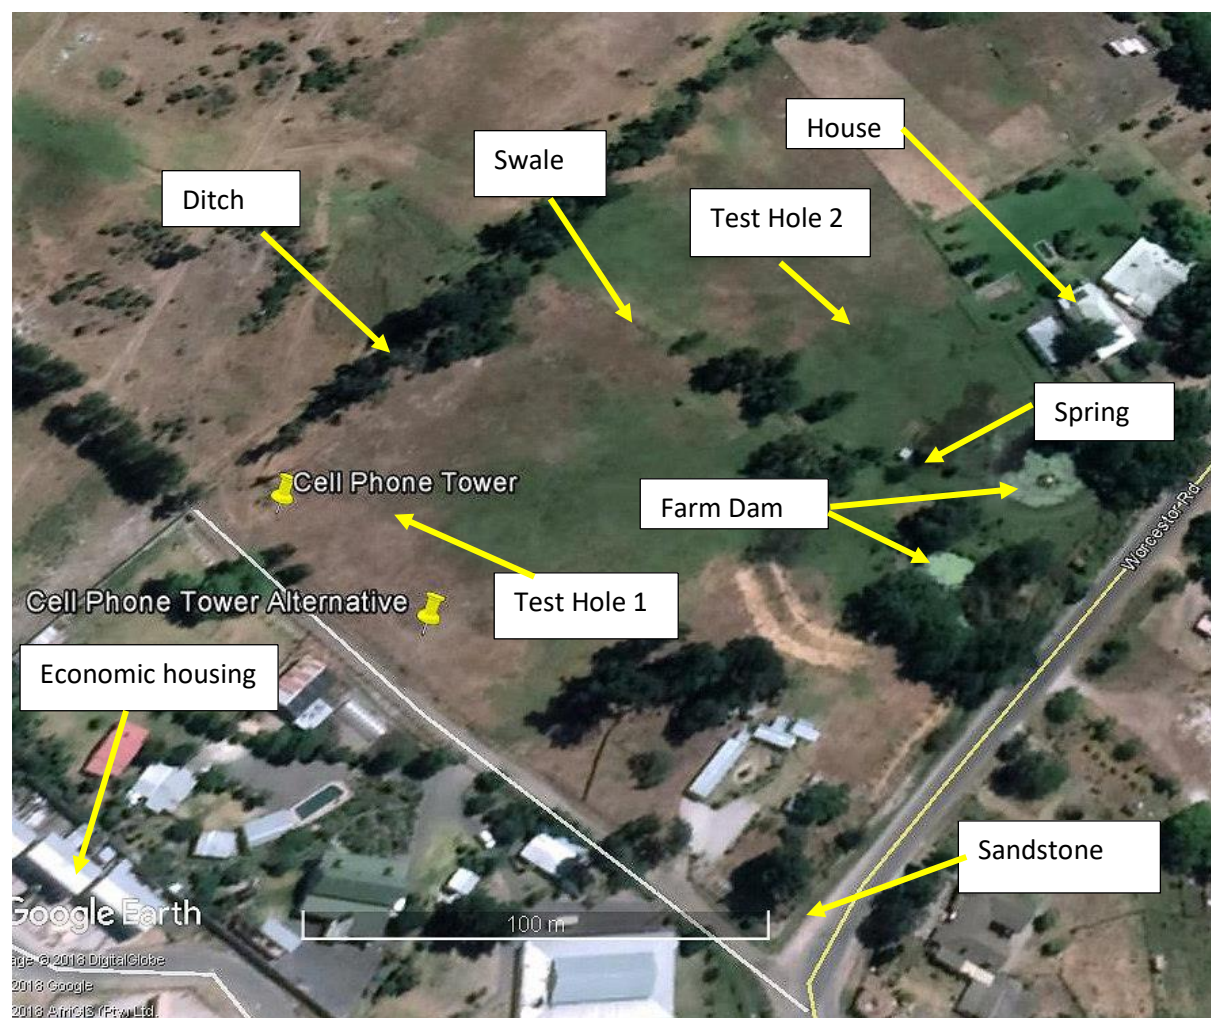
Figure 2 The Jagersvlakte Property

The Jagersvlakte property on which the cell phone tower is to be constructed in the northern part of Grabouw is on this hilly landscape, flanked by formal and informal housing (Figure 2). It used to be plantation, forest, but is now denuded of these trees.

A ditch passes the property from the south west to the north east. This comes out of the urban section and carries storm water with lots of litter. From this ditch, perpendicular, a swale goes to the south east, between the two small farm dams and then onto Worcester Road. This prevents litter and other rubble from the adjacent urban area to end up in the farm dams.

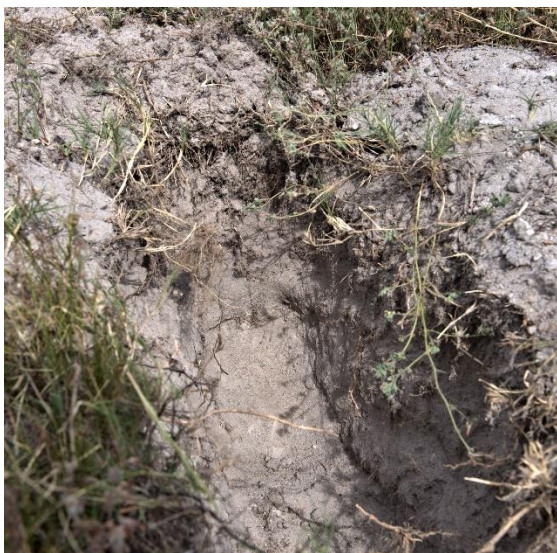
Figure 4 Test Hole 1

Two test holes were dug. The first one was near the location of the site where the cell phone tower is to go up, according to plan (Figure 4). The test hole was dug to a depth of only 400mm, when a bank of calcrete was struck. The sand was light in colour, somewhat yellow, all the way down to the calcrete and without any chroma mottles. The sand was very dry. Here was no sign of any temporary wetland or even a wetland support zone.

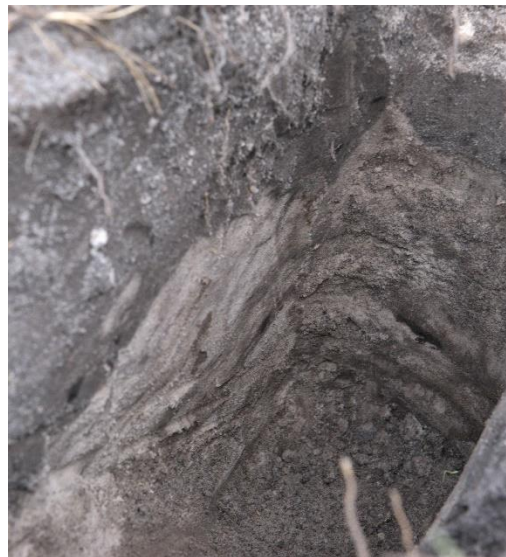
Figure 5 Test Hole 2

The second test hole was dug closer to the spring (Figure 5), up to a depth of 600mm. The upper soil was homogeneously grey, without any mottles. Deeper down the soil was lighter in colour, more towards the yellow of the first test hole, but still more grey, without mottles. The soil here was wet, more wet towards the surface than deeper down. This clearly is indicative of a permanent wetland with hydromorphic soils. Reportedly the water table is reached at a depth of 1.2m, where the sand is still soft, with no calcrete or bedrock.

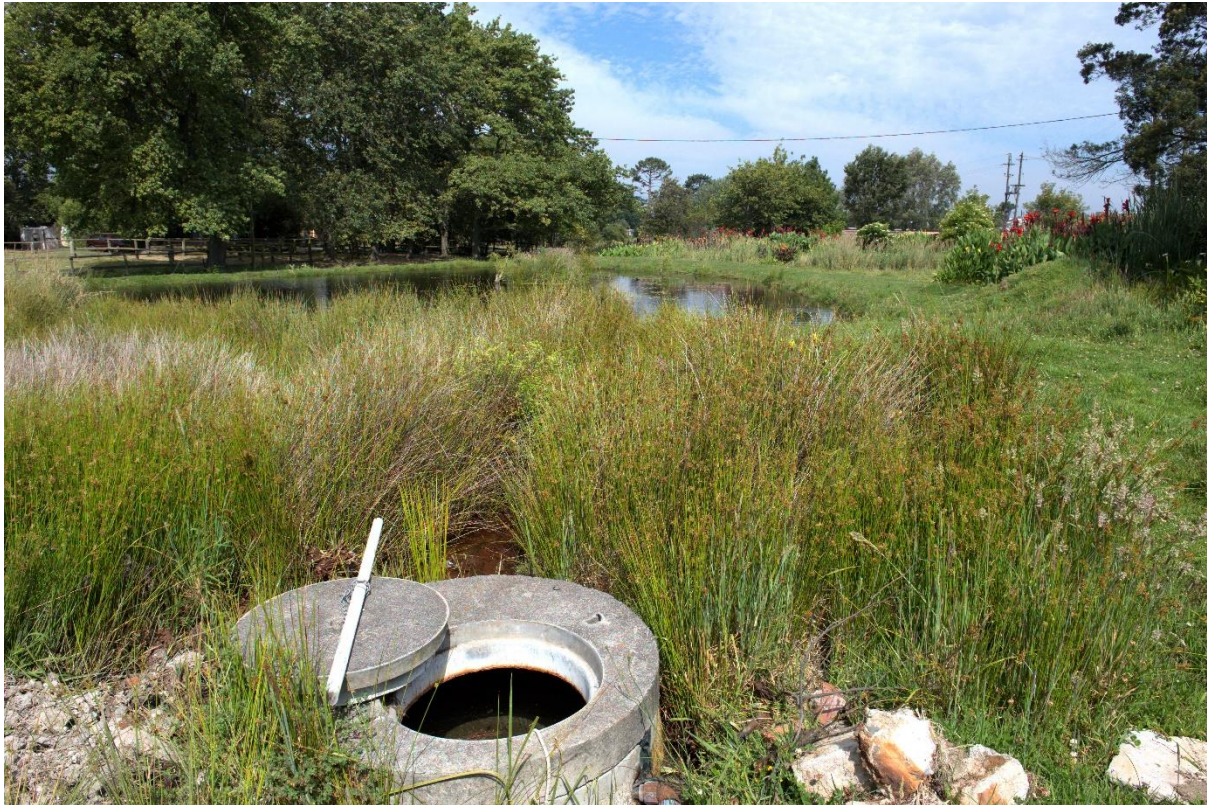
Figure 7 Spring, dam and *Juncus effusus*

A spring emerges on the property, as indicated on Figure 7. A concrete structure has been erected around the spring. Reportedly the spring delivers water at a reliable rate of not less than 0.5 to 1.0 l m^{-1} . Such a delivery was witnessed during the site visit on 11 December 2018. This is good-quality water that has been used for domestic use for many decades.

The water of from the spring ends up in a small farm dam. There is yet another small farm dam adjacent to the one that is being fed by the spring.

A dry drainage line can be seen across the road from the farm dam. The dam was built in a water course that now has running water when the dam overflows.

Around the farm dams a dense stand of the rush *Juncus effusus* occurs (Figure 7 and 8).

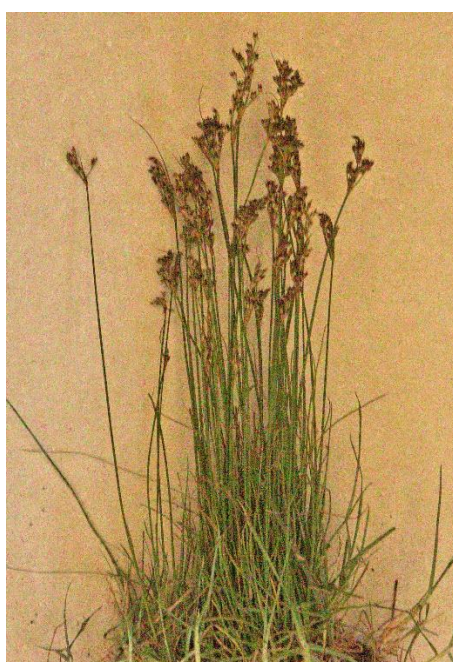
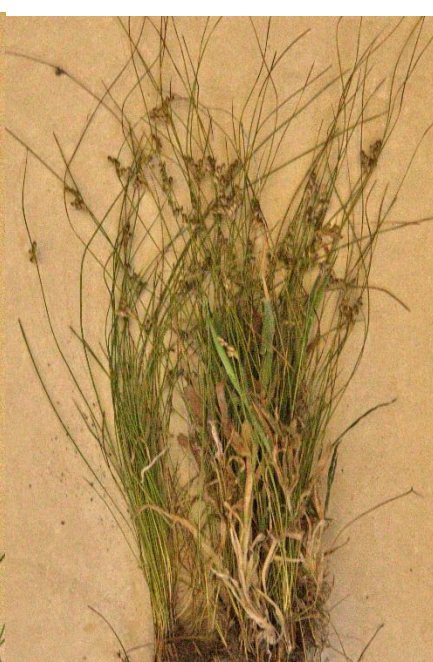
There are two other small sedges (Figure 10 and 11), up to 200 mm high, growing up to 100m up the slope. The identification is best left to the experts in this field.

Figure 10 Minor sedge 1

Figure 11 Minor sedge 2

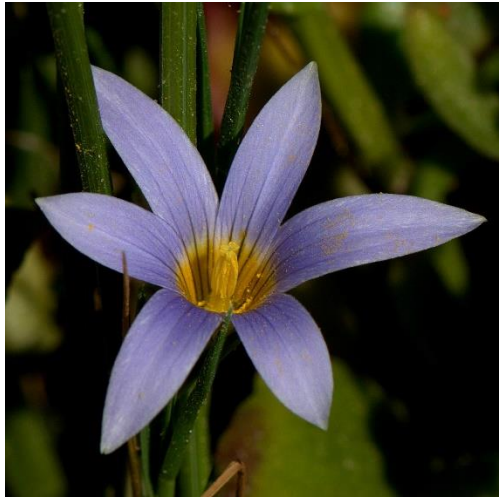
Figure 12 *Romulea tabularis*

The vegetation was interspersed with a pleasing stand of *Romulea tabularis* (Figure 12) and *R. rosea*. These grow in moist conditions and are further indicators of wetland conditions.

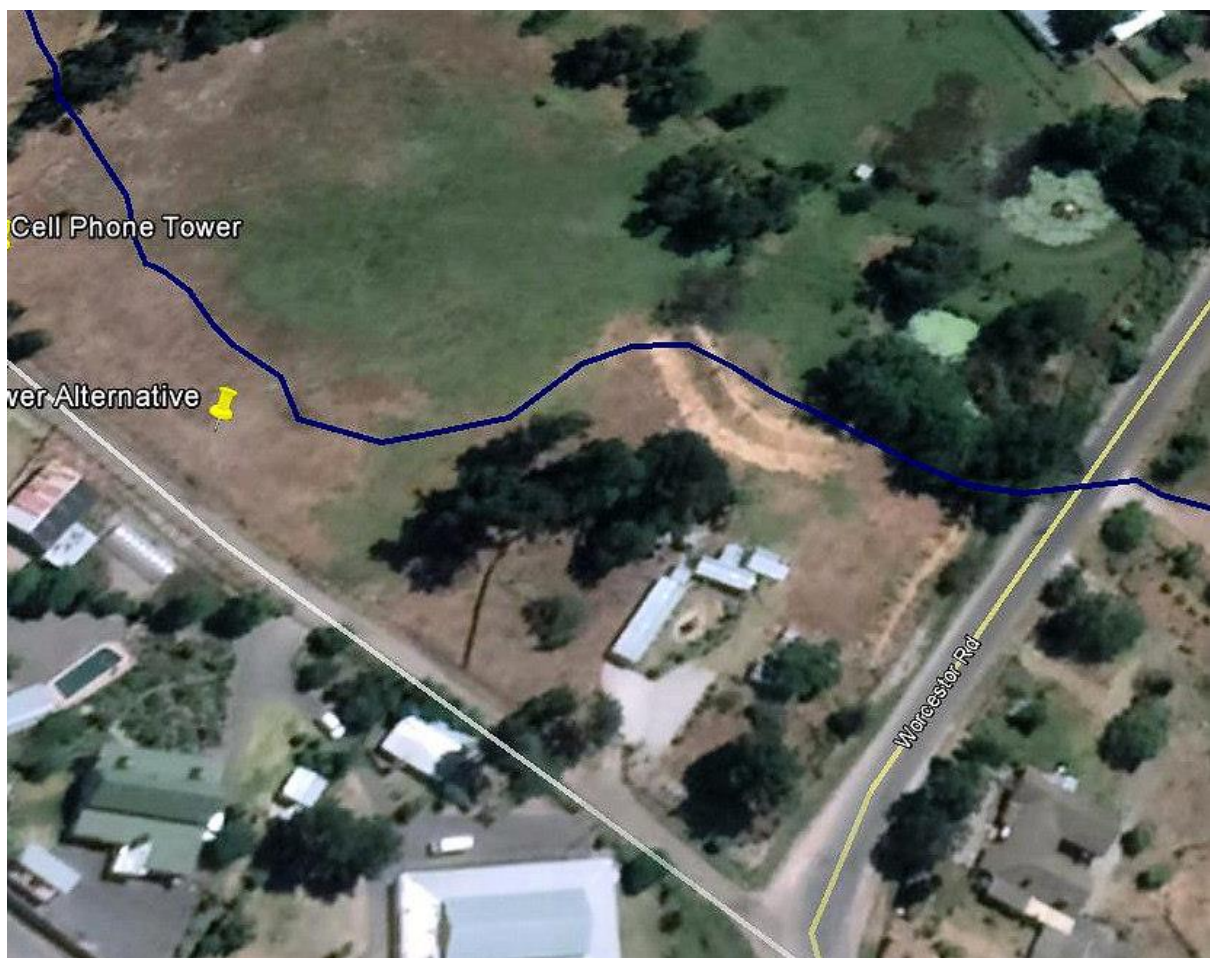
Figure 13 Wetland Demarcation

If the dry land area were to be separated from the wetland area on the Jagersfontein property, based on the vegetation, a line could be drawn as in Figure 13.

A worrying aspect of any construction near or on wetlands is access roads. Access to the site would be provided by the existing road servitude along the western border of the property. No new roads or access over the property and over the hydromorphic soils would be necessary. This arrangement would remain in place for the ongoing service and maintenance of the cell phone tower. In no point of its life cycle will the wetland area be compromised by additional access roads in any way. Vehicles should not be allowed to cross the demarcation line as indicated on Figure 13.

It is essential that building material, rubble and vehicles should be kept out of the wetland area, as indicated by the demarcation line on Figure 13.

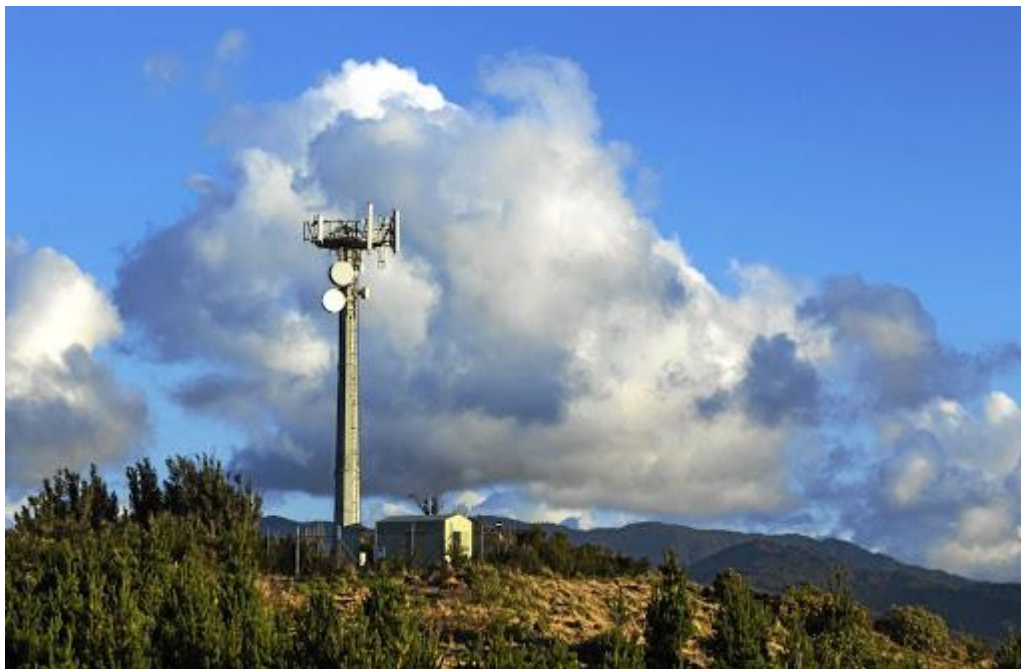
Figure 14 Typical 32m Atlas Cell Phone Tower

The cell phone tower that is planned for the Jagersvlakte site in Grabouw resembles the one depicted in Figure 14.

foundation of the cell phone tower. This is typically 5 meters long, 5 meters and 0.4 to 0.5 meter deep. Ground water would simply move around it, or perhaps underneath.
