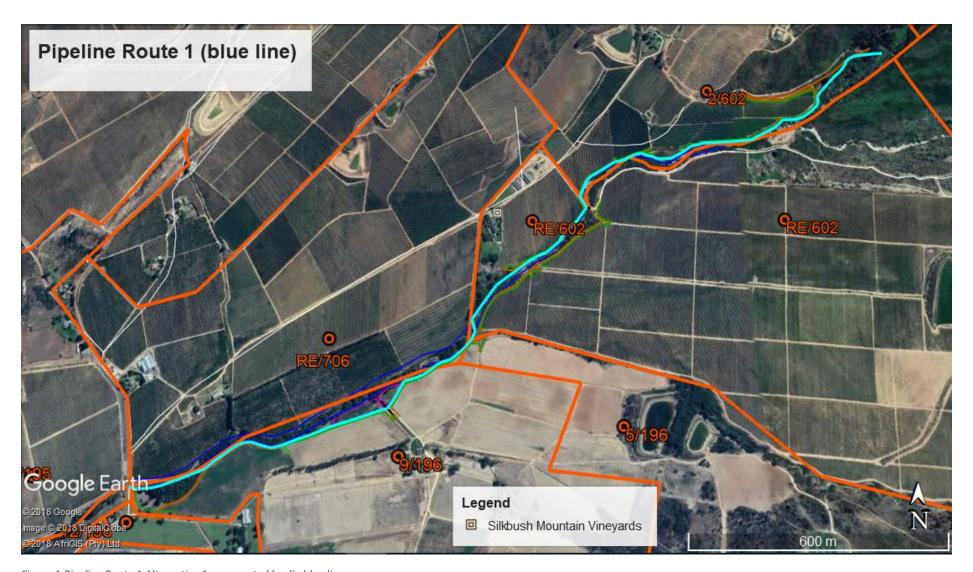
Figure 1:Pipeline Route 1 Alternative 1 represented by die blue line

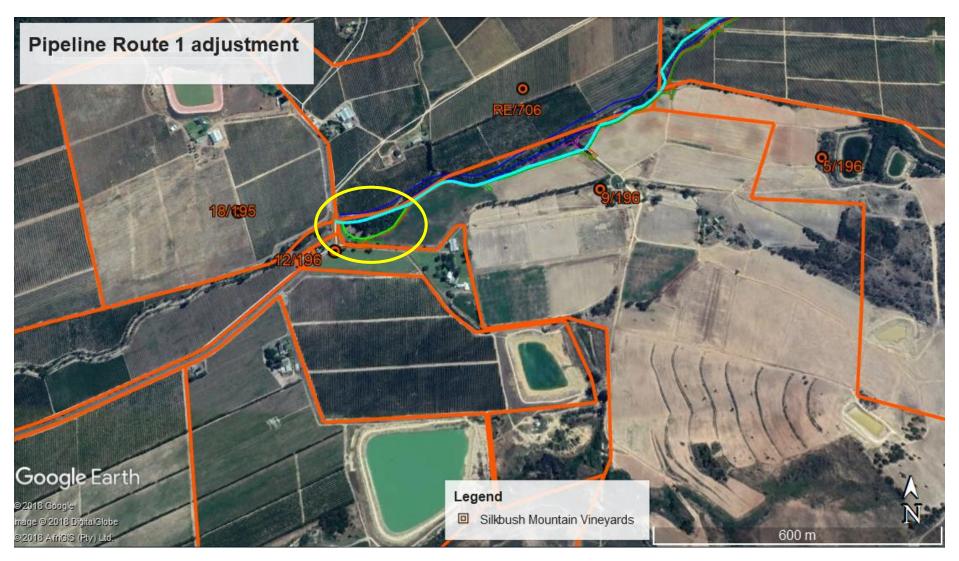
Figure 2:Adjustment of the last 205m of Pipeline Route 1 represented in green, as recommended by the specialist to avoid going through the bush which may cause the destabilisation of the river bank by removing vegetation.
