Technical Report

Toeka Dam and Harmony Dam

On the Farm Houdenbek 415, Koue Bokkeveld, Ceres District

May 2018

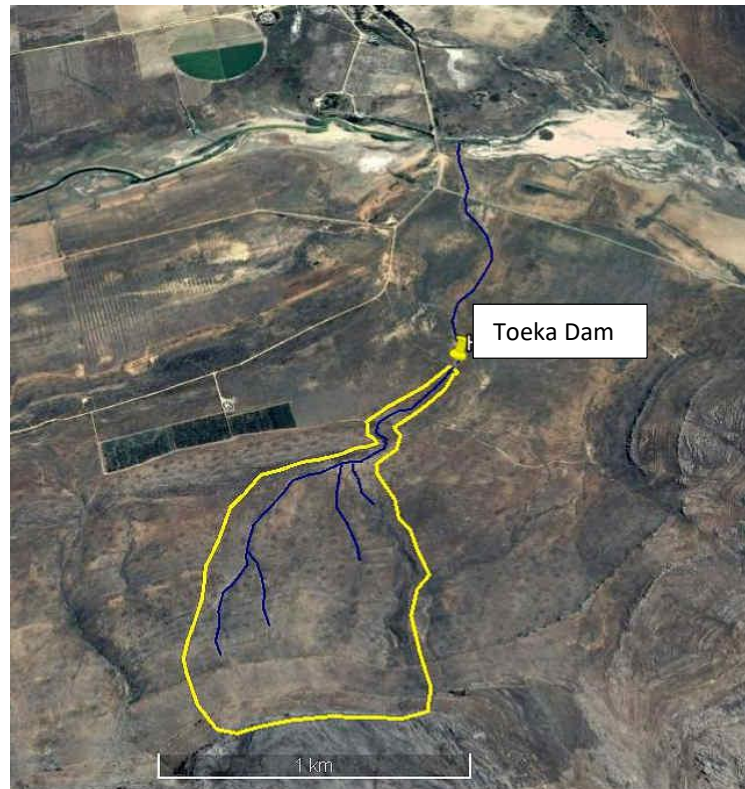
Figure 1 Toeka Catchment

The proposed Toeka Dam is to be constructed in a faint drainage line. This drainage line raises on a high mountain ridge and proceeds over relative level land over a distance of 2.1km to the Houdenbek River.

The ridge is approximately 1500m above sea level. The dam wall where it will cross the drainage line is at 952m above sea level. At this point the coordinates are as follows:

The catchment area of the drainage line is very small above the dam, only 2.2 square kilometres. The runoff is, as the crow flies, from the mountain ridge on the top of the catchment to the confluence with the Houdenbek River is only 3.25km. The circumference of the catchment is 5km.

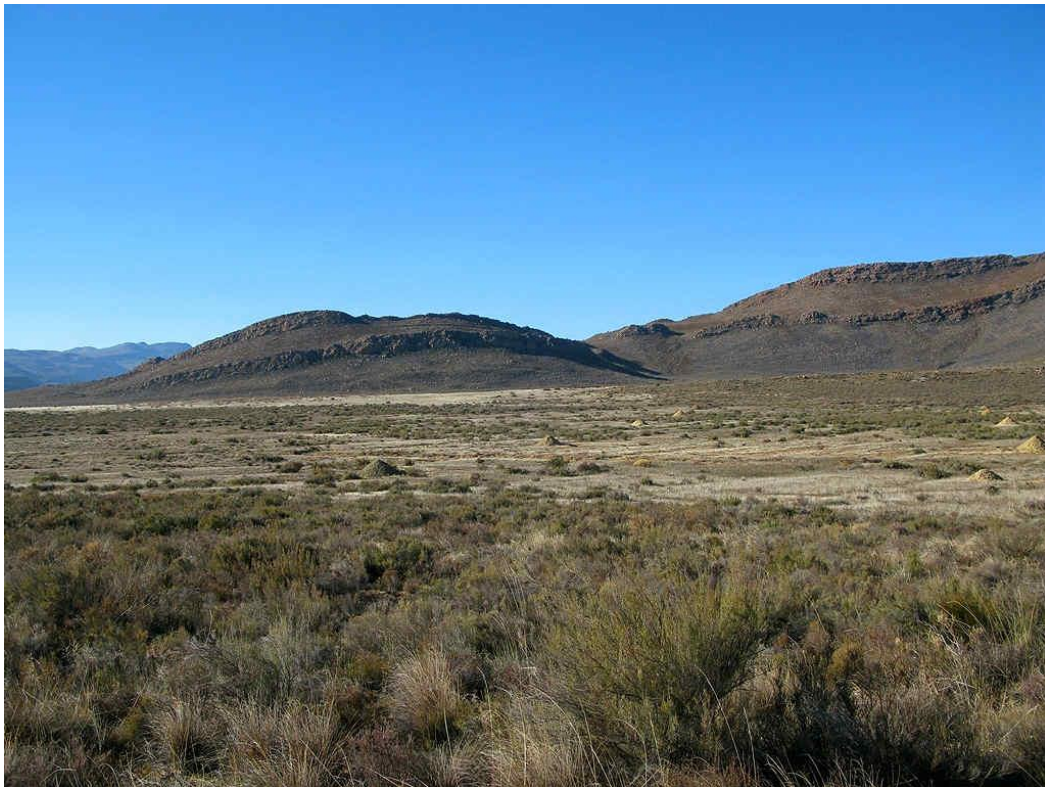
Figure 2 Toeka Dam Site. Foto Peet Botes.

Most of the dam site is on ploughed-over land (Figure 2). During the site visit there were no signs of any wetland or riparian vegetation.

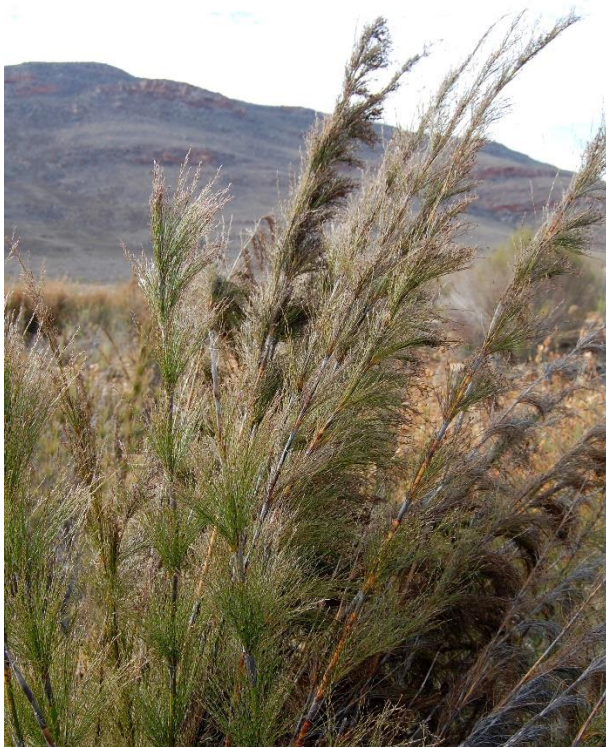
Figure 4
Elegia capensis

At the site of the proposed dam wall the drainage line is still natural, even near-pristine. The riparian zone is narrow and with steep sides and with a healthy stand of the restio *Elegia capensis* (Figure 4). This is a wetland indicator species and a sure sign of a mountain stream.

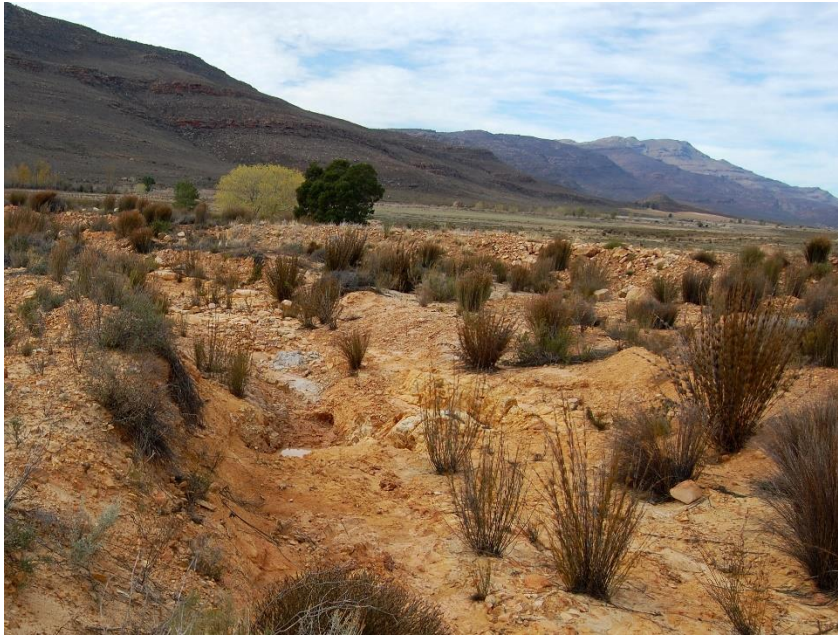
Figure 5
Harmony
Drainage

The drainage line downstream of the dam site is straightened, lined with high berms and deeply incised. From here the stream is highly impacted since farming started in the area many decades ago and has progressed since then to where the stream is today as a man-made trench (Figure 5).

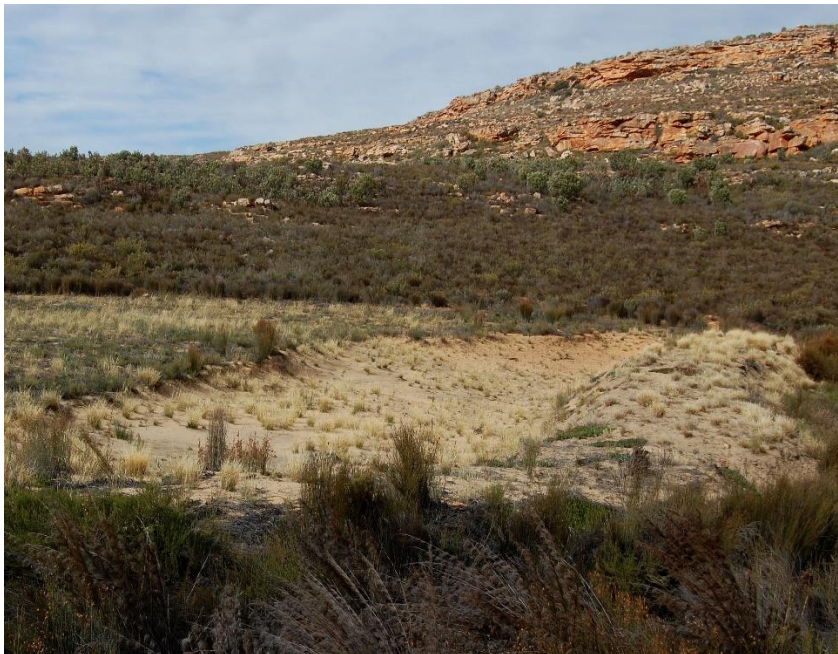
Figure 6
Diversion Wall

The location of the new Harmony dam is marked by an earthen wall (Figure 6) which seems to have been constructed to divert a portion of the flow from the catchment away from the Harmony drainage line. This separate stream runs alongside the drainage line into the overflow channel from the Harmony Dam, from where it flows into the Houdenbek River. This configuration will be further described later in the report. The site of the envisaged Harmony Dam wall has already been significantly disturbed.

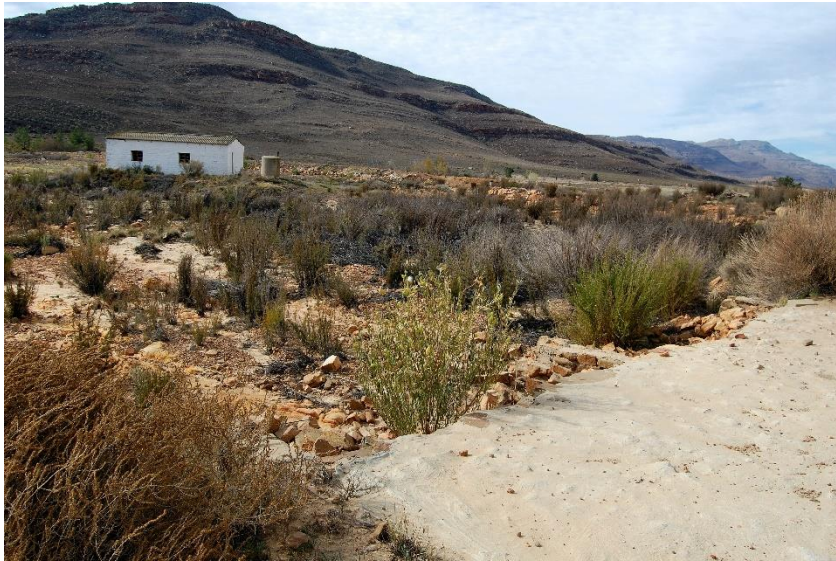
Figure 7

The Harmony drainage line passes underneath a dirt road with a small culvert that is covered with a concrete slab (Figure 7), from where it flows into the Morester Dam.

Harmony drainage line
culvert

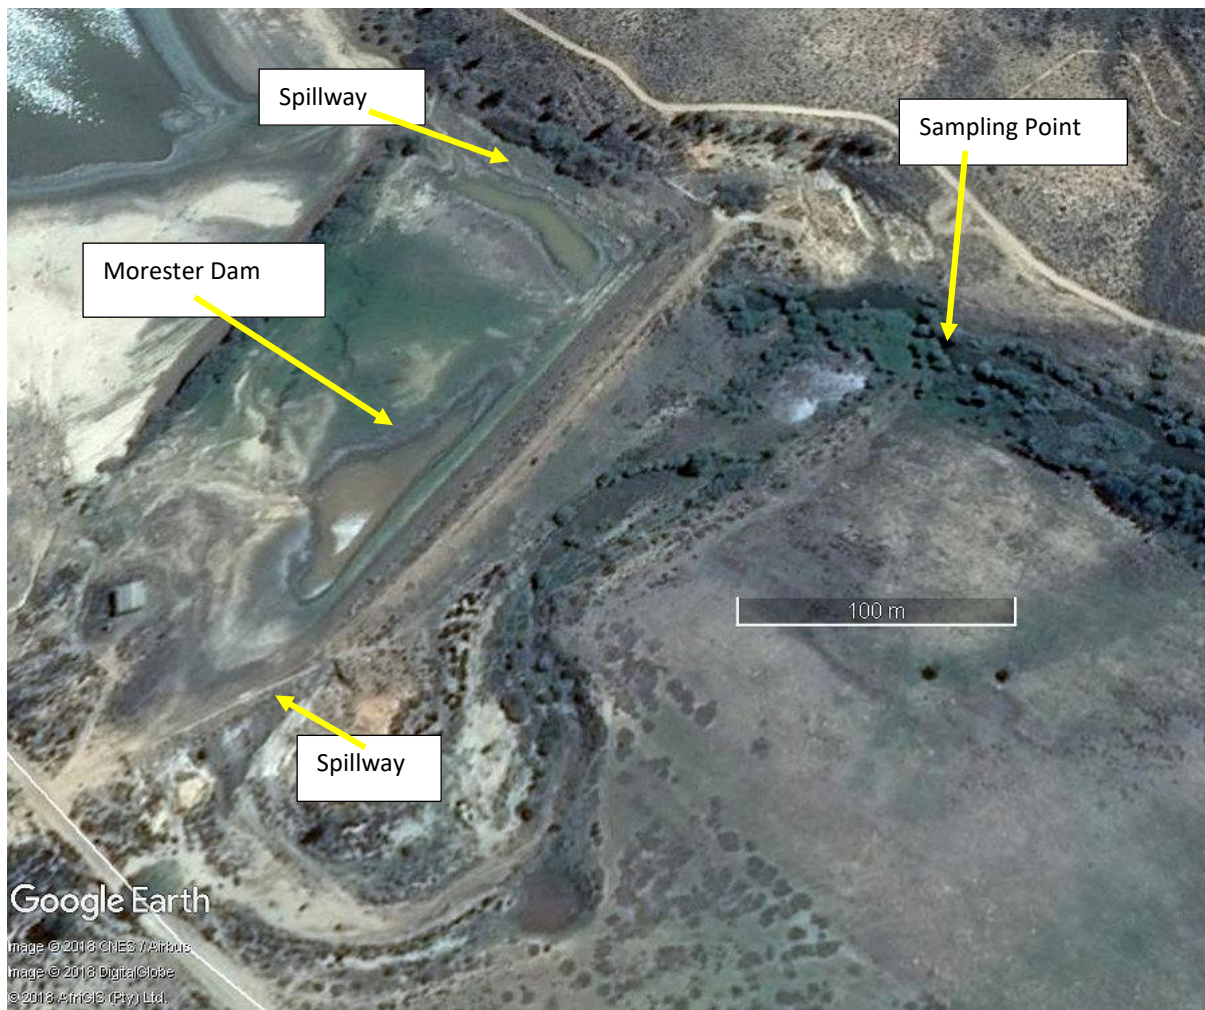
Figure 12 Houdenbek River sampling point

The Morester Dam (Figure 12) is an instream dam with the Houdenbek River still visible along its northern bank. The DWS named it the Houdenbek Onder Dam. It is divided into two sections, with the larger part of the dam on the western side. It has two spillways, the one directly on the southern end of the dam (Figure 13) wall and the smaller one on the northern end at right angles with the dam wall (Figure 14).

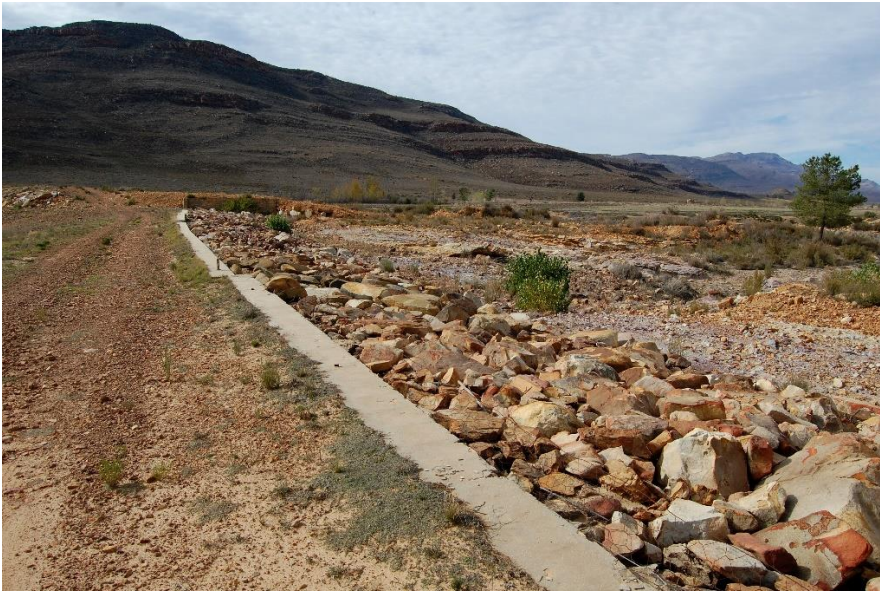
Figure 13
Southern Spillway

The southern spillway follows a wide upside-down question mark-shaped channel into the Houdenbeks River (Figure 13). This actually is the lower part of the Harmony Bypass. The northern spillway releases its water into the Houdenbek River through a short channel. The sampling point was chosen just downstream of where the Harmony Bypass meets the Houdenbek River.

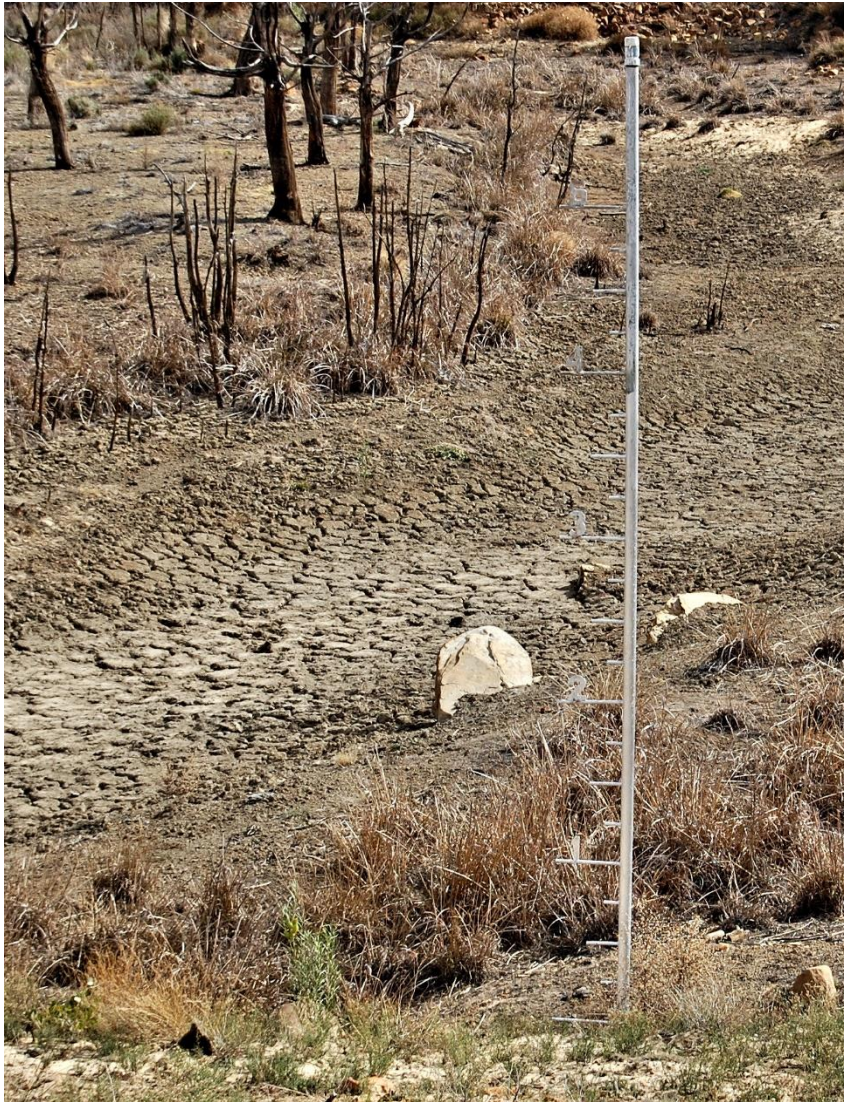
Figure 15
Gauge

The Morester Dam is monitored with a depth gauge (Figure 15). The dam was empty and dry at the time of the site visit. The wall (Figure 16) is provided with a valve (Figure 17) that allows for instream flow requirements (IFR) releases.

The measuring of water levels in the Morester Dam is internalised in the Morester management. Likewise, additional measuring of water levels in the Houdenberg River would be an extension of current practice. It is recommended that a measuring mechanism is set up in the Houdenberg River. Abstraction of water for storage in the Toeka and Harmony Dams should only take place when the water level in the Houdenberg River is higher than will be indicated by this envisaged measuring device. Once the level drops lower than the mark on this yard stick, abstraction should be stopped.

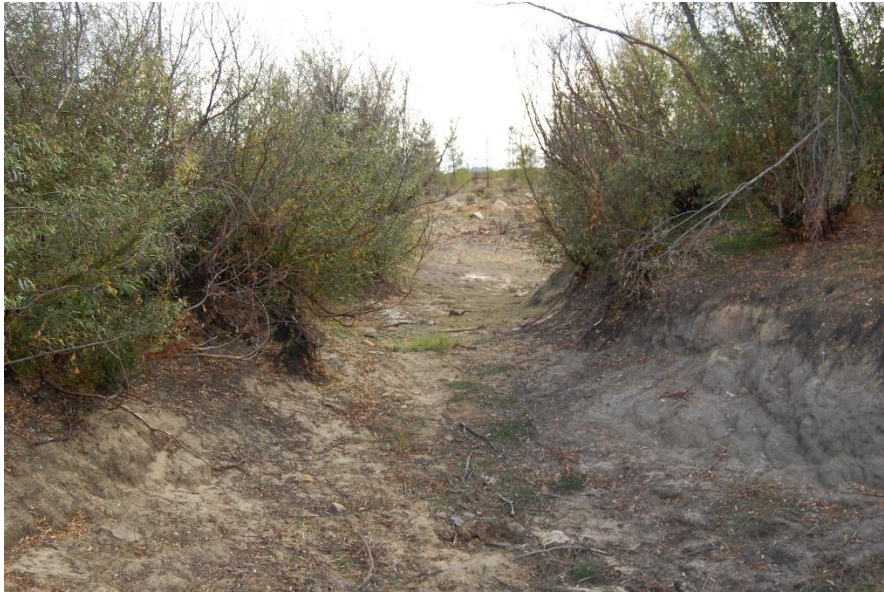
Figure 17
Houdenbek
River Channel

There were several pine trees near the dam wall and a patch of poplar trees further downstream. Cattle were grazing the area. Apart from these as well as upstream water abstraction there were no other human-induced impacts.

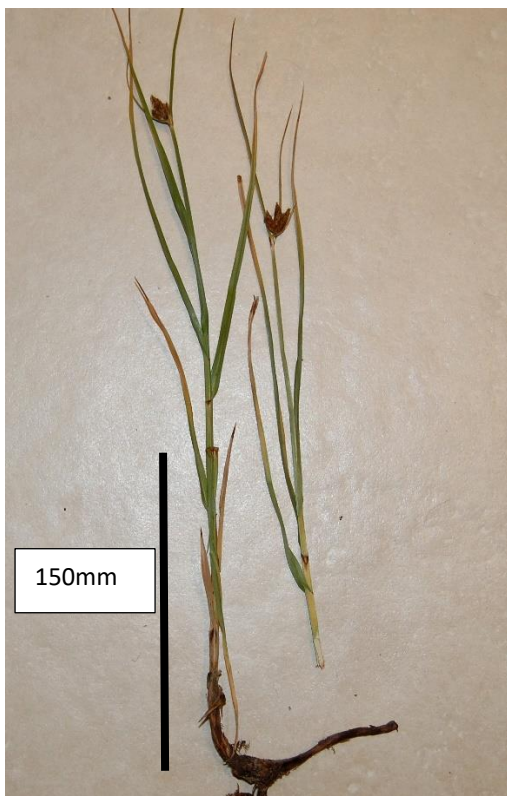
Figure 18
Sedge species

There was a smaller sedge as well (Figure 17), of which the identification is left to the experts. The culms were sharply triangular. These were less drought stressed and better coping with the harsh conditions.
