HERITAGE IMPACT ASSESSMENT

Proposed Development of the Houdenbek Dams, Western Cape

HWC Ref: 1809305AS0904E

Prepared by Heritage CTS

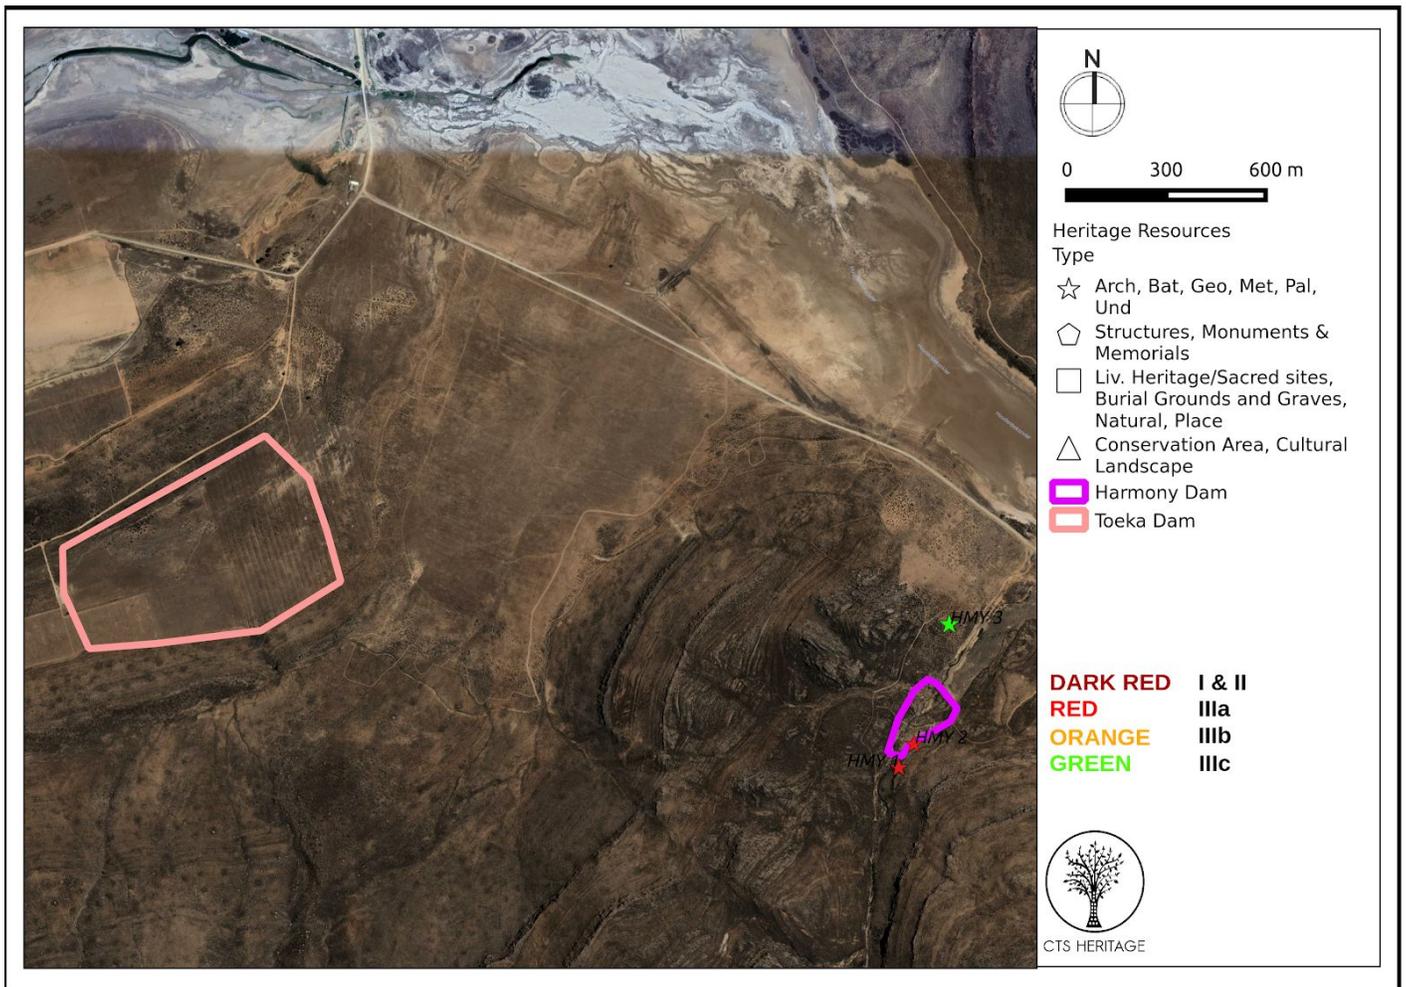
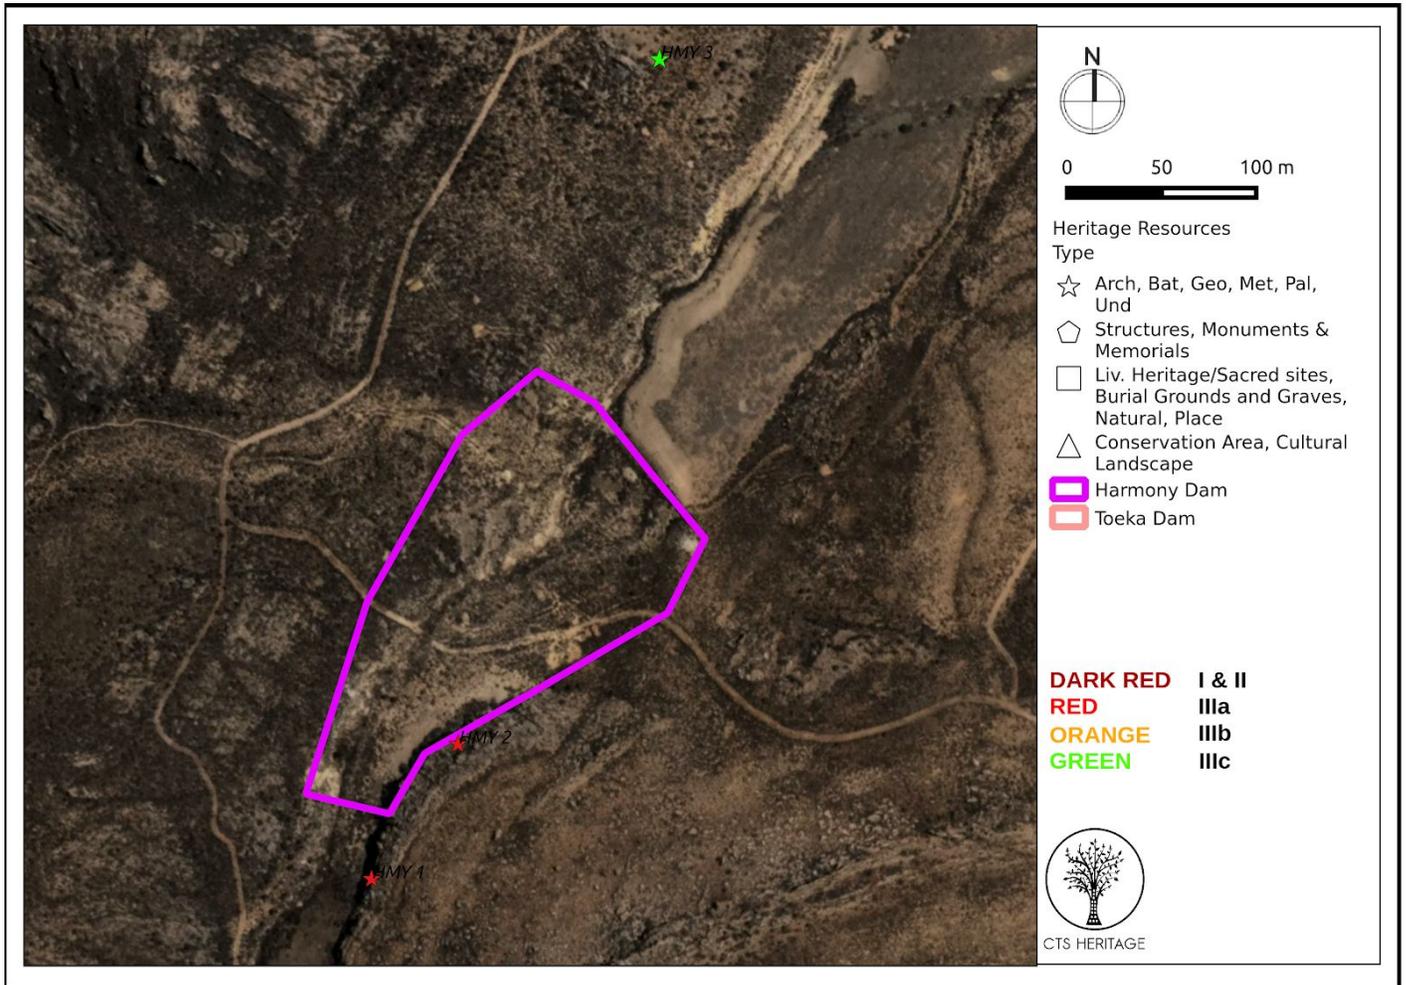
Map 4a: Heritage resources in the vicinity of the proposed development

Map 4b: Heritage resources in the vicinity of the proposed development

Point ID	Site No	Site Name	Description	Co-ordinates	Grading	Mitigation
	HMY1	Harmony 1	Rock art site	S32° 59.966' E19° 27.697'	Grade IIIA	Dam must be moved, 40-50m buffer
	HMY2	Harmony 2	Rock art site	S32° 59.928' E19° 27.727'	Grade IIIA	Dam must be moved, 40-50m buffer
	HMY3	Harmony 3	Artefacts	S32° 59.733' E19° 27.795'	Grade IIIC	None

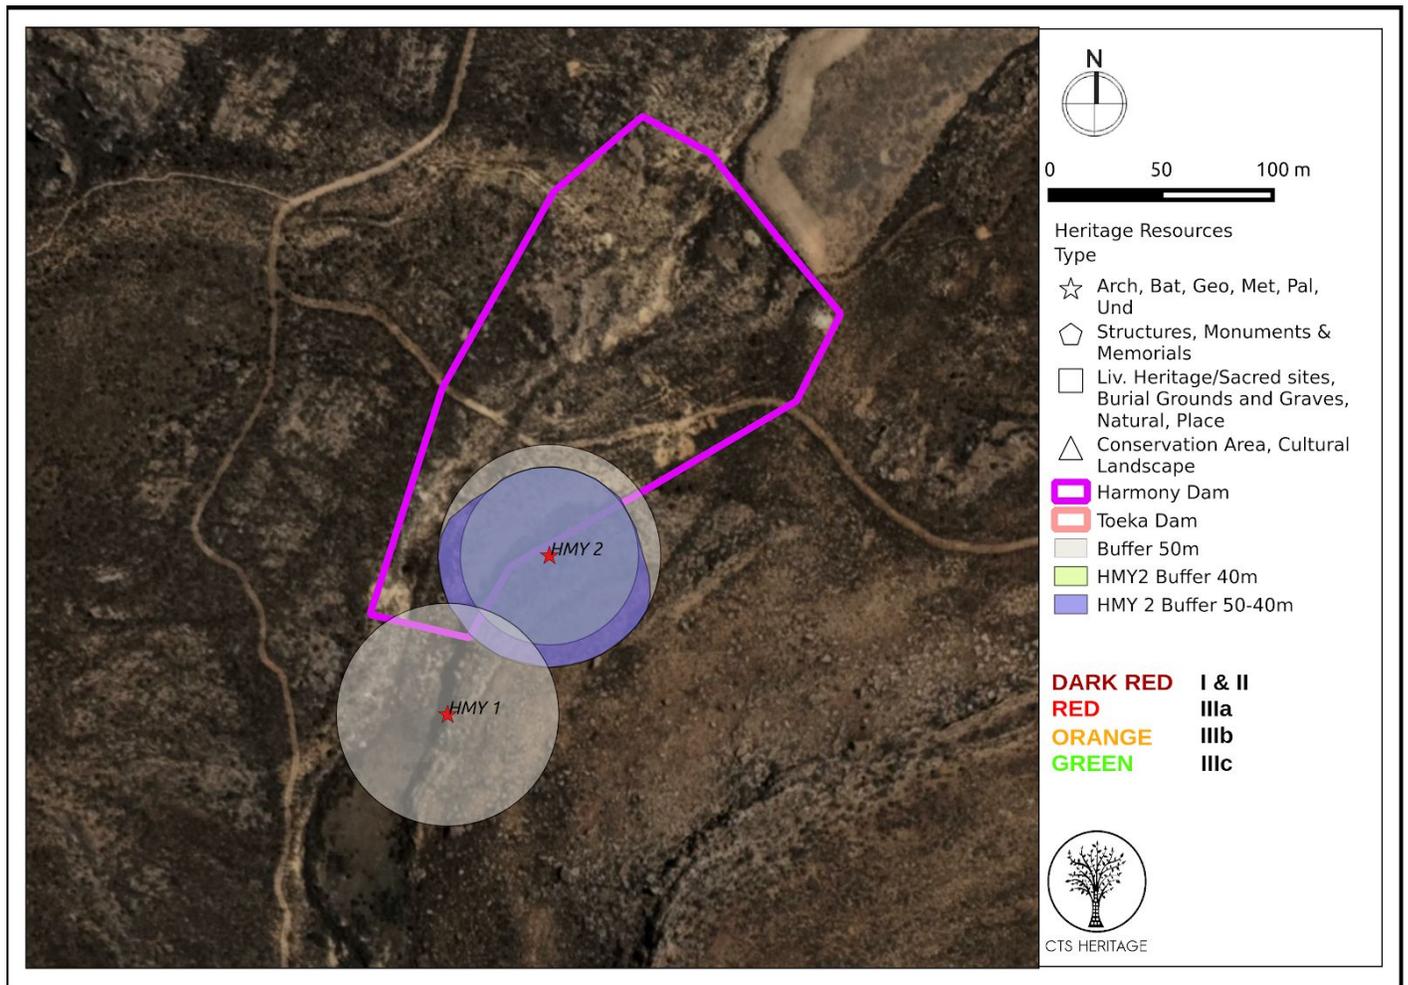
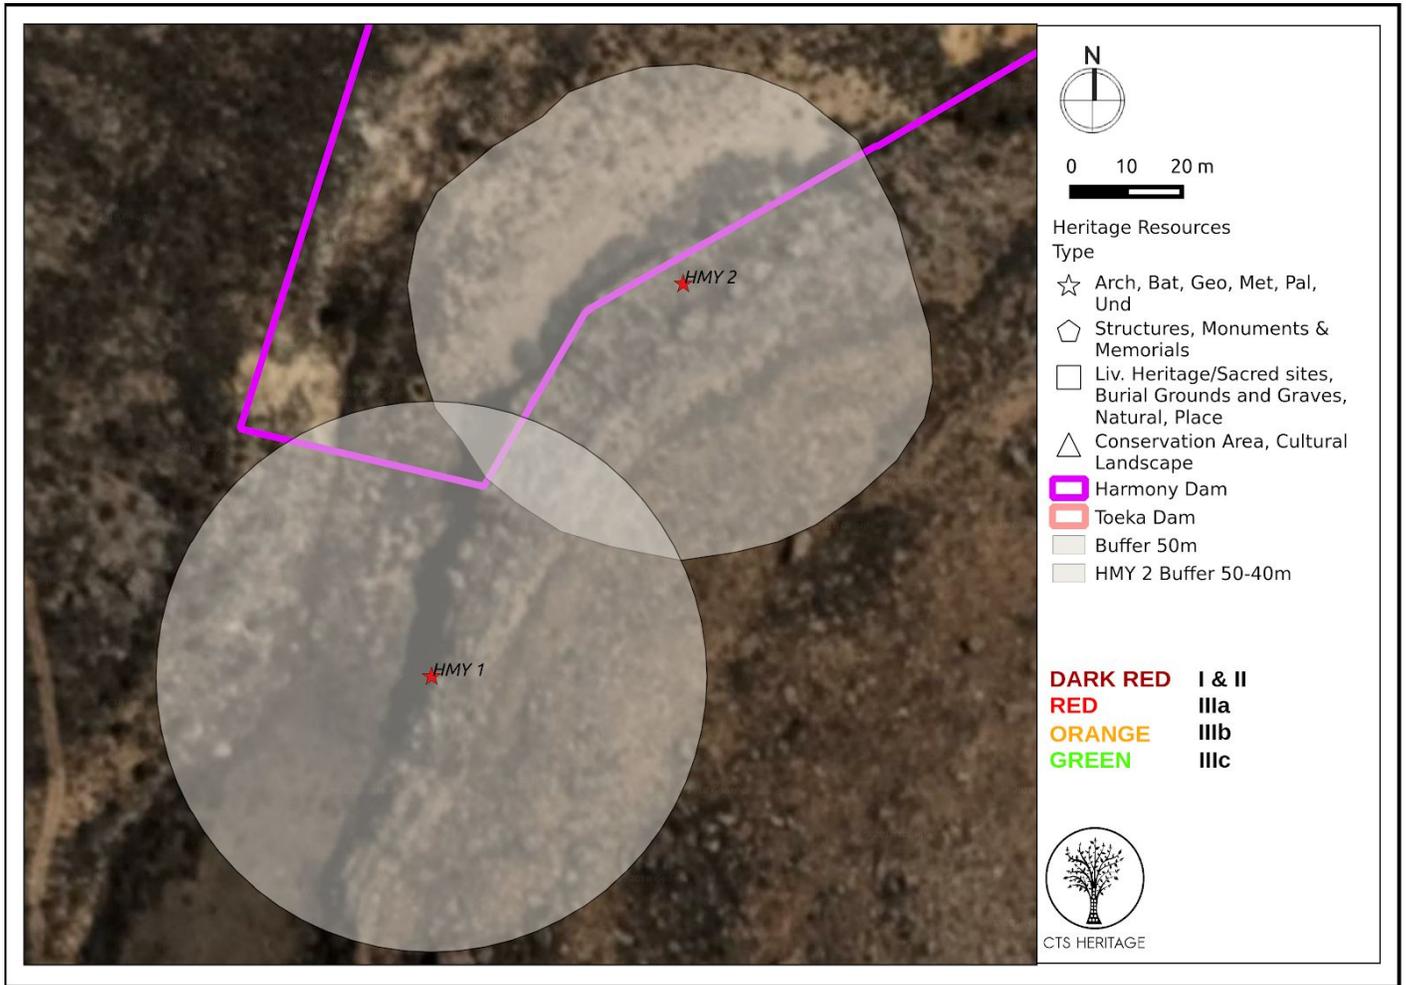
Map 5a: Heritage resources in the vicinity of the proposed development with proposed no-go buffer areas

Map 5b: Heritage resources in the vicinity of the proposed development with proposed no-go buffer areas

A 40-50m no-go buffer around each site (HMY1 and HMY2) is proposed as this will also allow for the protection of the archaeological deposit within the rocky overhang as well as the rock art.

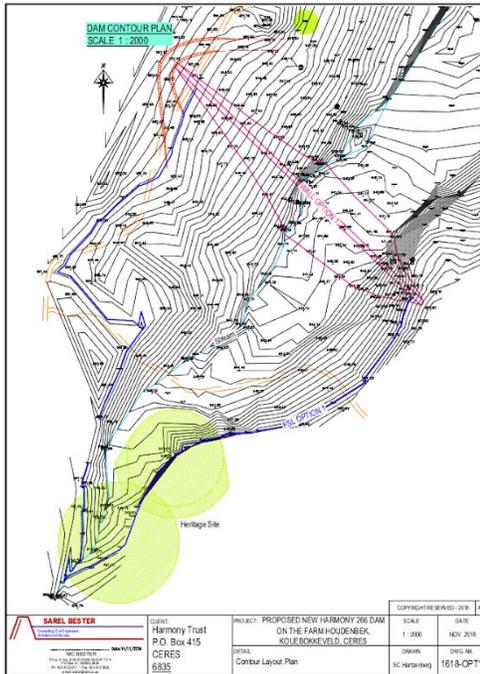
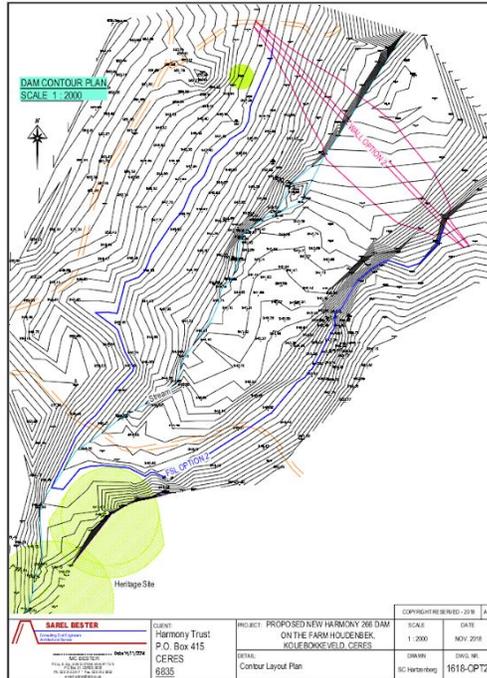
Figure 7a and b: Site Layout Plan indicating the proposed Options 1 and 2

Option 1: Original Design (Alternative A - preferred above)

Option 2: Wall of the dam moved further north. This option is not preferred as the capacity of this dam is too small to be viable.

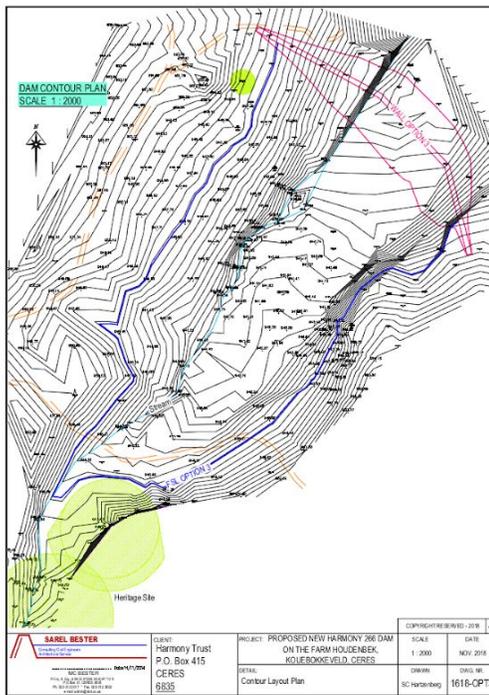
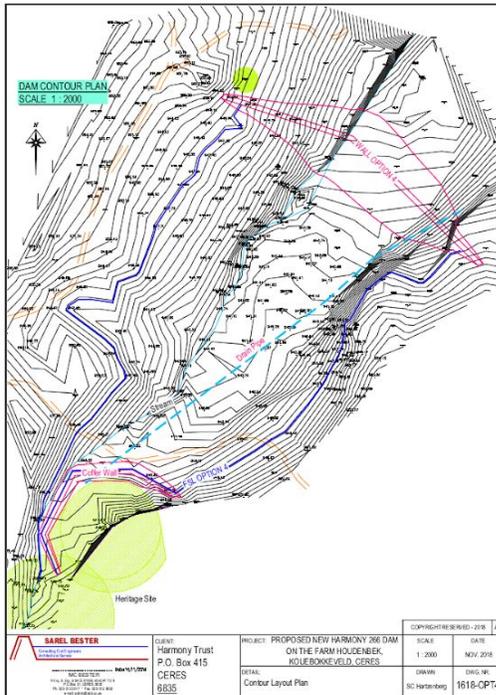
Figure 7c and d: Site Layout Plan indicating the proposed Options 3 (preferred) and 4

Option 3 (preferred): Wall moved north, but also curved to increase capacity

Option 4: Original dam position, but with additional wall erected to the south in order to secure the heritage resources. In this option, the buffer zones remain un-impacted, but the additional cost of the wall makes this option unviable.

Of the four options proposed, Option 3 is preferred. This new preferred layout will ensure that the significant heritage resources identified are not negatively impacted by the proposed dam as the maximum dam height will be below the 40-50m recommended no-go buffer zone (Figure 7a to 7d).
