A PHASE ONE GEOTECHNICAL INVESTIGATION REPORT FOR THE PROPOSED TOWNSHIP ESTABLISHMENT OF A NEW TOWNSHIP IN LETHABO PARK, KIMBERLEY

Report Number: 2019/J004/MAC

Prepared by: Soilkraft cc

On Behalf of: Macroplan Town & Regional Planners

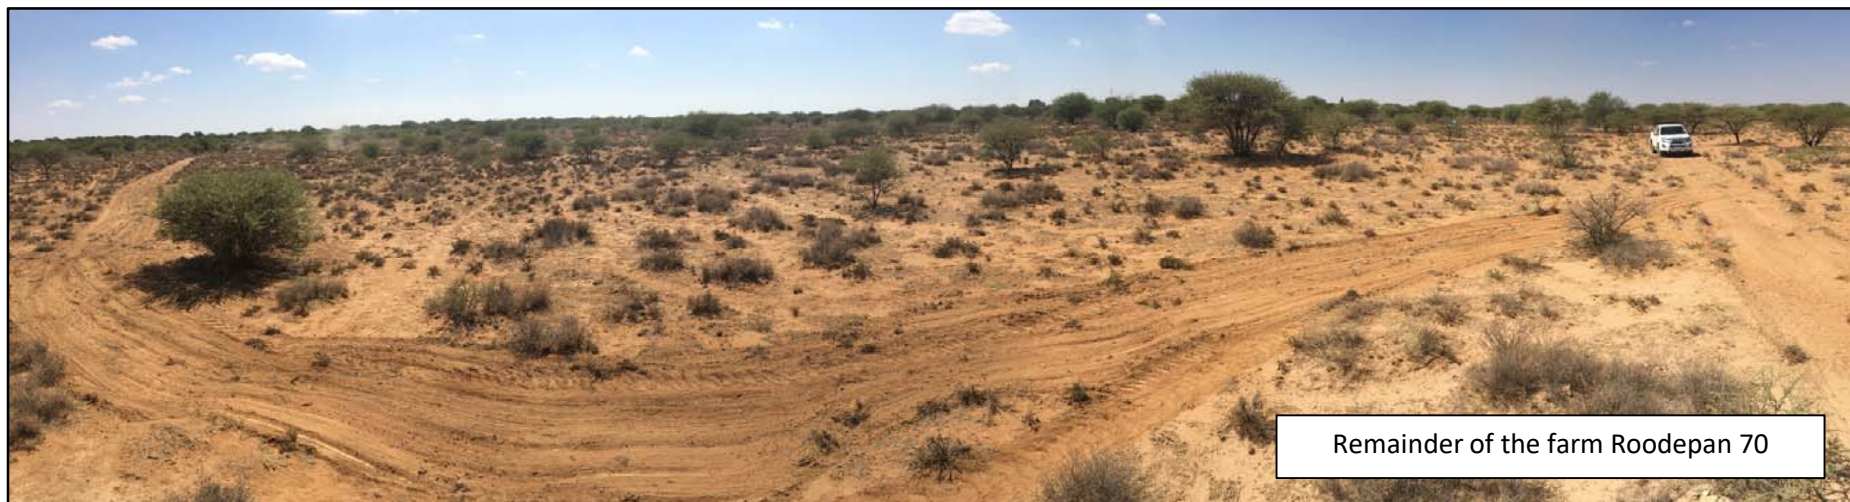
Remainder of the farm Roodepan 70

Photo 1 illustrates site conditions encountered on the north western part of the site (i.e. remainder of the farm Roodepan 70), while Photo 2 shows conditions encountered on erf 15089, to the east.

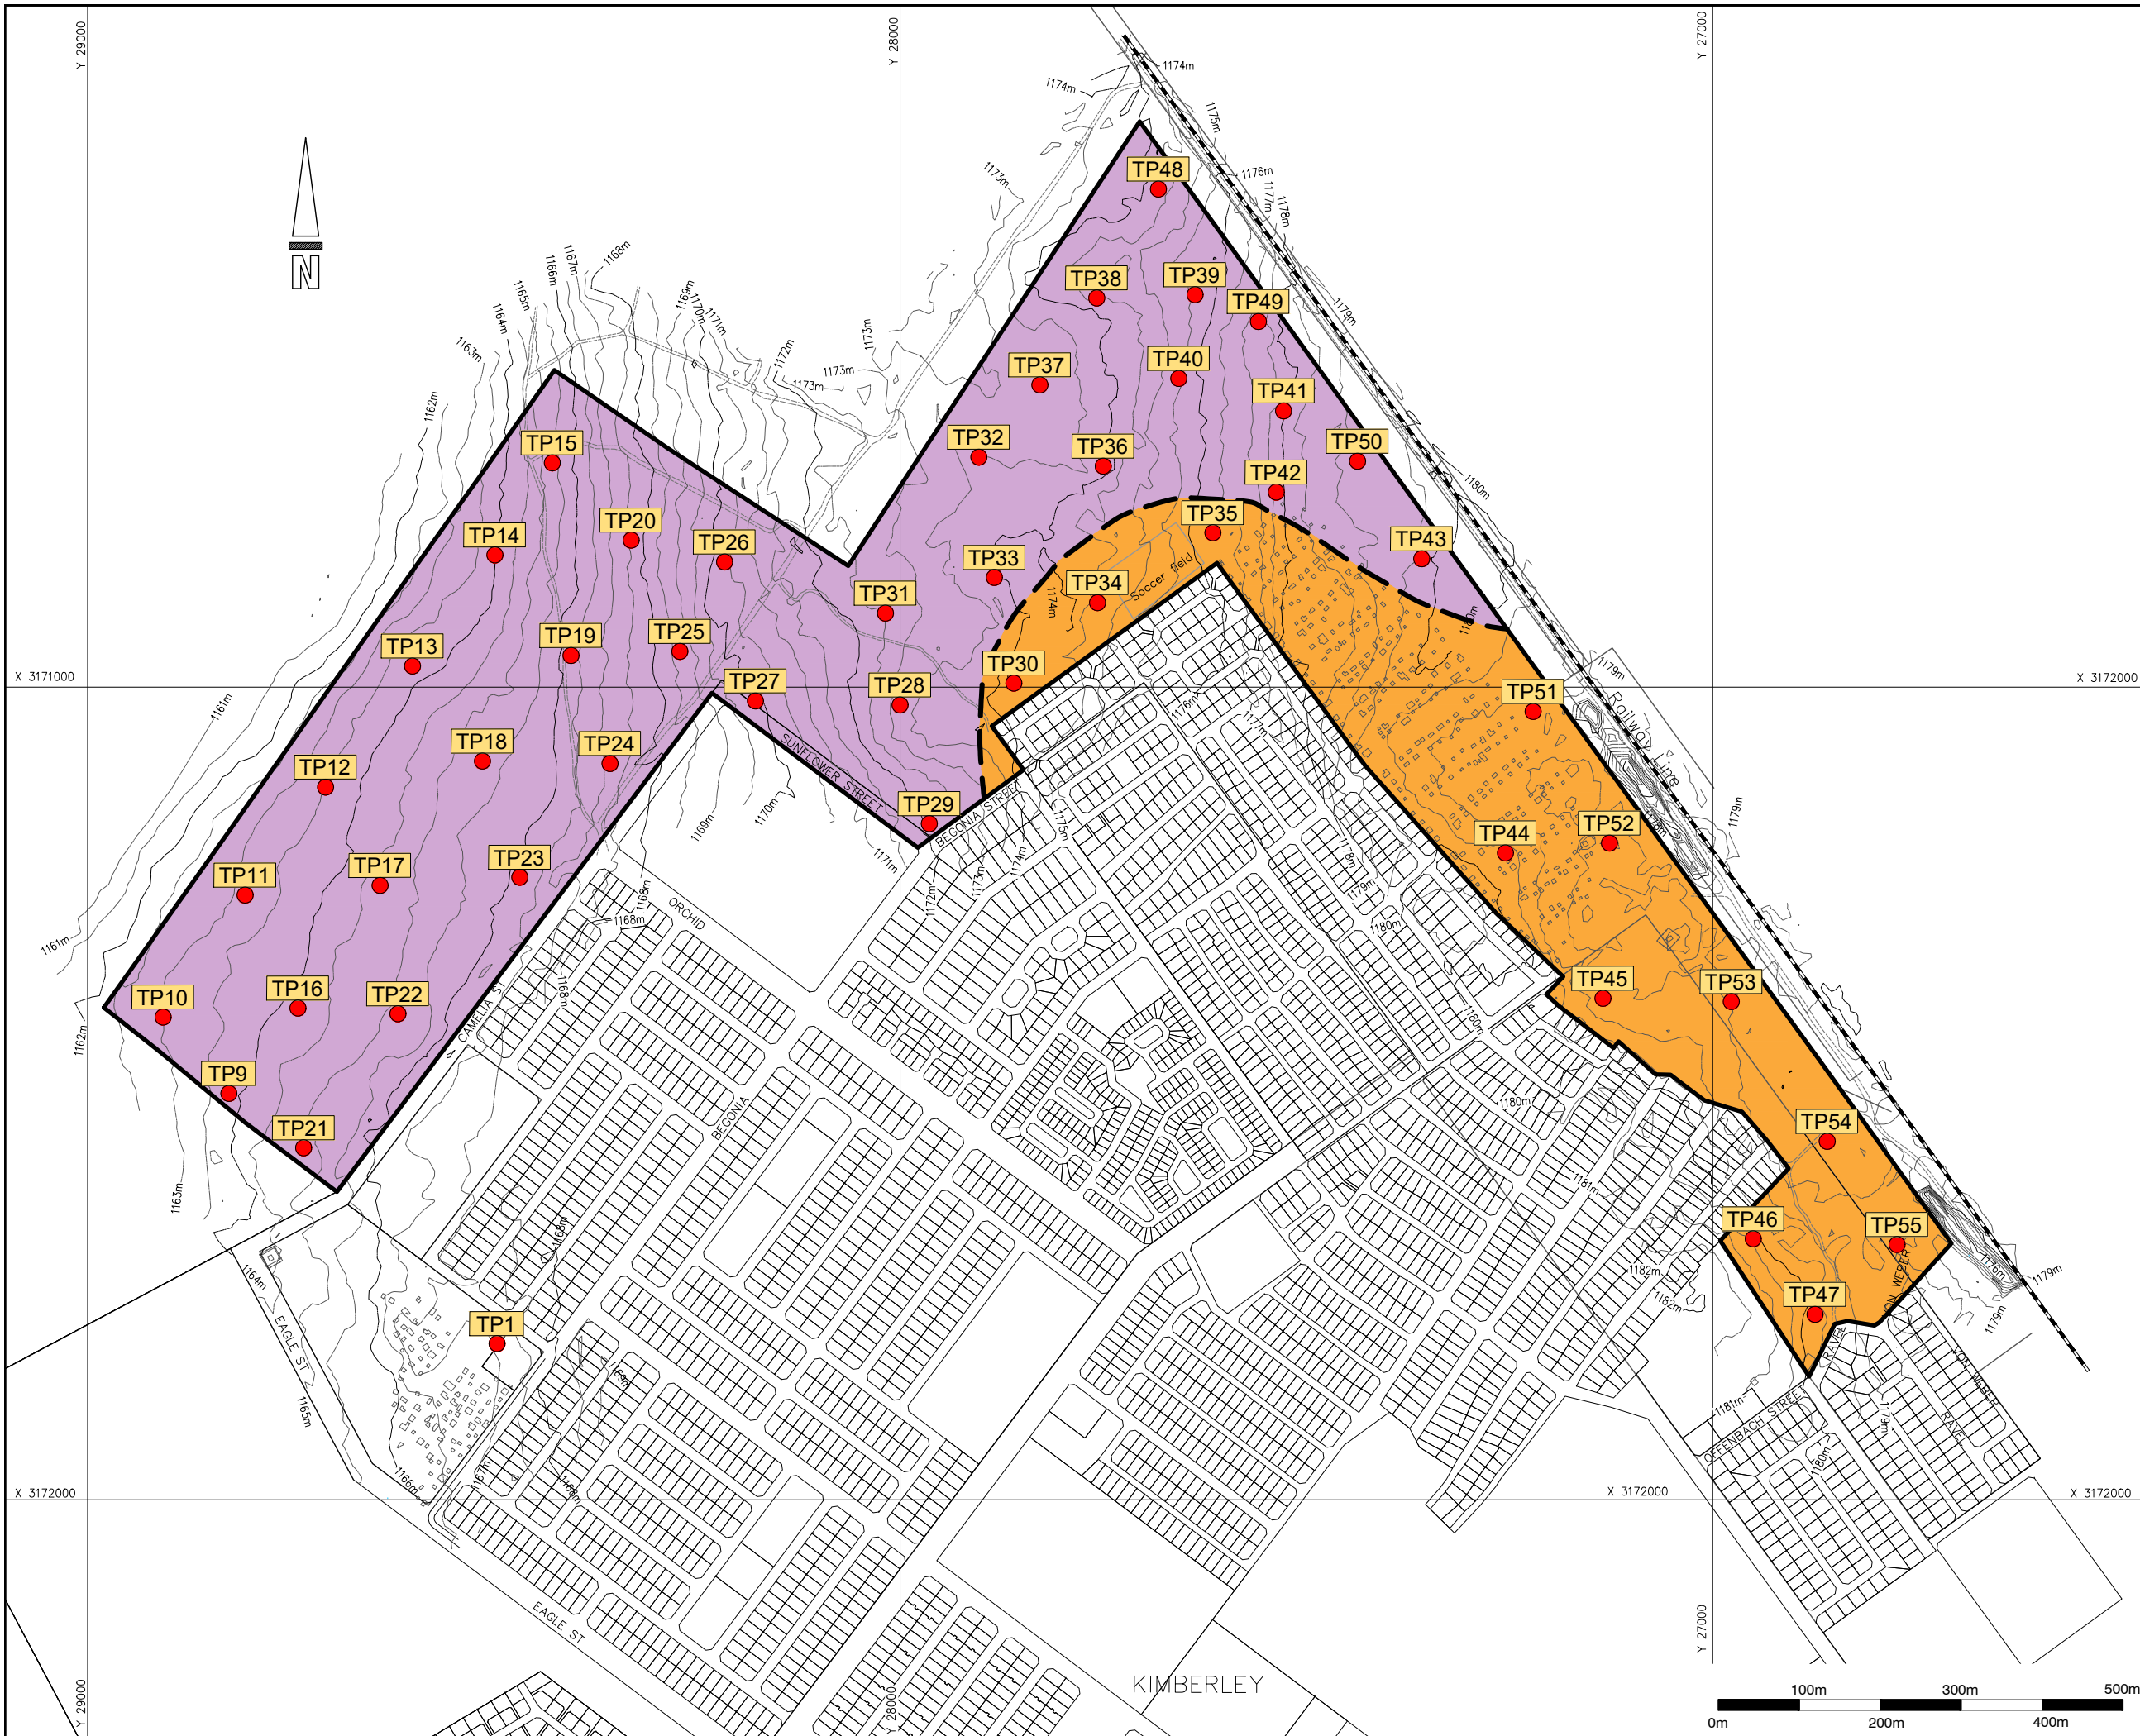
FIGURE 4

- *Geology*: The study area is underlain by a dolerite intrusion in the east and the Prince Albert Formation in the west. The geology was verified by bedrock materials encountered in trial holes.

- TP1 TRIAL HOLE
- TRIAL HOLE
- INFERRED BOUNDARY
- SHALE
(Prince Albert Formation)
- DOLERITE

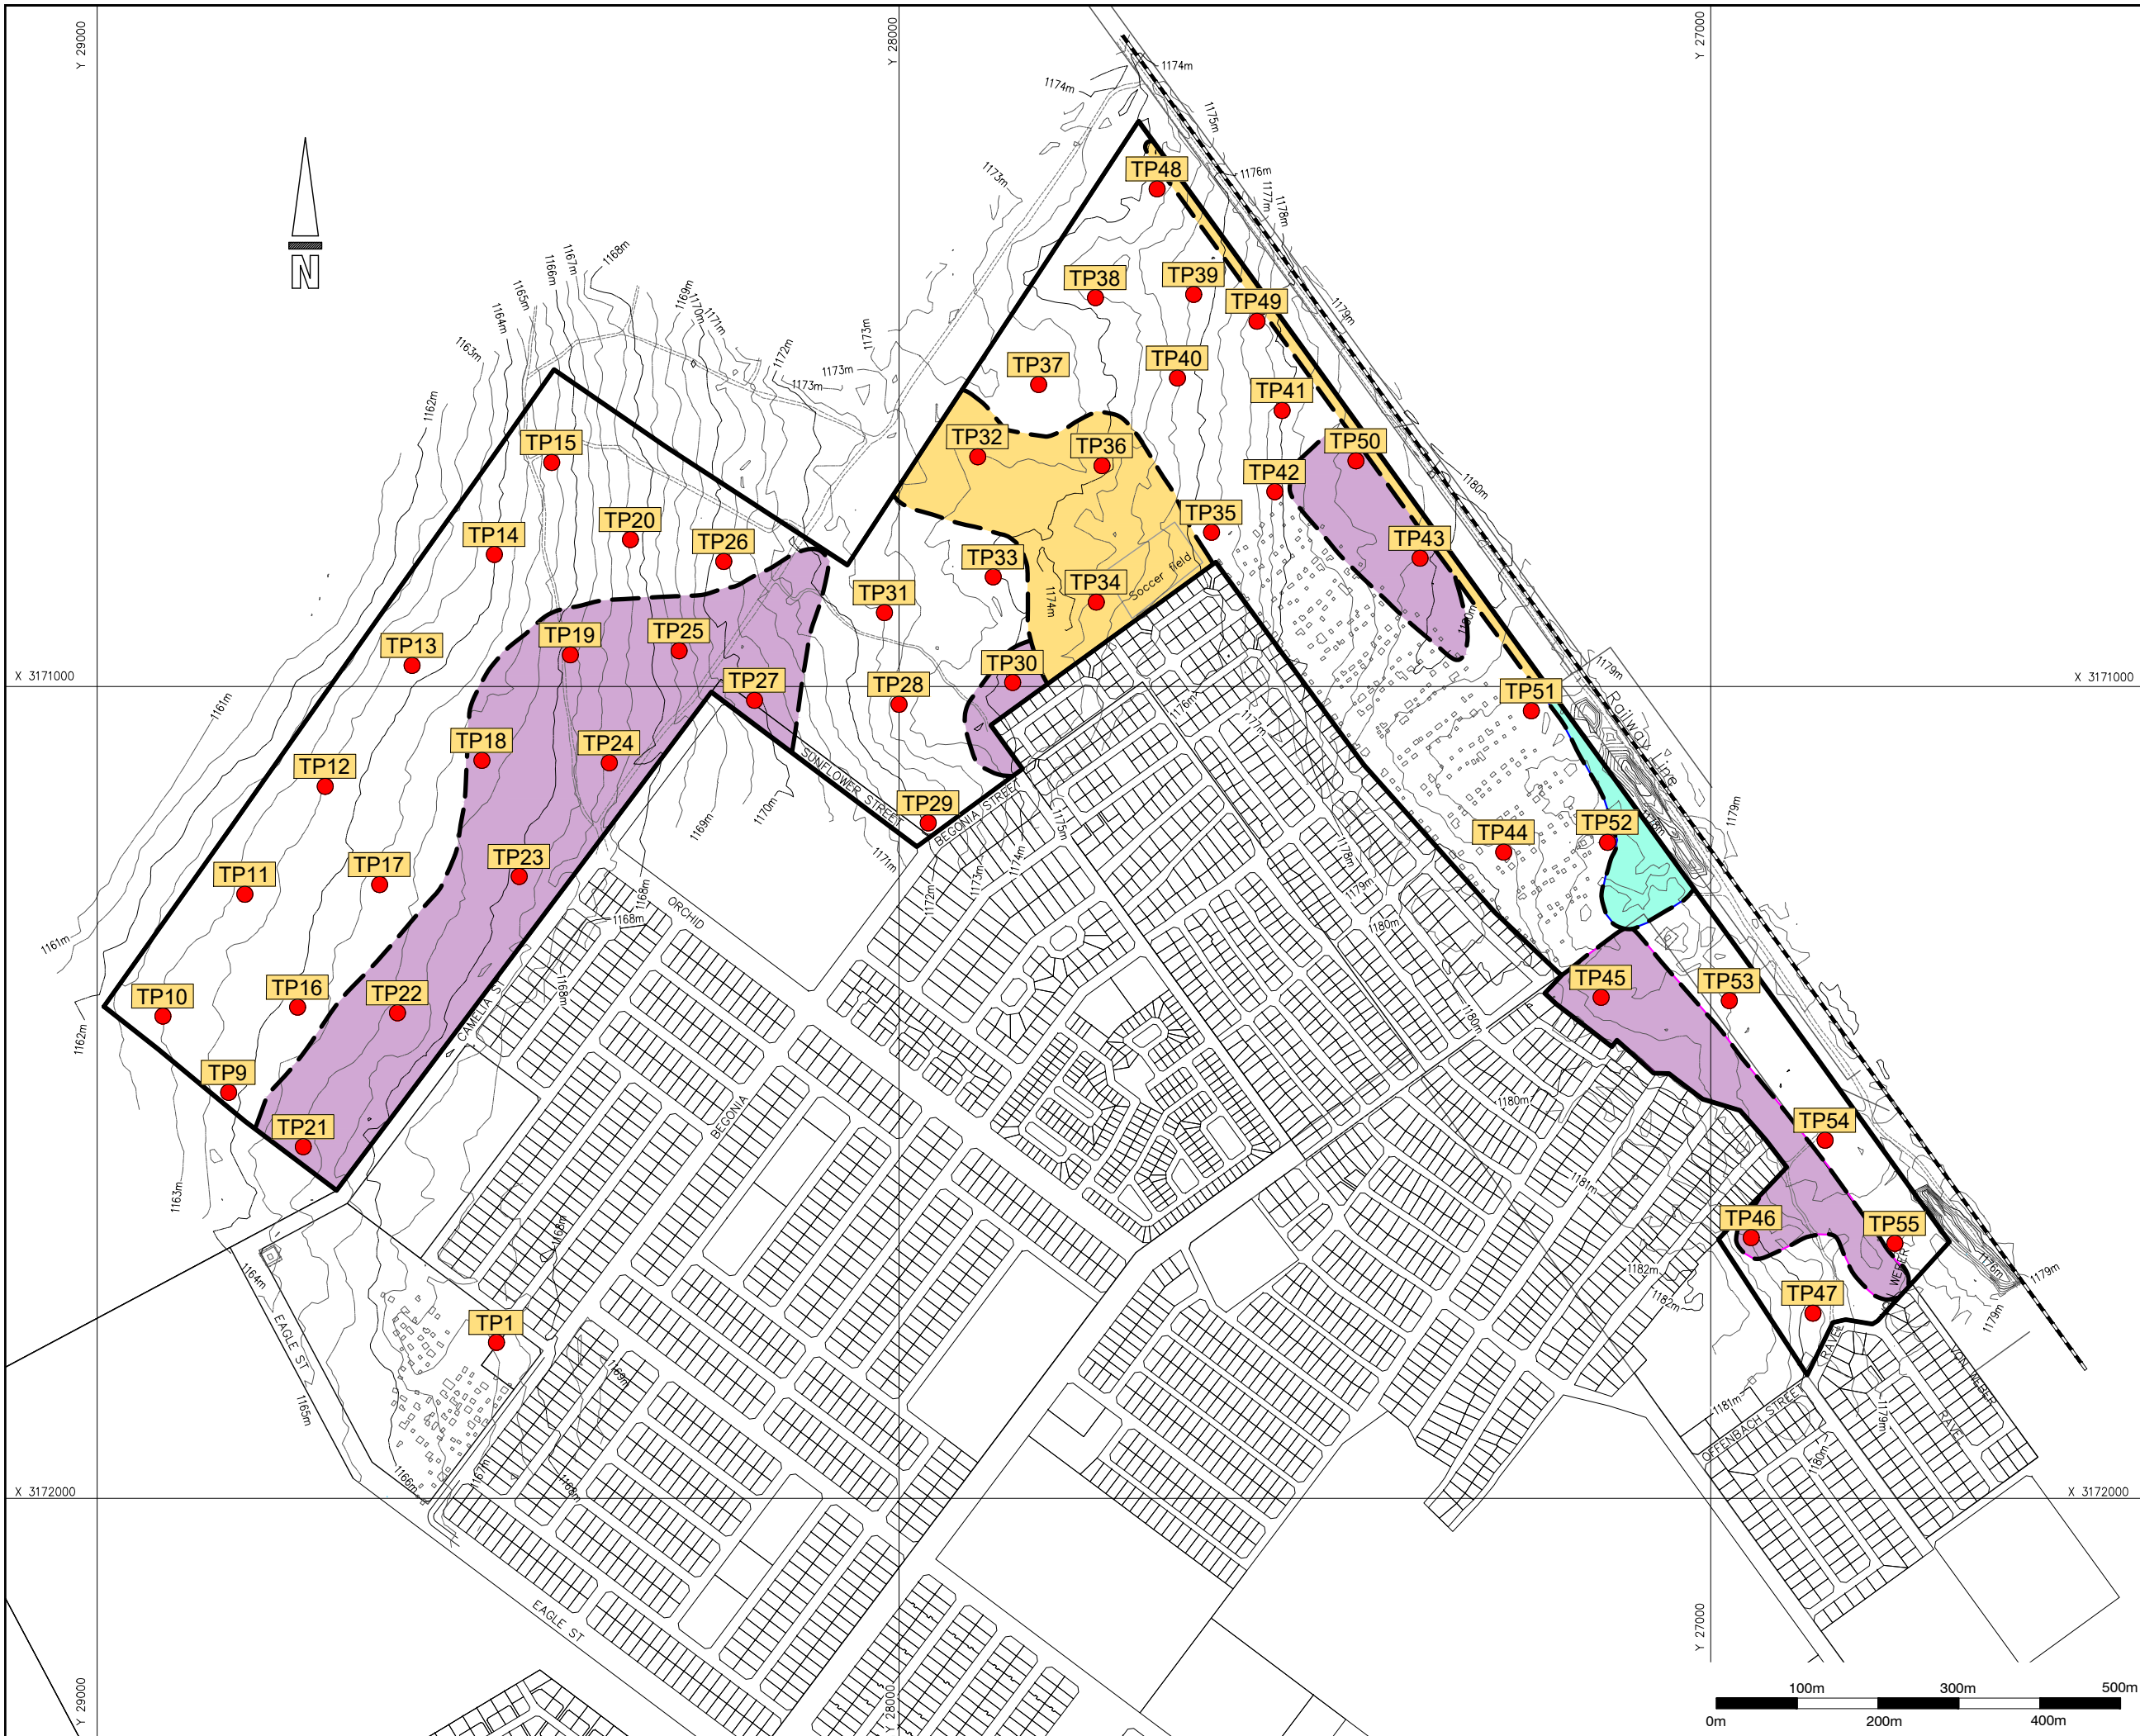
- *Digging and Rubble:* Areas were identified where diggings or excavation had been undertaken in the past. The purpose of the digging is unknown, but it is likely that sand was excavated for use in construction. In many cases the diggings had been filled with rubble and other waste. A trench was also found along the eastern boundary of the site. Such conditions clearly do not comply with the geotechnical zoning properties.

- *Water Leakages:* The area between trial holes 45 and 52 hosted a large, saturated area where water was ponding on surface. According to local residents, this water originates from leaking water infrastructure. Similar leakages occur west of the study area.

- TP1 TRIAL HOLE
- INFERRED BOUNDARY
- SURFACE RUBBLE DUMPS
- DIGGINGS, EXCAVATIONS AND RUBBLE
- WATER LEAKAGES AND SURFACE PONDING
