KNYSNA
ERF 3244, KNYSNA CELLULAR MAST

VISUAL ASSESSMENT

Final Report

17 May 2019

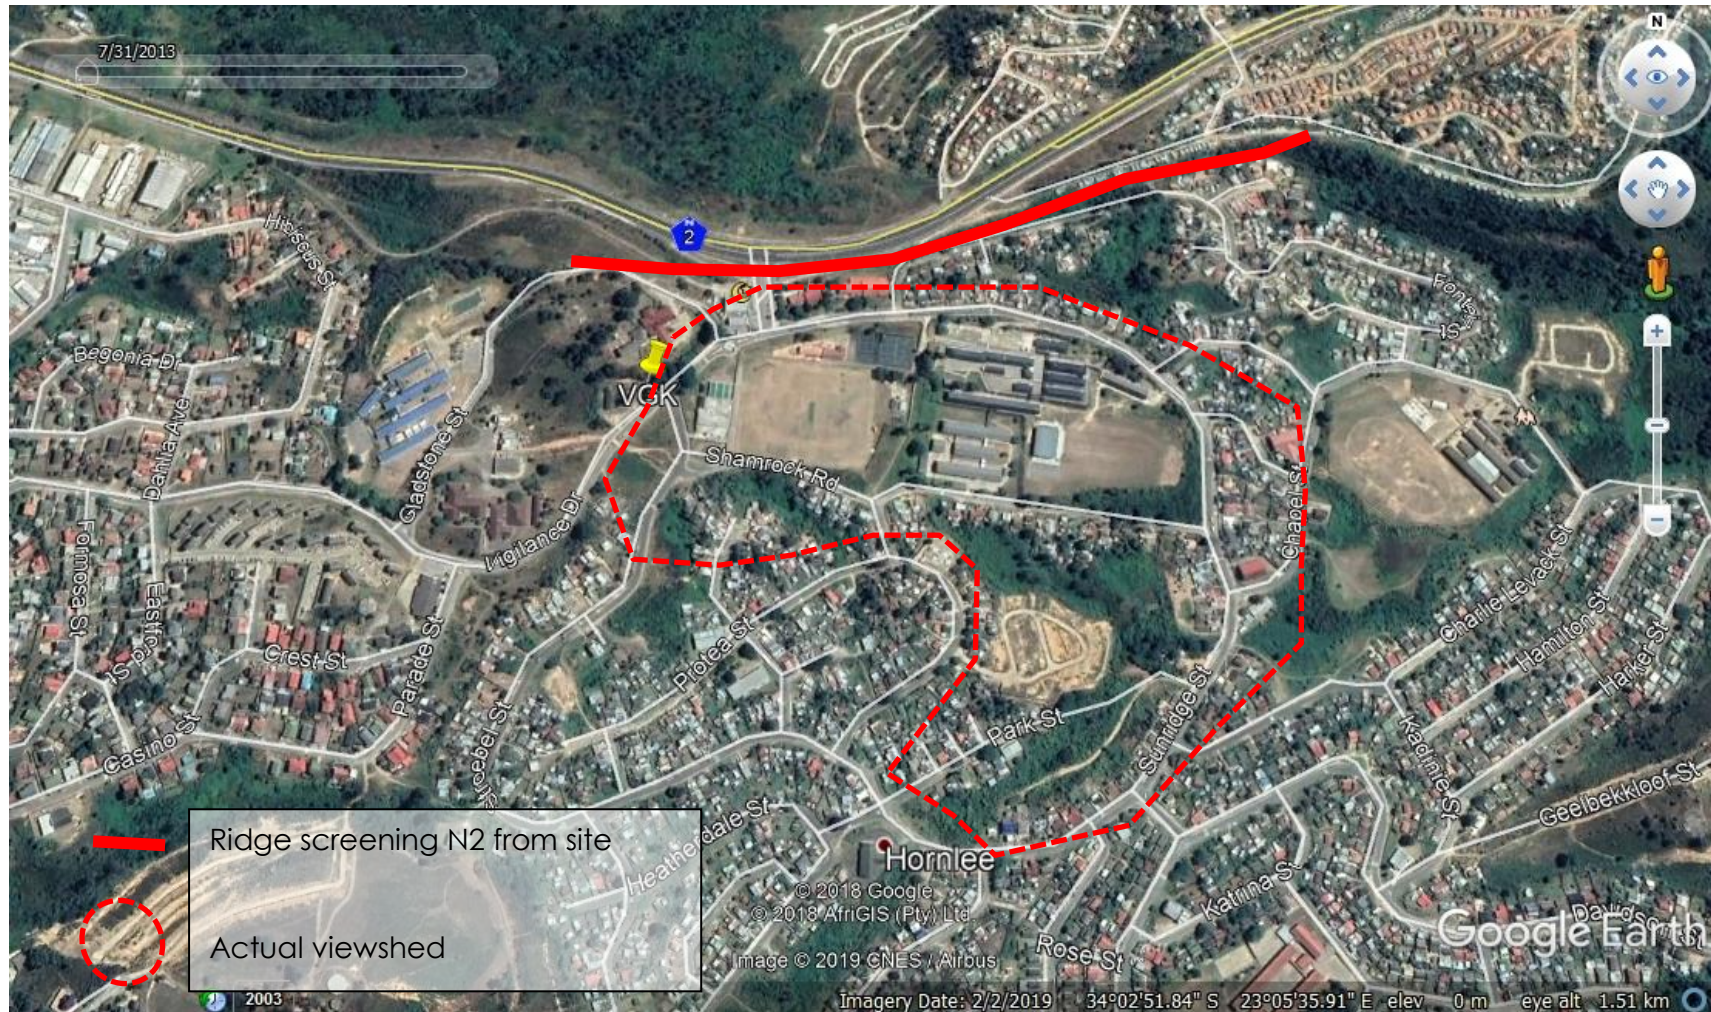
Figure 6: Actual view catchment based on landscape elements

This viewshed is however impacted by secondary changes in topography and various site elements, reducing the view shed significantly, especially to the south.

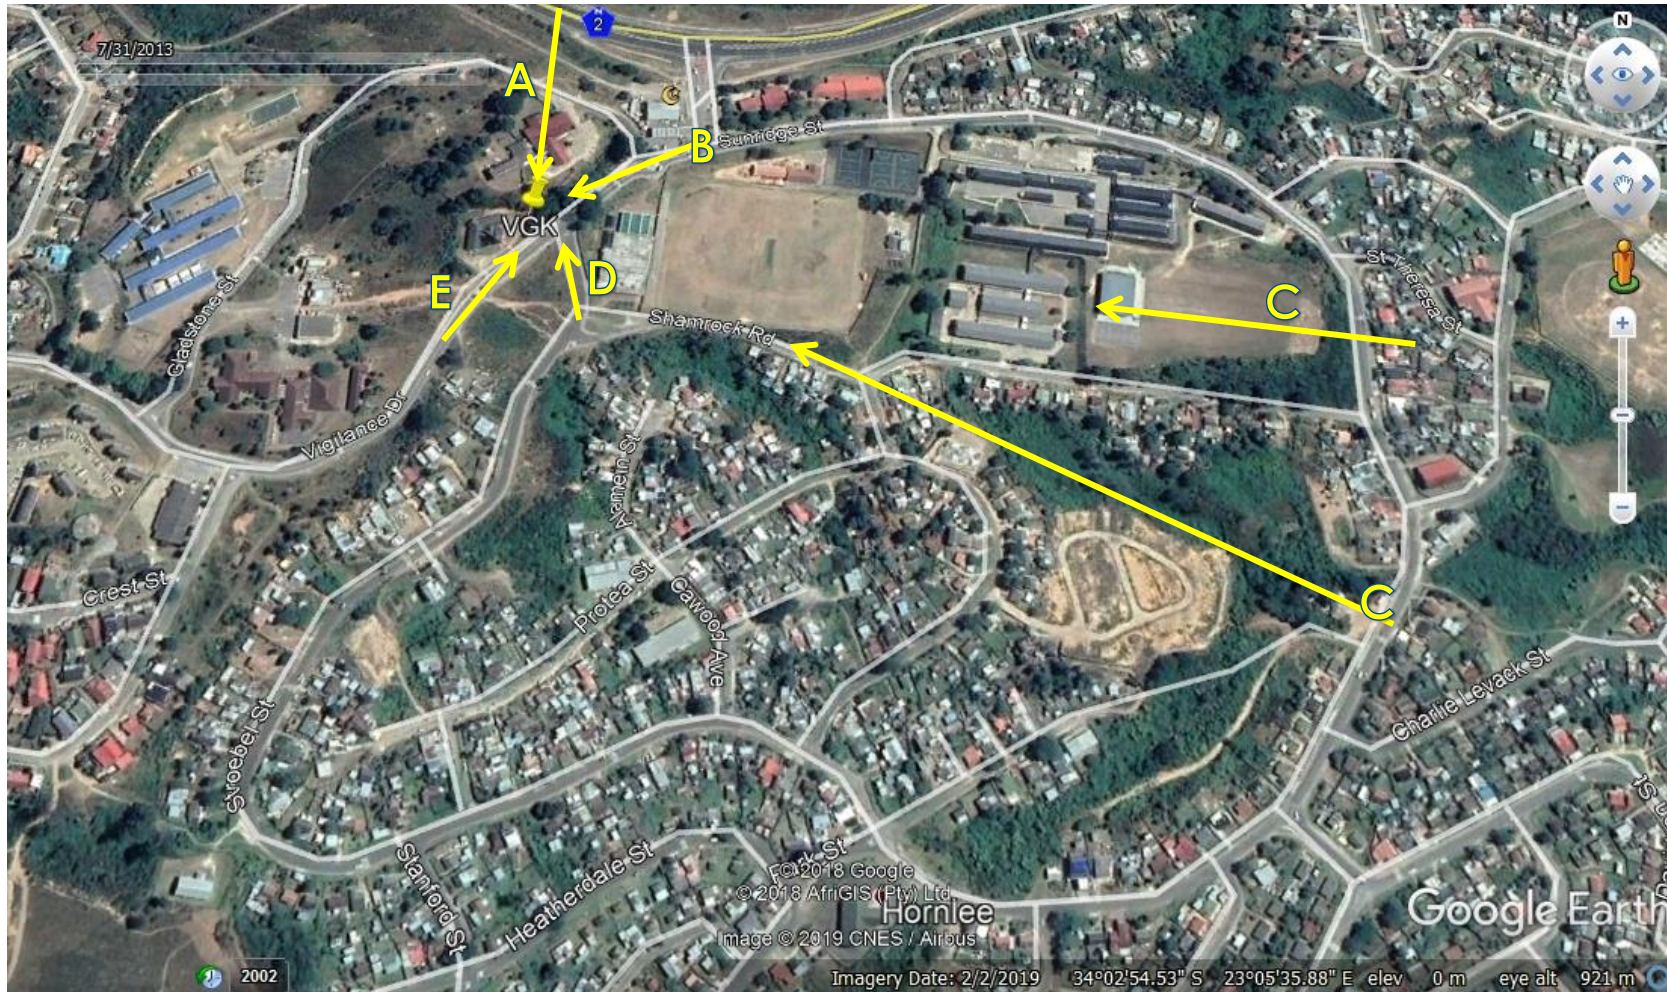
Figure 8: Potential Receptors

- A – View from N2
- B – View from Sunridge Entrance/intersection
- C – View across valley/basin
- D – Stroebeel street intersection with Vigilance Dr
- E – Vigilance Dr approach from south

Sunridge Street is the main entrance to Hornlee and upon entry the Hornlee basin lies in full view of the observer. The application property would then be to the right. Turning in this direction, the site will come into view (Refer Fig 8, viewpoint B).

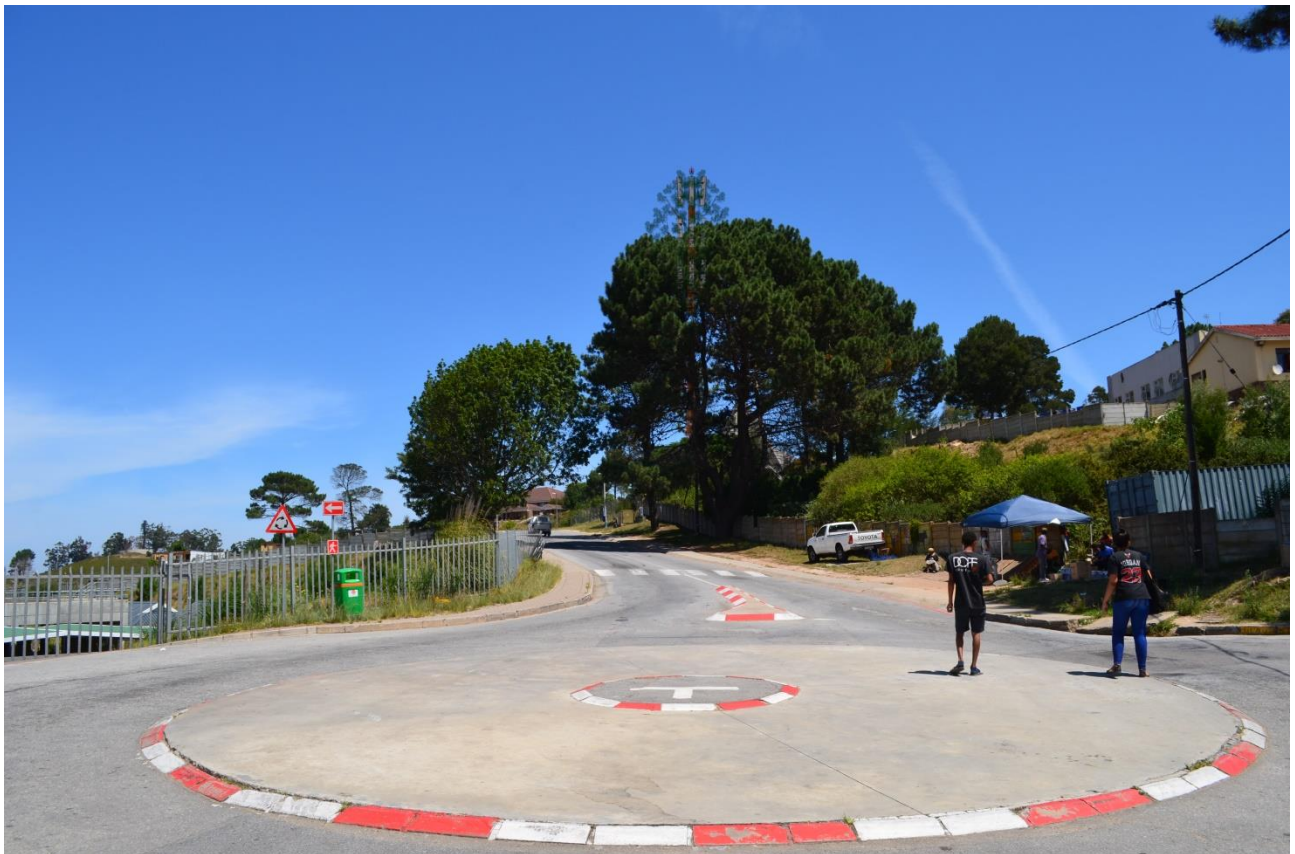
Photo 1: View from Sunridge intersection

The mast will be visible but since the tree design fits against the existing tree backdrop the Intrusion level is reduced. The overall impact is moderate.

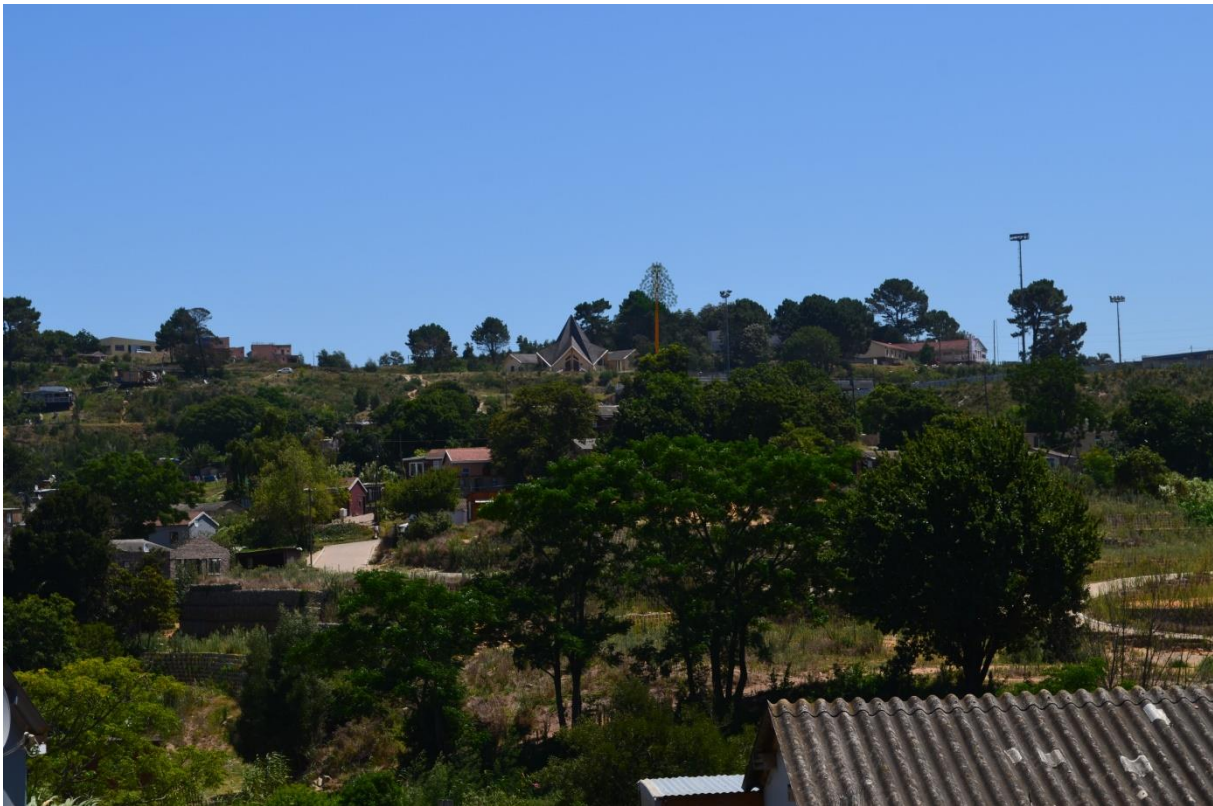
**Photo 2: View across valley**

When the site is entered, which is also an entrance to a number of small holdings/houses directly abutting the application property, the mast will be clearly visible. On exiting the property, the tree will be in direct view of the observer. This will however be brief. The houses closer to the escarpment are already on a height below the view line.

The visual significance is rated as moderate to low. The tree backdrop absorbs the mast to a level where it fits in the context and is observed as a distraction from the environment.

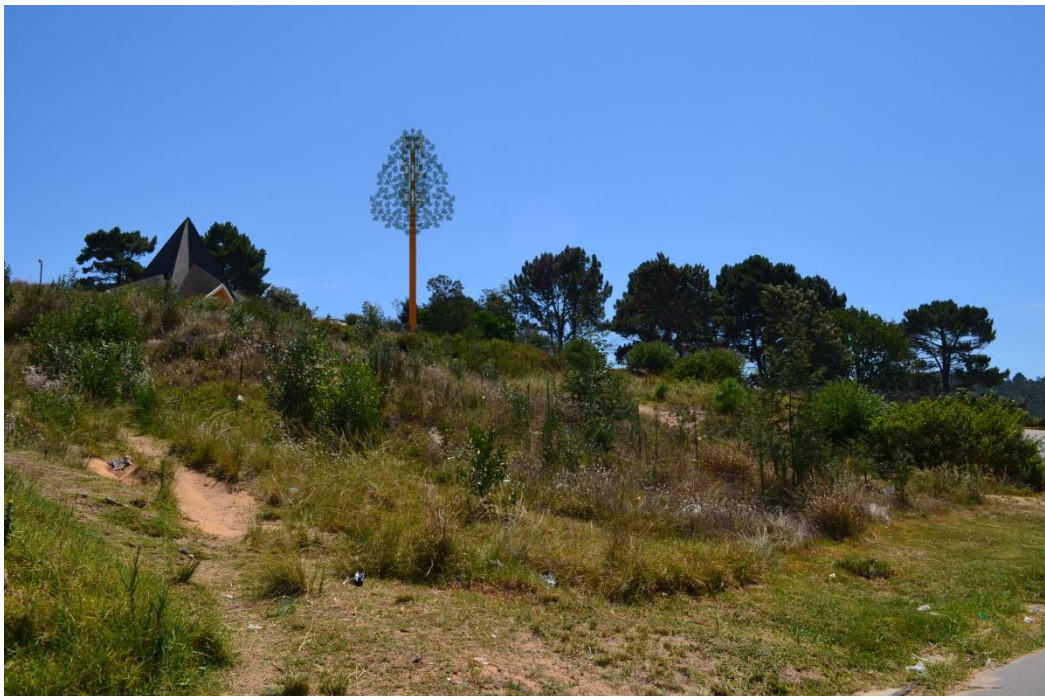
**Photo 3: Stroebelstreet approach**

Approaching the site from Stroebelstreet the observer is at first obscured from the site due to the topography. As the intersection is approached the mast will come into view. The observer is however travelling diagonal to the mast and therefore the mast remains in peripheral view until the road turn sharply at the intersection and into direct line with the mast.

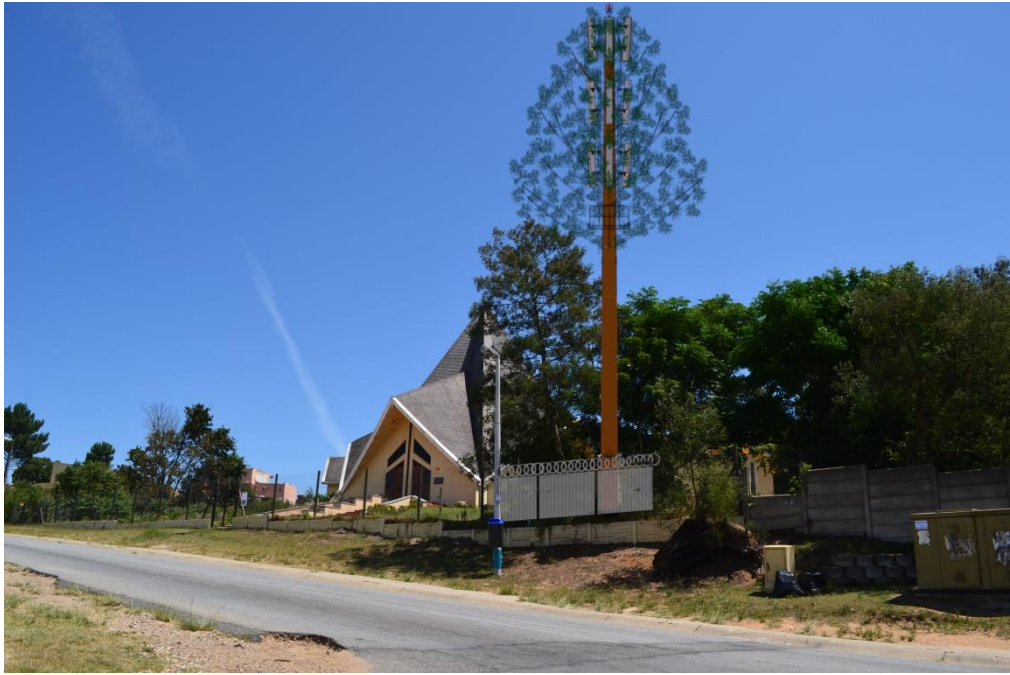
Photo 4: Stroebelstreet Intersection

At the intersection the mast is in direct view of the observer. Although the tree design softens the impact it would be clearly distinguishable as a cell mast. Note that the boundary trees will be removed for the construction of the mast. The observer will however focus on the road and decide on a direction to turn. The duration of view is thus short.

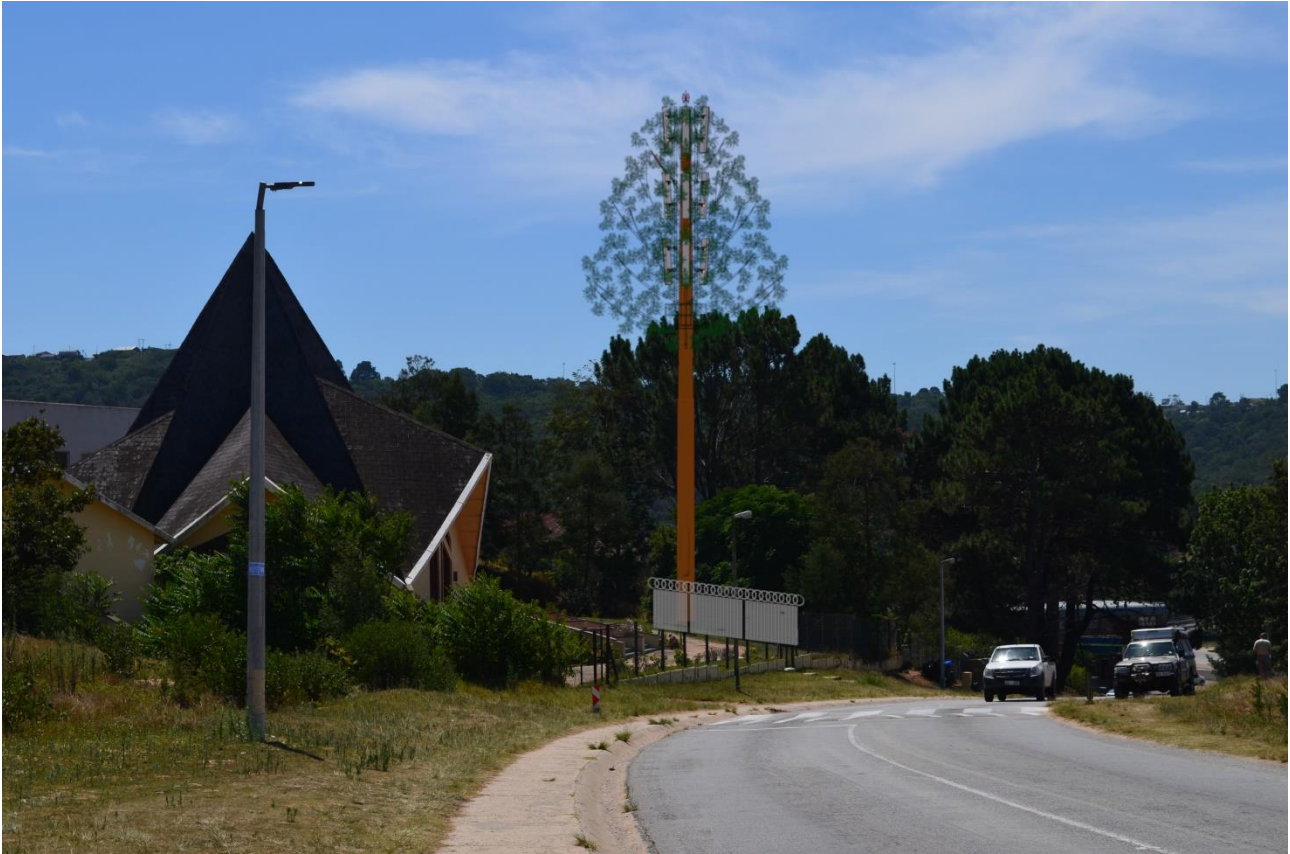
Photo 5: Vigilance Drive approach

Approaching with Vigilance Drive from the south, the site remains out of site due to the topography. Only once the traveler comes round the bend in the road does the mast come into clear view. The pine tree backdrop softens the view and although it would most probably be distinguished as a cell tower, the view is more pleasing than a

monopole or lattice mast. The duration of view is short as the mast disappears out of view as the traveler passes the mast.
