HERMANUS
PORTION 14 OF FARM 587, HEMEL EN AARDE, CALEDON FARMS
CELLULAR MAST

VISUAL ASSESSMENT

Final Report

28 May 2019

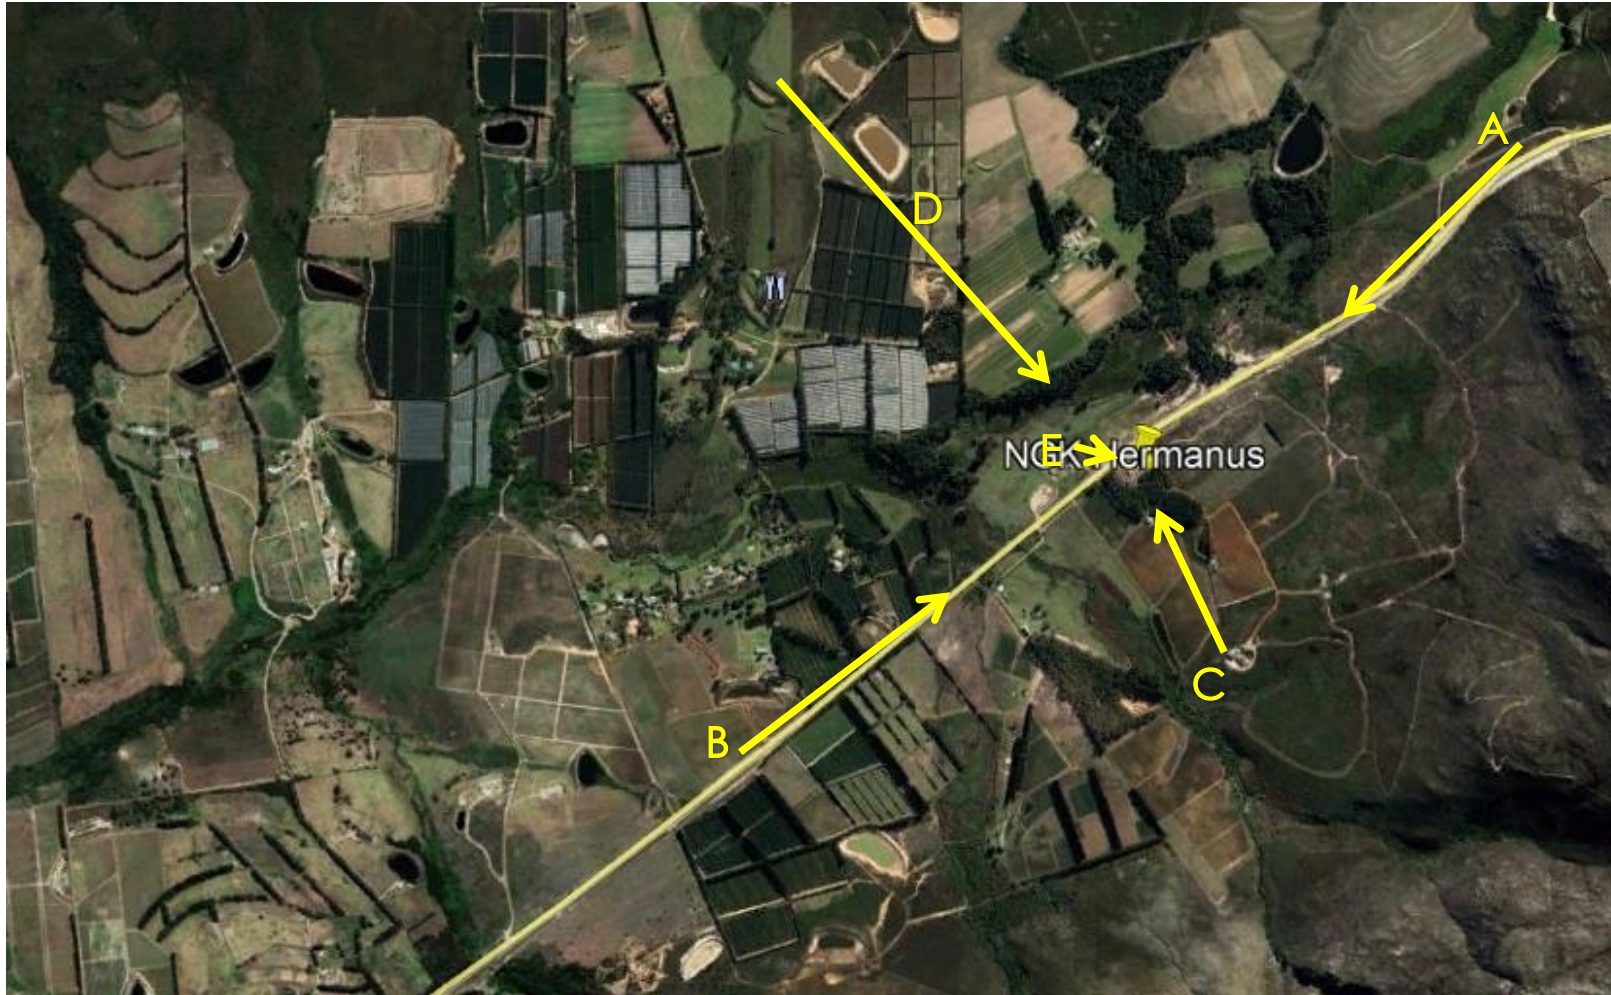
Figure 7: Potential Receptors

- A – R320 approach from Caledon
- B – R 321 approach from Hermanus
- C – Spookfontein cottages and restaurant
- D – Opposite valley side
- E – Site entrance

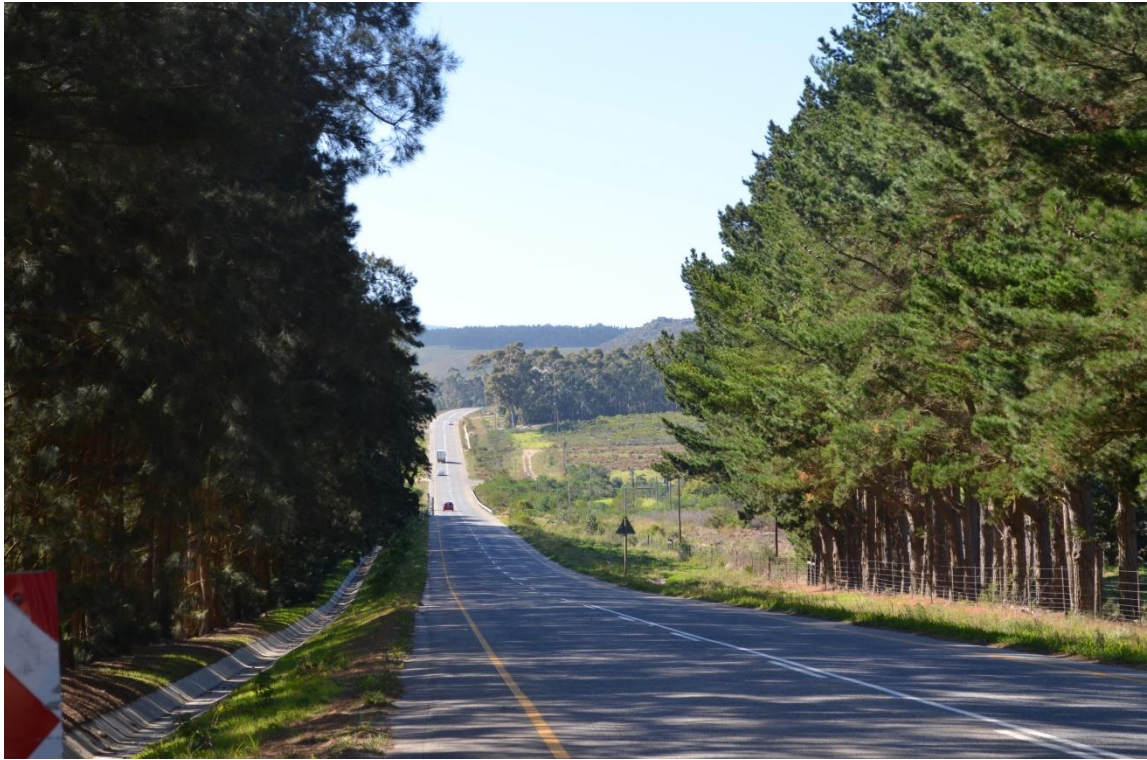
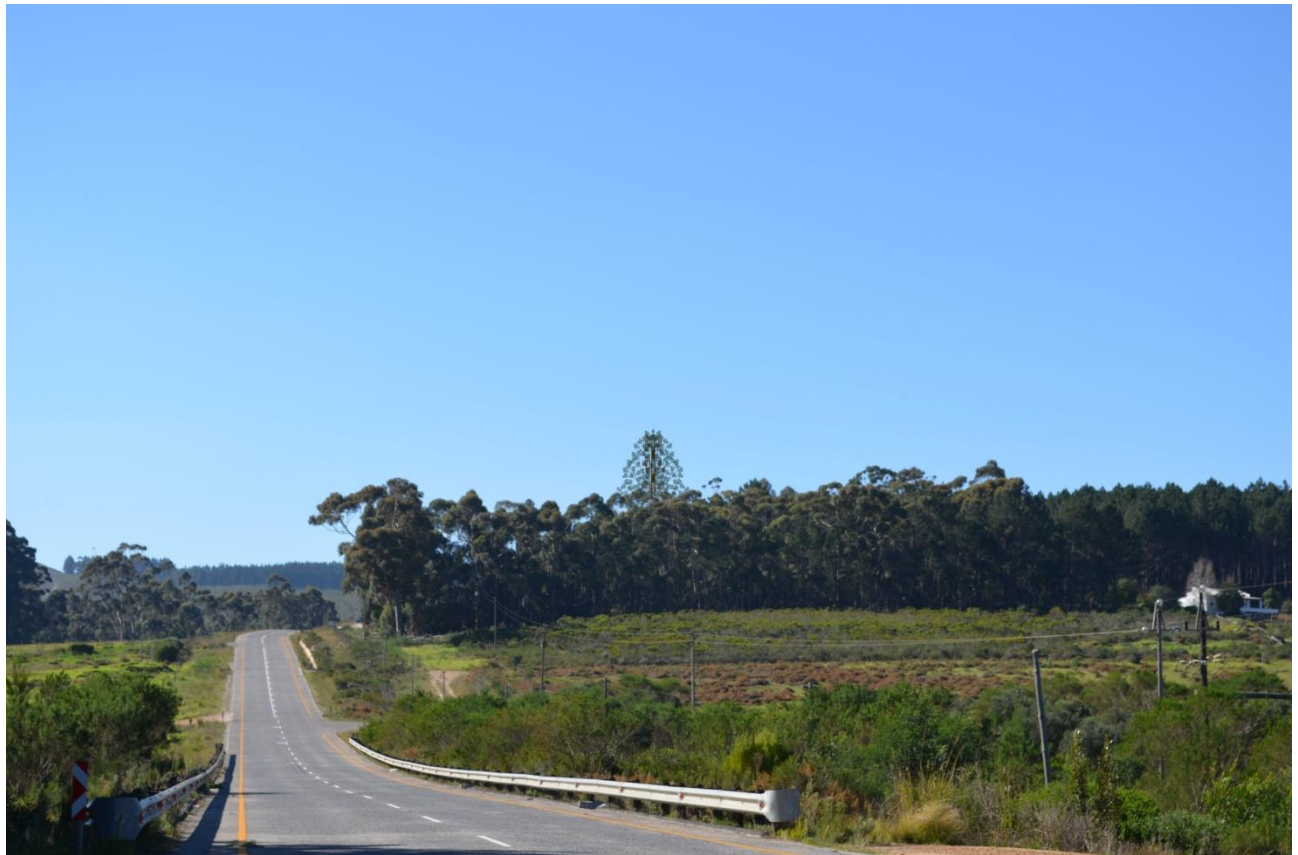
Photo 2: R320 Hermanus approach

When crossing the rise looking towards the site, the stand of trees is in the distance. At this point the site is still too far to distinguish the mast behind the trees. Only at night the navigation lights will be visible above the tree line. Only when the observer reaches the bottom of the side valley, the site is close enough to distinguish the mast but due to the tree type, it will not be obtrusive and most travellers may not even notice the mast.

The on-site trees consist of blue gum and pines trees of approximately 12 to 20 m in height.

The visual impact is moderate due to the sensitivity of the R320 as a scenic drive and the on-site venue. The use of a tree type which is in context with the landscape elements reduces the intrusion level and therefore this view is acceptable.

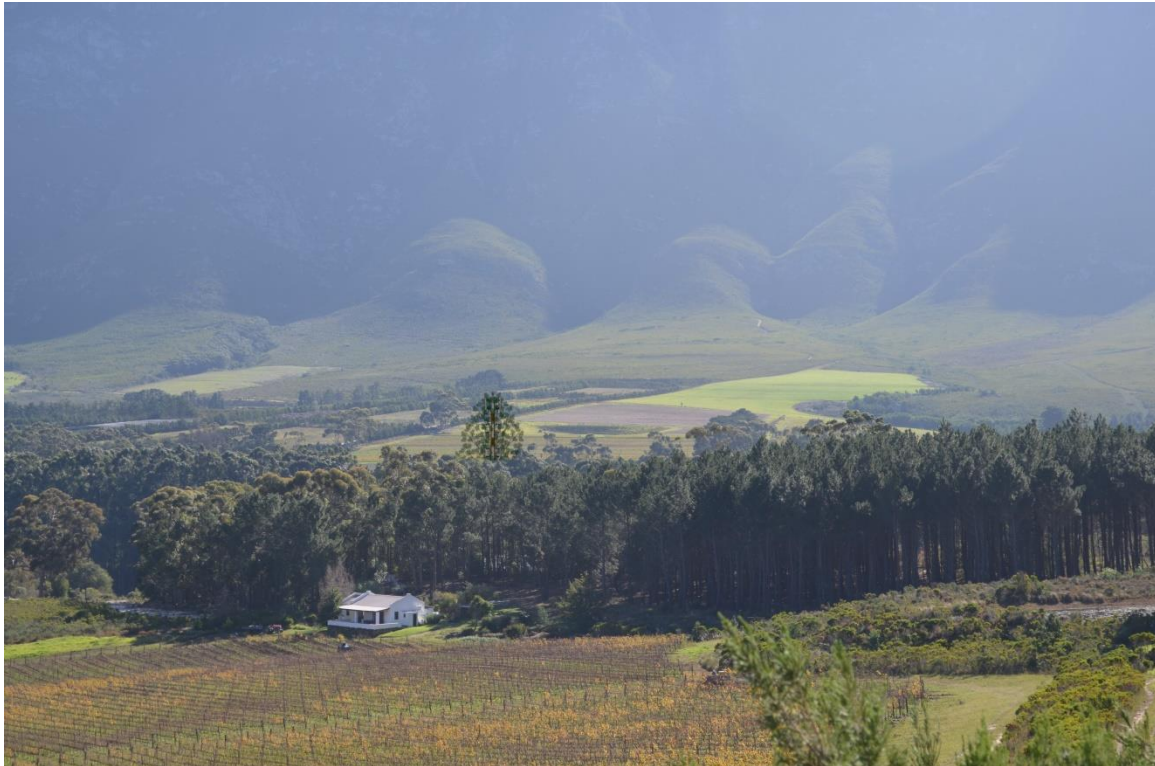
Photo 4: Spookfontein restaurant view

The adjacent property host tourist accommodation and a restaurant. The restaurant is located high above the valley with views of the valley. The site is directly below the restaurant. From the front porch, the stand of trees surrounding the site (Ertjiesvlei venue) screens the site as such that the buildings are not even visible. The mast will protrude above the trees but due to the tree design, it will not be obtrusive. The navigation lights will be visible at night.

The accommodation cottages are direct behind the stand of trees and thus the mast will not be visible from the cottages due to the proximity to the trees which screen the site.

The visual significance is rated as moderate. The tree design is in context with the landscape elements and thus the intrusion level is moderate to low and thus within acceptable levels as it would not detract from the quality of experience of Spookfontein patrons.

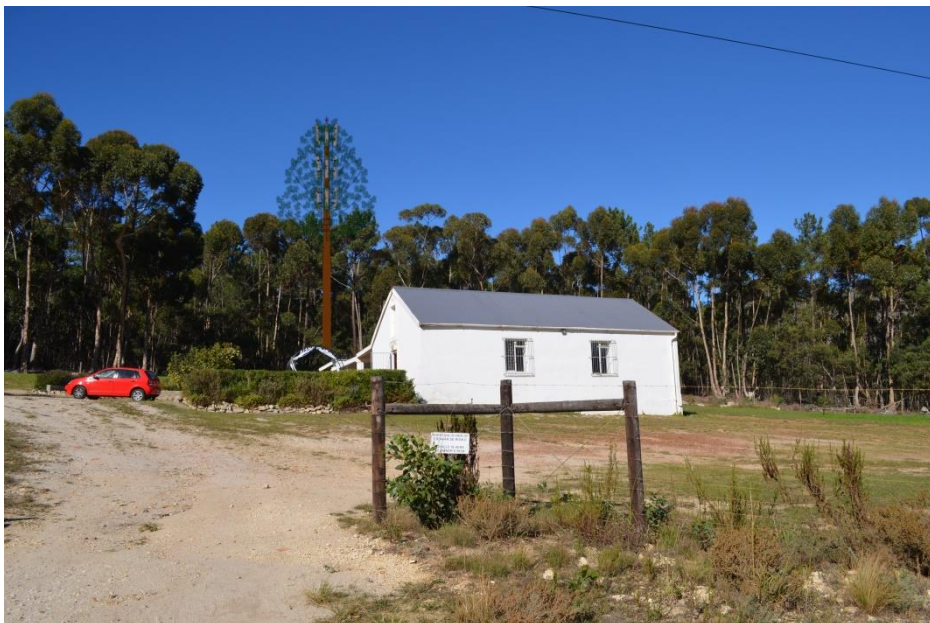
Photo 5: Entrance view

At the turn off the R320 the Ertjiessvlei hall is directly in front of the observer. The Spookfontein entrance fork off to the left and the visitor is directed away from the hall and the cell site. The mast would thus be in the observer's peripheral view when entering towards Spookfontein.
