Report to CK Rumboll & Partners on a Geotechnical Investigation carried out for the Louw's Bos North, RE/502, Cemetery Site, Stellenbosch, Western Cape

Project No.: 18-812R03

Date Issued: June 2019

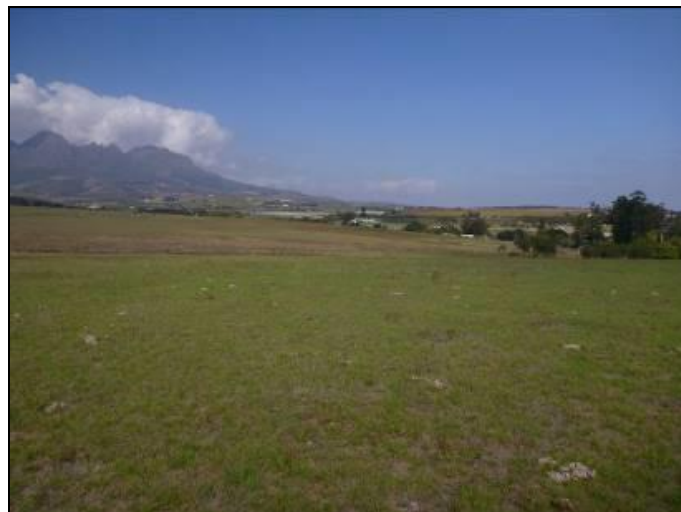
Plate 3: View towards the east from TP3. The brown area in the middle distance is the vlei

There is a small vlei area roughly in the centre of the site which was dry at the time of the investigation but which will become saturated in normal rainfall years. A small area in the extreme south east abuts onto the Bonterivier. If these areas are avoided the bulk of the proposed site will comply (Figure 4). The vlei area is depicted in Plate 3 below.

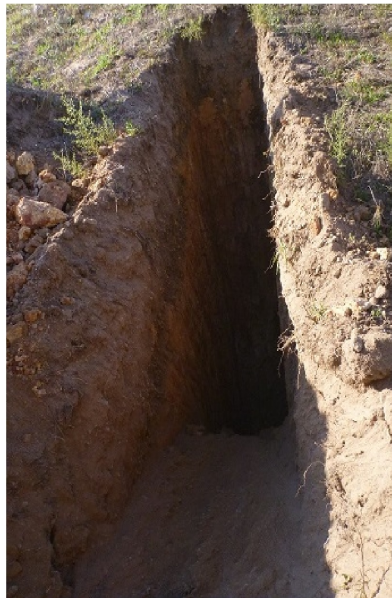
HOLE No: **TP1**

- 1) Final depth at 3.50m. TLB limit.
- 2) No groundwater seepage.
- 3) No sidewall collapse.
- 4) Samples taken :
S1 1.00--3.50m

Five trial pits, designated TP1 through TP5 were put down at the location as shown in Figure 2 at the site. Trial pits TP1, TP2, TP3, TP4 and TP5 were terminated in clay at a depth of 3.50m, 3.0m, 2.90m, 3.10m and 3.10m respectively, below existing ground level.

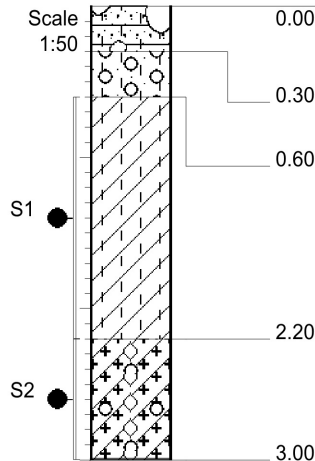
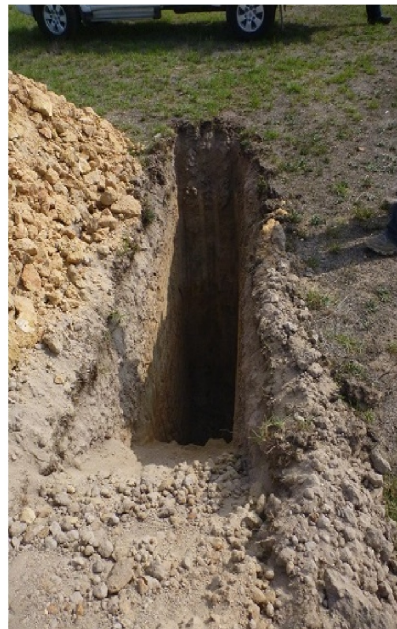
HOLE No: **TP2**

Dry light brown medium dense intact silty SAND with sandstone pebbles and cobbles. Colluvium.

Dry yellow brown dense intact sandy silty GRAVEL. Colluvium.

Slightly moist cream grey stiff to firm intact gravelly CLAY. Residual Granite?

- 1) Final depth at 3.00m. TLB limit.
- 2) No groundwater seepage.
- 3) No sidewall collapse.
- 4) Samples taken :
 S1 0.60--2.20m
 S2 2.20--3.00m

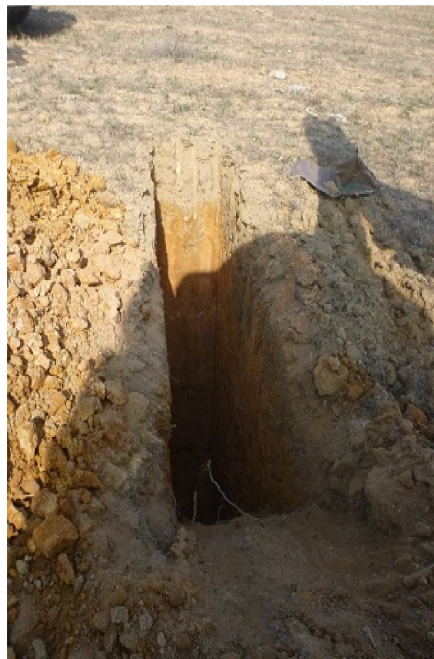
HOLE No: **TP3**

- 1) Final depth at 2.90m. TLB limit.
- 2) No groundwater seepage.
- 3) No sidewall collapse.
- 4) No samples taken.

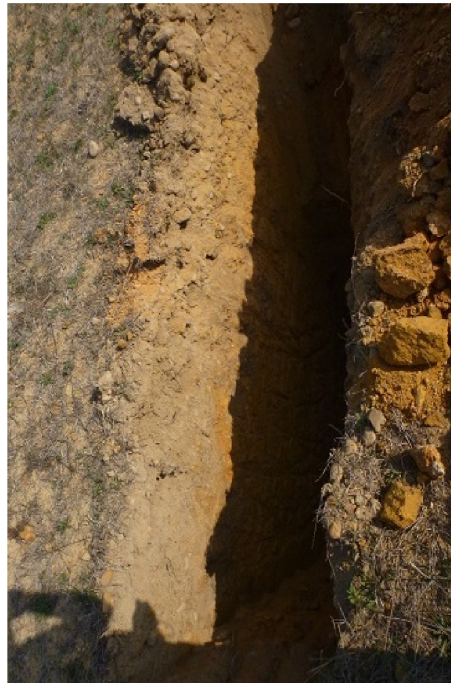
HOLE No: **TP4**

- 1) Final depth at 3.10m. TLB limit.
- 2) No groundwater seepage.
- 3) No sidewall collapse.
- 4) Samples taken :
 S1 0.00--0.50m
 S2 1.10--3.10m

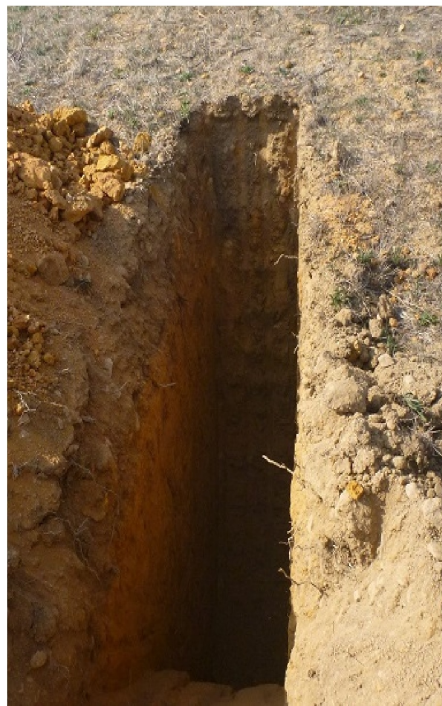
- 1) Final depth at 3.10m. TLB limit.
- 2) No groundwater seepage.
- 3) No sidewall collapse.
- 4) No samples taken.
