**Report on soil investigation of parts of  
Farm RE/502  
near Stellenbosch**

**Report by  
Johann Lanz**

**March 2019**

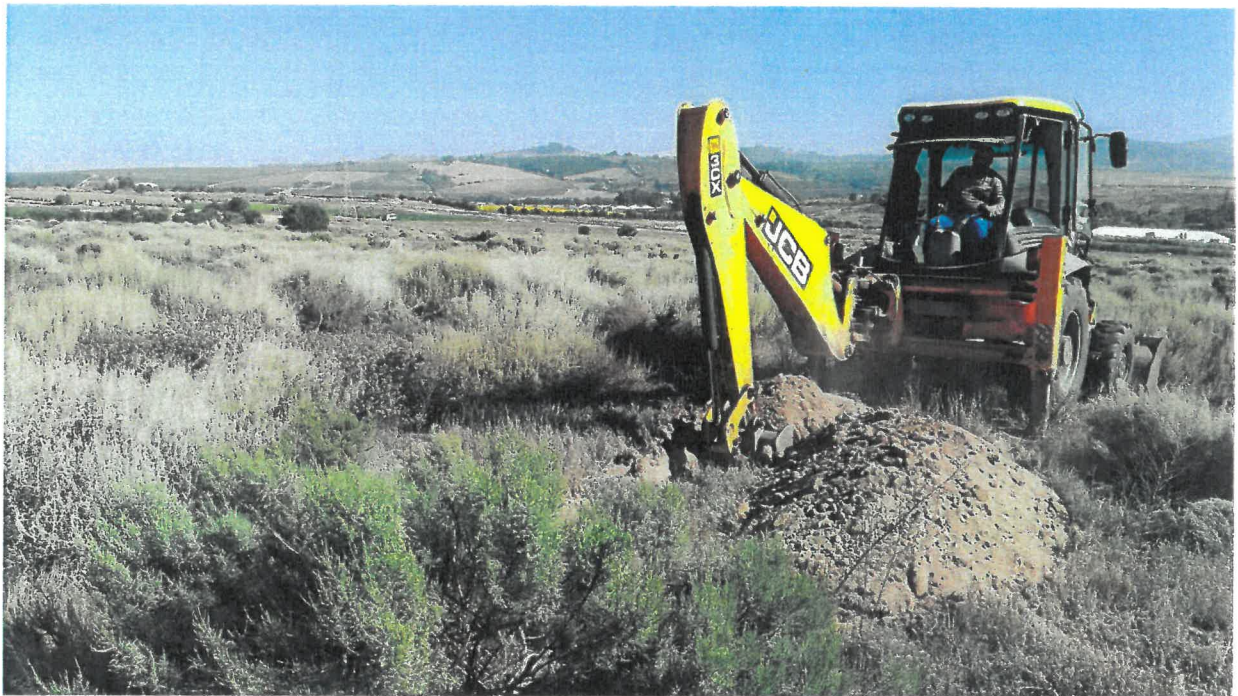
**Figure 2.** Site conditions looking down the focus area part of the site.

The site straddles a low hill with an elevation difference from bottom to top of approximately 60 metres. The focus area comprises most of the north facing slopes of the hill, which have a gradient of between 2 and 5% and an aspect that varies from north west to north east. The rest of the site comprises the top of the hill and the west and south west facing slopes on the other side of it. The west slope has a similar gradient to the north slope, but the south westerly slope is lower with an approximate average slope of 1%.

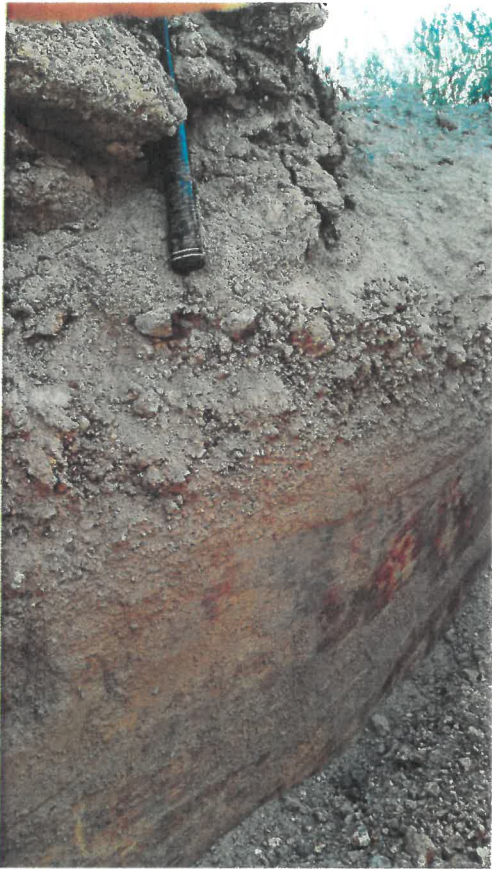
**Figure 4.** *Examples of typical shallow soil profiles from site, limited by the dense clay that occurs in the subsoil.*

The field soil investigation identified a fairly high degree of soil variation across the site, particularly in terms of soil depth. All soils are coarse, sandy (<5% clay) soils with high gravel content on underlying, dense clay. The depth to clay varies between 30 and >150cm. The underlying, less permeable clay causes all soils to have drainage limitations because infiltrating rain tends to build up above the clay layer and then drain laterally down slope. Periodic saturation therefore occurs above the clay during rainy periods. These soils have up to a moderate drainage limitation, which is defined as saturation occurring between 30 and 70 centimetres below surface for up to a cumulative of 30 days per year.

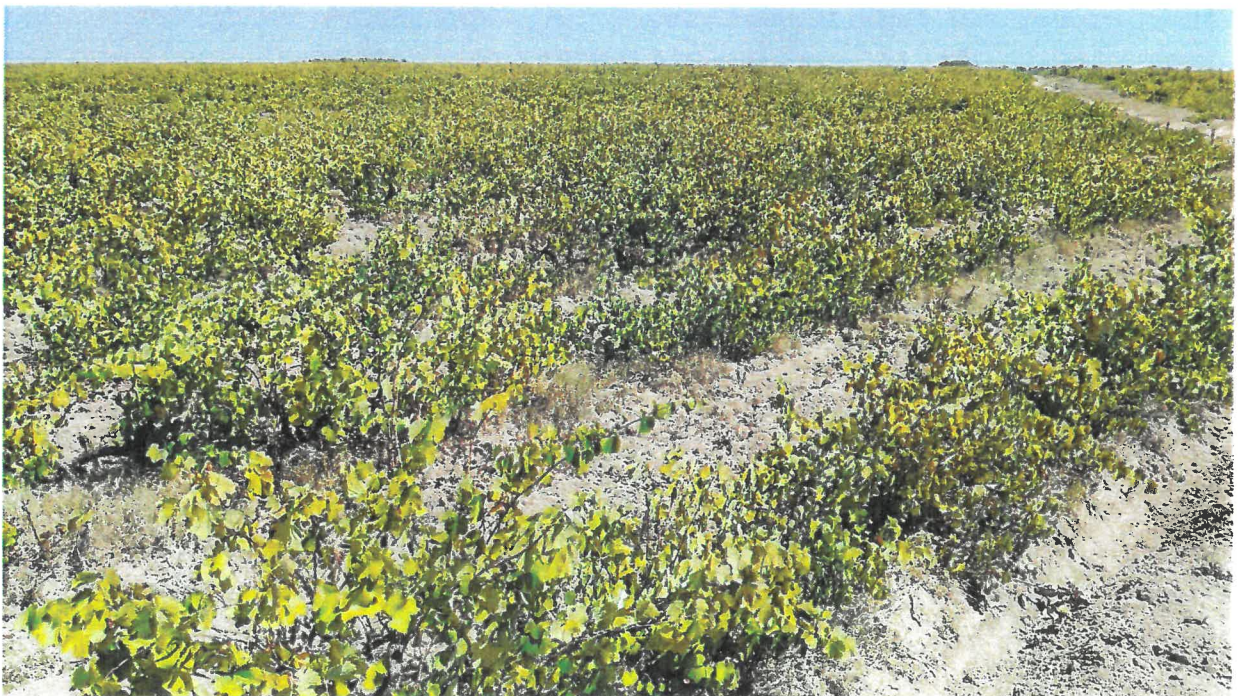
**Figure 5.** *Vineyards in fairly poor condition on the site.*

Only a strip along the north eastern boundary of the site contains 19.4 hectares of wine grapes and 6.3 hectares of dryland perennial pastures. The wine grapes are bush vines that are not currently under irrigation, although the vineyards appear to have had irrigation infrastructure in the past. The vineyards are not in particularly good condition (see figure 5).

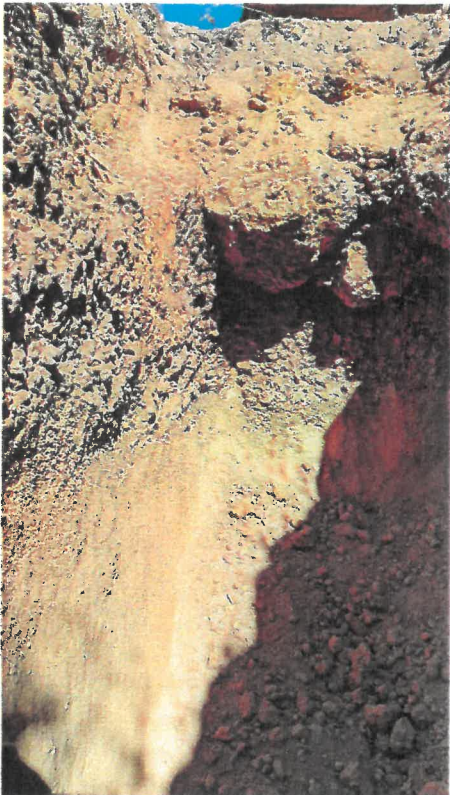
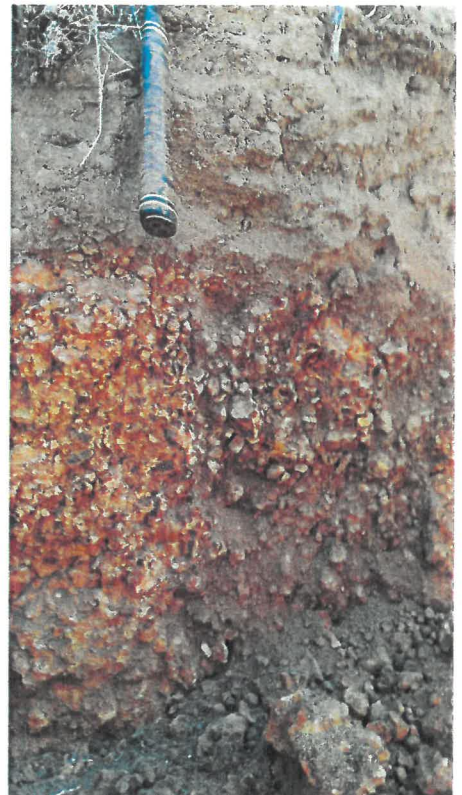
**Figure 7.** Examples of soil profiles from site, that contain a hardpan laterite horizon.

A hardpan laterite horizon occurs in patches across the site and is indicated by the presence of the following three soil forms: Dresden (Dr), Glencoe (Gc), and Wasbank Klappmuts (Km) is the dominant soil form across the site. Pinedene (Pn) and Vilafontes (Vf) forms occur in better drained positions.
