BOTANICAL STATEMENT

SWARTFONTEIN DAM

Proposed enlargement of an existing dam on the Remainder of the Farm Zwartfontein No. 792 (Malmesbury), Swartland Local Municipality, Western Cape Province.

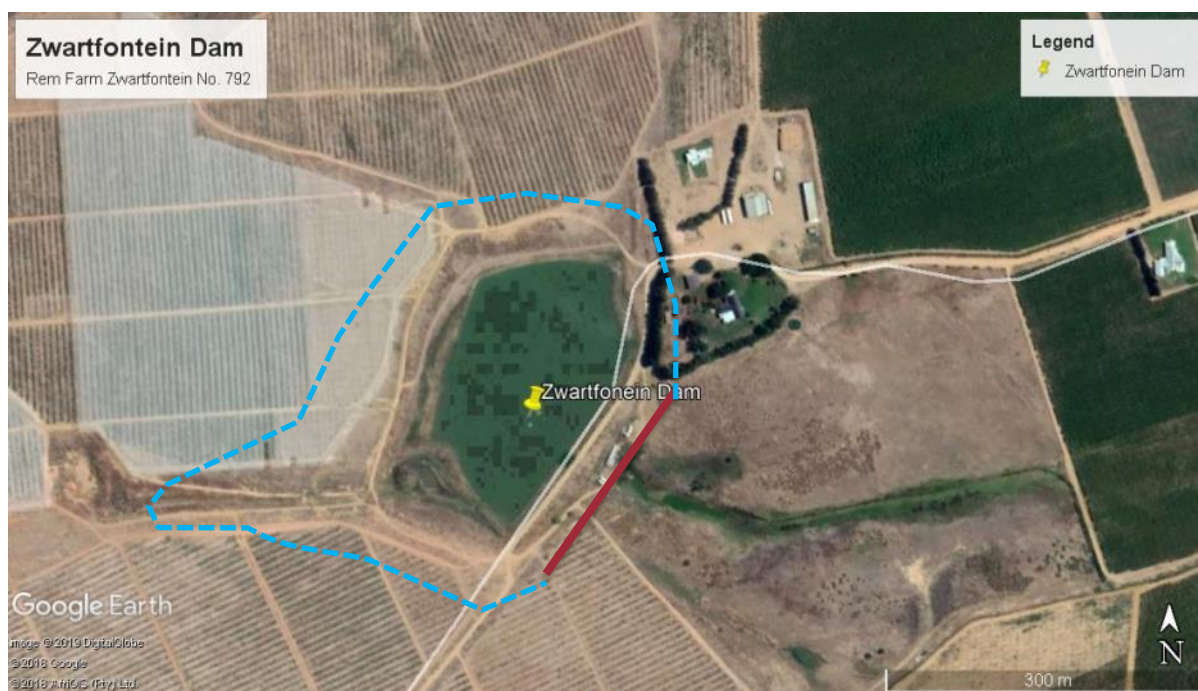
Figure 3: The Zwartfontein Dam, showing the dam wall location (Red) and the area that may be affected (blue dotted line)

Figure 3 shows the existing dam and illustrates the approximate footprint enlargement. It also shows the areas that will be impacted by the proposed footprint.

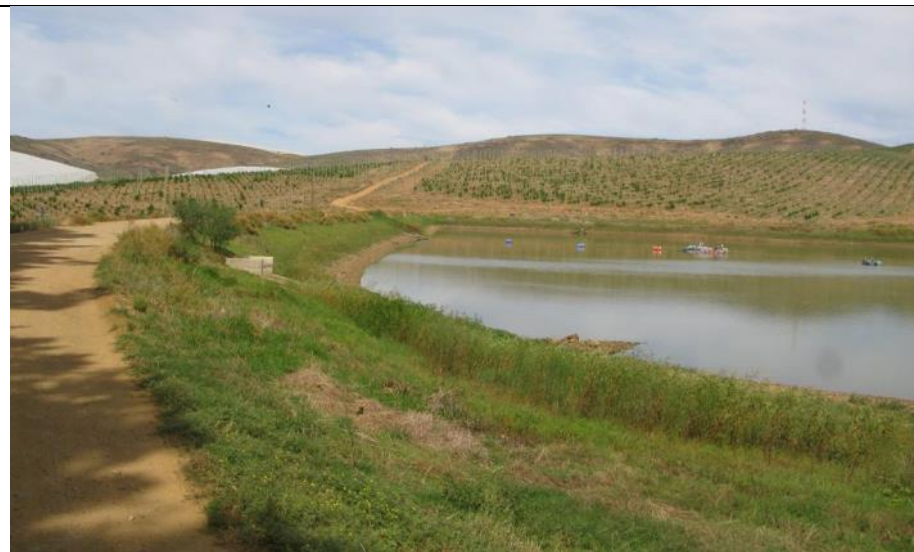
Photo 1:

Looking over the existing dam wall from east to west. Note the degraded vegetation along the dam slopes.

He site visit confirmed that the small edge of vegetation that can still be observed next to the dam is in fact degraded veld, which only now only supports hardy weeds and shrubs and perennial grasses finding some shelter and water within the excavated edge of the original dam. In fact, apart from a small section at the back of the dam (Photo 2), most of this area was most likely part of the originally excavated area that would have been left stripped of topsoil and any remaining indigenous vegetation (Refer to Photo 1).

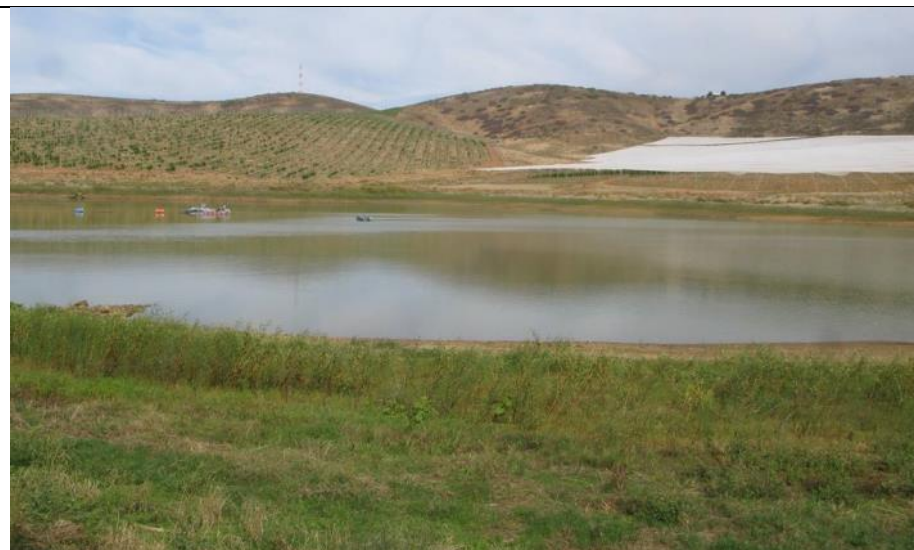
Photo 2

Looking over the middle of the dam from east to west. Again the degraded weedy vegetation should be noted along the dam wall. It is expected that in these areas all the topsoil was removed when the original dam was build.

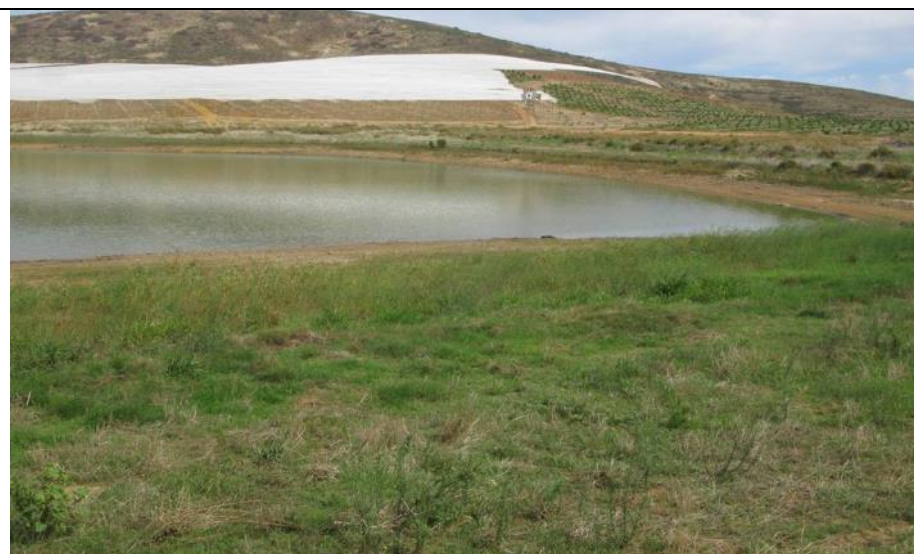
Photo 3

Looking at the bottom part of the dam (from southeast to northwest over the dam. Note the slightly better vegetated area to the back of the dam (Refer Photo 4).

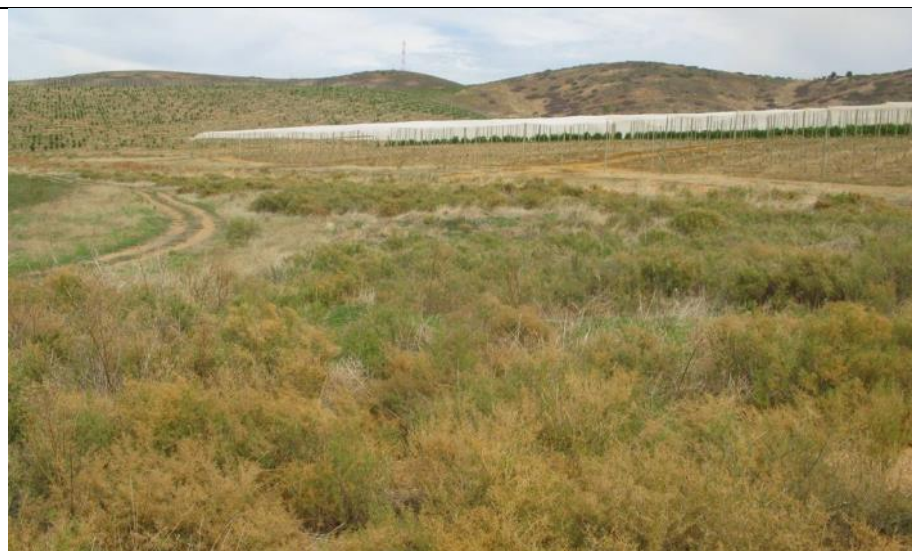
**Photo 4**

Looking from east to west over the bottom part of the dam, again showing the slightly better vegetated area. This area was basically dominated by *Galenia africana* and *Salsola kali*, other shrubs like *Stoebe* and *Eriocephalus* scattered in between.

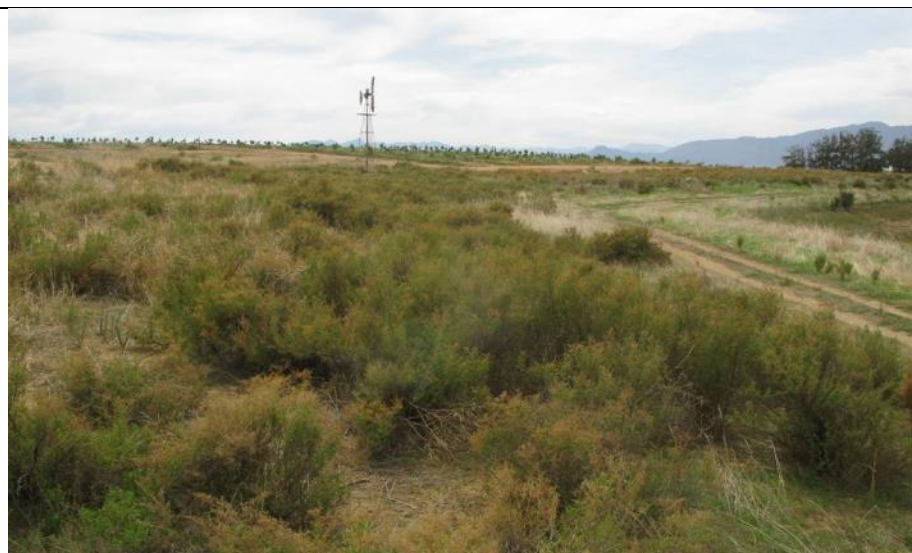
**Photo 5**

Looking from west to east over the bottom part of the dam. Again showing the *Galenia* dominated disturbed veld.

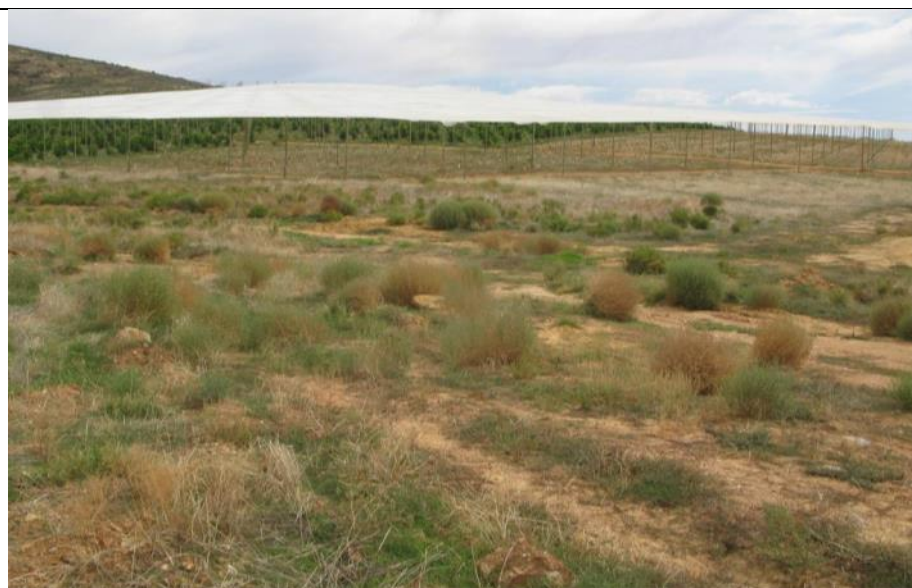
**Photo 6**

Showing the *Salsola kali* dominated remaining veld to the west of the dam. Again it is clear that this area were subject to heavy disturbance in the past. It is almost certain that all topsoil were removed in this area during the construction of the original dam.

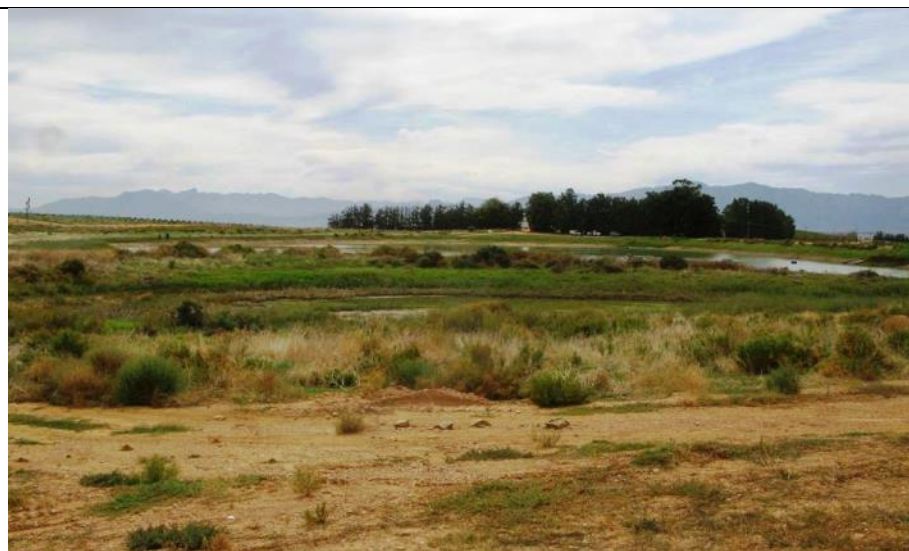
**Photo 7**

The south western corner of the dam where the CBA and ESA has been identified. Again the vegetation can only be described as transformed, with only hardy weedy and alien invasive species remaining.

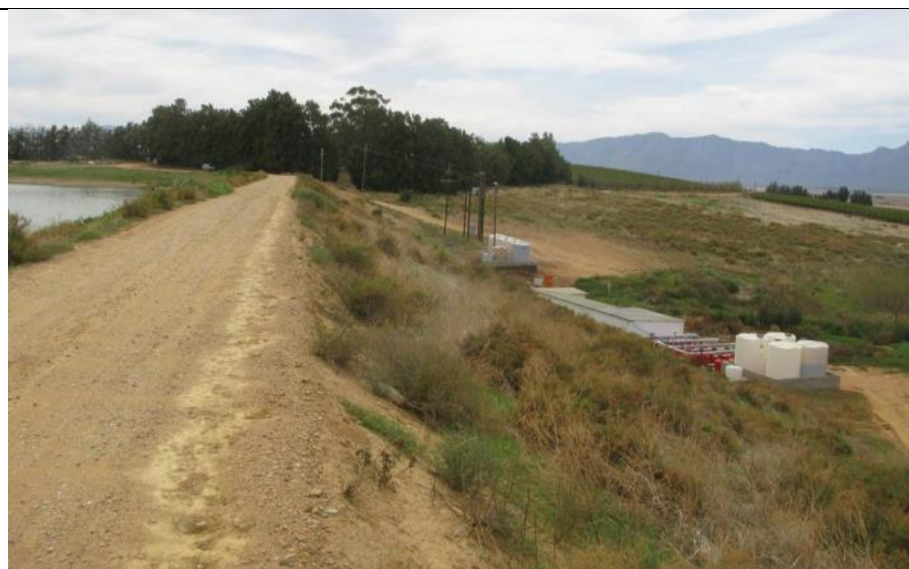
**Photo 8**

A view over the dam wall looking from west to east.
