Fresh Water Report
Proposed enlargement of the dam
Farm Zwartfontein 792, Malmesbury

A requirement in terms of the National Water Act (36 of 1998).

April 2019

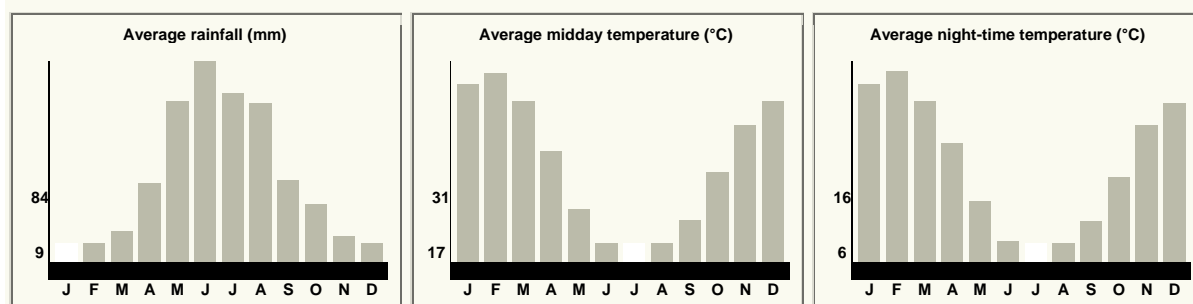
Figure 2 Hermon Climate

Hermon normally receives about 471mm of rain per year and because it receives most of its rainfall during winter it has a Mediterranean climate. The chart below (Figure 2, lower left) shows the average rainfall values for Hermon per month. It receives the lowest rainfall (9mm) in January and the highest (84mm) in June. The monthly distribution of average daily maximum temperatures (centre chart below) shows that the average midday temperatures for Hermon range from 17.3°C in July to 30.2°C in February. The region is the coldest during July when the mercury drops to 6°C on average during the night. Consult the chart below (lower right) for an indication of the monthly variation of average minimum daily temperatures.

The rainfall is too little to sustain the Zwartfontein fruit farming venture. The farming industry heavily depends on the Berg River's water for irrigation. Because of the absence of rain during mid-summer when water is most needed, water is taken from the river during the rainy winter months and then stored in dams for irrigation later on when it becomes really dry later on in summer.

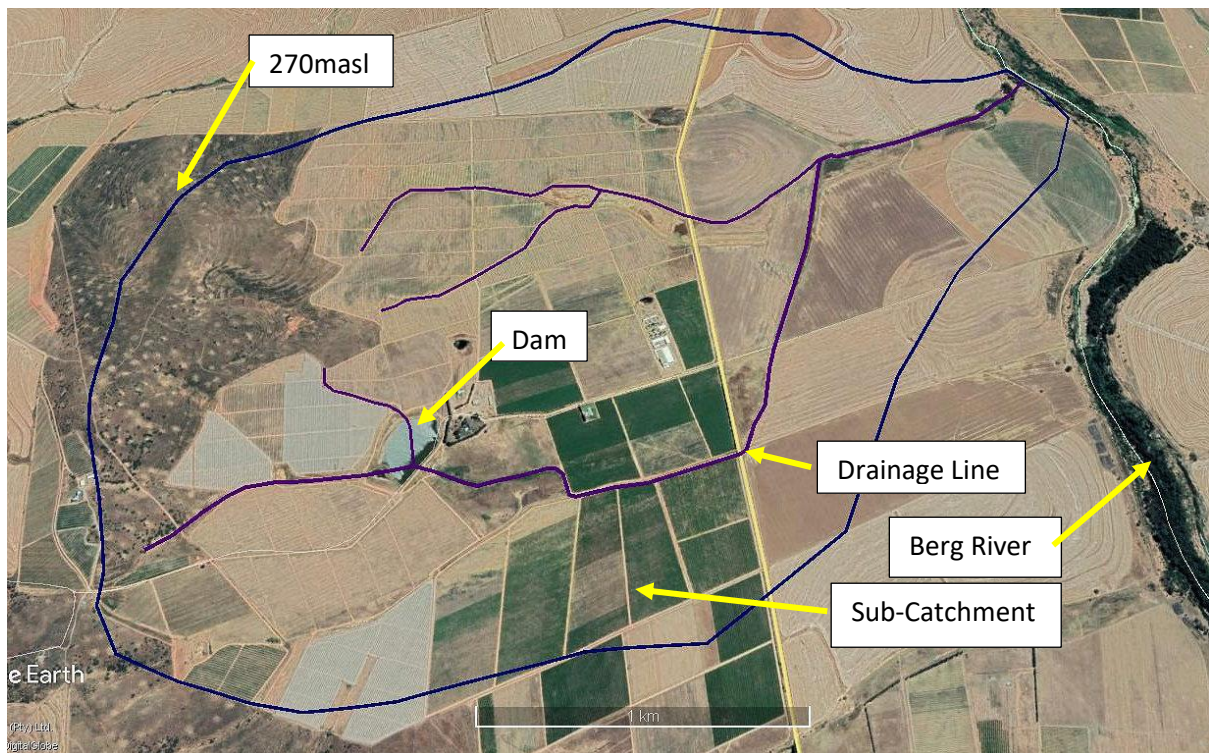
Figure 3 Sub-Catchment

The sub-catchment in which the dam is located is one of many along the Berg River in among the vineyards and the wheat fields (Figure 3). It is only 3.8km long and 2.3 km wide. It covers a surface area of 663 hectares. Only 130ha are above the farm dam to form the catchment area of the dam up the hill.

The highest point of the catchment is 270masl, up on a hill (Figure 3). The lowest point is at its point of discharge in the Berg River at 73masl. The slope is rather steep at 5.2m vertical in every 100 horizontal metres. This steep slope gives rise to fast moving water during high rainfall events and a high erosion potential.

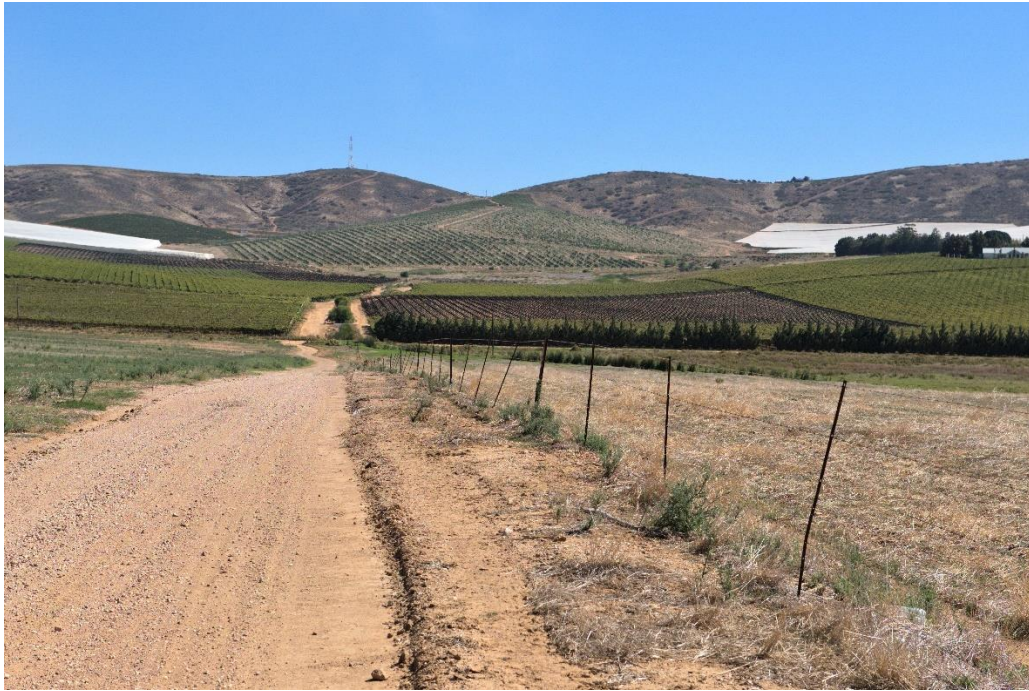
Figure 4 Hills above the dam

It rises on the hill above the sub-catchment (Figure 4). The drainage line upstream of the dam takes the shape of wide valleys with no discernible drainage line and with the same vegetation as elsewhere on the hill. The drainage line downstream of the dam (Figure 5) has been engineered into a straight agricultural return flow furrow all the way down to its confluence with the Berg River.

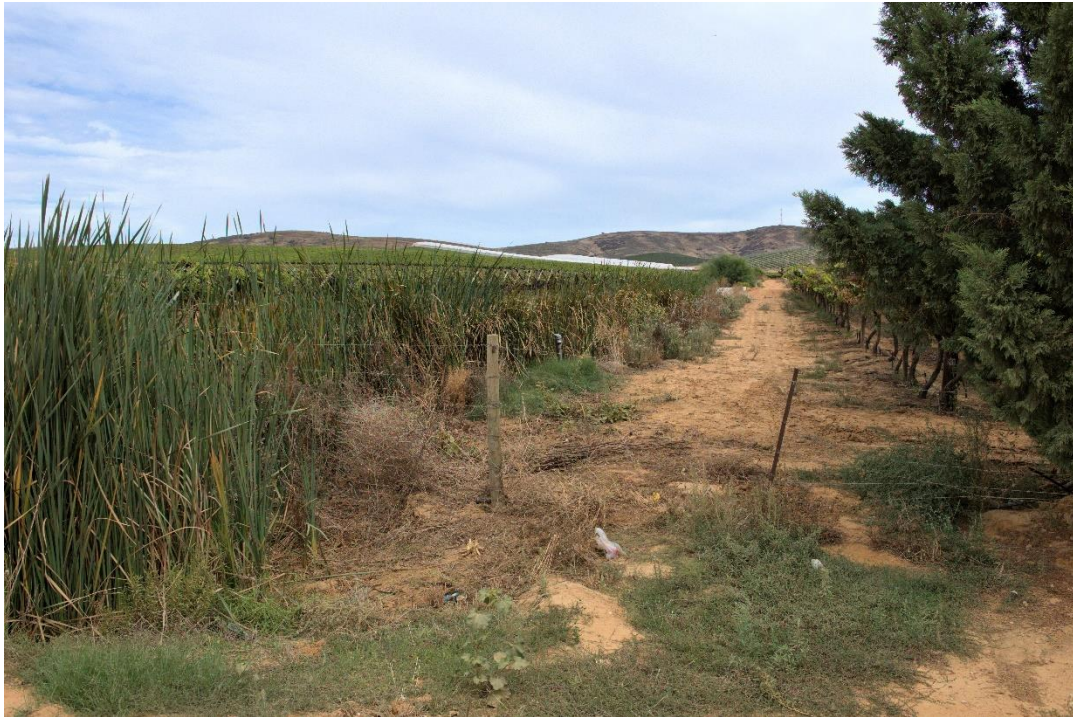
Figure 6 Drainage line in the vineyards

A second reach of the drainage line (Figure 6), now a straight canal, passes through the vineyards and a third diagonally across a large wheat field (Figure 7) and into the Berg River. The entire canal was overgrown with reeds, which were thick among the vineyards and sparse over the wheat field.

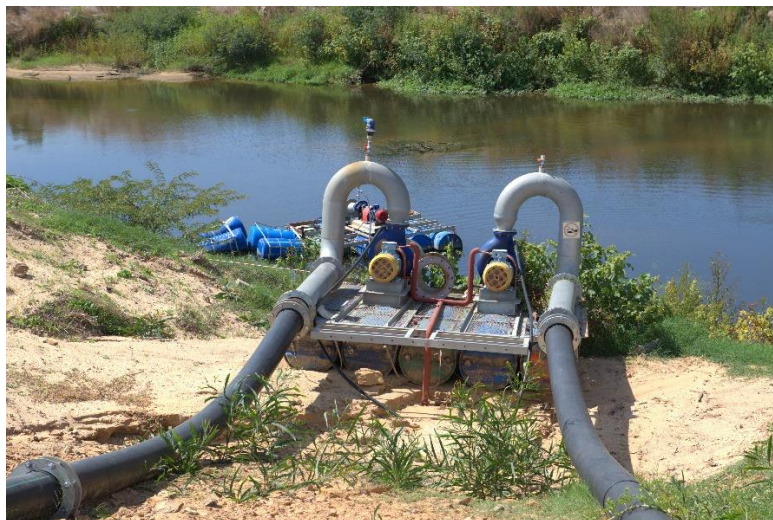
Figure 8 Pump

The sampling site was chosen where the pump (Figure 8) was located in the Berg River to abstract water for the farming operation.

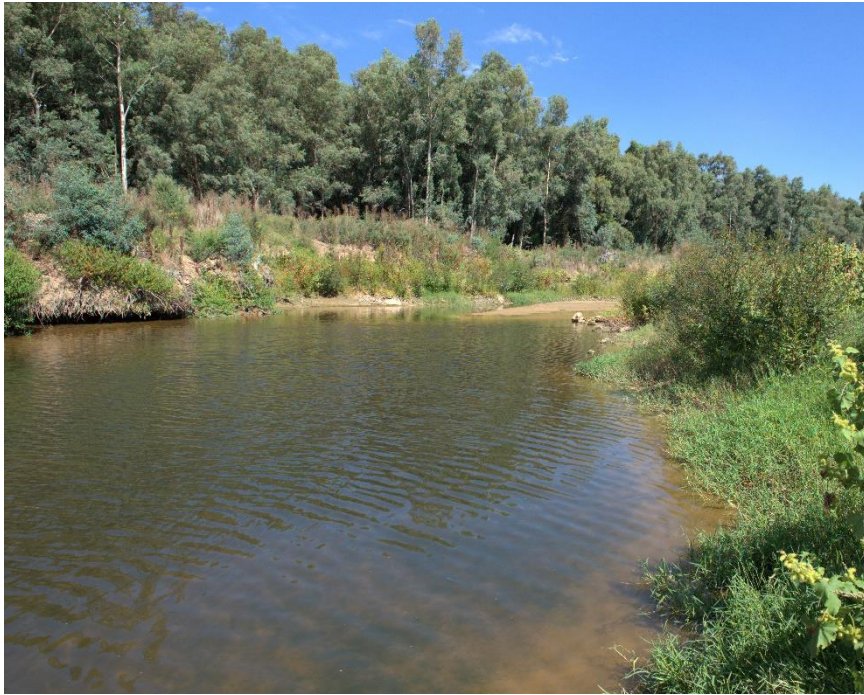
Figure 9 Upstream end of the pool

The river here was shallow, less than a metre deep, some 15m wide, slow moving, pool-like. The river was narrow upstream from the pool, perhaps a metre wide and the water was moving fast, more than 1ms^{-1} (Figure 9).

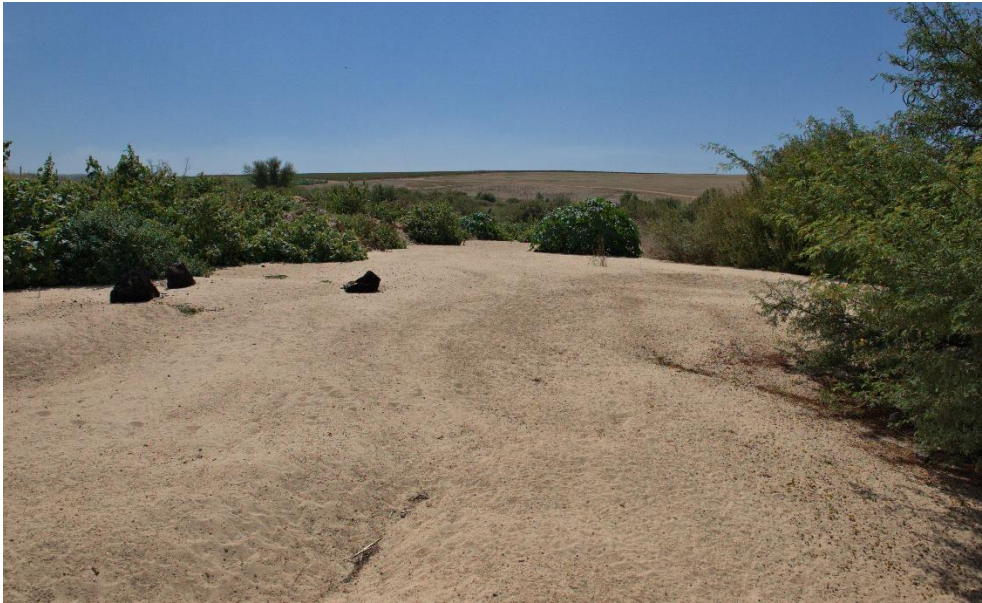
Figure 10 Sand deposits

The river was incised, with steep banks, with the Karoo shale base exposed in places. During floods sand is deposited high up the banks. The banks are erodible, but then mobilised sediments are deposited all along (Figure 10). The riparian zone seemed most dynamic, with material eroded and deposited as floods pass through during the winter rainy season. Erodibility is enhanced by agricultural practices close to the river banks.

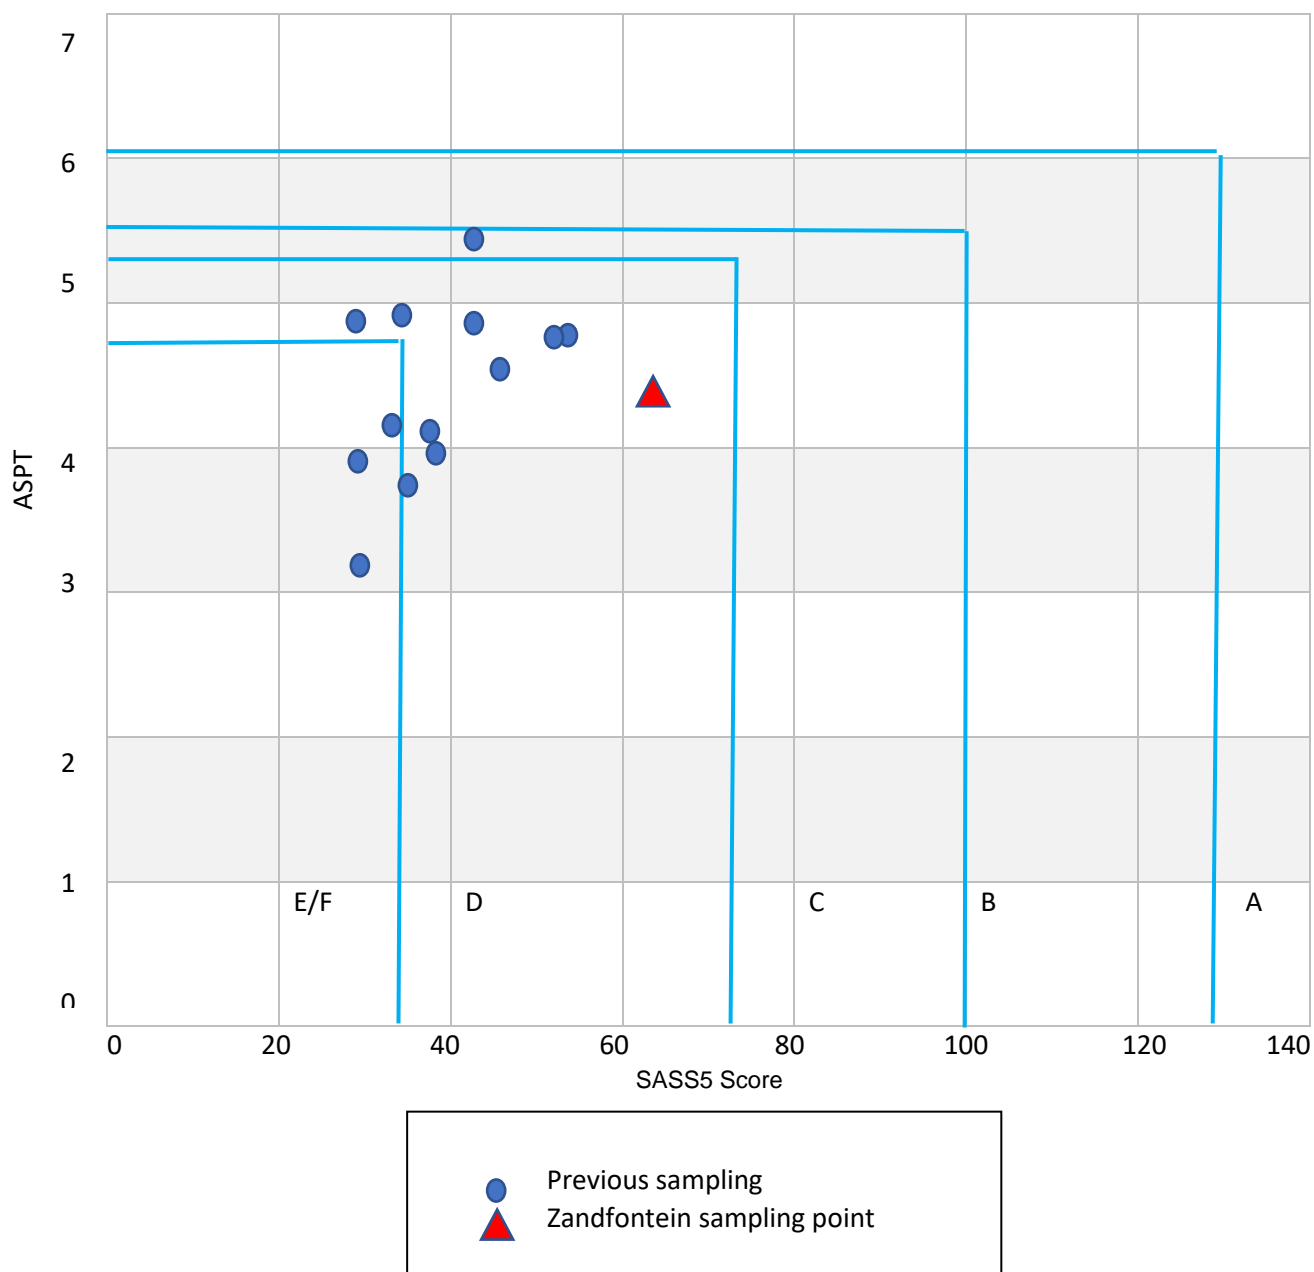
Figure 11 Biomonitoring

The SASS5 score (see SASS5 score sheet in the Appendix) at 65 was rather high for a mature river on a coastal plain, with a high number of taxa. However, the aquatic invertebrates were of the low-scoring type, with the result that the ASPT amounted to only 4.3. The score represented a class D (Figure 11), which signifies a “Fair” state-of-the-river.

Integrity Class	Description
A	Pristine; not impacted
B	Very Good; slightly impacted
C	Good; measurably impacted with most ecological functioning intact
D	Fair; impacted with some loss of ecological functioning
E	Poor; loss of most ecological function
F	Very Poor; loss of all ecological function

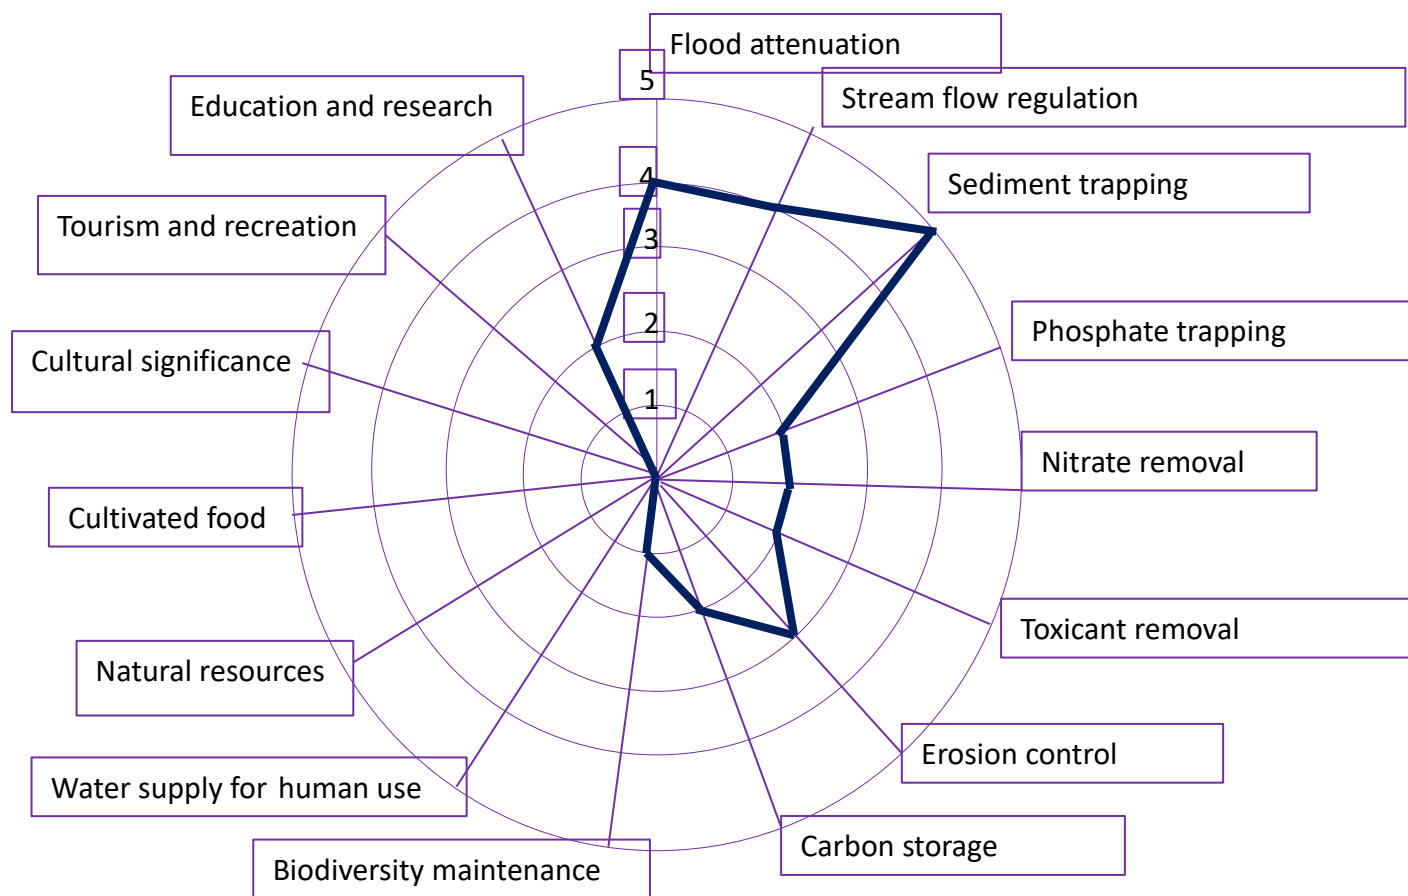
Figure 12. Resource Economics Footprint of the Drainage Line

Goods & Services	Score
Flood attenuation	4
Stream flow regulation	4
Sediment trapping	5
Phosphate trapping	2
Nitrate removal	2
Toxicant removal	2
Erosion control	3
Carbon storage	2
Biodiversity maintenance	1
Water supply for human use	0
Natural resources	0
Cultivated food	0
Cultural significance	0
Tourism and recreation	0
Education and research	2

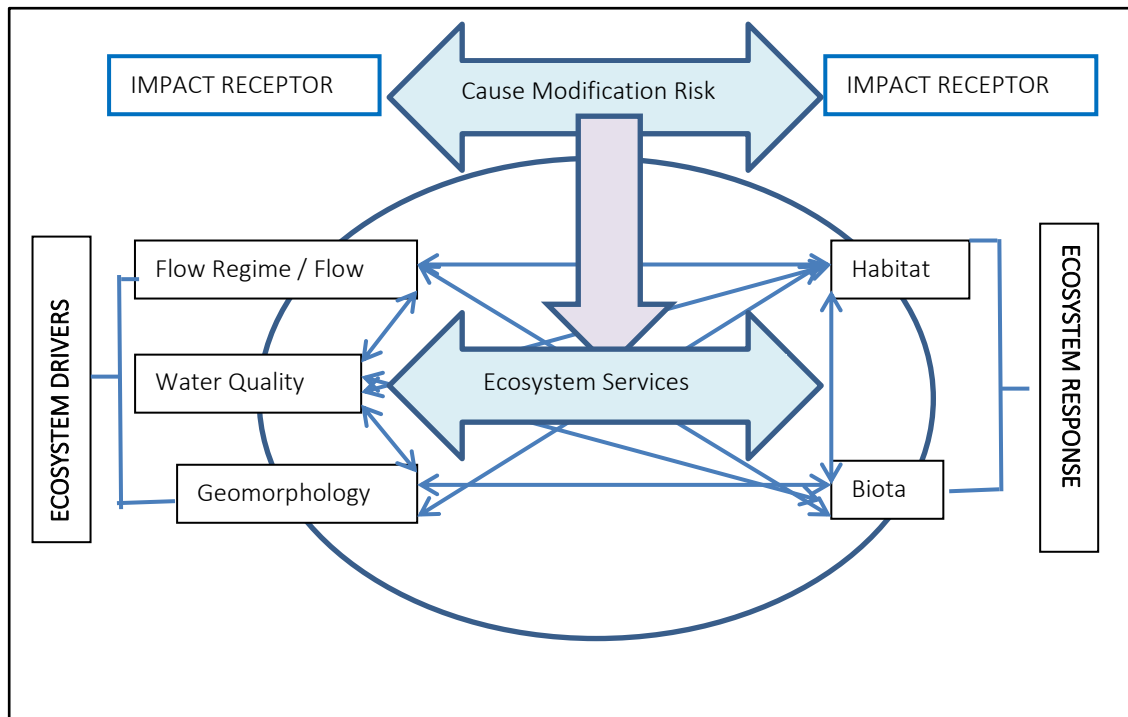
Figure 13 Minimum Requirements for a S21(c) and (i) Application

Figure 13 has been adapted from one of the most recent DWS policy documents.

The driver of the Zwartfontein drainage line is the seepage from the dam, that will predictably be more when the dam wall height is increased, as well as the runoff and return flow from agricultural areas. This results in a prolific growth of reeds, *Typha* in the drainage line and *Phragmites* below the dam wall.
