WATER USE LICENCE APPLICATION
Portion 18 Farm 387 Gordonia
Fresh Water Report

In terms of the National Water Act (36 of 1998)

September 2019

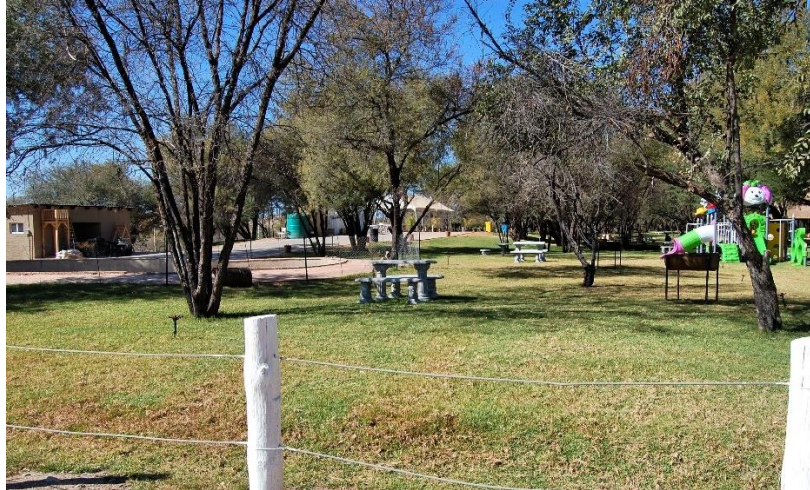
Figure 7 Camping site

The camping site (Figure 7) is detached from the river bank by a channel (Figure 8). This channel previously was a part of the braided Orange River, but is now dry. It is likely to flood during high flows and peak flows, to cut the camping site off from the bank. There is no bridge to the camping site. The channel has been transformed into a road, complete with street lights.

The camping site has hard structures such as an ablution block, swimming pool and restaurant.

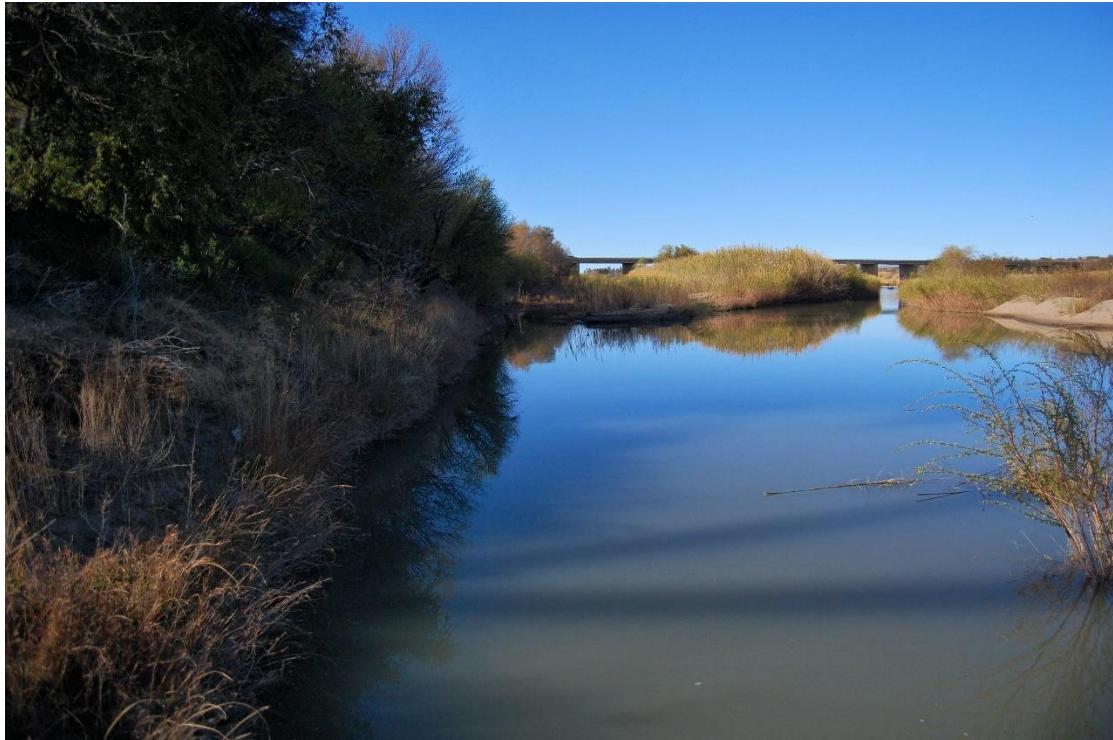
Figure 11 Steep river bank below camping site

The Groblershoop resort is from 7 to 12 meters above the base flow level of the Orange River (Figure 11). It is evident that the resort is not prone to the occasional floods. However, the camping area will predictably be cut off from the banks in event of a flood and will be under water during a major flood.

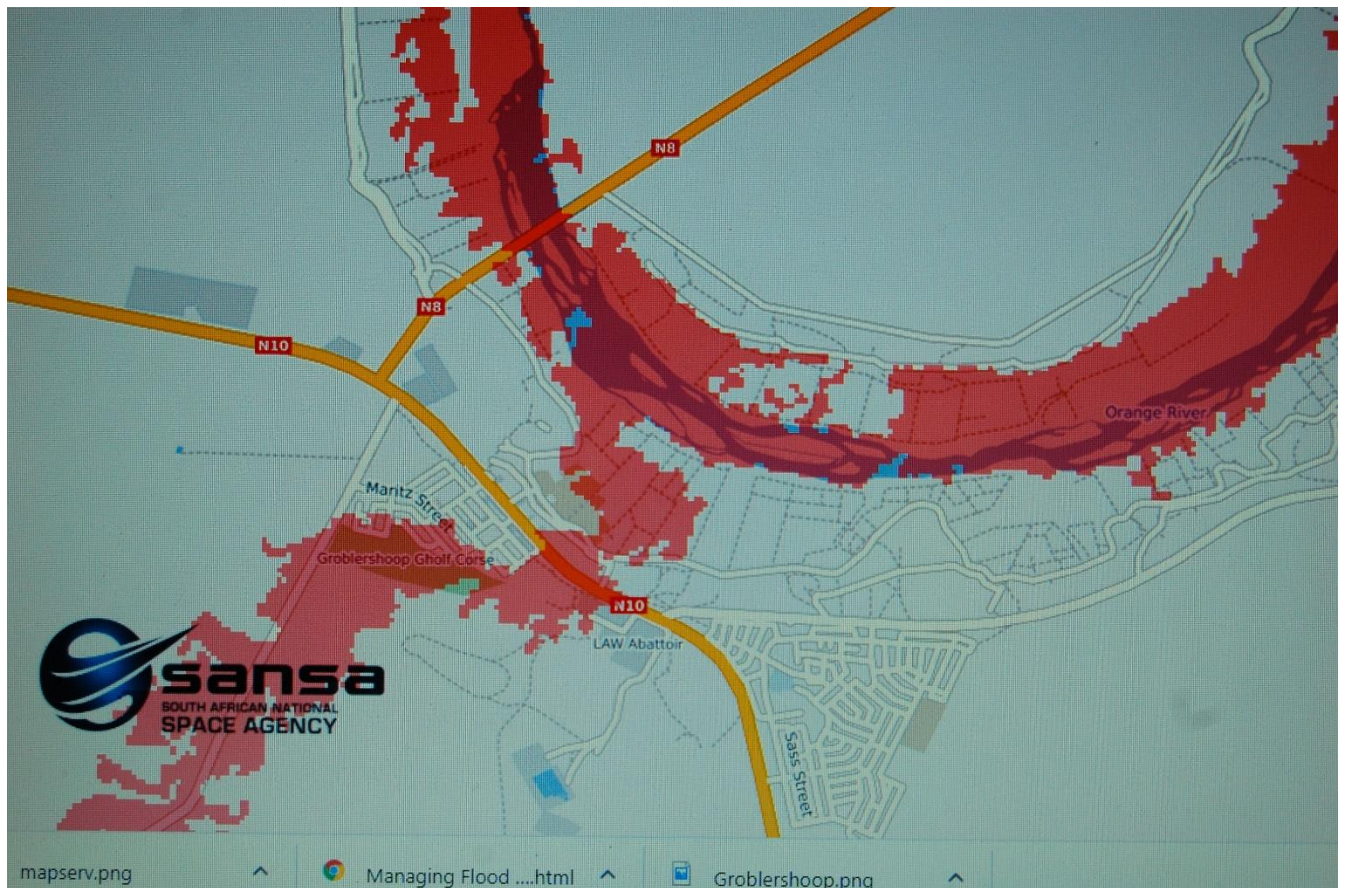
Figure 12 Flood prone areas

South African National Space Agency (SANSAT) of the national Department of Science & Technology mapped flood prone areas in South Africa (Figure 12). According to this map the Groblershoop resort is not prone to floods. However, the camping area is indicated as a part of the flood path of the river.

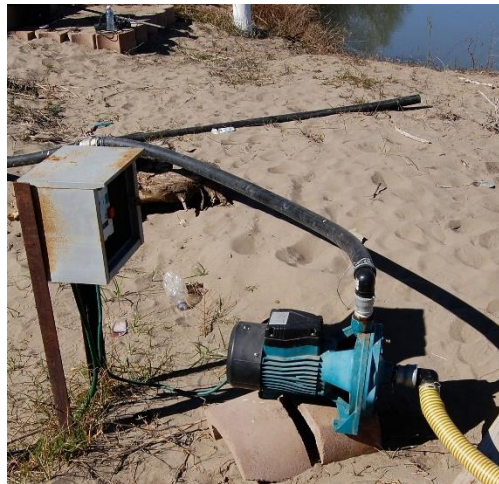
Figure 13 Water pump

Water for irrigation of the grounds is taken from the Orange River. Reportedly, this is an existing legal water use. There is a small electric pump on the river's bank (Figure 13).

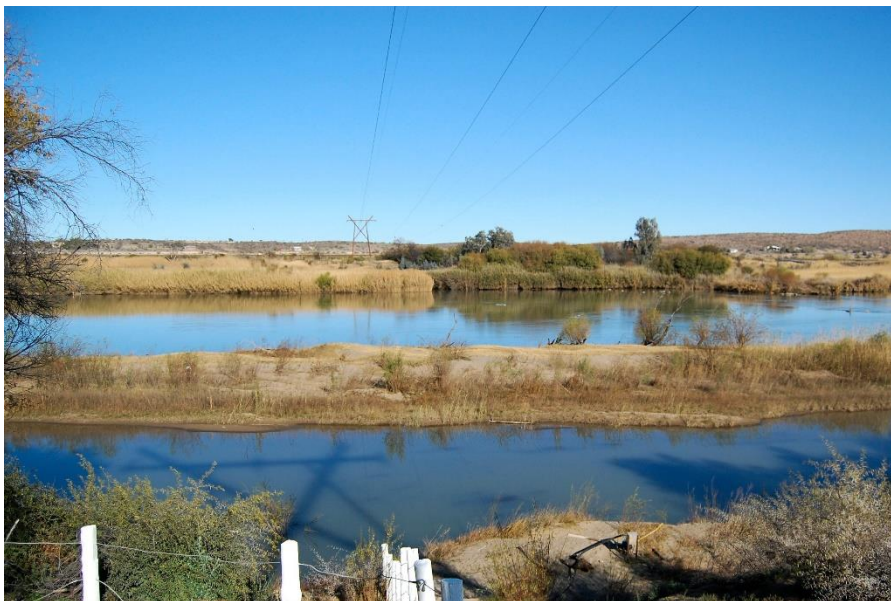
Figure 14 Sampling Point

The sampling point (Figure 14) was selected underneath the Eskom power line because it was readily accessible. It was separated from the main stream by an island, as is often the case in these braided rivers.

The habitat at the sampling point consisted of a sandy bottom right next to the river's edge, with little else to add to variability. There was emerging vegetation such as *Phragmites* reeds. Submerged vegetation was represented by recently flooded terrestrial grasses.

The current was some 20cms⁻¹, but much faster in the middle of the river.
