VENTURA ENERGY (PTY) LTD

Fresh Water Report Proposed Visserspan Solar Plant Project 4

A requirement in terms of National Environmental Management Act

January 2020

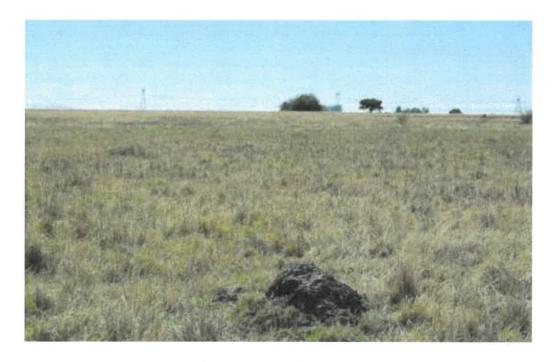
Figure 4 Central Pan

The central pan seemed to be a mixed grass pan (Figure 4), on the day of the site visit on 27 November 2019. There was no distinct margin, the floor was thickly overgrown with a variety of grasses, there was no barren patch of pan floor and was without any sedges or scrub.

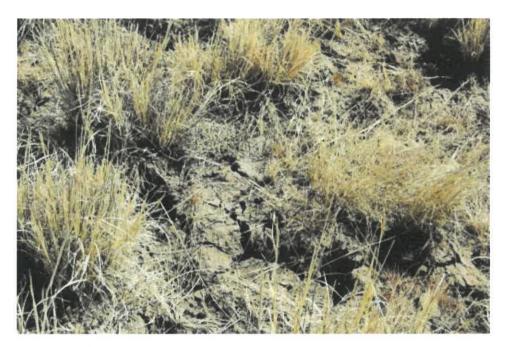
Figure 7 Dry clayey soil with cracks

A dolerite intrusion intersects the central pan, with only a couple of dolerite boulders and stones (Figure 6) on the ground's surface. Dolerite weathers into several fractions, the one being a Montmorillonite swelling clay. The central pan consists of this swelling clay (Figure 7), with obvious cracks because of the prolonged current drought.

The presence of this swelling clay is the reason for the existence of a mixed grass pan, without a barren patch, as the clay is too cohesive and heavy to be blown away by the Free State's stormy winds. The central pan developed into a consistent marshy area and not into a bare pan, as is evident in many places all over the western Free State.

It was obvious that soils were saturated the previous season, judging from the cracks in the clayey soils (Figure 9). These were obviously hydromorphic soils, verifying its wetland status.
