**VISSERSPAN PV FACILITY
PROJECT 2
FARM 40, DEALESVILLE, FREE STATE**

VISUAL ASSESSMENT

Final Report

Sarien Lategan was appointed to undertake the visual impact assessment for the Visserspan PV Facility, Project 2, near Dealesville, Free State.

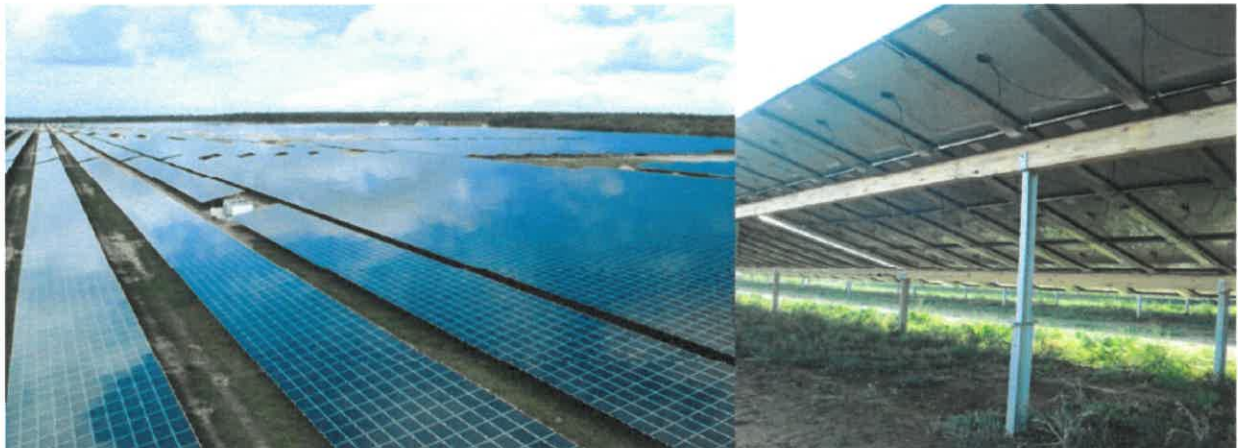
Figure 3: Typical single axis PV arrays

The development will consist of solar panels mounted on steel supporting array structures and are configured into a number of sub array systems. The units will be able to tilt up and down but not rotate with the sun. The units will thus always be positioned in a northerly direction.

Site needs some leveling. Expected height 2,4m but maximum height for any structures assumed at 3m above ground. Arrays orientated east-west with horizontal movement north-south

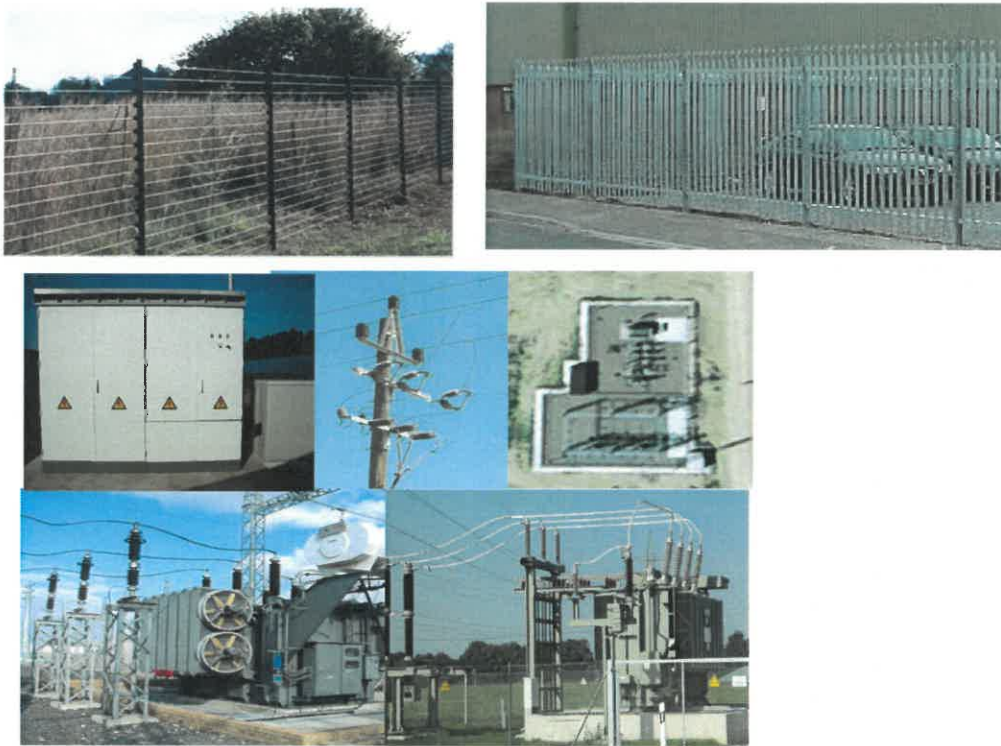
Figure 3: Typical support infrastructure i.e. power lines, substation & switches, fences

Site circumscribed with fire access road and fence. Probably consisting of electrified, galvanized palisade fence of 2,4m in height.

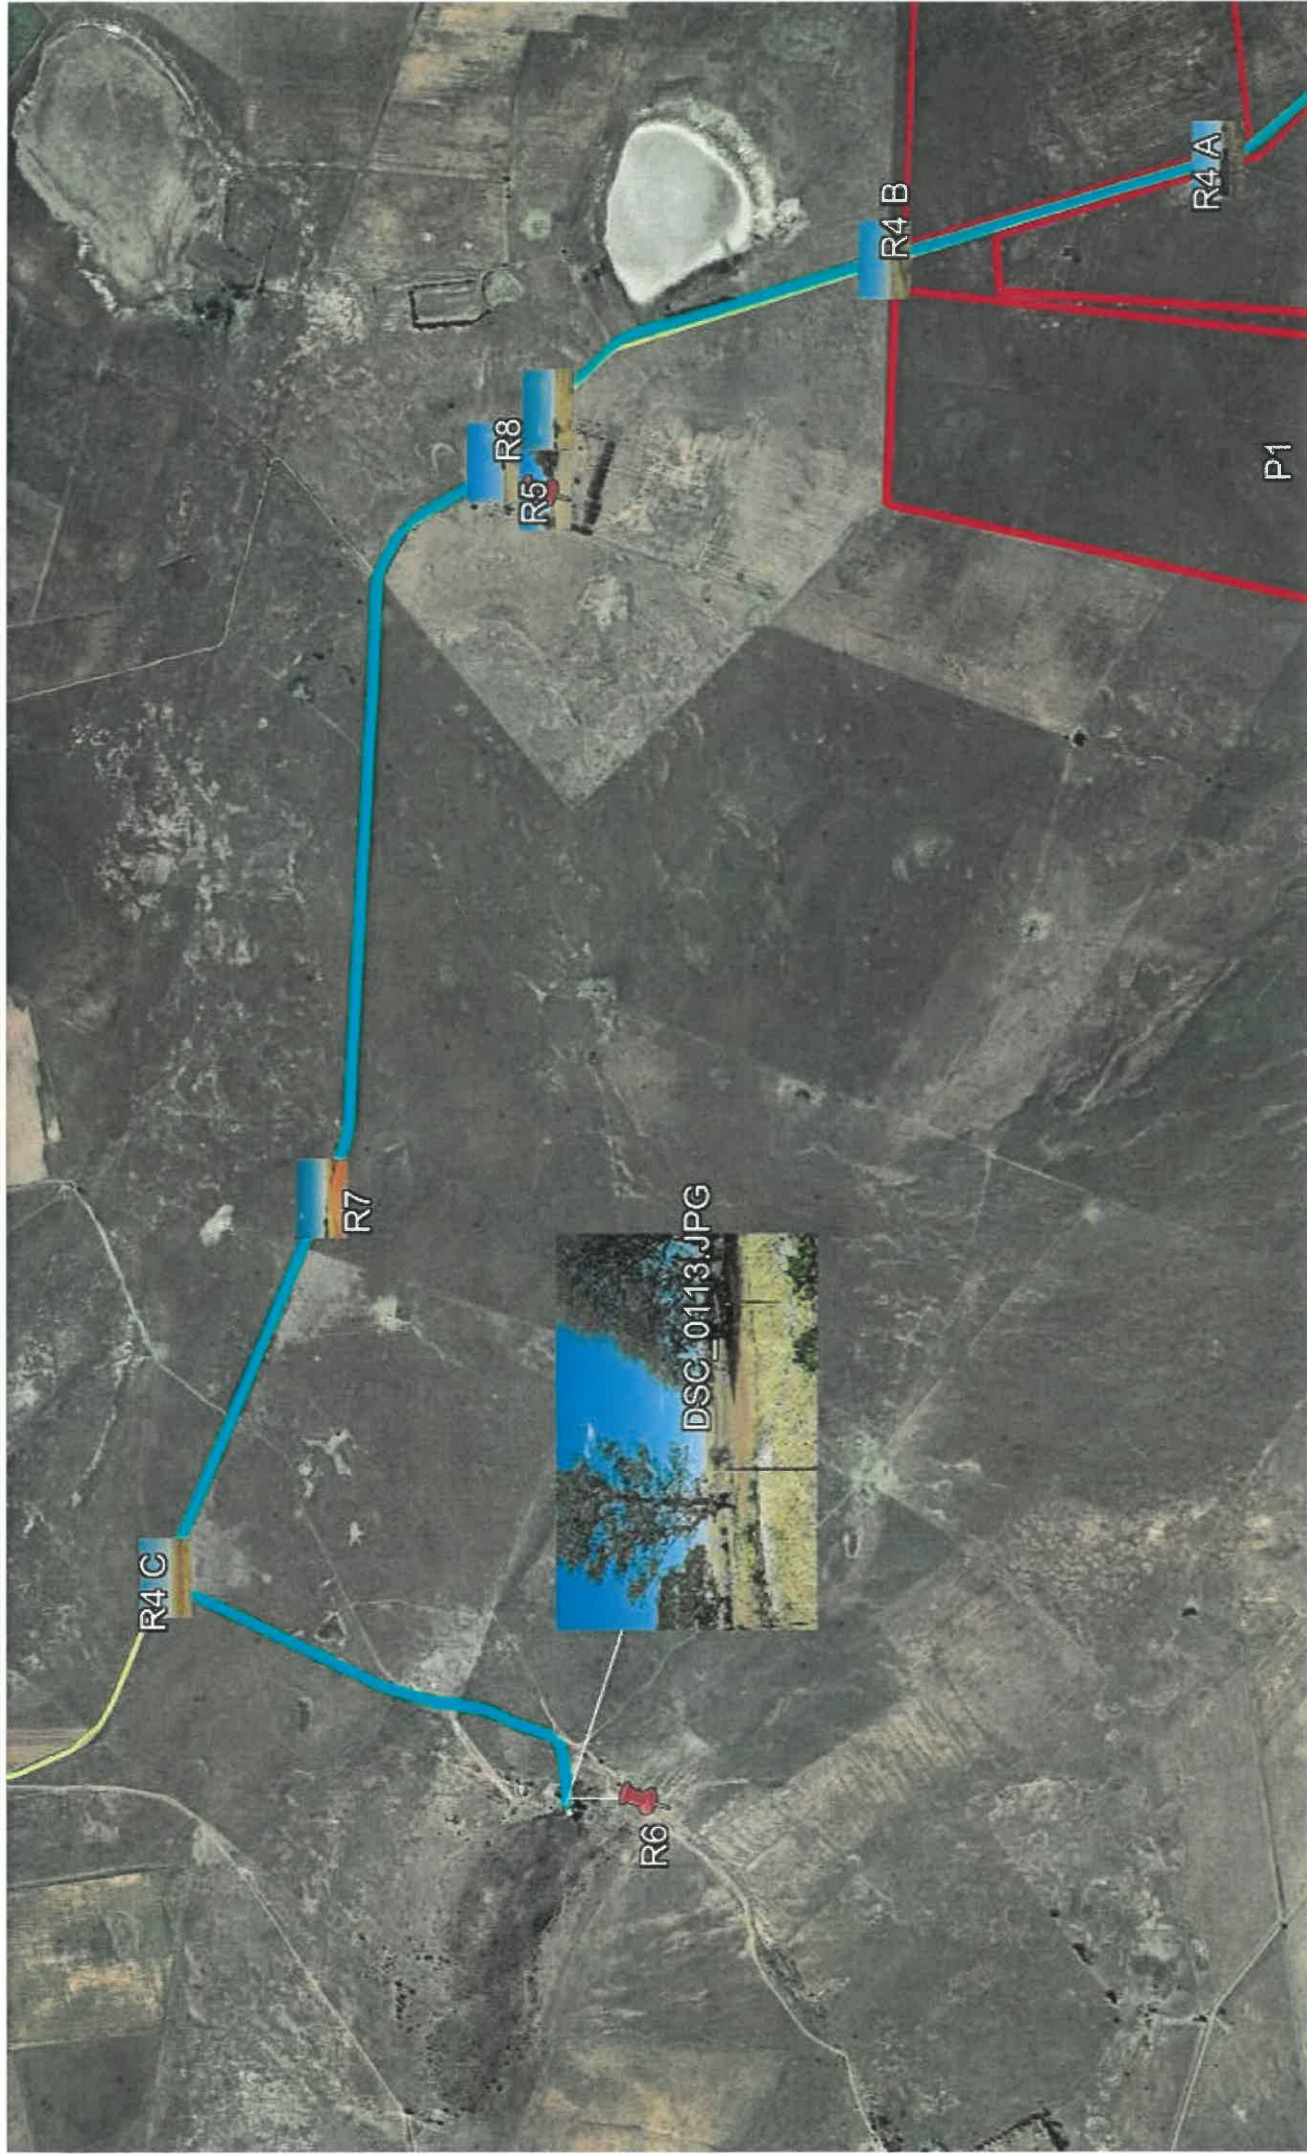
R5 Rooidam Homestead

P1 arrays will be behind trees

The Rooirand Homestead is situated adjacent the site. The homestead is however in a degraded state and only occupied by a farm worker family. The perimeter fence and the first row of PV arrays of Project 1 will be in clear site from the farm worker cottage. Project 2 is screened by Project 1. Trees on the Rooirand property however provide some screening. The overall visual significance is rated low due to the degraded state of the homestead and the screening provided by landscape elements which reduce the intrusive level of the facility

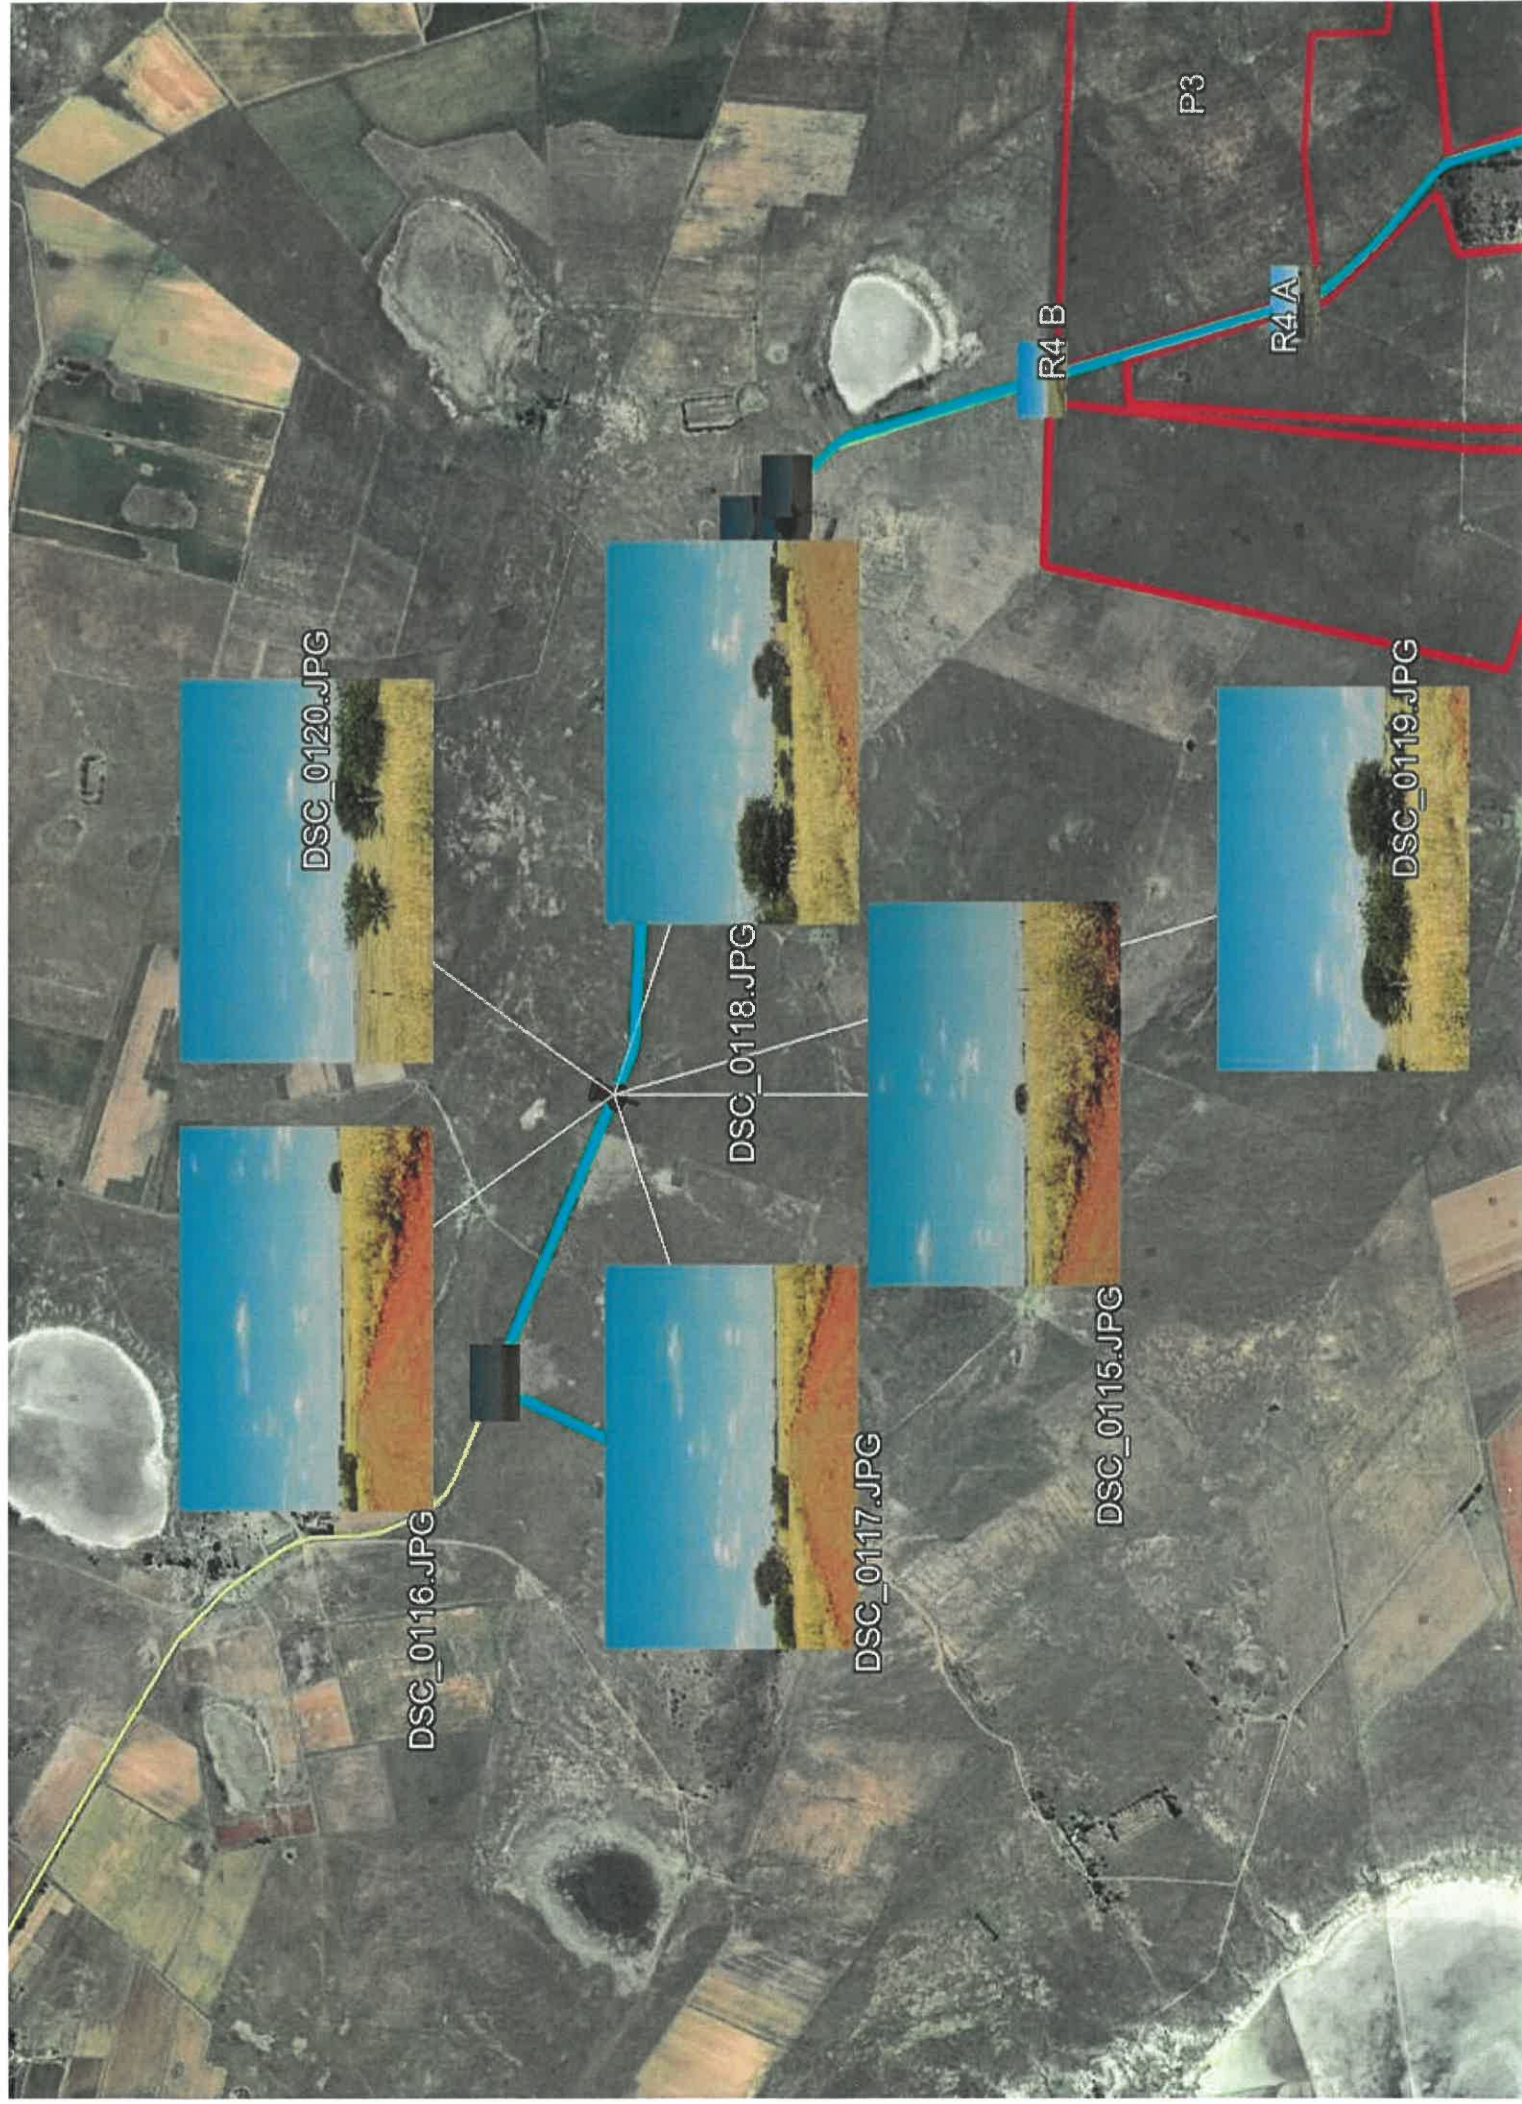
R6 Wonderkop Homestead

Low hills screen site

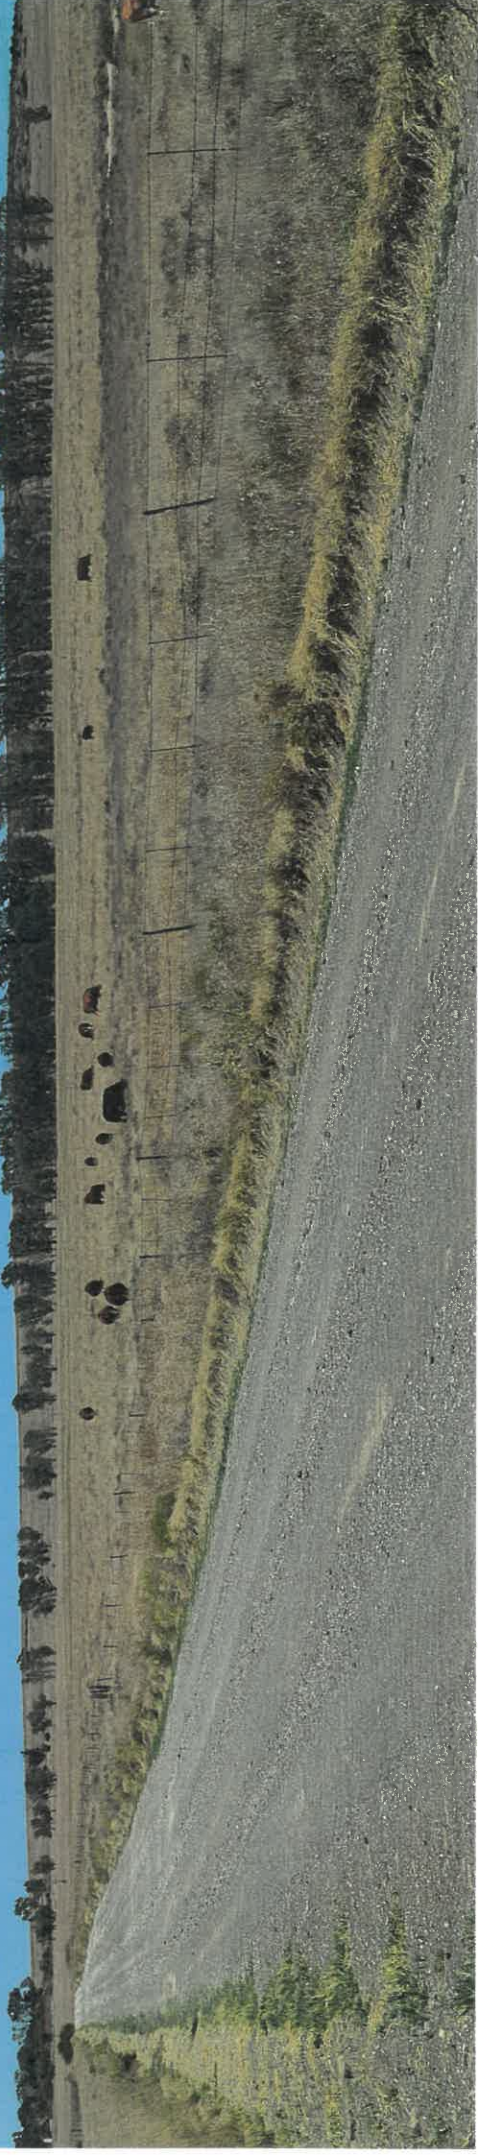
R15 Bultfontein road

Visspan out of view

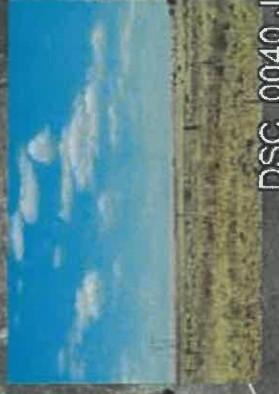
R13

Visserspan in the distance
PV arrays not visible

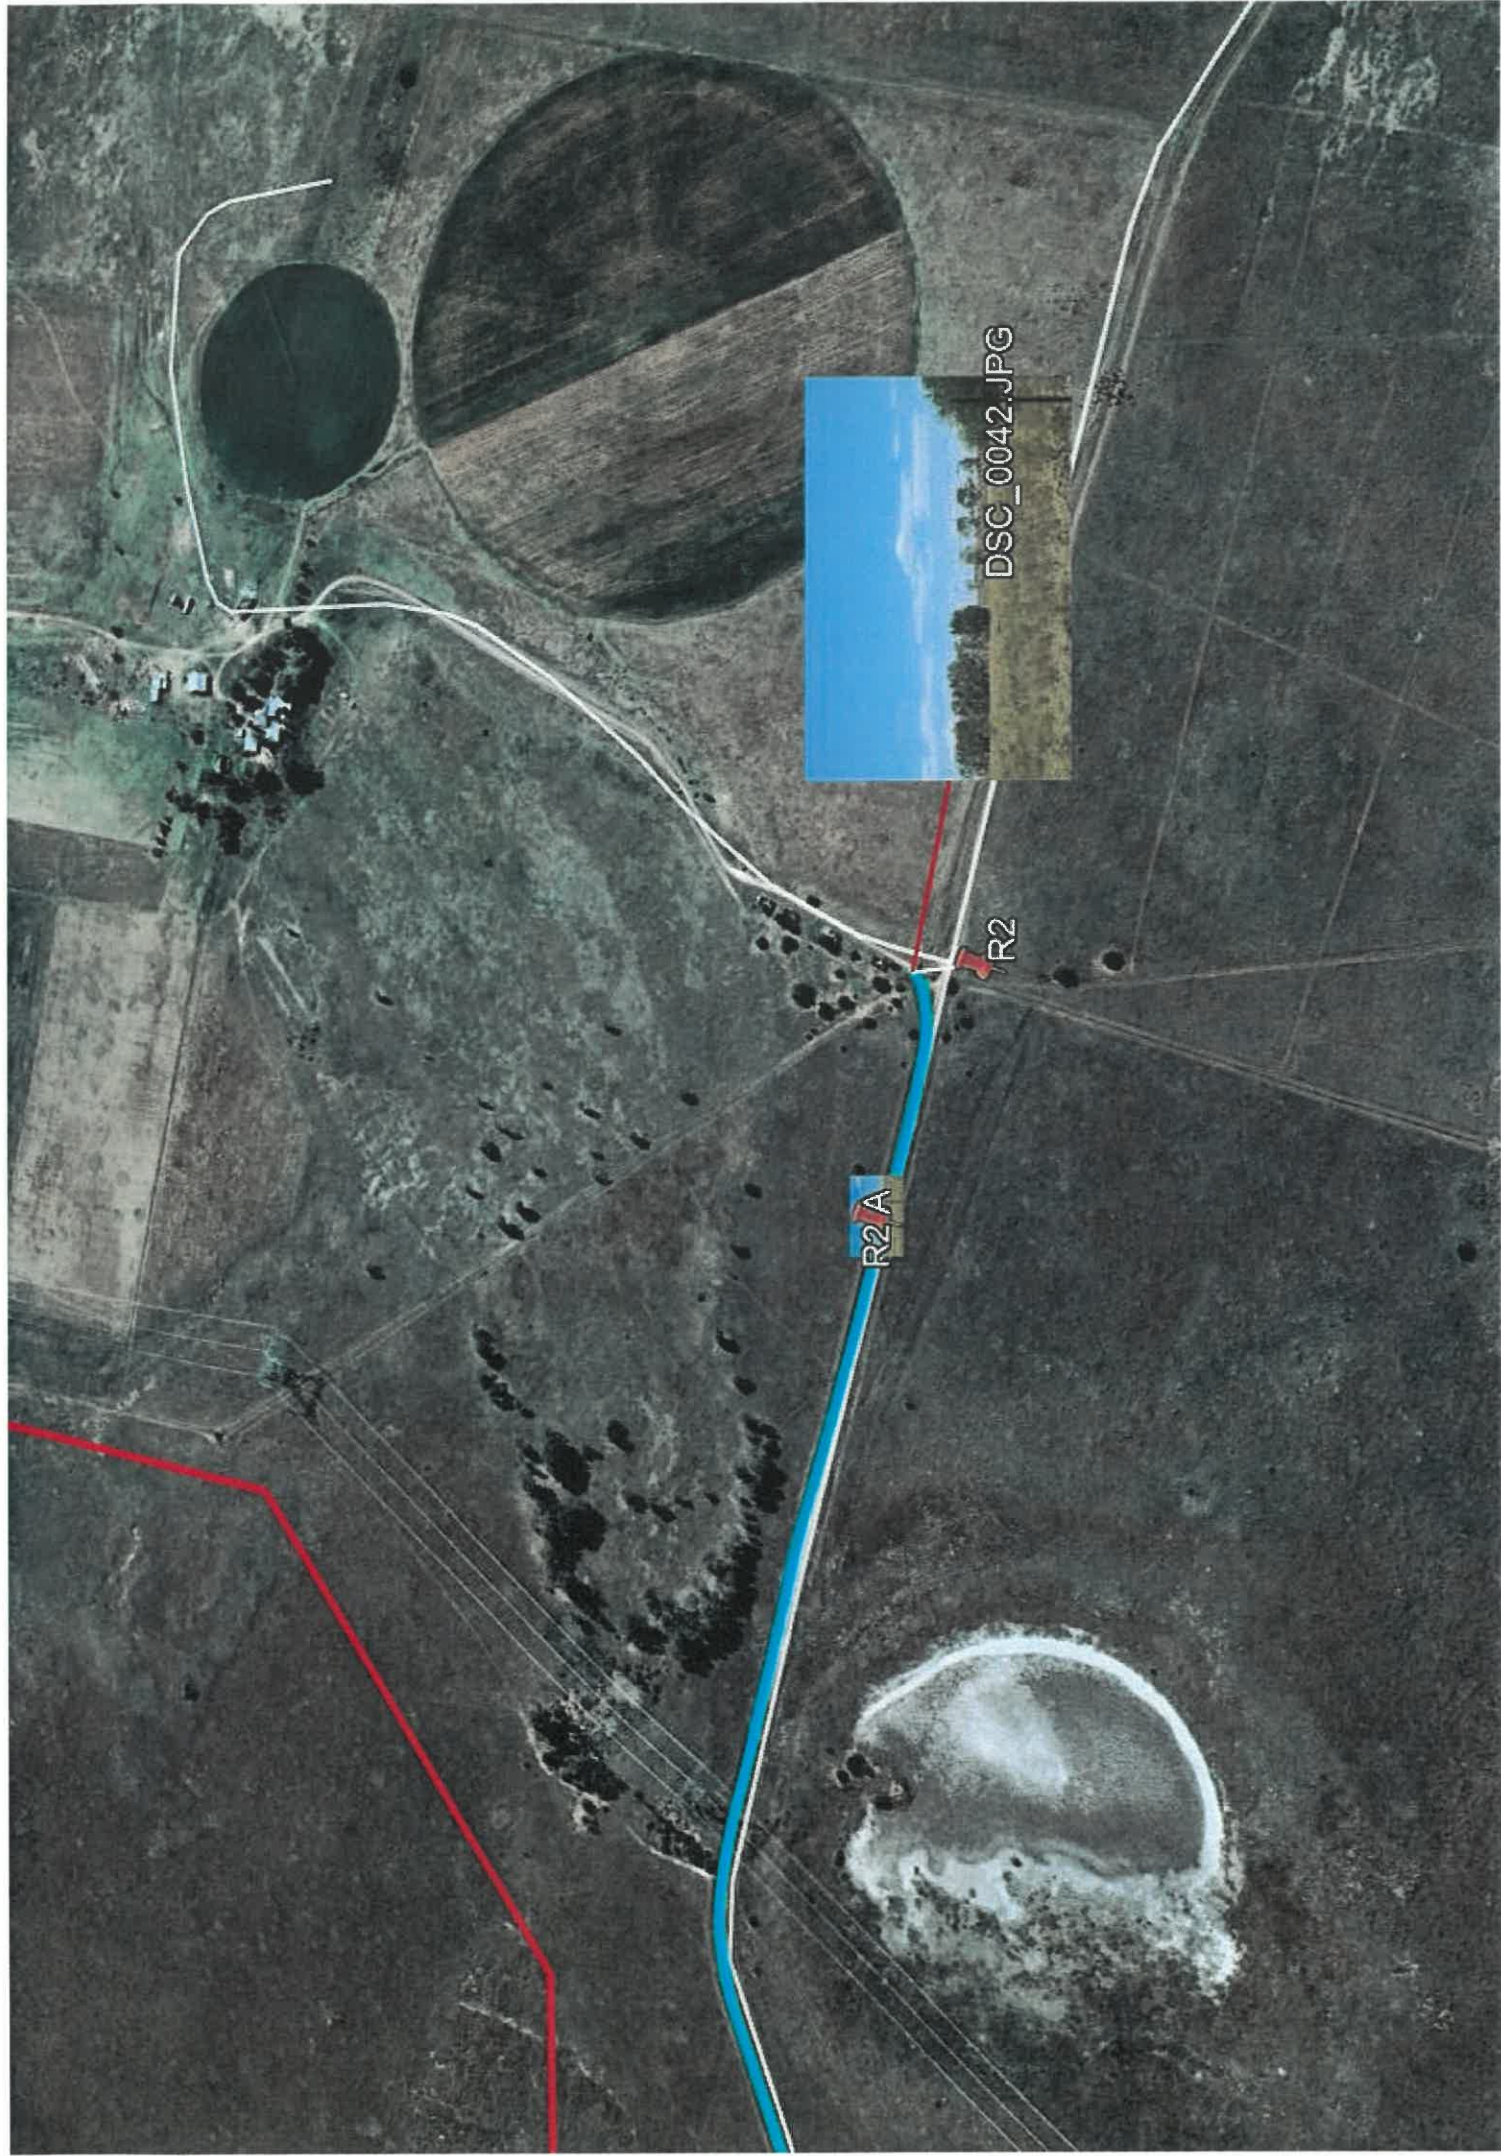
R2 Melsetter Homestead

PV arrays behind trees with sideview to observer

HV Powerlines
