**VISSERSPAN PV FACILITY  
PROJECT 1  
FARM 40, DEALESVILLE, FREE STATE**

**VISUAL ASSESSMENT**

**Final Report  
10 Feb 2020**

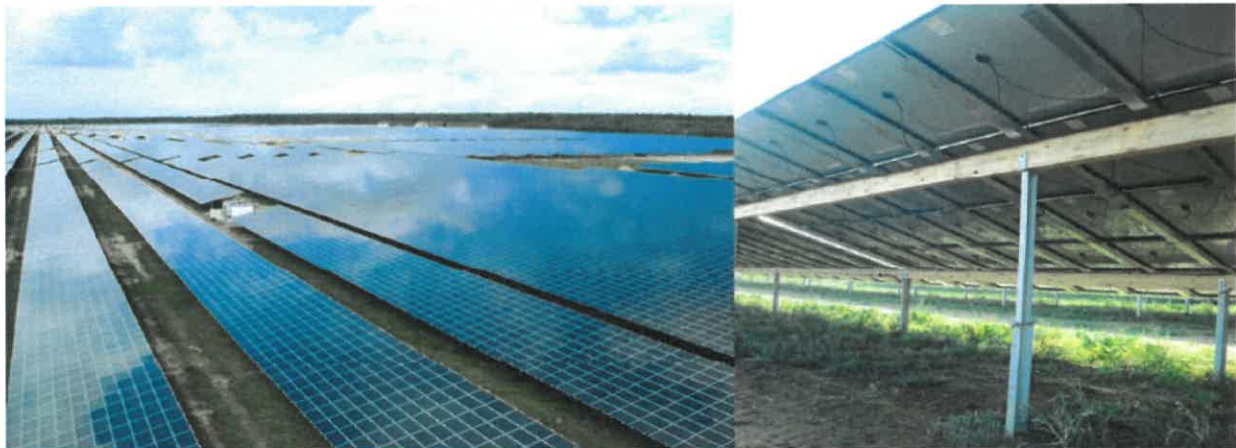
*Figure 2: Typical single axis PV arrays*

Site needs some leveling. Expected height 2,4m but maximum height for any structures assumed at 3m above ground. Arrays orientated east-west with horizontal movement north-south

The development will consist of solar panels mounted on steel supporting array structures and are configured into a number of sub array systems. The units will be able to tilt up and down but not rotate with the sun. The units will thus always be positioned in a northerly direction.

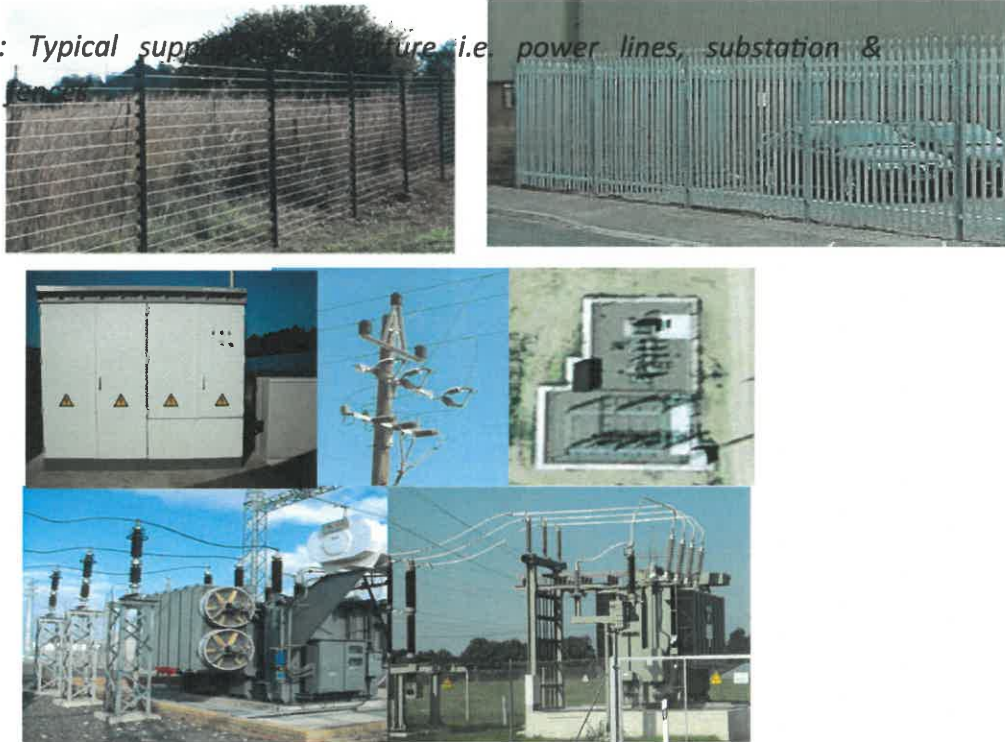
*Figure 3: Typical supply infrastructure i.e. power lines, substation & switches, fences*

Site circumscribed with fire access road and fence. Probably consisting of electrified, galvanized palisade fence of 2,4m in height.

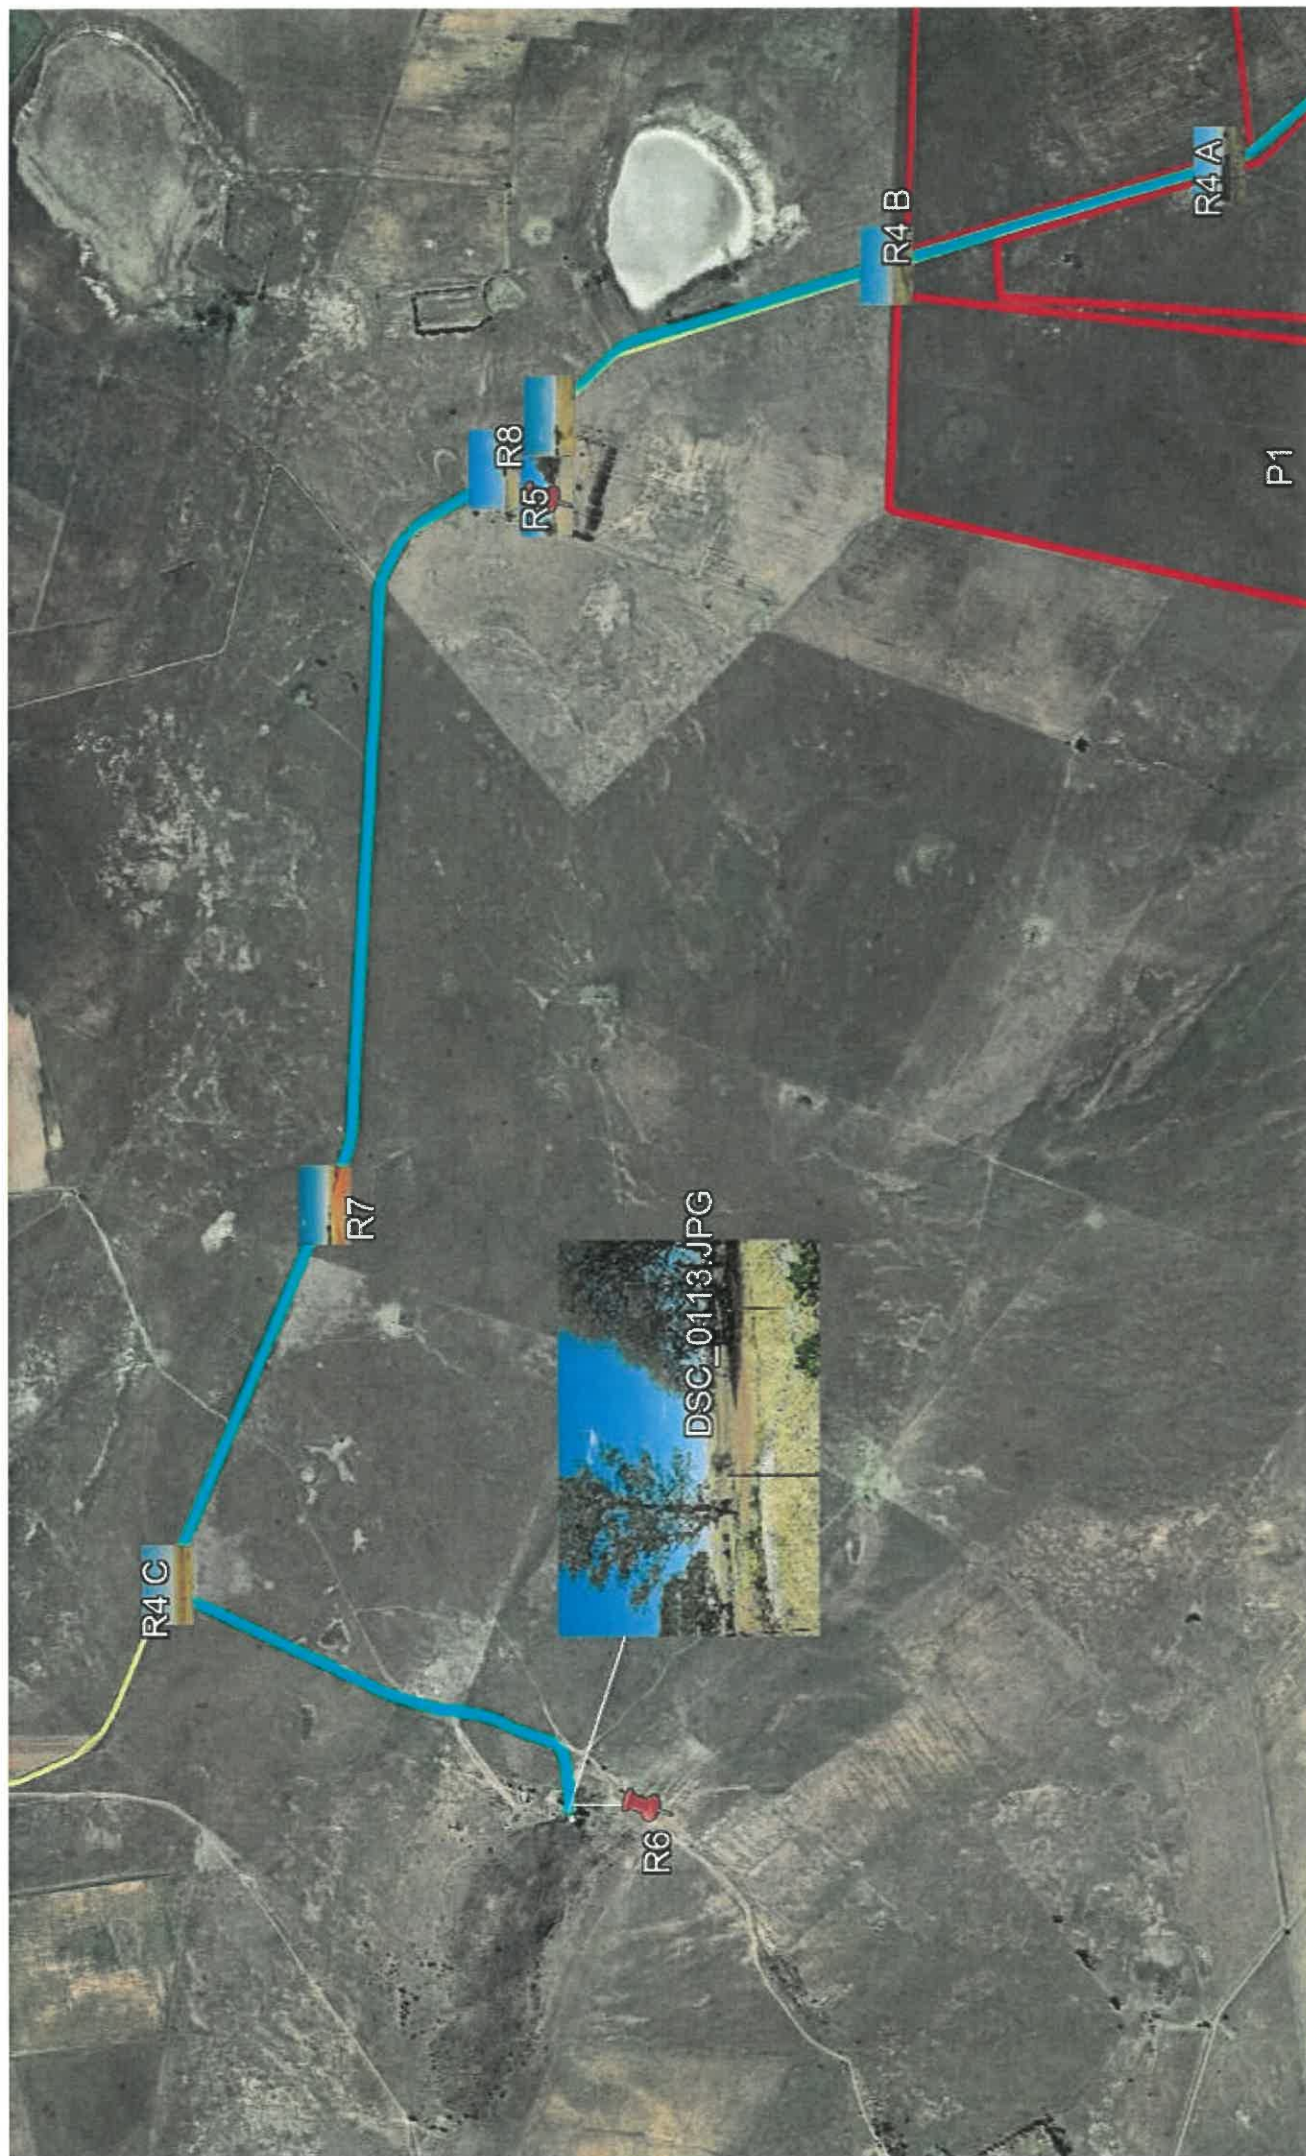
## R5 Rooidam Homestead

P1 arrays will be behind trees

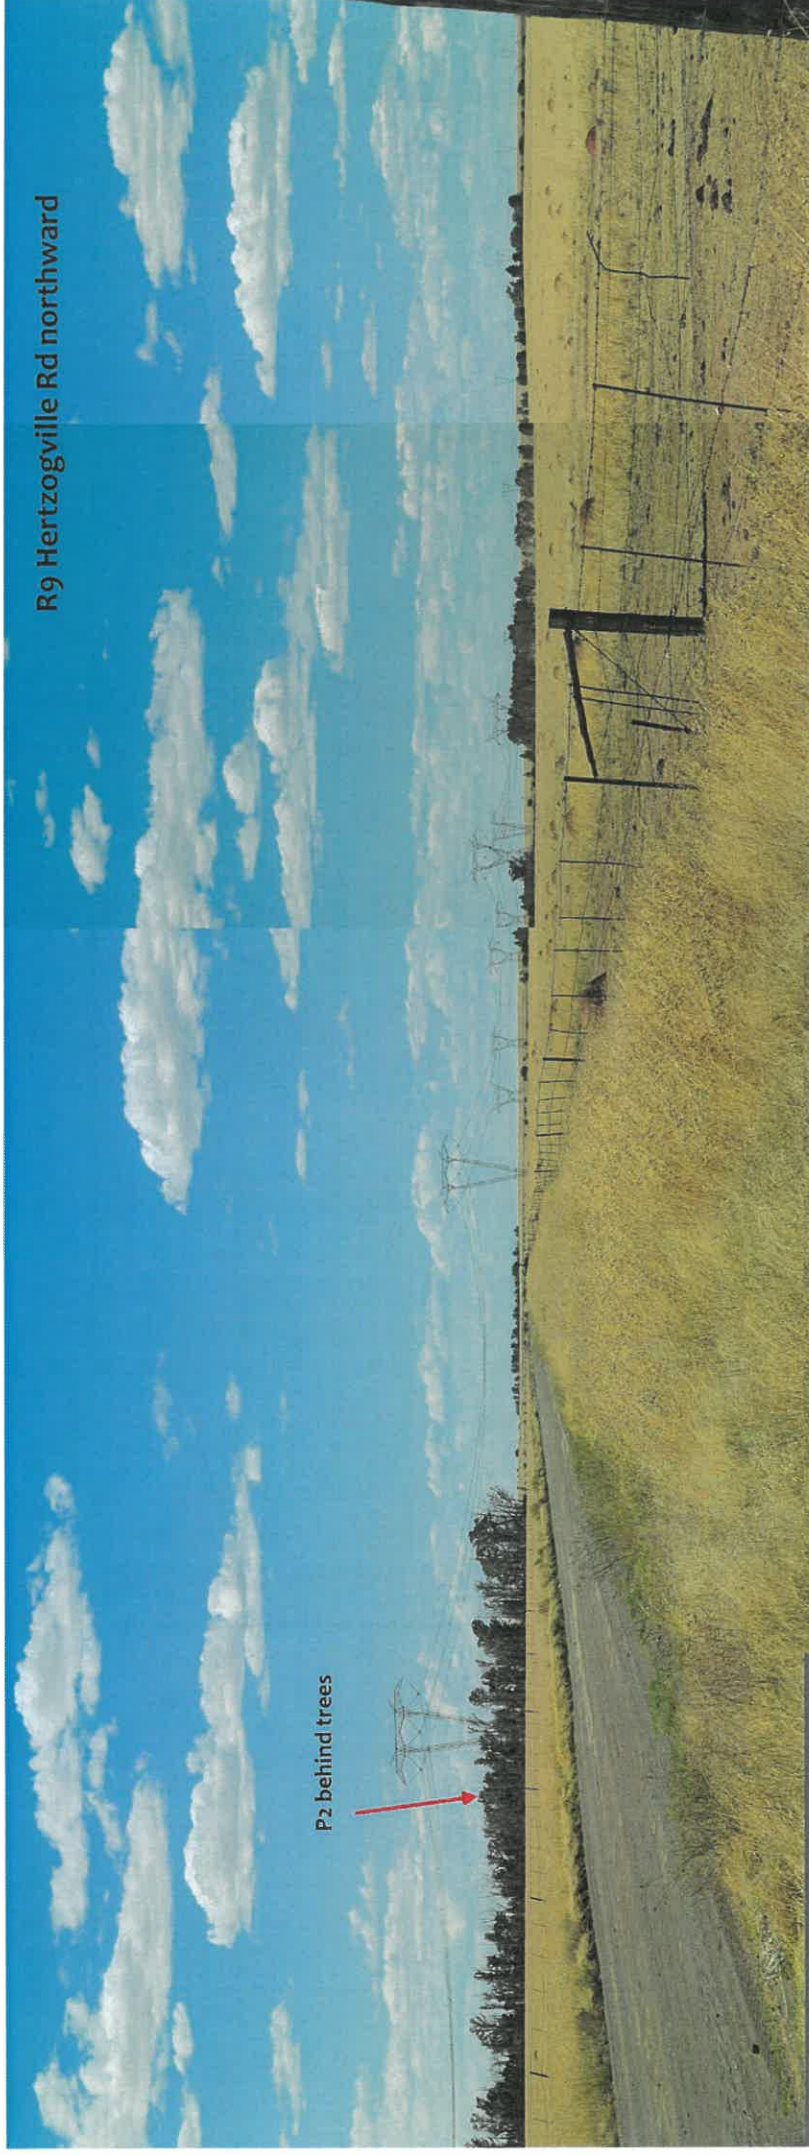
R9 Hertzogville Rd northward

P2 behind trees

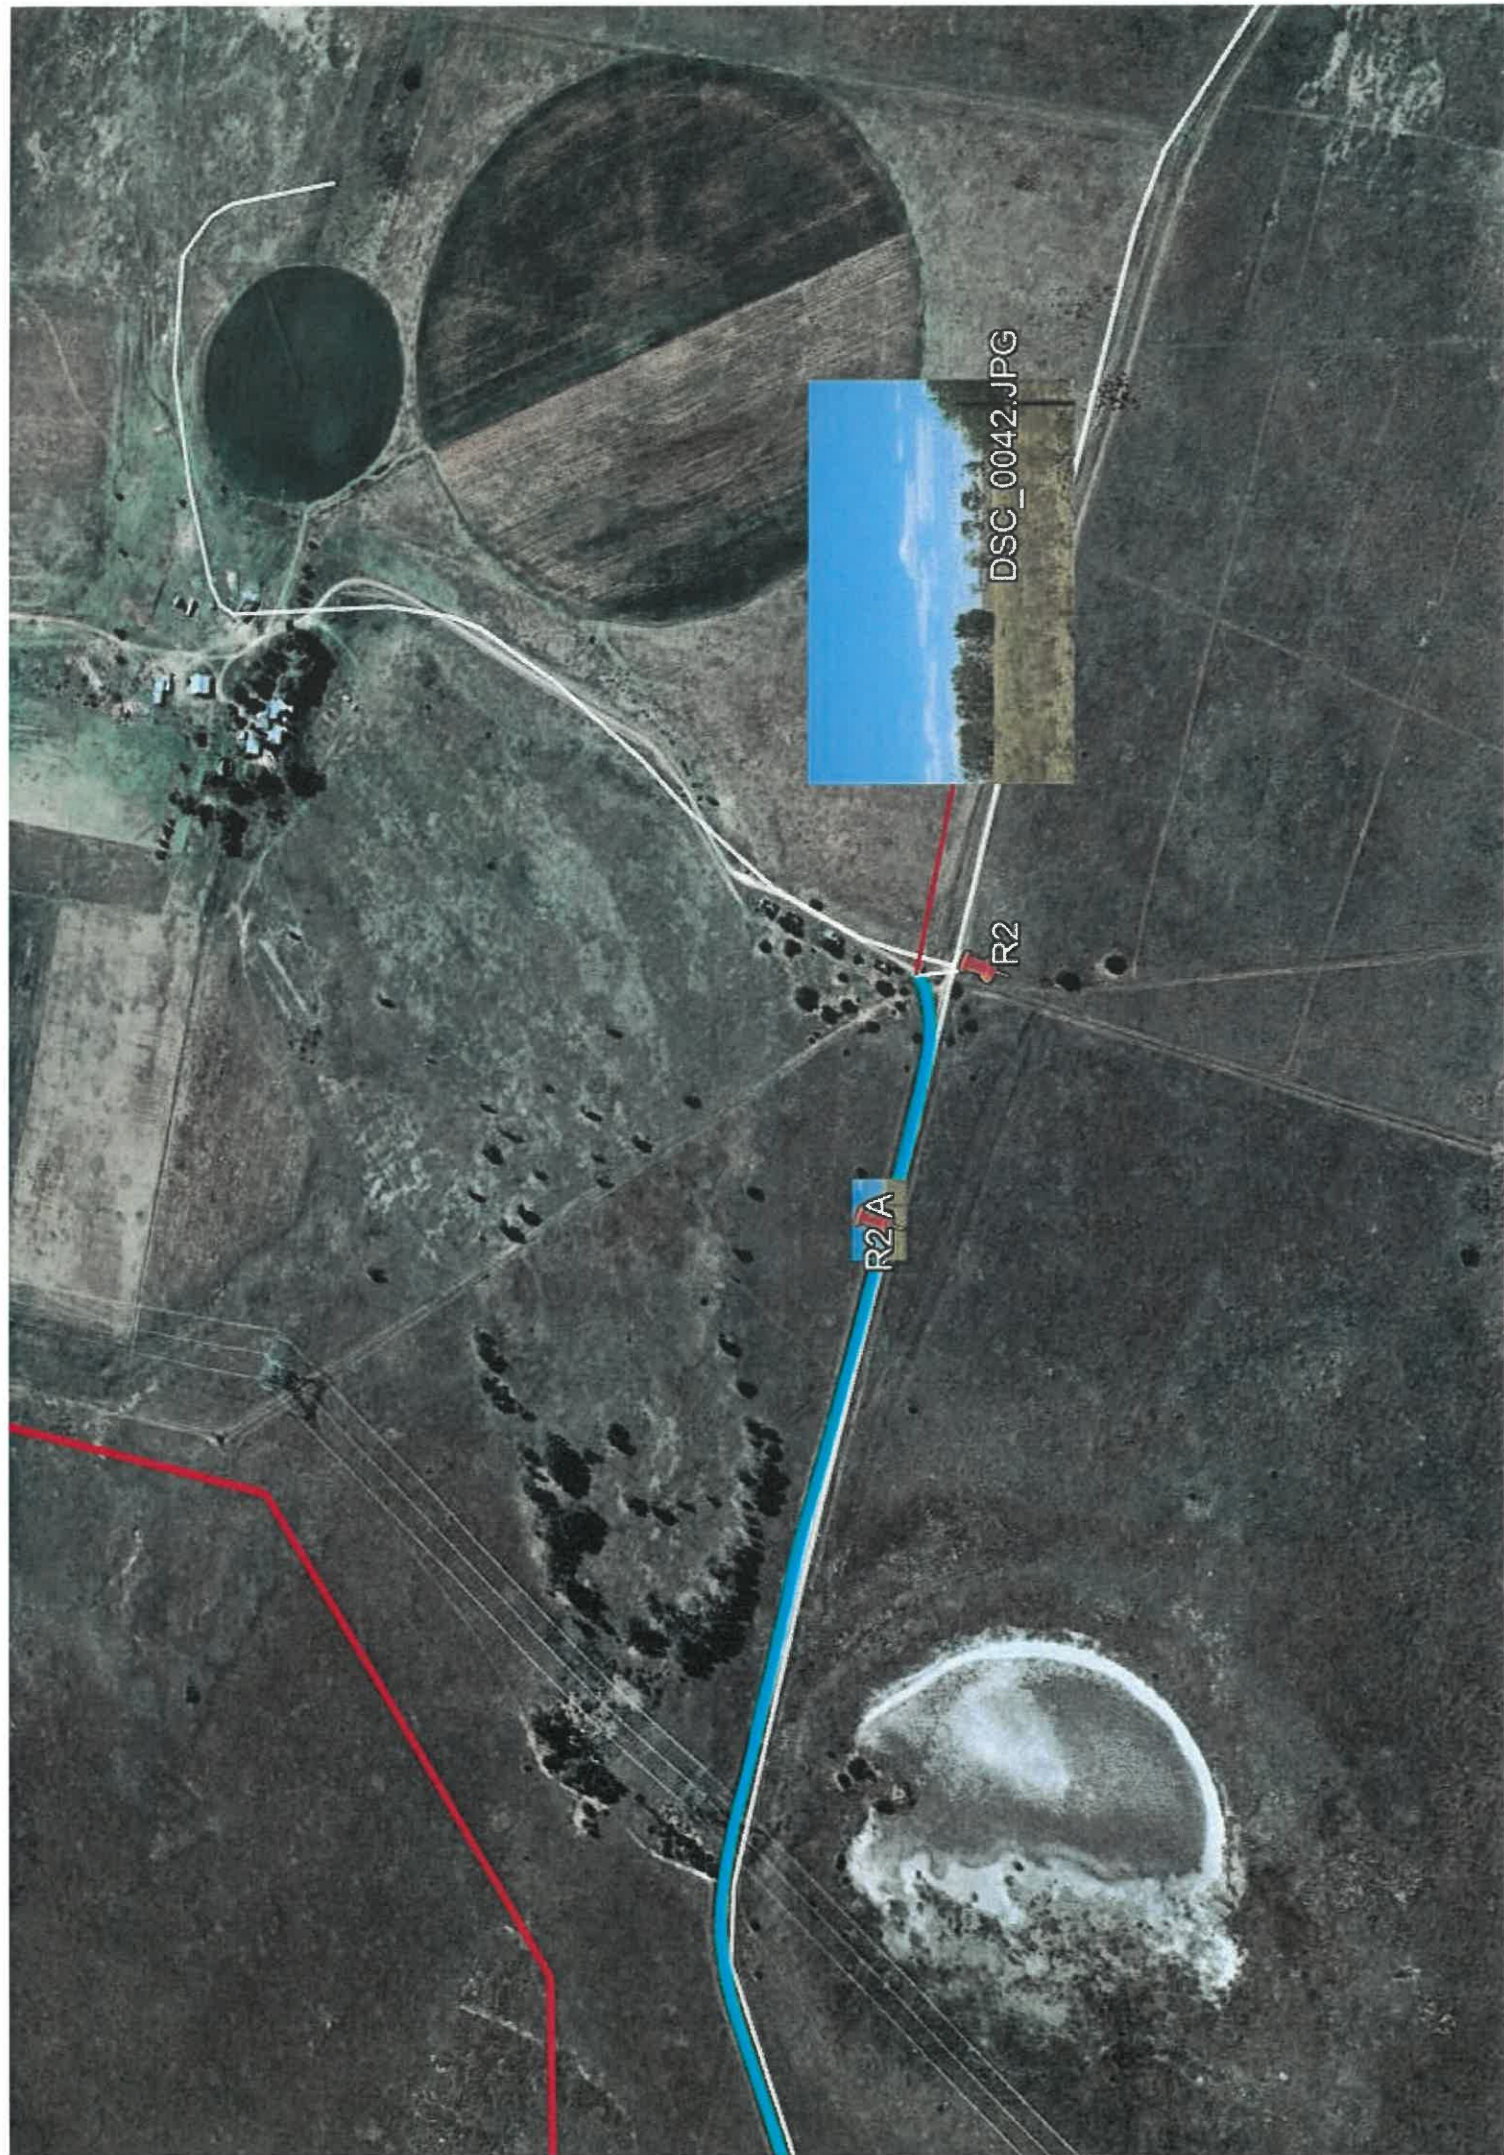
## R2 Melssetter Homestead

PV arrays behind trees with sideview to observer

HV Powerlines
