# VENTURA ENERGY (PTY) LTD

Fresh Water Report

Proposed Visserspan Solar Plant

Project 2

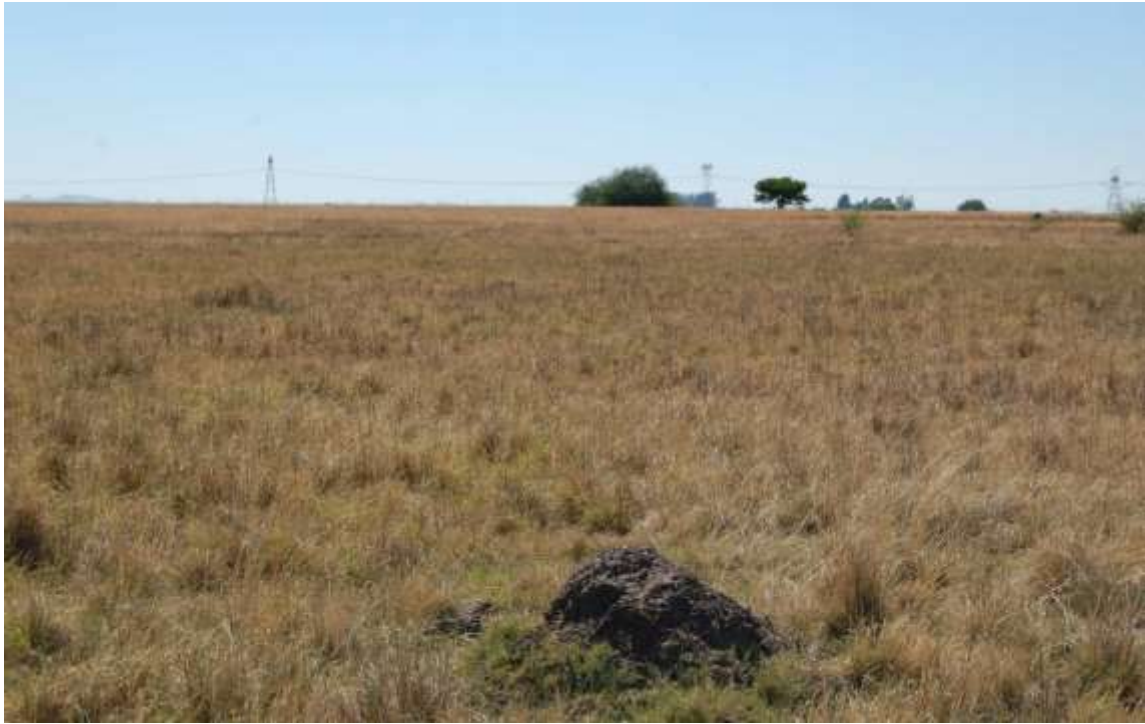
**Figure 4** Central Pan

The central pan, the one that is going to be surrounded by the PV panels, seemed to be a mixed grass pan (Figure 4), on the day of the site visit on 27 November 2019. There was no distinct margin, the floor was thickly overgrown with a variety of grasses, there was no barren patch of pan floor and was without any sedges or scrub.

The presence of this swelling clay is the reason for the existence of a mixed grass pan, without a barren patch, as the clay is too cohesive and heavy to be blown away by the Free State's stormy winds. The central pan developed into a consistent marshy area and not into a bare pan, as is evident in many places all over the western Free State.

The central pan was heavily grazed, with the grasses trimmed of short in most places. There were lots of animal hooves imprints in the clay that has probably been there since the previous rainy season.

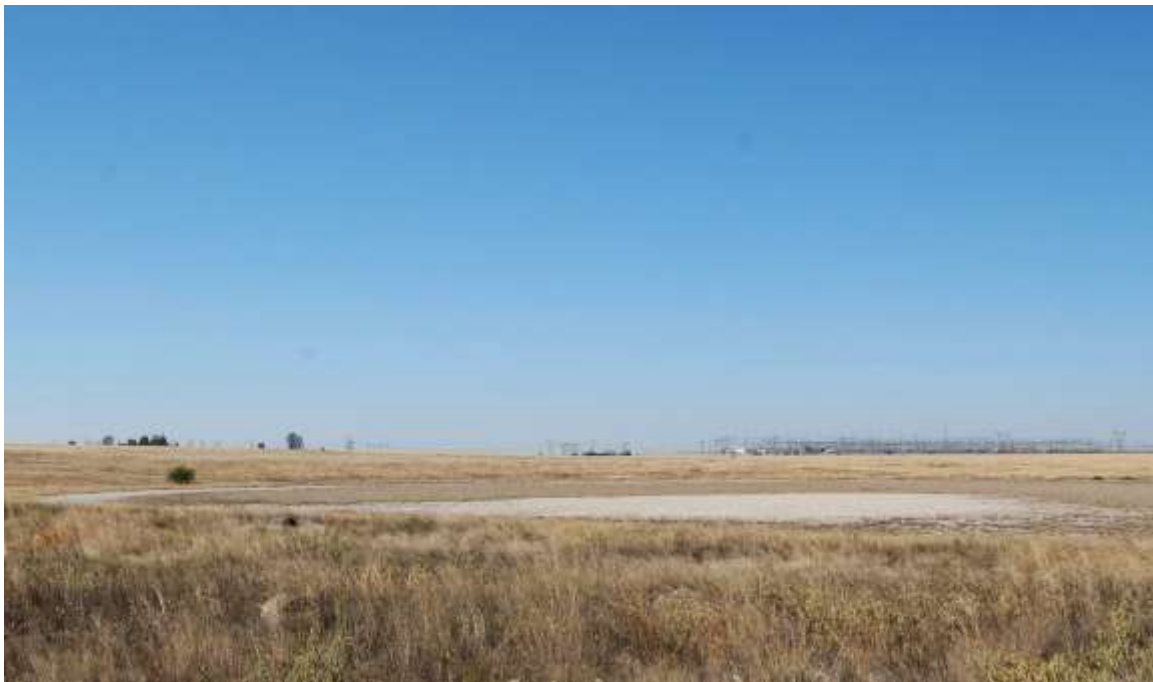
**Figure 5** South Eastern Pan

The other two pans, the one along the northern boundary and in the south eastern corner (Figure 5), can be classified as bare pans, with a secondary tendency becoming scrub pans.

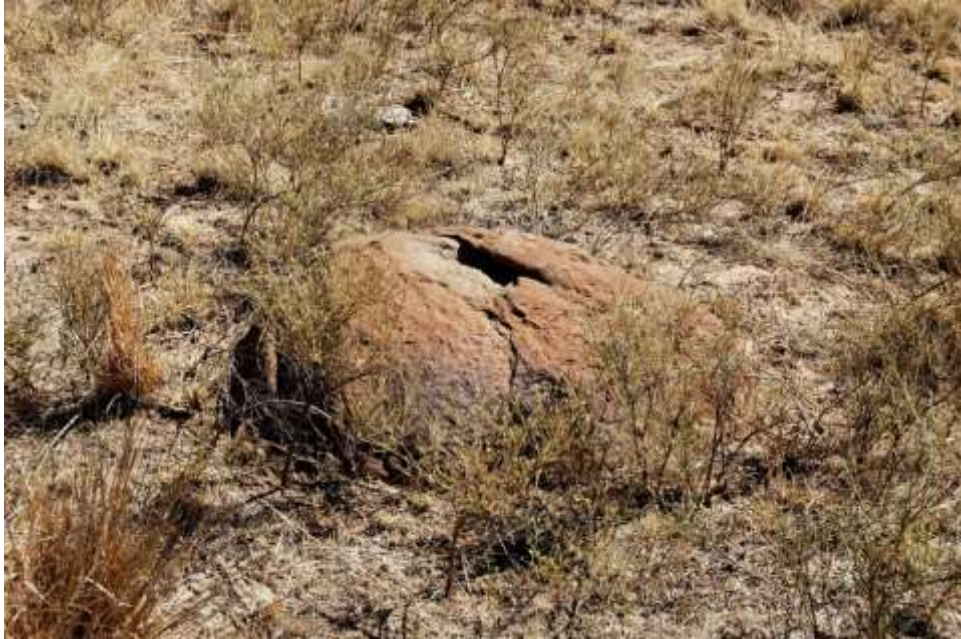
**Figure 6 Dolerite**

A dolerite intrusion intersects the central pan, with only a couple of dolerite boulders and stones (Figure 6) on the ground's surface. Dolerite weathers into several fractions, the one being a Montmorillonite swelling clay. The central pan consists of this swelling clay (Figure 7), with obvious cracks because of the prolonged current drought.

The dolerite rock was conspicuously subject to long-term erosion, with outer layers peeling off like shells, which is often seen in dolerites.

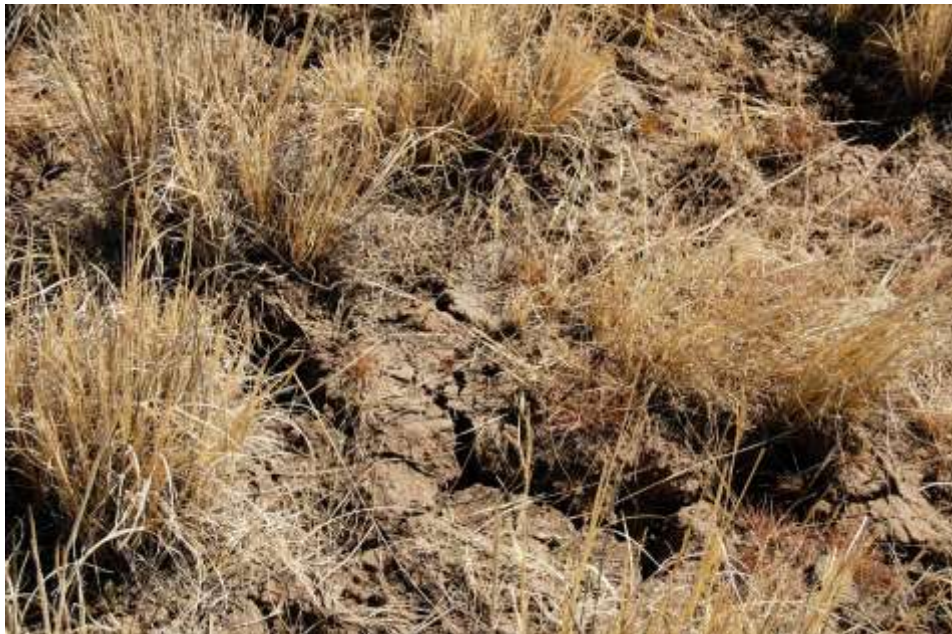
**Figure 7 Dry clayey soil with cracks**

It was obvious that soils were saturated the previous season, judging from the cracks in the clayey soils (Figure 7). These were obviously hydromorphic soils, verifying its wetland status.

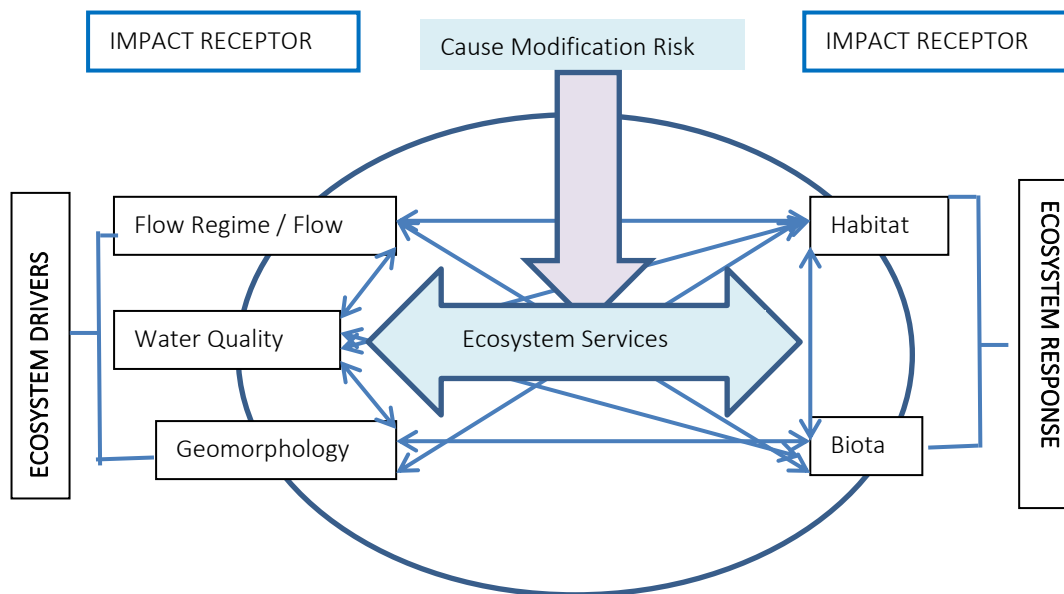
**Figure 12** Minimum Requirements for a S21(c) and (i) Application

Figure 12 has been adapted from one of the most recent DWS policy documents.

The ecological driver of the central pan is the summer rain that comes infrequently in electric thunderstorms. The pan's hydromorphic soils swell out with moisture and retains it for a longer period of time, perhaps well into the winter dry season, to maintain vegetation that would have been dried out as elsewhere in the grassy habitat. Reportedly there are geophytes growing there that are absent elsewhere. The long dry and frosty winter prevents this depression from developing into the next higher level of biodiversity.
