VENTURA ENERGY (PTY) LTD

Fresh Water Report

Proposed Visserspan Solar Plant

Project 3

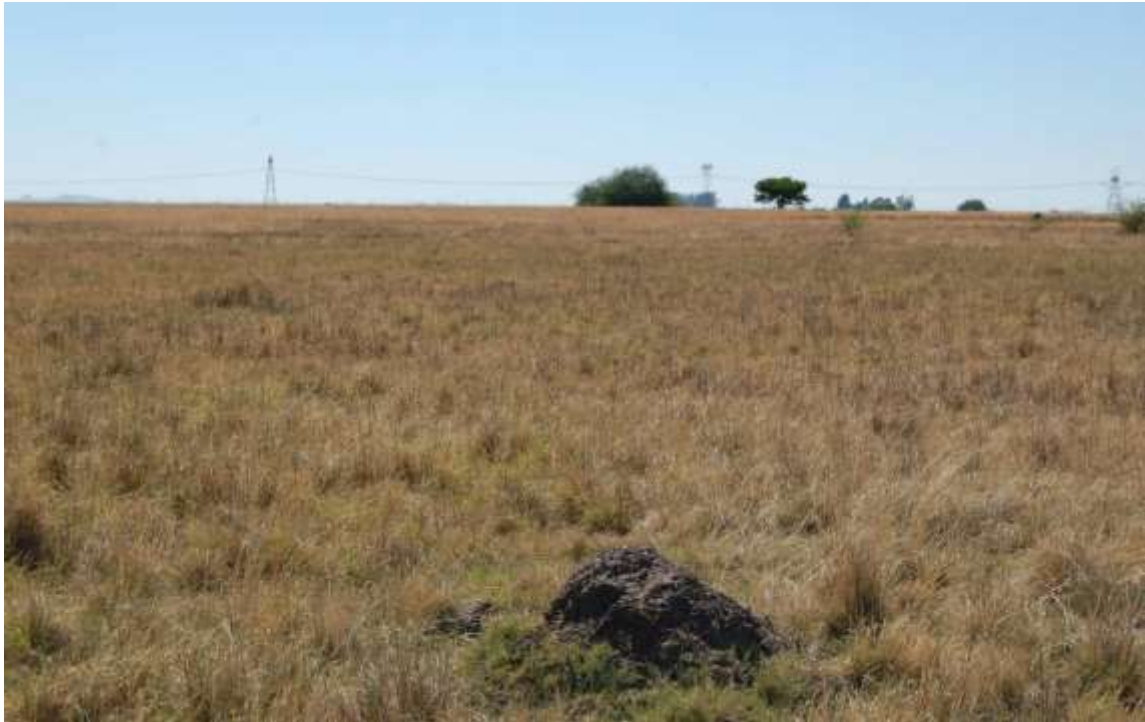
Figure 4 Central Pan

The central pan seemed to be a mixed grass pan (Figure 4), on the day of the site visit on 27 November 2019. There was no distinct margin, the floor was thickly overgrown with a variety of grasses, there was no barren patch of pan floor and was without any sedges or scrub.

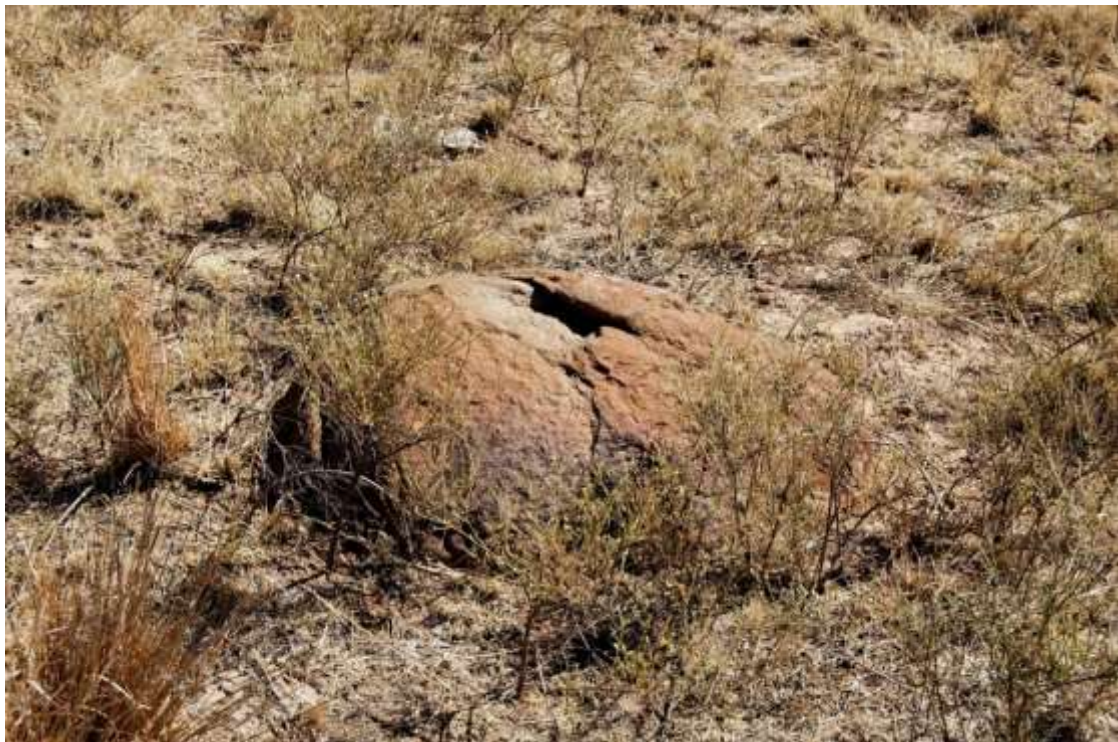
Figure 5 Dolerite

A dolerite intrusion intersects the central pan, with only a couple of dolerite boulders and stones (Figure 5) on the ground's surface. Dolerite weathers into several fractions, the one being a Montmorillonite swelling clay. The central pan consists of this swelling clay (Figure 7), with obvious cracks because of the prolonged current drought.

The dolerite rock was conspicuously subject to long-term erosion, with outer layers peeling of like shells, which is often seen in dolerites.

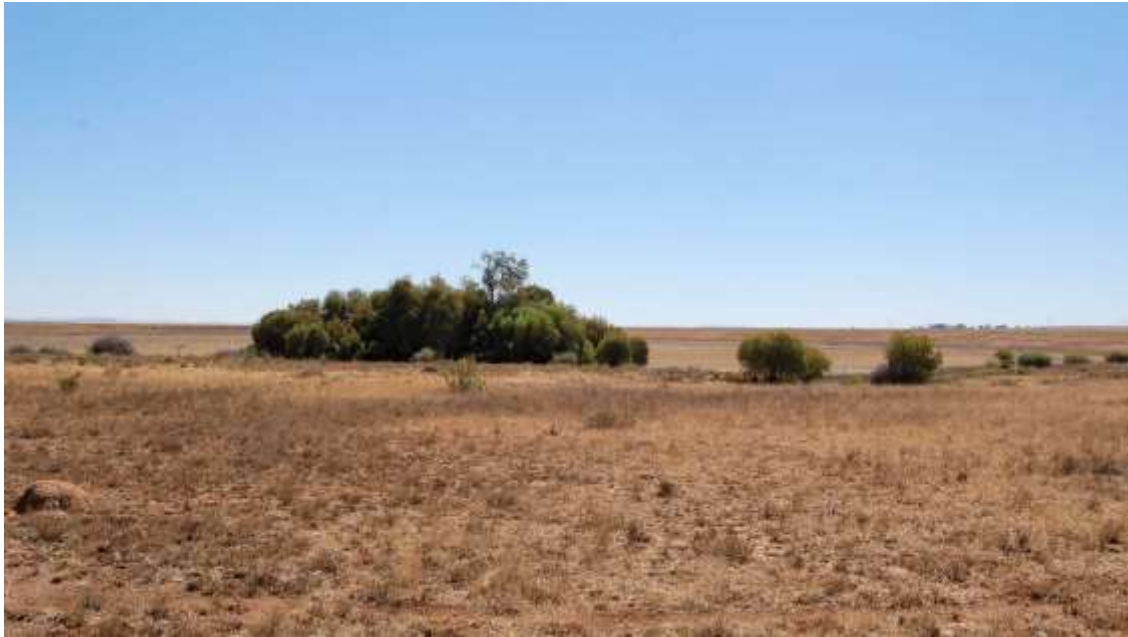
Figure 6 Northern Pan

The other two pans, the one along the northern boundary (Figure 6) and in the south western corner, can be classified as bare pans, with a secondary tendency becoming scrub pans.

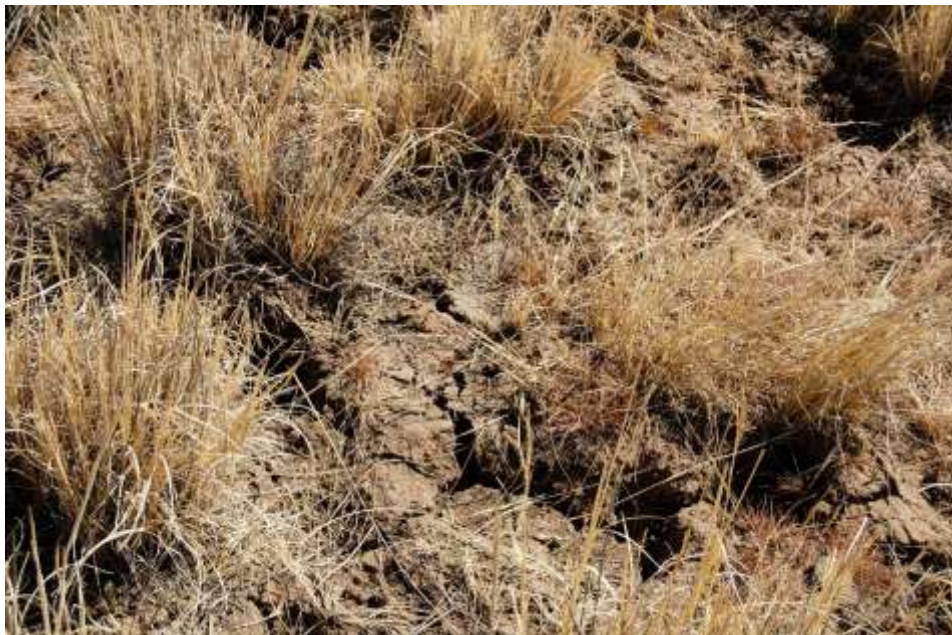
Figure 7 Dry clayey soil with cracks

It was obvious that soils were saturated the previous season, judging from the cracks in the clayey soils (Figure 7). These were obviously hydromorphic soils, verifying its wetland status.
