VENTURA ENERGY (PTY) LTD

Fresh Water Report

Proposed Visserspan Solar Plant

Project 1

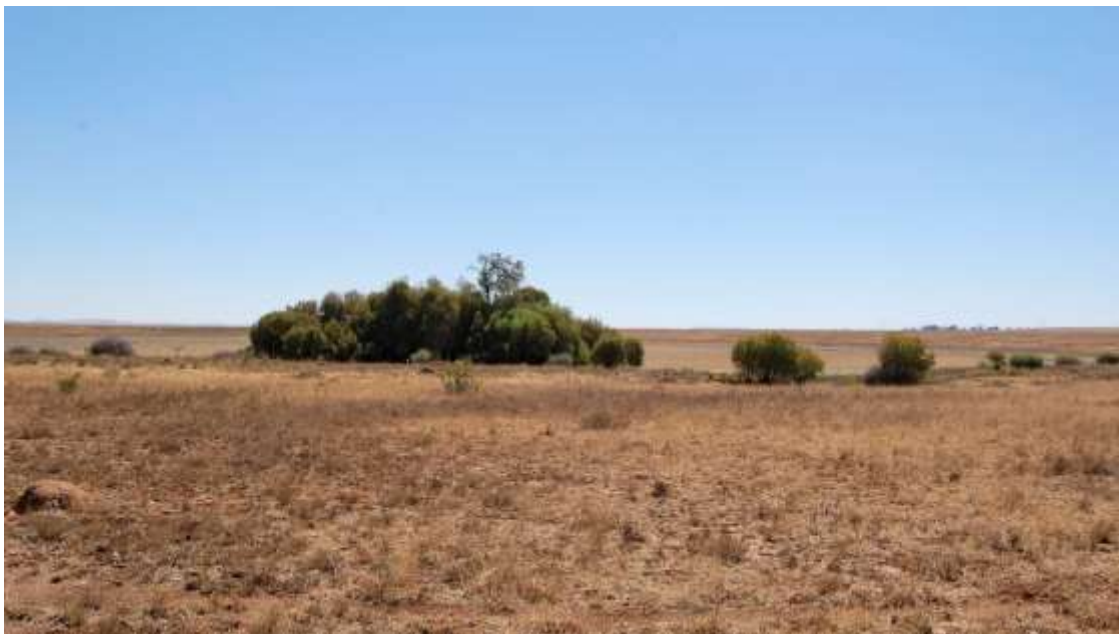
Figure 5 Northern Pan

The other two pans, the one along the northern boundary and in the south western corner (Figure 5), can be classified as bare pans, with a secondary tendency becoming scrub pans.

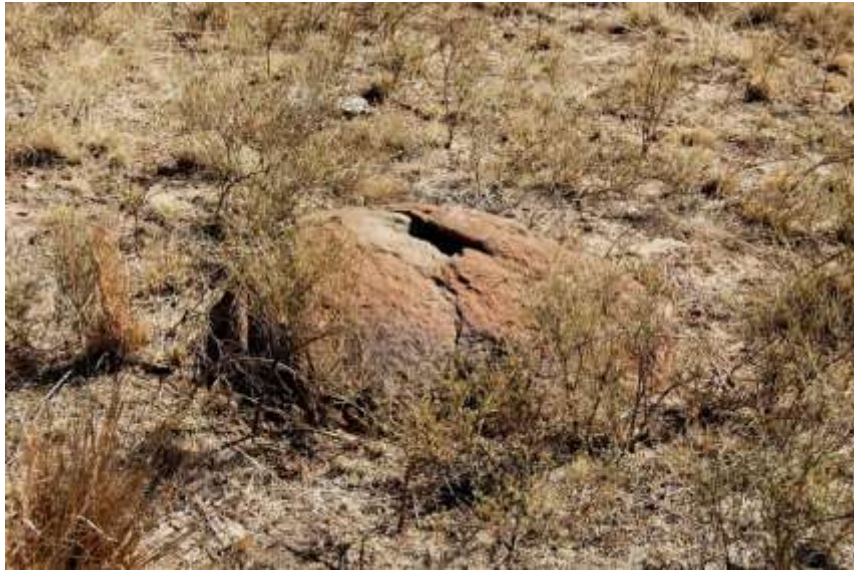
Figure 6 Dolerite

A dolerite intrusion intersects the central pan, with only a couple of dolerite boulders and stones (Figure 6) on the ground's surface. Dolerite weathers into several fractions, the one being a Montmorillonite swelling clay. The central pan consists of this swelling clay (Figure 7), with obvious cracks because of the prolonged current drought.

The dolerite rock was conspicuously subject to long-term erosion, with outer layers peeling of like shells, which is often seen in dolerites.
