# VENTURA ENERGY (PTY) LTD

Fresh Water Report

Proposed Visserspan Solar Plant

Project 4

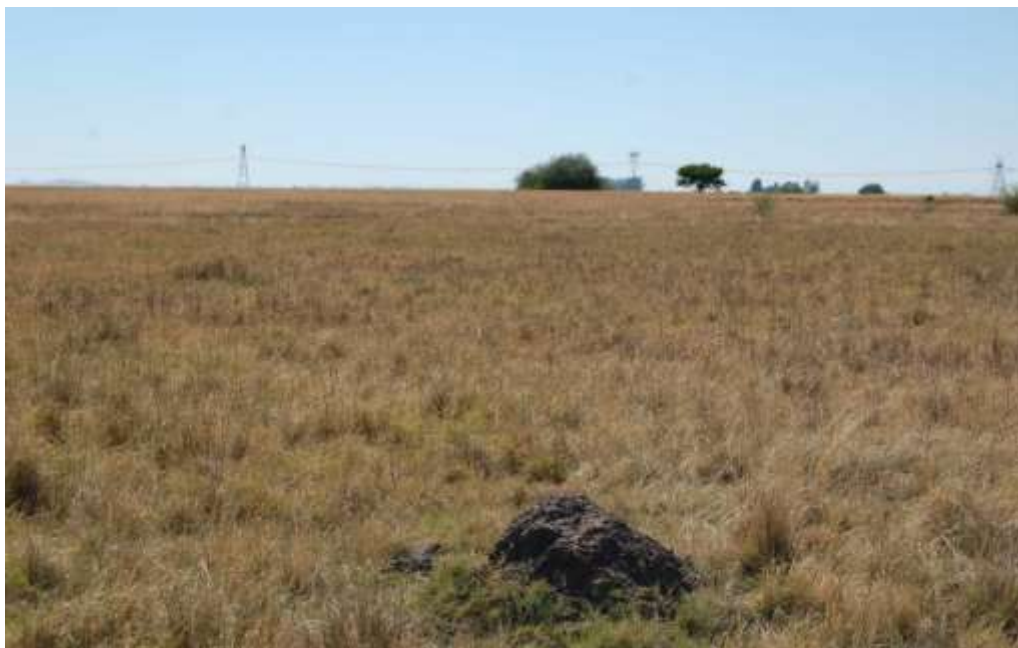
**Figure 4 Central Pan**

The central pan seemed to be a mixed grass pan (Figure 4), on the day of the site visit on 27 November 2019. There was no distinct margin, the floor was thickly overgrown with a variety of grasses, there was no barren patch of pan floor and was without any sedges or scrub.

The central pan was heavily grazed, with the grasses trimmed of short in most places. There were lots of animal hooves imprints in the clay that has probably been there since the previous rainy season.

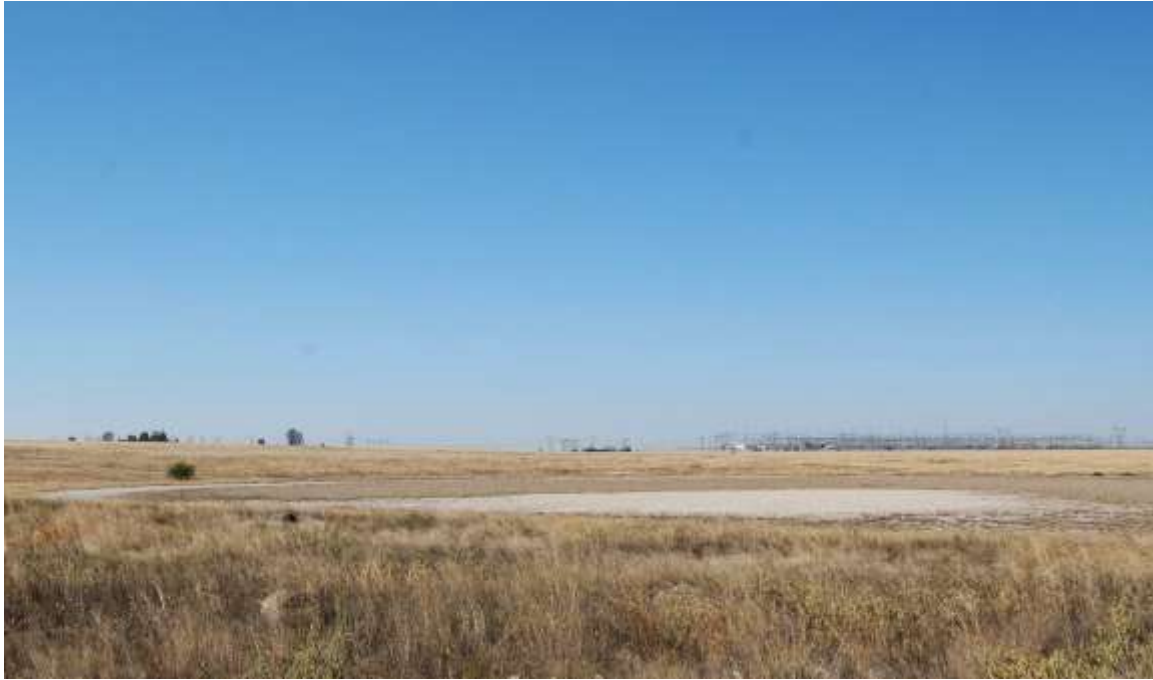
**Figure 5** Bare Pan (South Eastern Pan)

The other two pans, the one along the northern boundary and in the south western corner (Figure 5), can be classified as bare pans, with a secondary tendency becoming scrub pans.

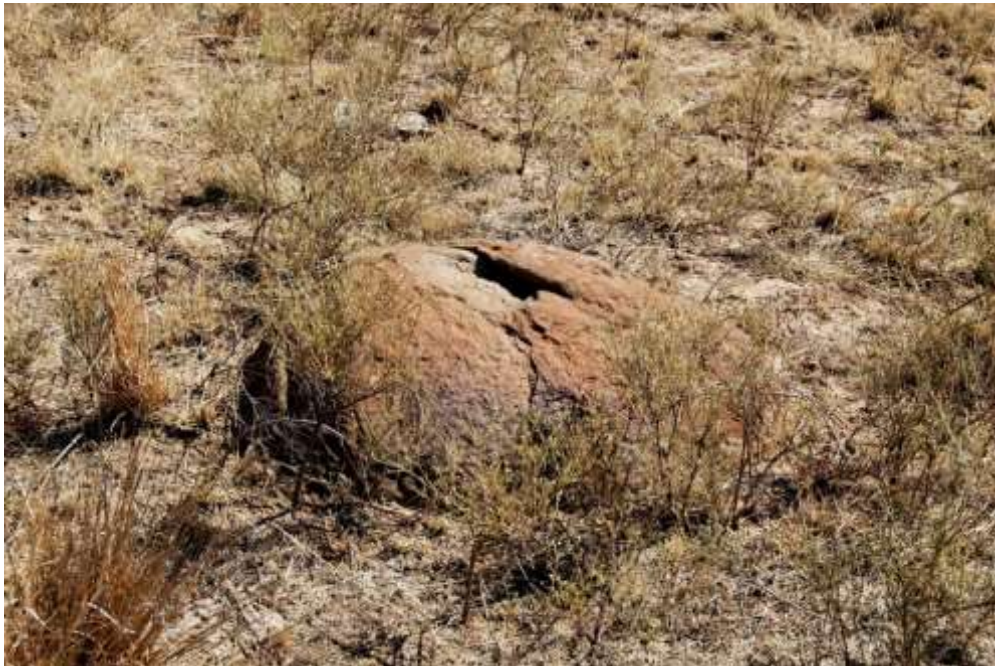
**Figure 6** Dolerite

The dolerite rock was conspicuously subject to long-term erosion, with outer layers peeling of like shells, which is often seen in dolerites.

A dolerite intrusion intersects the central pan, with only a couple of dolerite boulders and stones (Figure 6) on the ground's surface. Dolerite weathers into several fractions, the one being a Montmorillonite swelling clay. The central pan consists of this swelling clay (Figure 7), with obvious cracks because of the prolonged current drought.

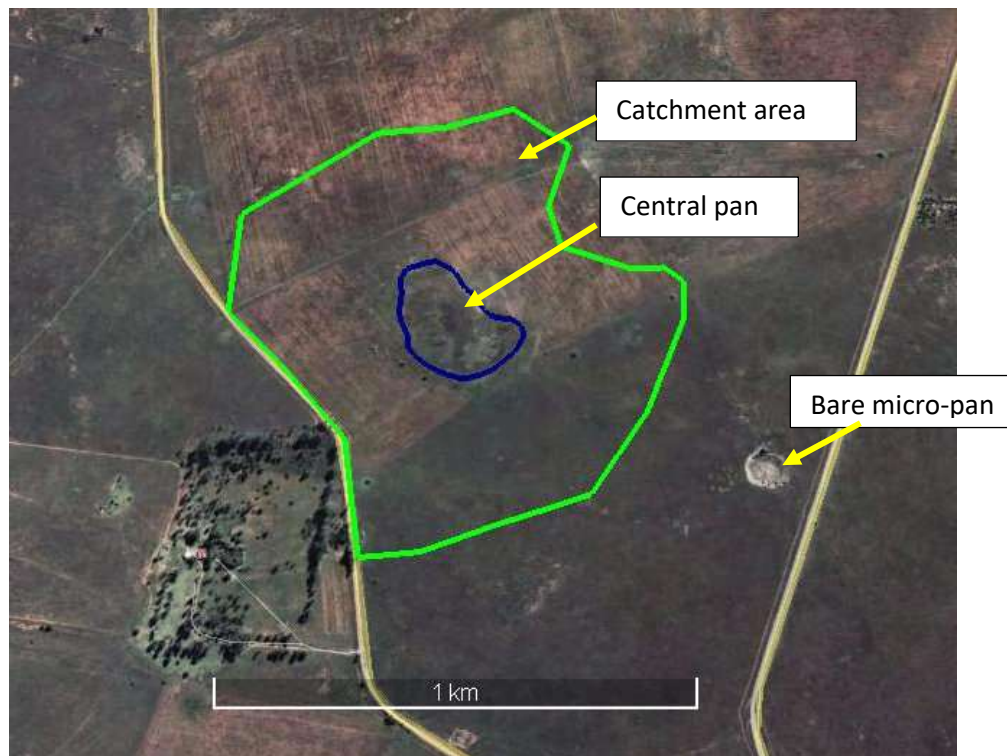
**Figure 9** Central pan & catchment

The central pan is roughly demarcated in Figure 9, according to the faint difference in the pan's grasses and that of the surrounding area. The central pan is approximately 6ha in size, with a circumference of 980m.

The pan's catchment area can be demarcated by connecting the highest points around the pan with Google Earth's polygon function.

The pan's elevation is 1284masl. The catchment's northern and western boundary is at 1290masl to 1291masl and the southern and south western boundary at only one metre higher than the pan at 1285masl.

The catchment is 83ha in size, with a circumference of 3.7km.

Note the bare micro-pan to the south west of the central pan. This micro-pan was not observed during the site visit, as the area was densely overgrown with grasses. The Google Earth image was taken on 5/9/2018. Nevertheless, reportedly the micro-pan

It was obvious that soils were saturated the previous season, judging from the cracks in the clayey soils (Figure 9). These were obviously hydromorphic soils, verifying its wetland status.
