**VISSERSPAN PV FACILITY
PROJECT 3
FARM 40, DEALESVILLE, FREE STATE**

VISUAL ASSESSMENT

Final Report
10 Feb 2020

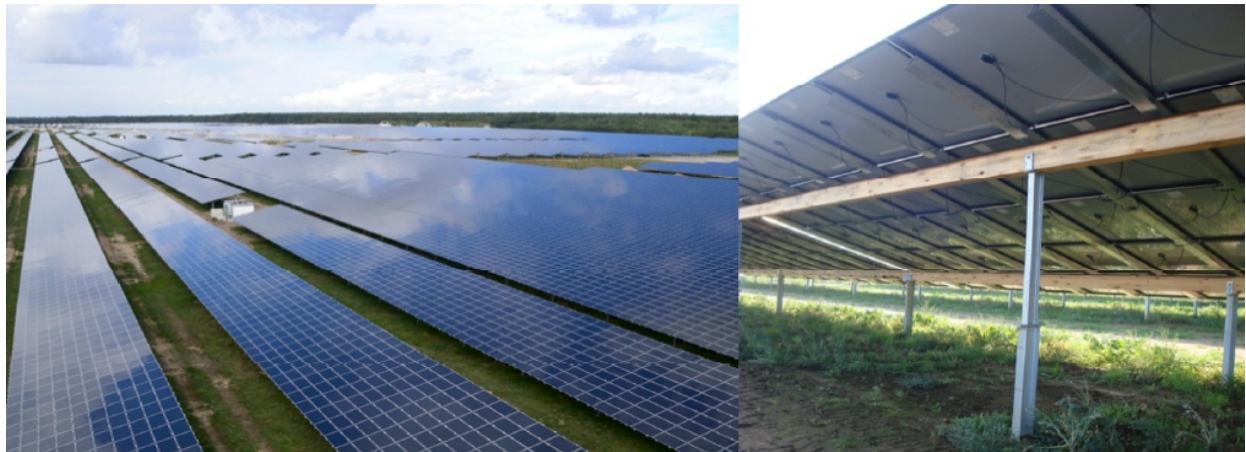
Figure 3: Typical single axis PV arrays

Site needs some leveling. Expected height 2,4m but maximum height for any structures assumed at 3m above ground. Arrays orientated east-west with horizontal movement north-south

The development will consist of solar panels mounted on steel supporting array structures and are configured into a number of sub array systems. The units will be able to tilt up and down but not rotate with the sun. The units will thus always be positioned in a northerly direction.

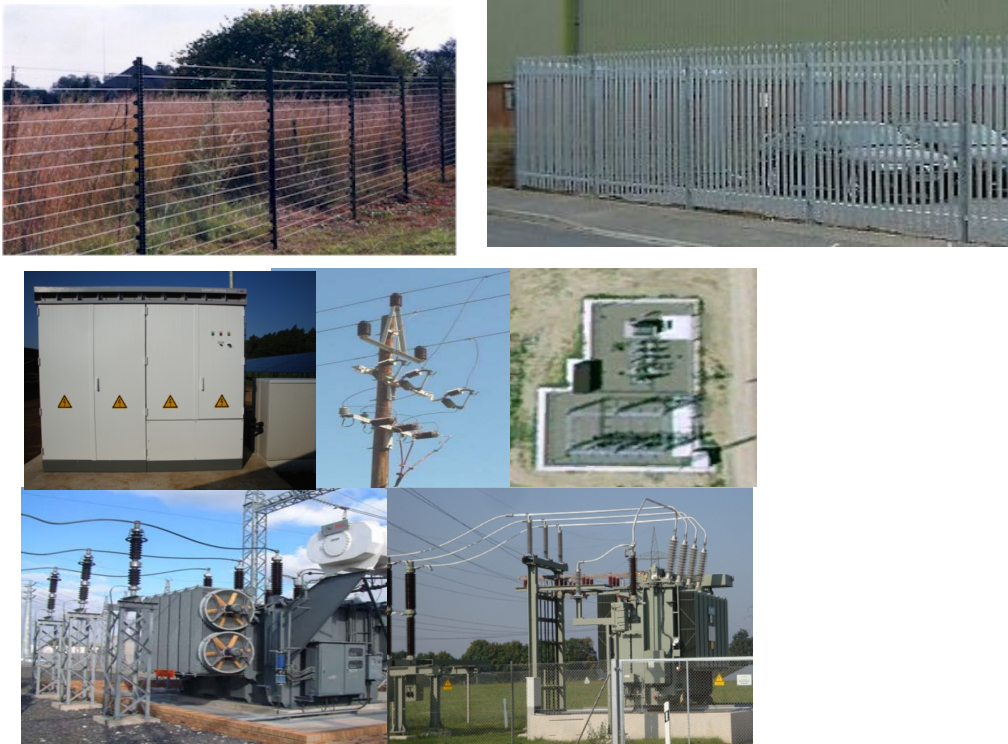
Figure 3: Typical support infrastructure i.e. power lines, substation & switches, fences

Site circumscribed with fire access road and fence. Probably consisting of electrified, galvanized palisade fence of 2,4m in height.

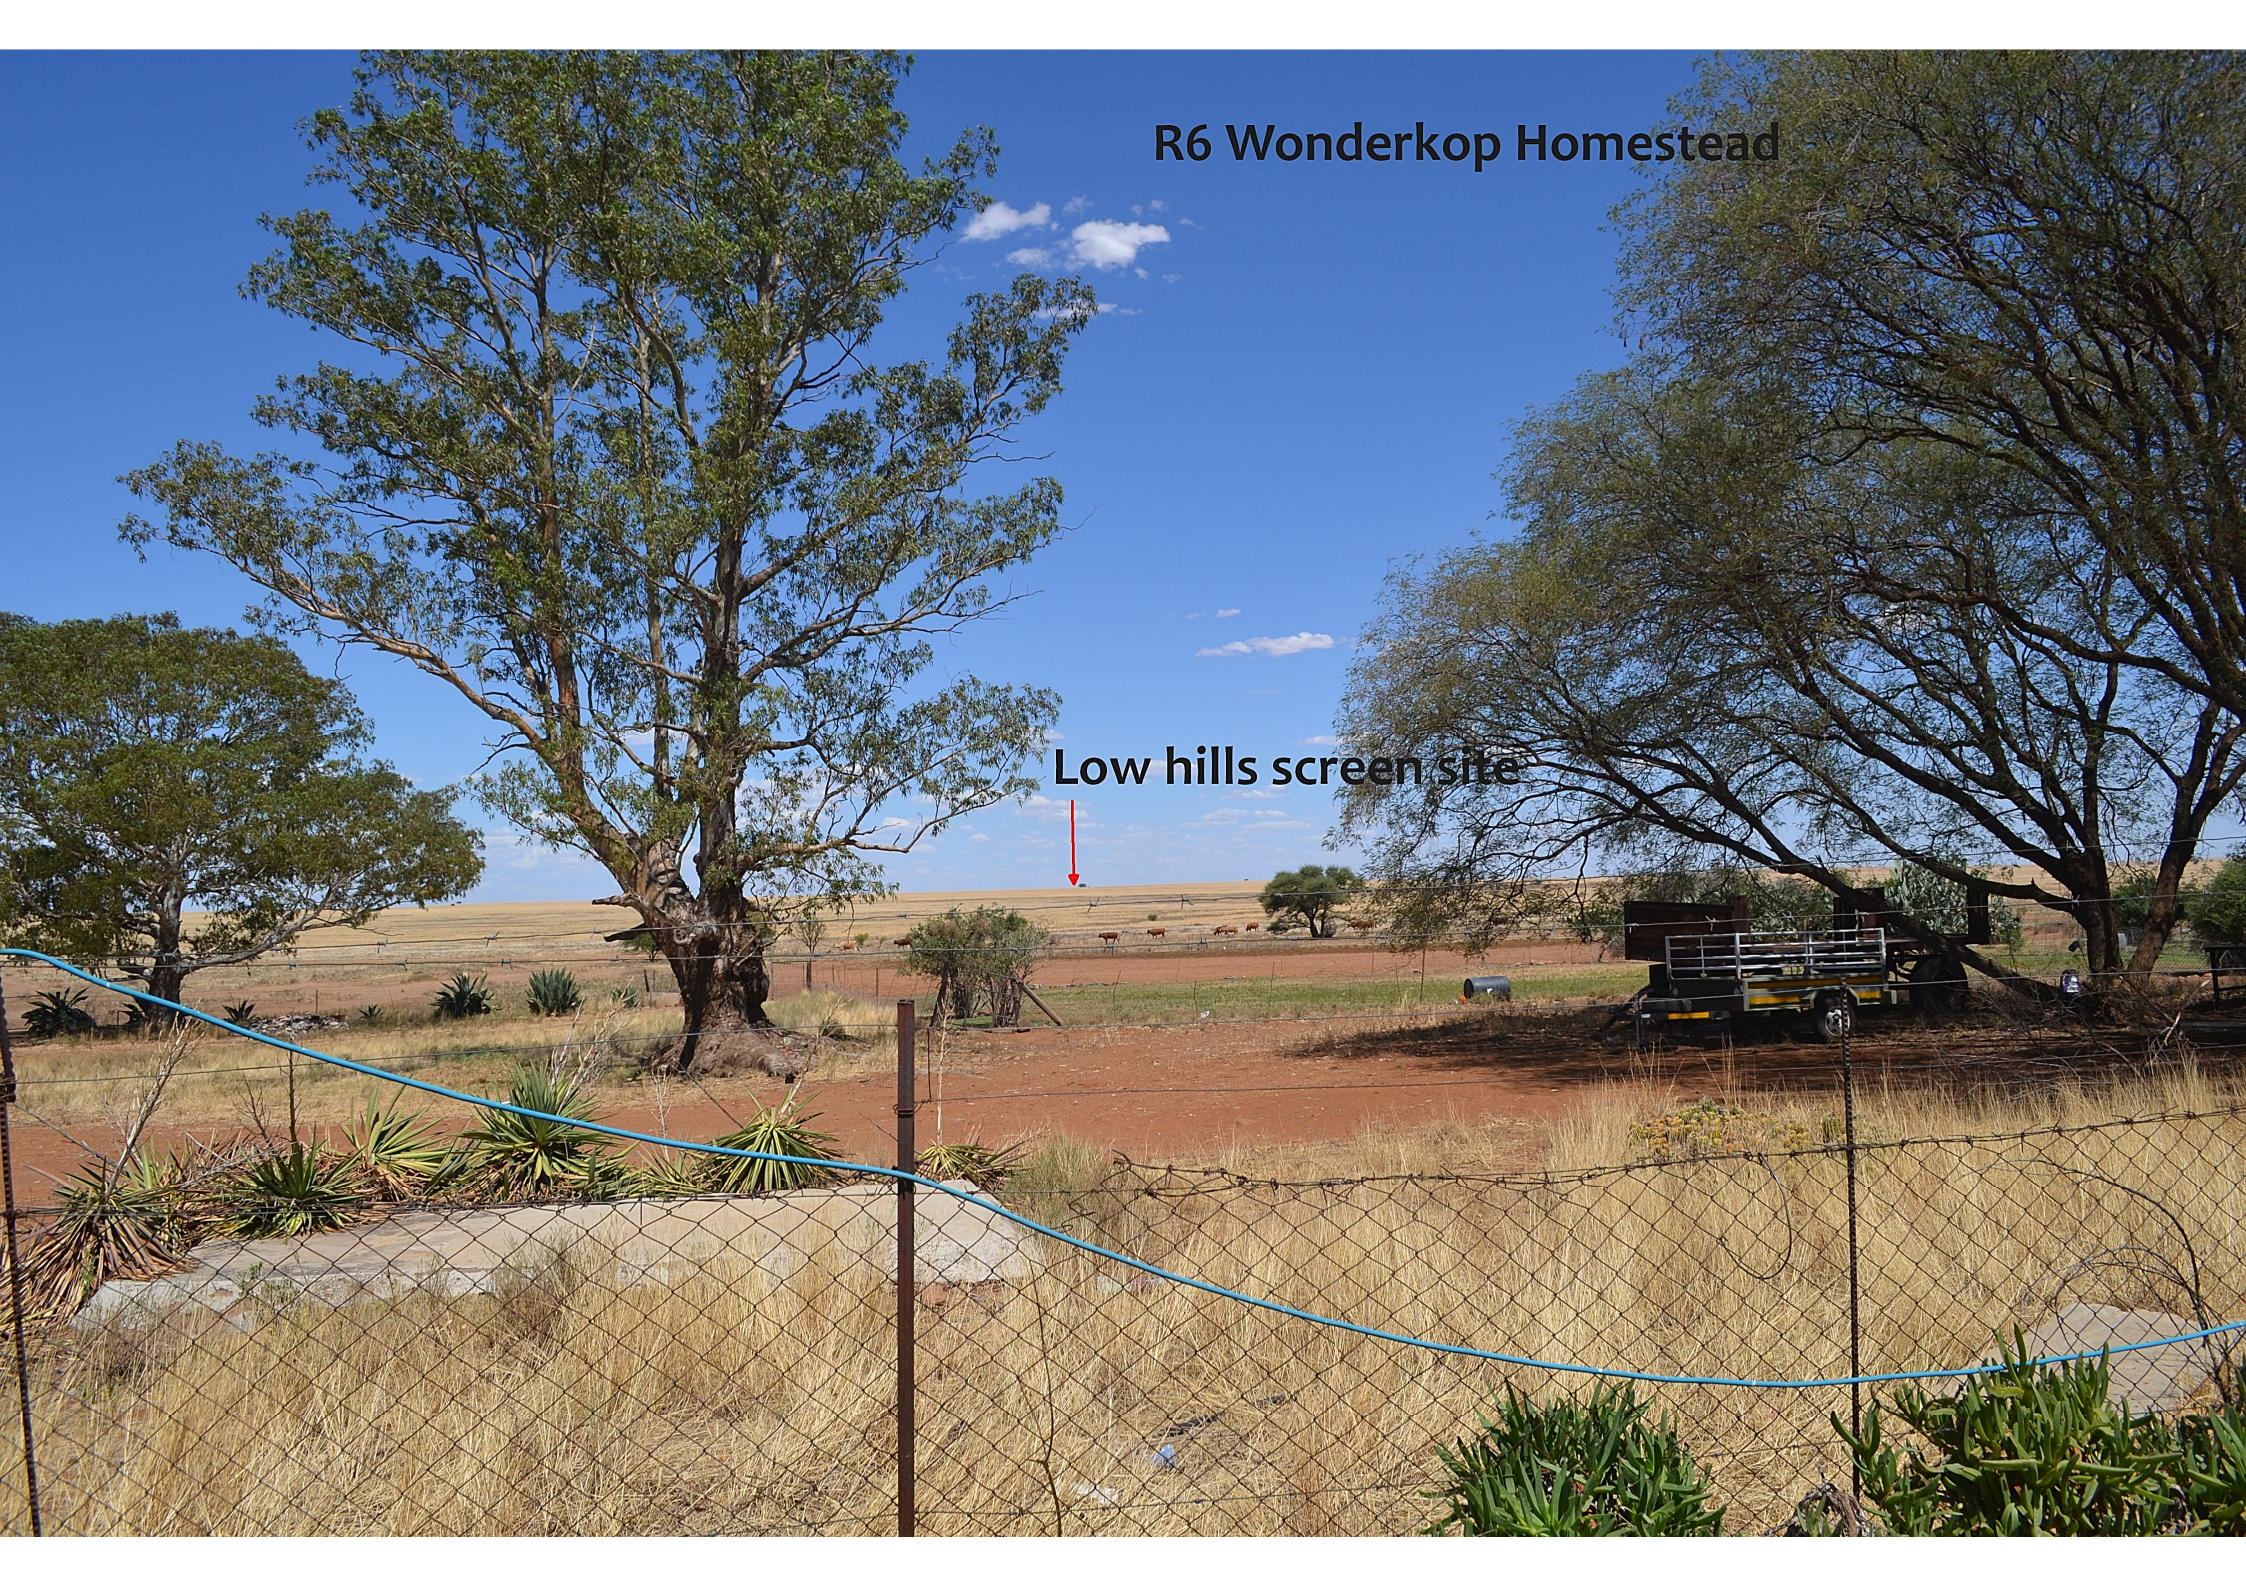
R6 Wonderkop Homestead

Low hills screen site

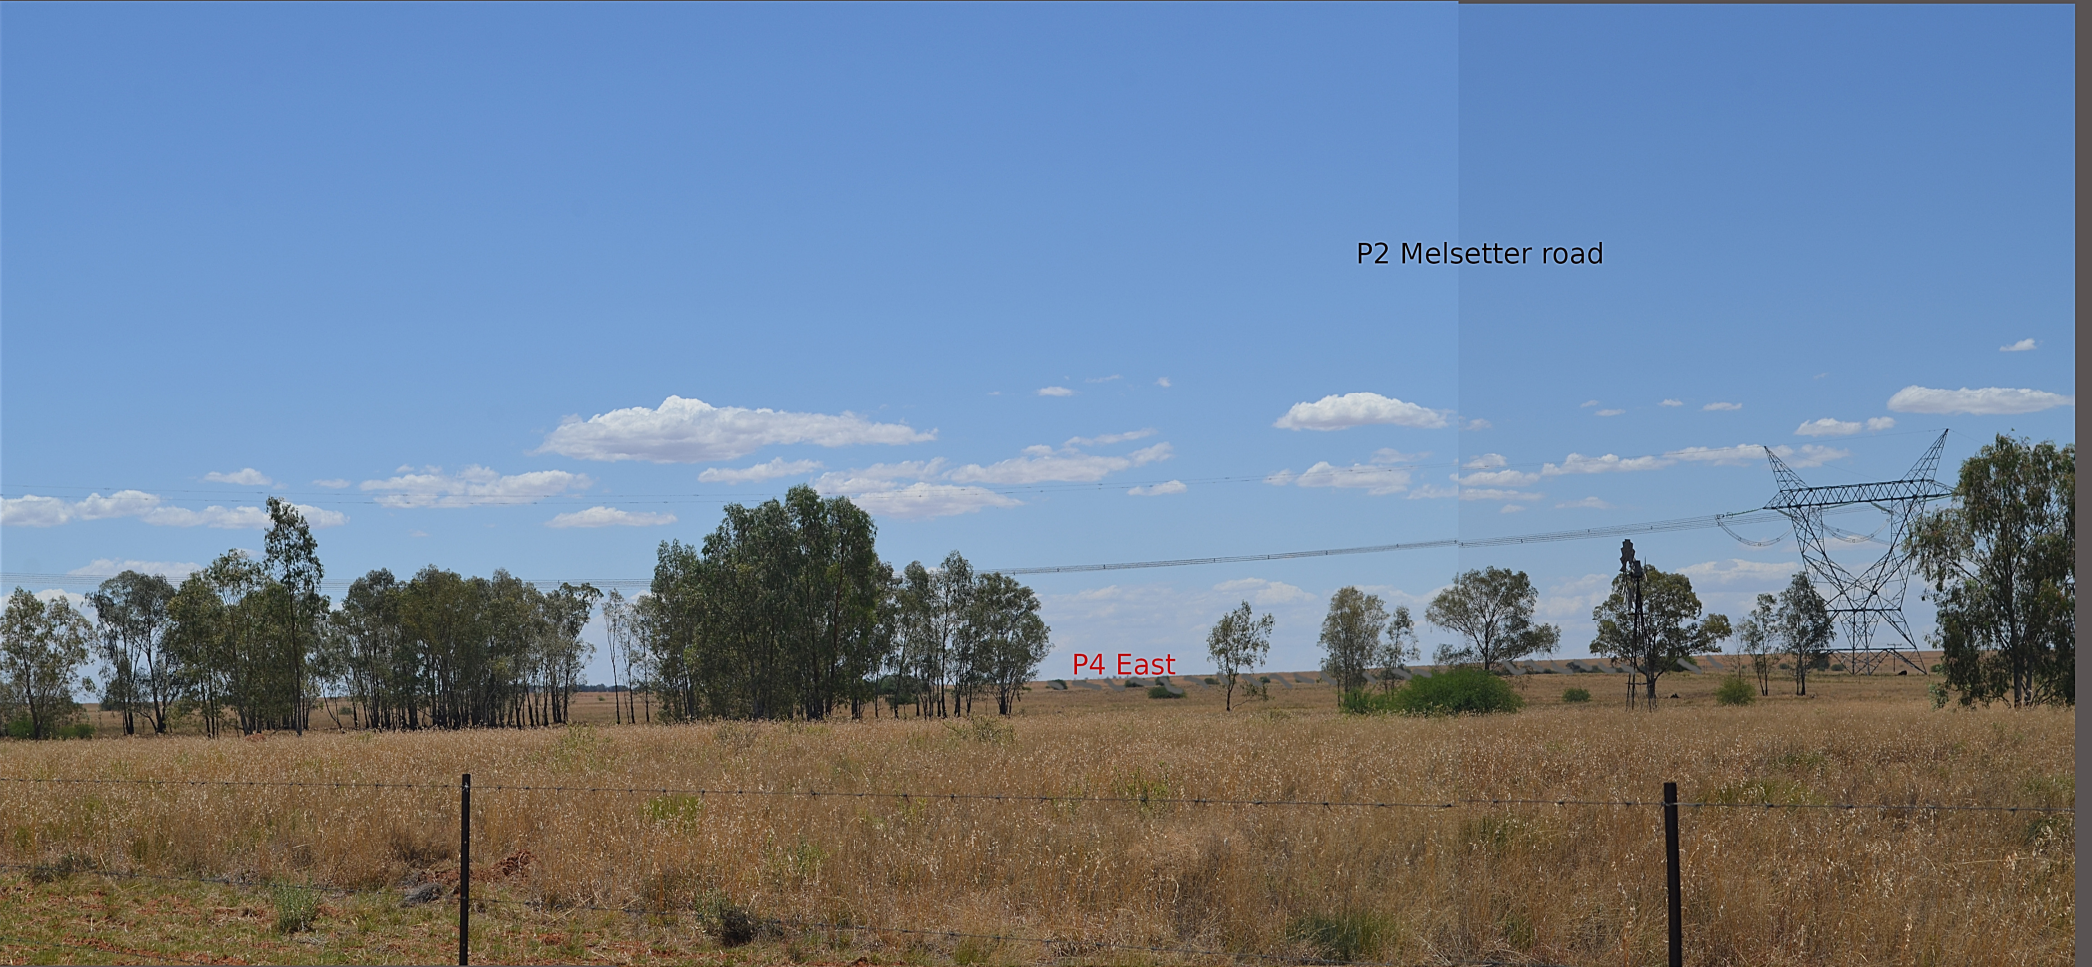
R2 Melsetter Homestead

PV arrays behind trees with sideview to observer

HV Powerlines
