**Appendix G – Specialist Reports/Opinions:
G3c (Visual Impact Assessment)**

**VISSERSPAN PV FACILITY
PROJECT 1
FARM 40, DEALESVILLE, FREE STATE**

VISUAL ASSESSMENT

Final Report

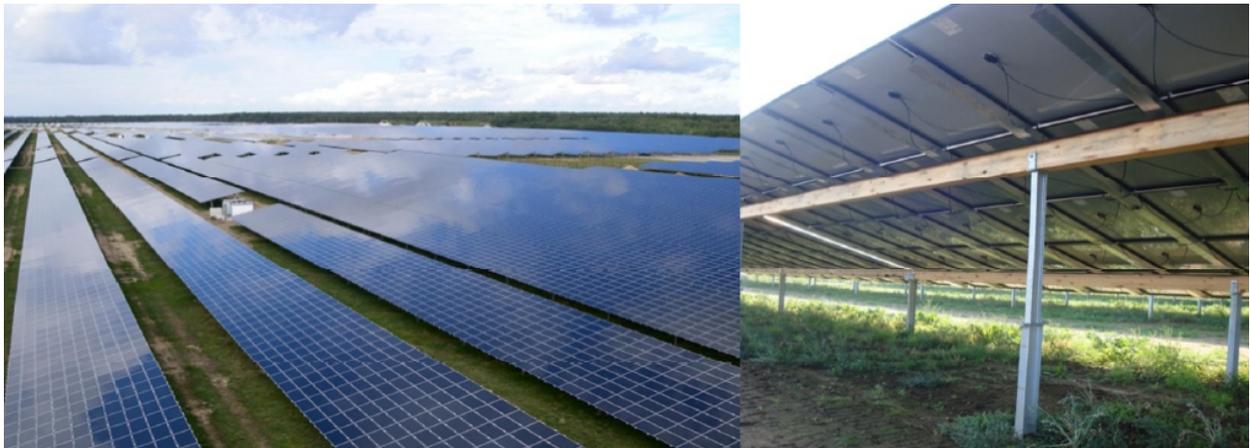
Figure 2: Typical single axis PV arrays

The development will consist of solar panels mounted on steel supporting array structures and are configured into a number of sub array systems. The units will be able to tilt up and down but not rotate with the sun. The units will thus always be positioned in a northerly direction.

Site needs some leveling. Expected height 2,4m but maximum height for any structures assumed at 3m above ground. Arrays orientated east-west with horizontal movement north-south

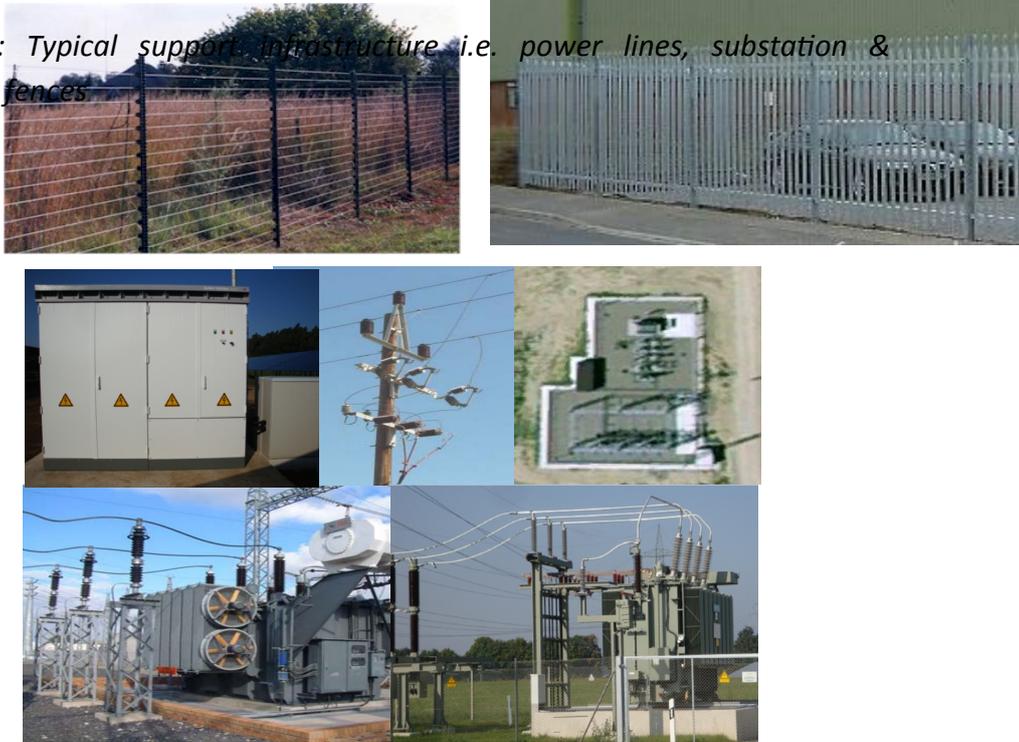
Figure 3: Typical support infrastructure i.e. power lines, substation & switches, fences

Site circumscribed with fire access road and fence. Probably consisting of electrified, galvanized palisade fence of 2,4m in height.

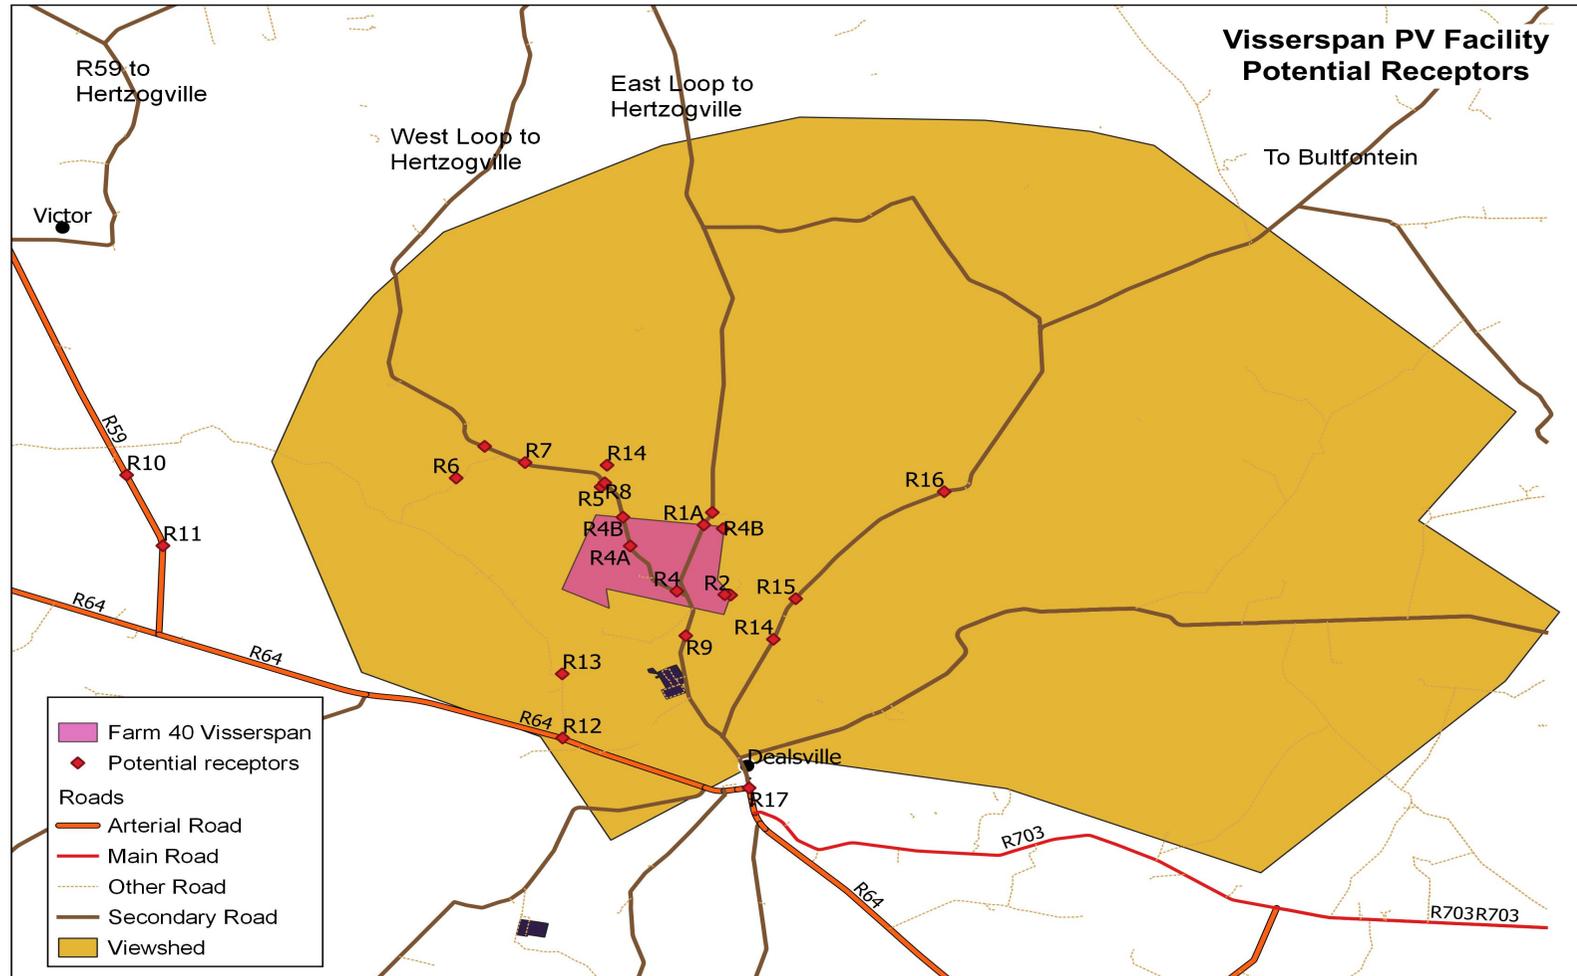
Figure 3: Viewshed

The catchment area is limited to the 1300 to 1320 relief line resulting in a fairly limited viewshed. The viewshed extend to the north as the area south of Dealesville slopes down towards the Modder river valley.

Although the topography may appear fairly flat, the landscape is characterized by undulating rises and valleys which create significant visual screening for infrastructure with a low vertical extent. Any structures under 10m can be easily absorbed into the landscape.

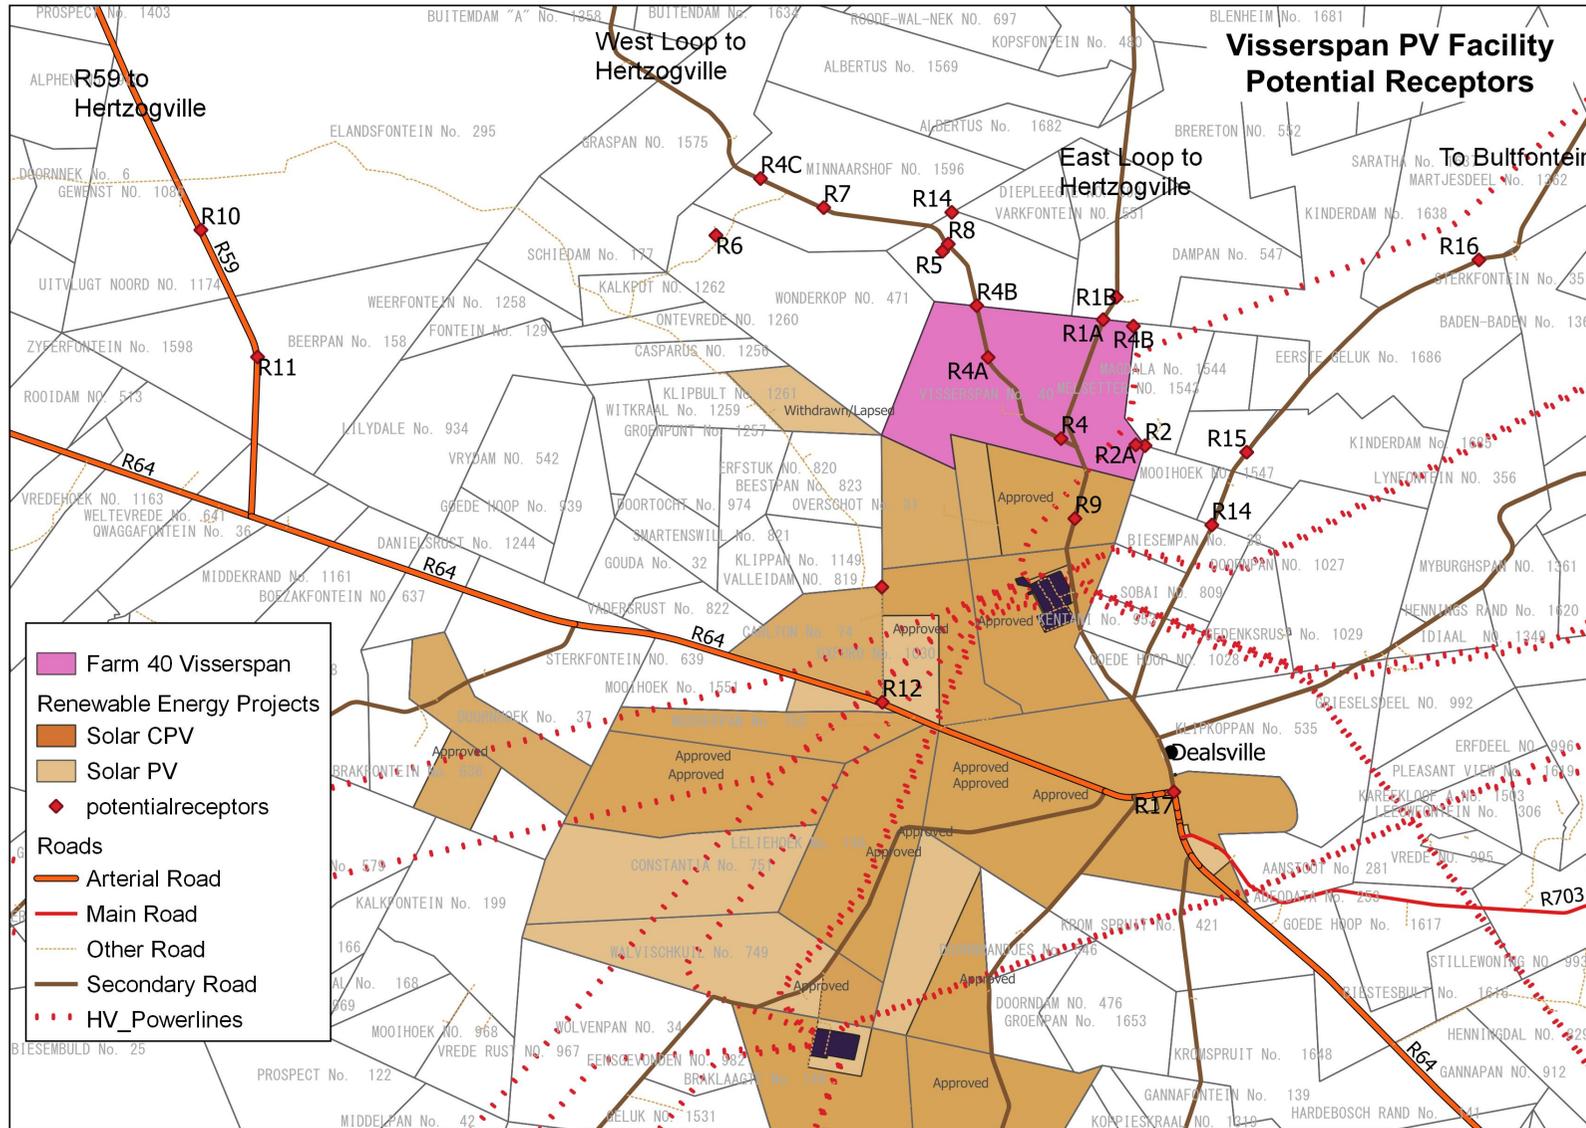
Figure 4: Potential Visual Receptors

Gravel road from Dealesville to Herzogville (west loop loop)	Low order road with low traffic volumes. The road skirt the site to the east	Assess profile. Low visibility expected (R4, R8, R7)
R703 to Soutpan	The road is on lower gradient and thus outside the viewshed	Outside viewshed.
Visserspan Homestead	Homestead will be amid the project.	Medium sensitivity. Owner of property
Rooirand Homestead	Close to the site on same gradient. View directly towards PV arrays	Assess profile. Homestead of medium sensitivity (R85)
Wonderkop Homestead	Towards the north on higher ground	Assess profile. Homestead of medium sensitivity (R6)
Melsetter homestead	Abutting eastern boundary of farm 40	Assess profile. Homestead of medium sensitivity (R2)
Mooihoek/Kinderdam Hunter's cottage	Mooihoek indicated tourism accommodation but on inquiry it was indicated the only unit is the Hunter's cottage to the east of the Bultfontein road	Assess Bultfontein road profile. Hunters cottage on same gradient (R14, R15)

Dealesville	The town is on a lower altitude and screened by the landscape and landscape elements	Assess Profile. Medium sensitivity. (R17)

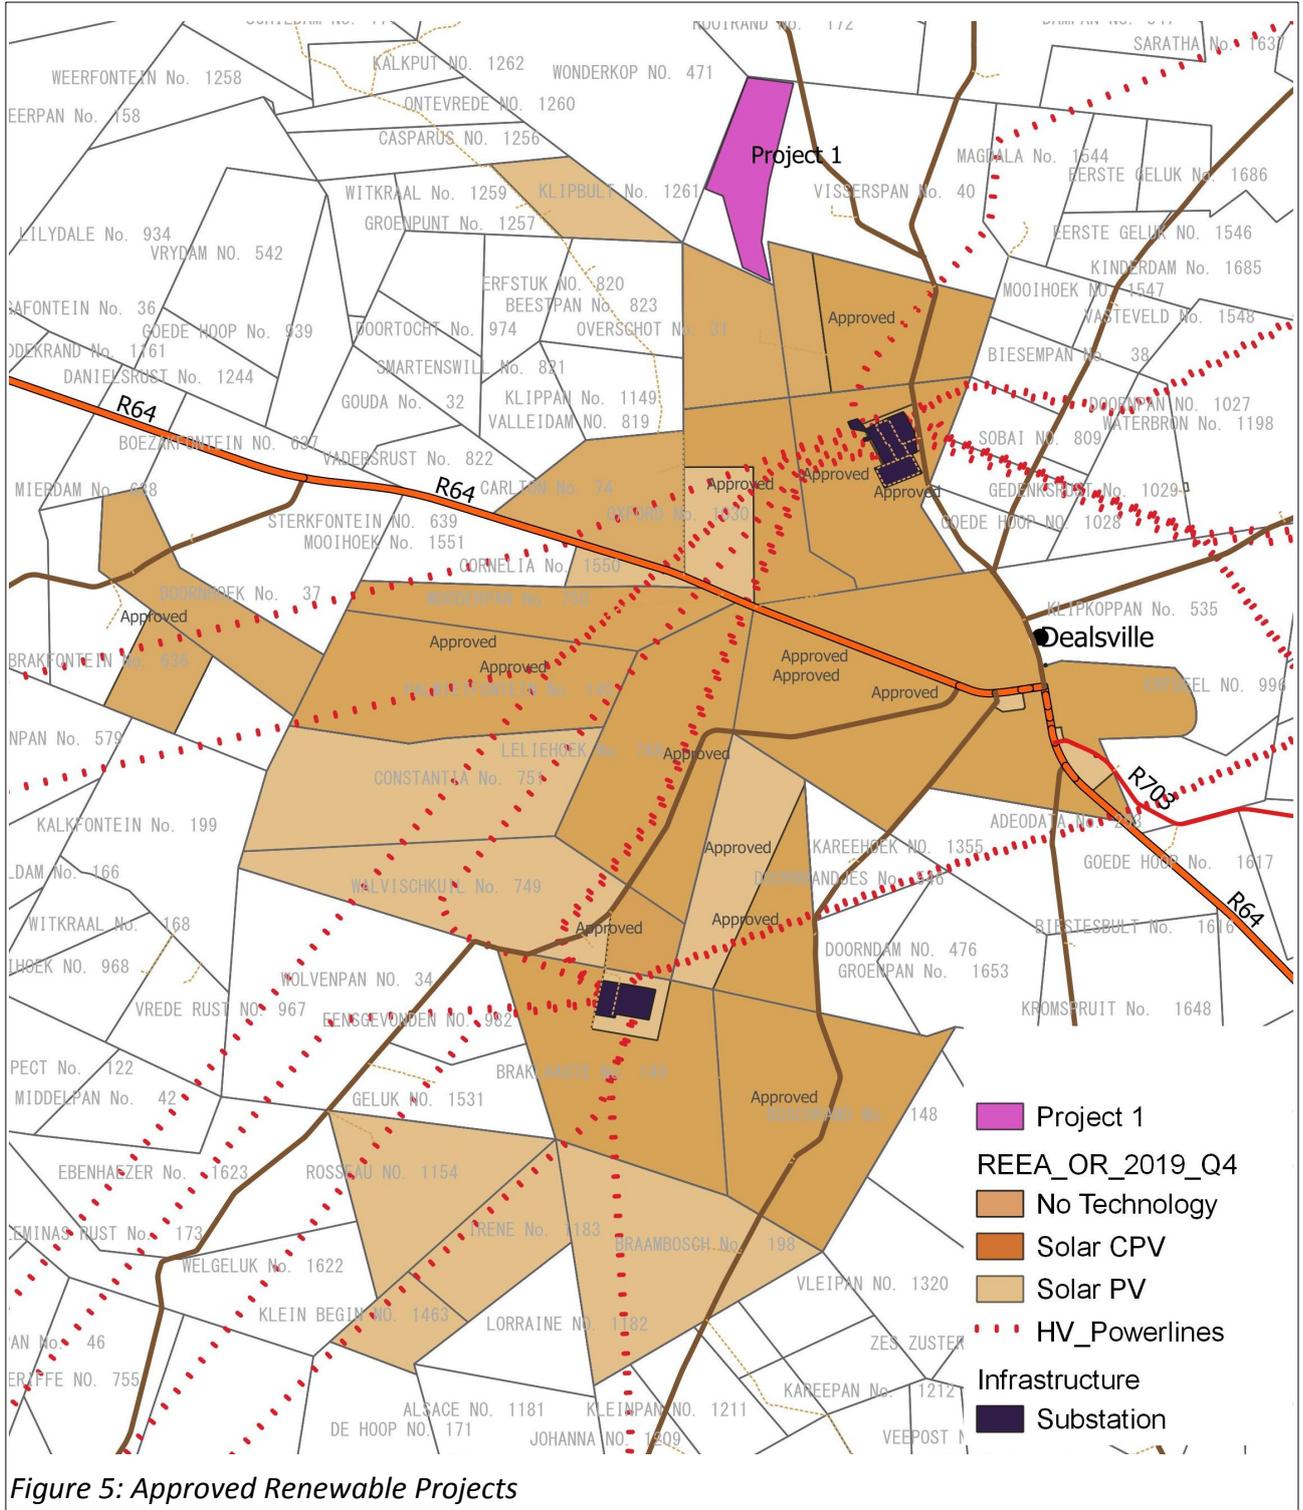
Figure 5: Approved Renewable Projects

The cumulative impact of Project 1 of the Visserspan PV facility contribute little to the overall cumulative impact of the total number of PV facilities already approved. Due to the fact that thresholds have not been determined on a regional level, a statement to that effect on a project level is not appropriate.

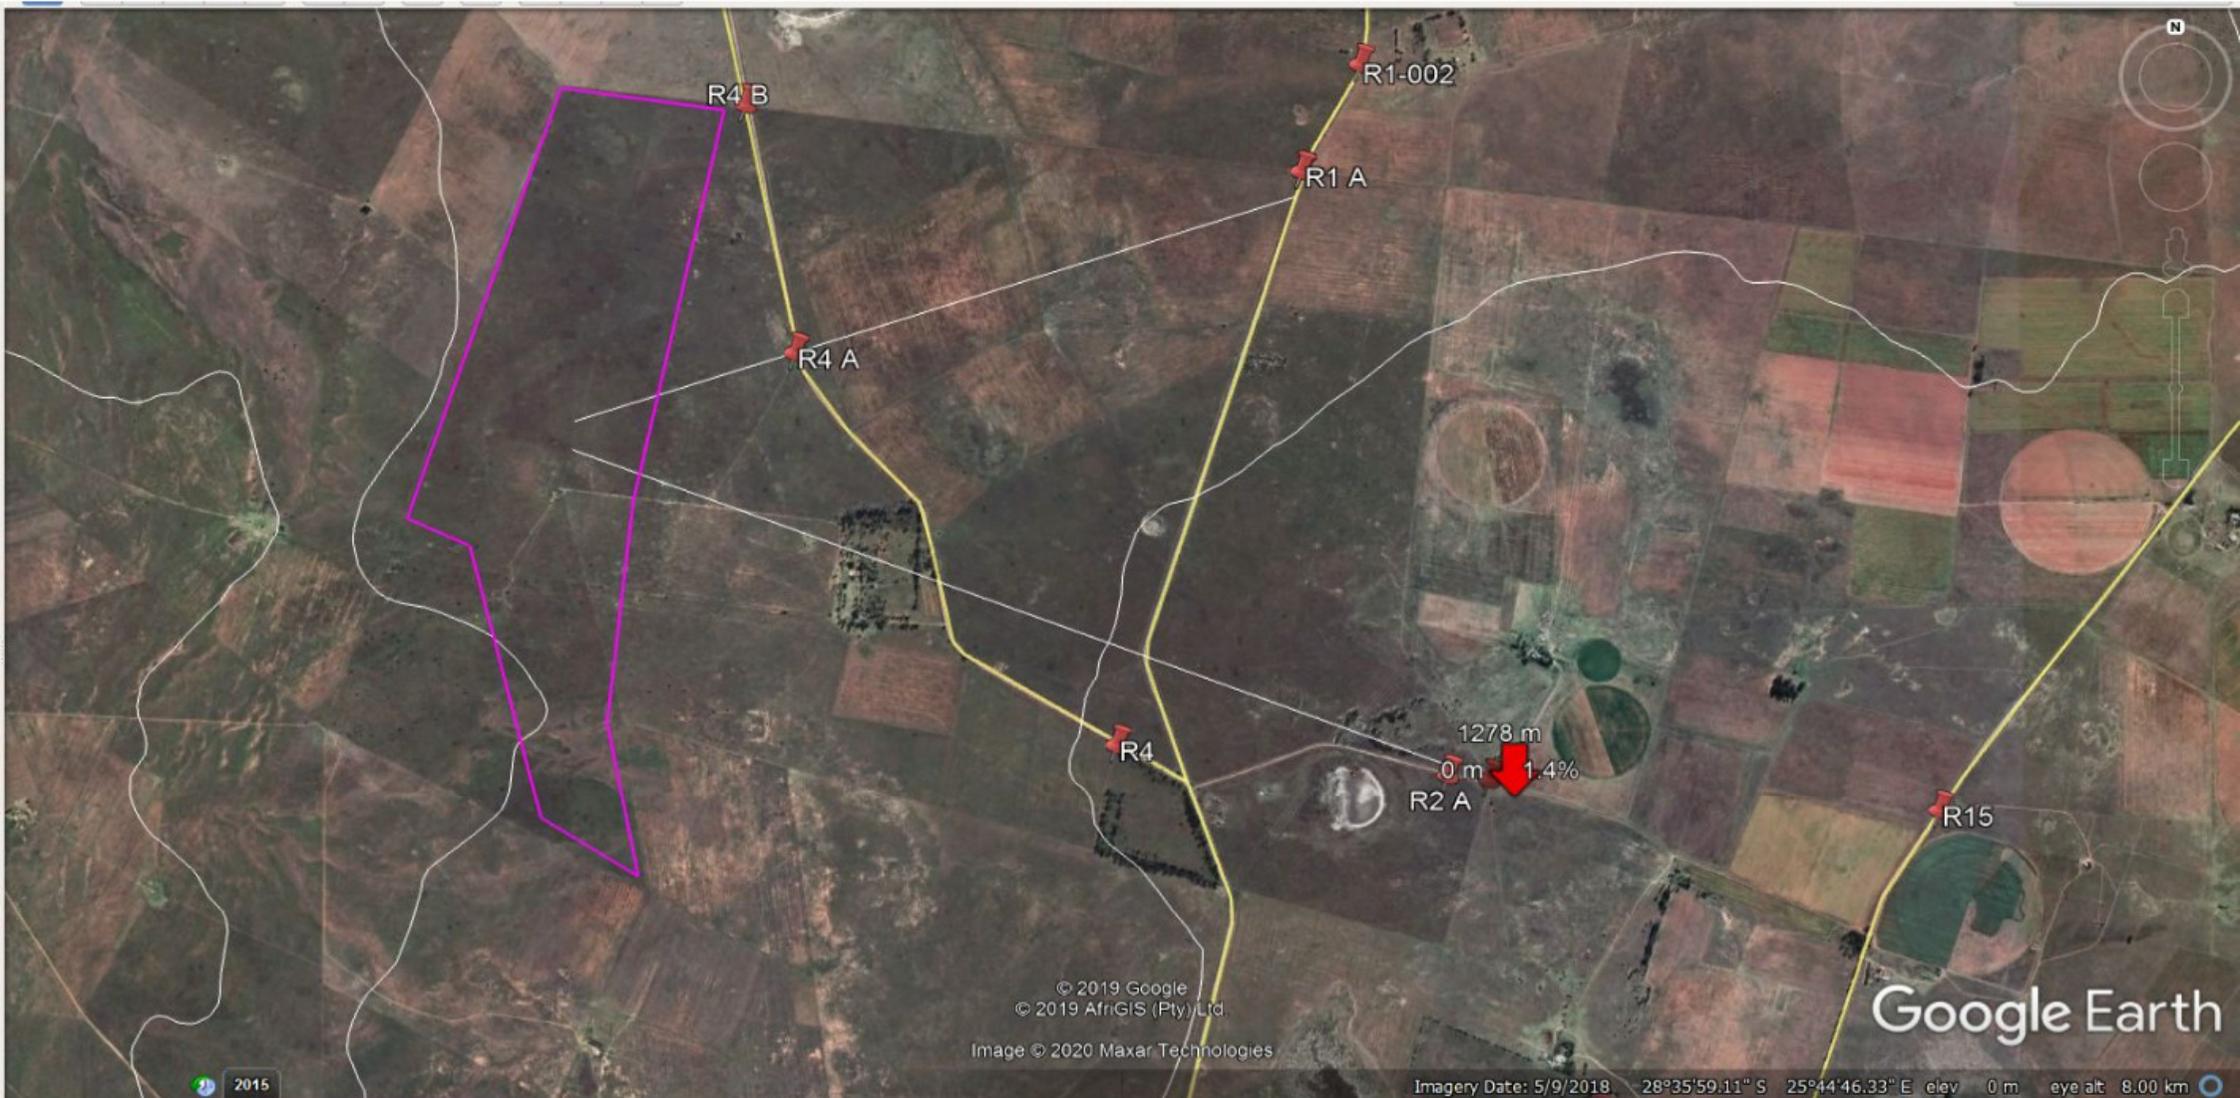
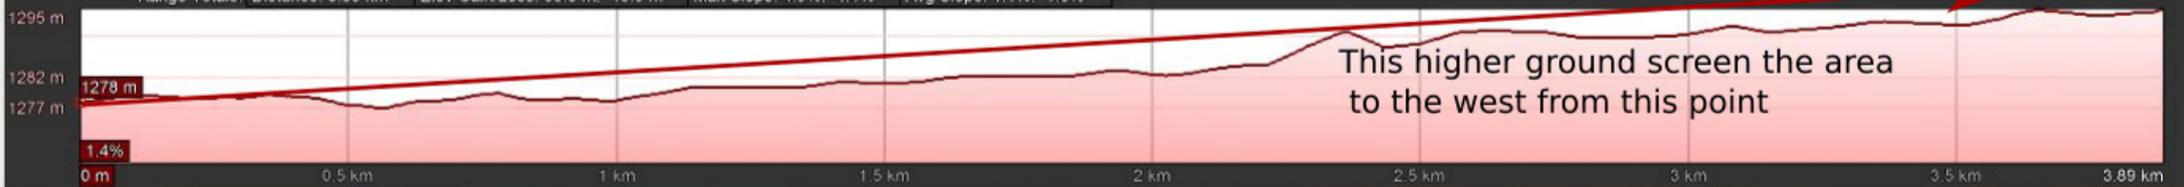
Graph Min. Avg. Max Elevation: 1277, 1285, 1295 m
Range Totals: Distance: 3.89 km Elev Gain/Loss: 30.3 m, -13.5 m Max Slope: 4.9%, -4.4% Avg Slope: 1.1%, -1.0%

This higher ground screens the area to the west from this point

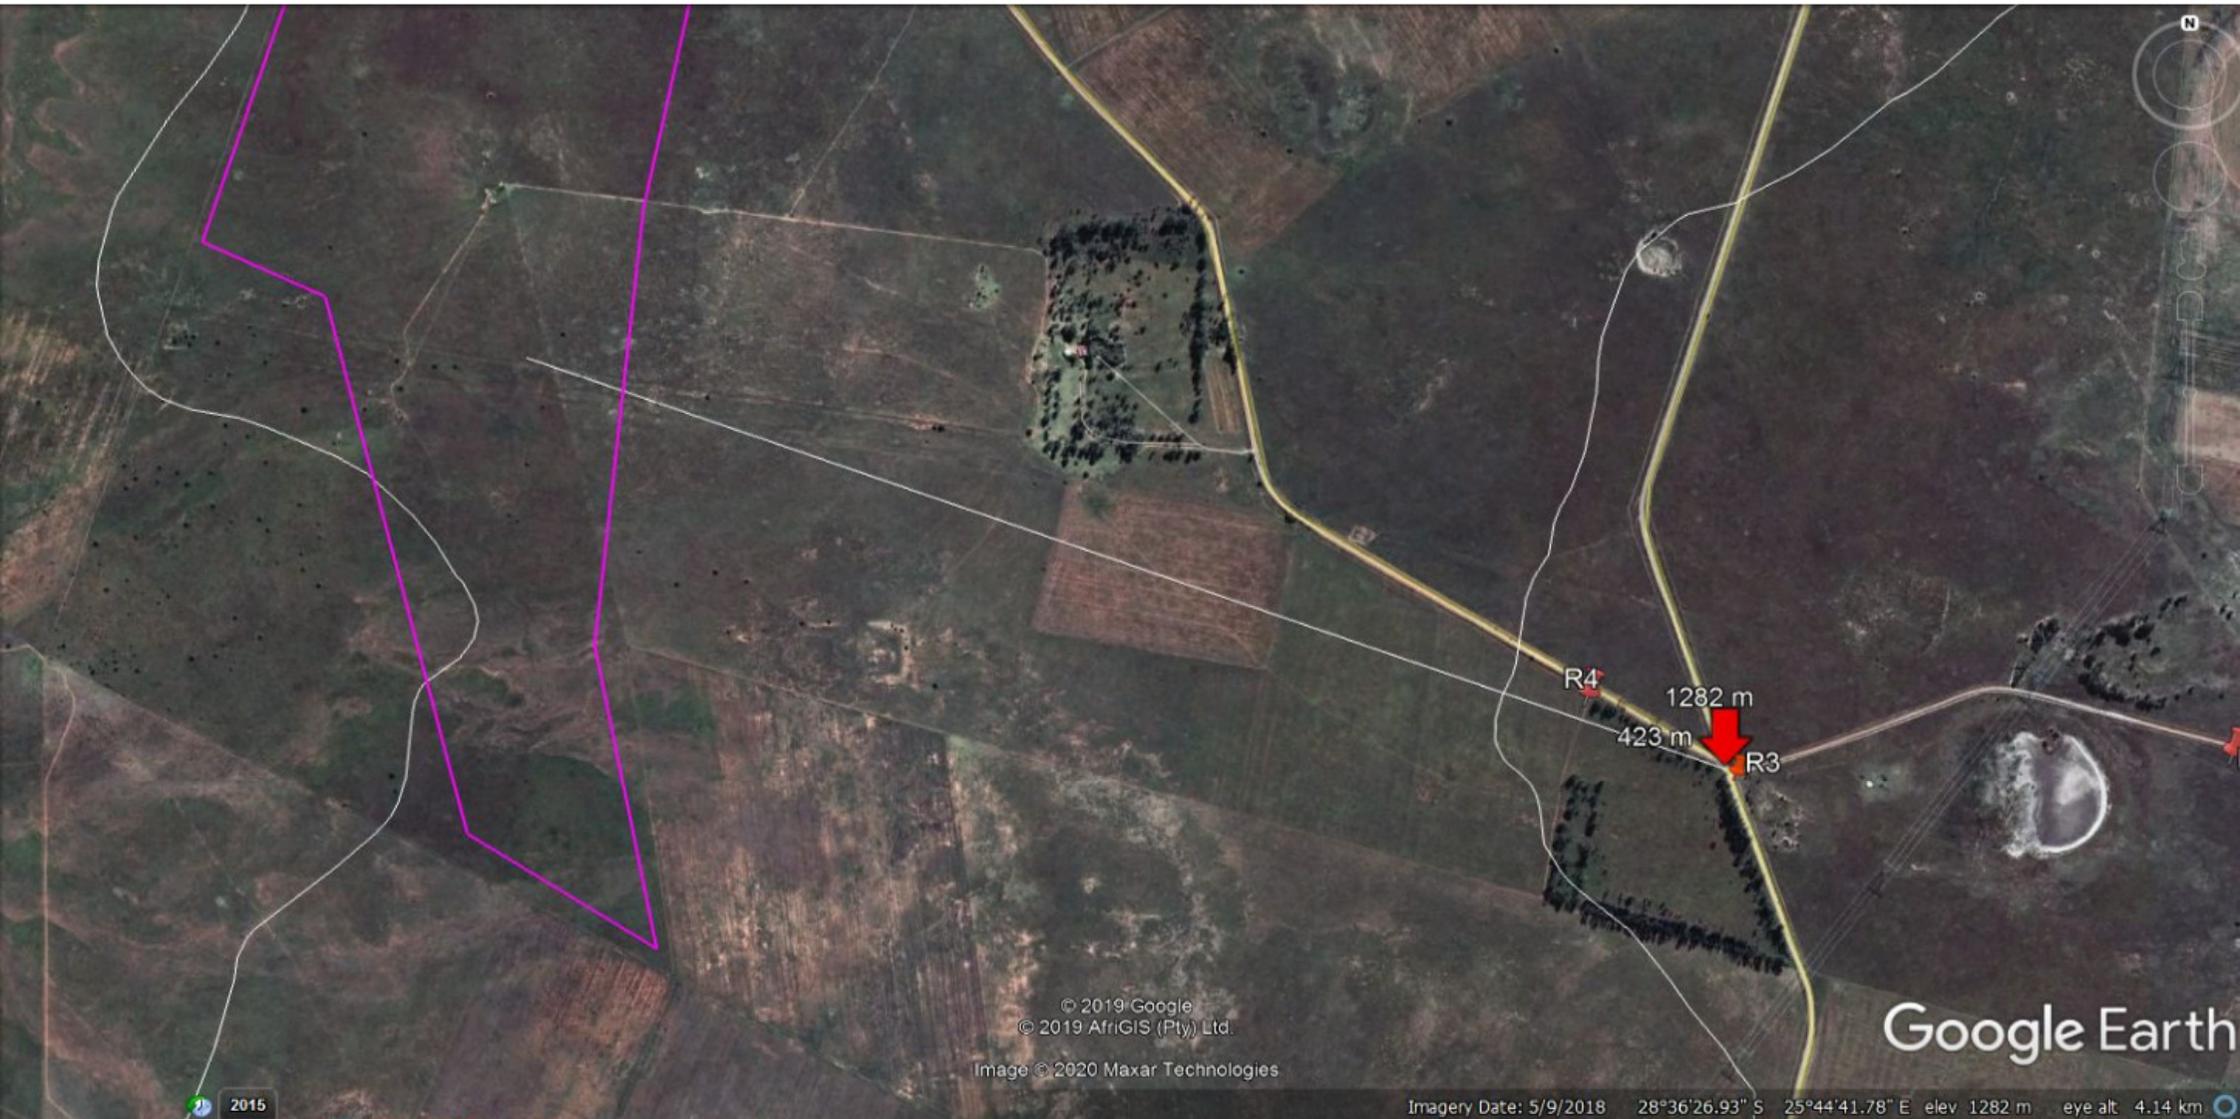
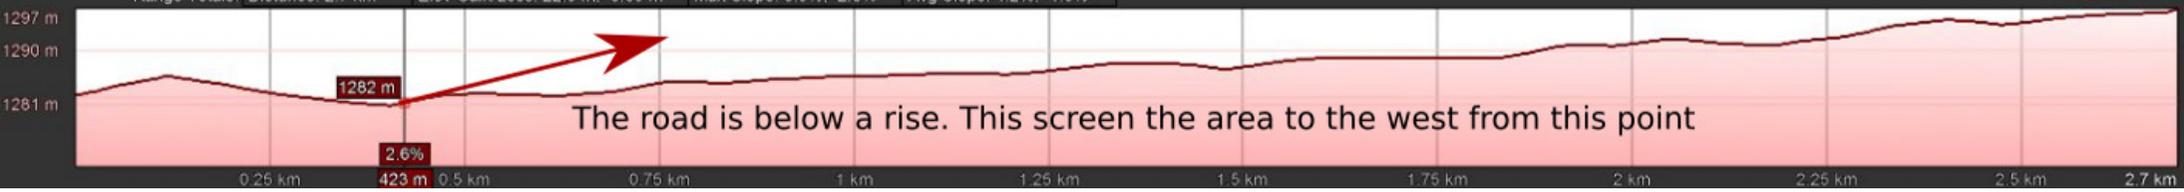
Graph: Min, Avg, Max Elevation: 1281, 1288, 1297 m
Range Totals: Distance: 2.7 km Elev Gain/Loss: 22.5 m, -8.69 m Max Slope: 3.9%, -2.8% Avg Slope: 1.2%, -1.0%

The road is below a rise. This screen the area to the west from this point

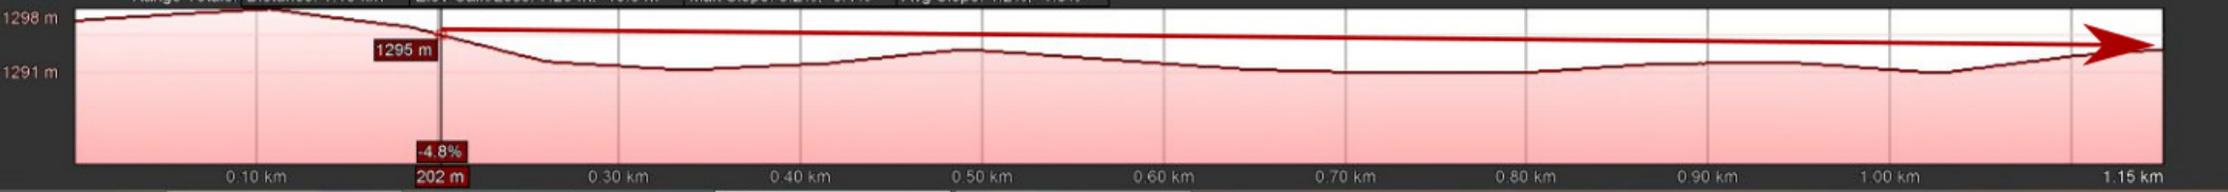
Graph: Min, Avg, Max Elevation: 1291, 1293, 1298 m
Range Totals: Distance: 1.15 km Elev Gain/Loss: 7.23 m, -10.3 m Max Slope: 3.2%, -6.1% Avg Slope: 1.2%, -1.8%

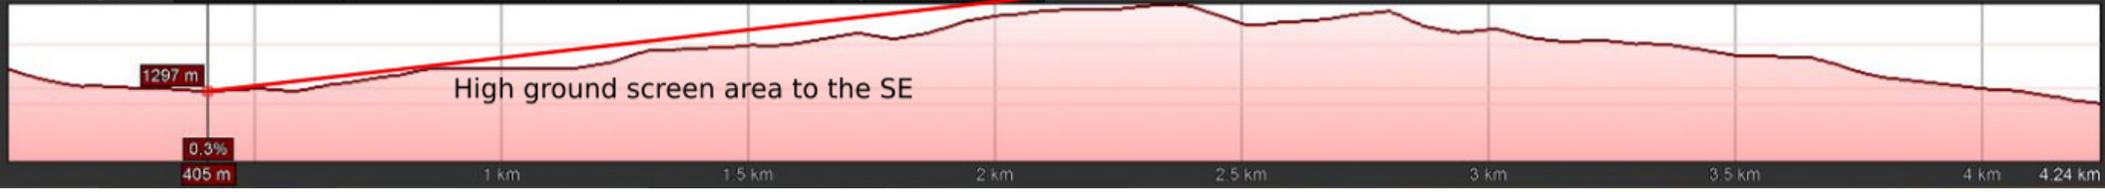
Graph: Min, Avg, Max Elevation: 1295, 1304, 1312 m
Range Totals: Distance: 4.24 km Elev Gain/Loss: 20.1 m, -26.3 m Max Slope: 3.0%, -4.2% Avg Slope: 0.9%, -1.3%

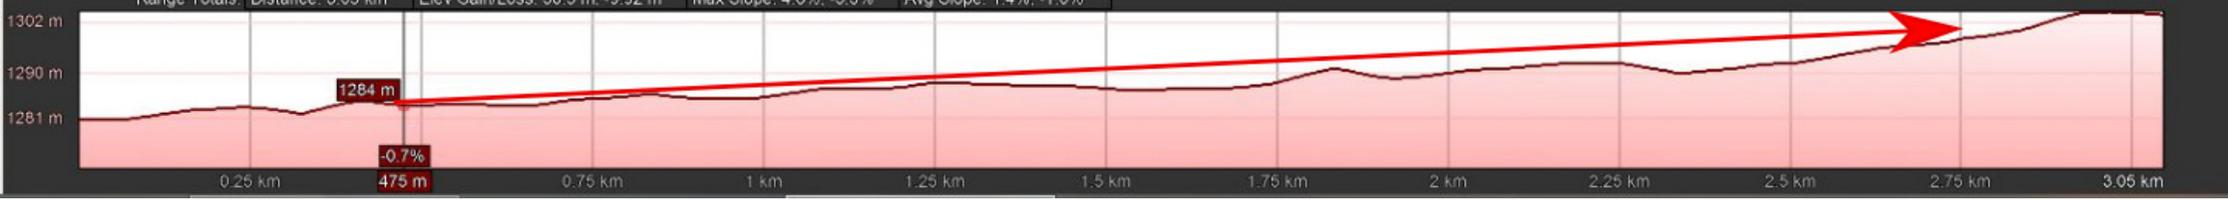
2015
Graph: Min, Avg, Max Elevation: 1281, 1289, 1302 m
Range Totals: Distance: 3.05 km Elev Gain/Loss: 30.5 m -9.92 m Max Slope: 4.6%, -3.3% Avg Slope: 1.4%, -1.0%

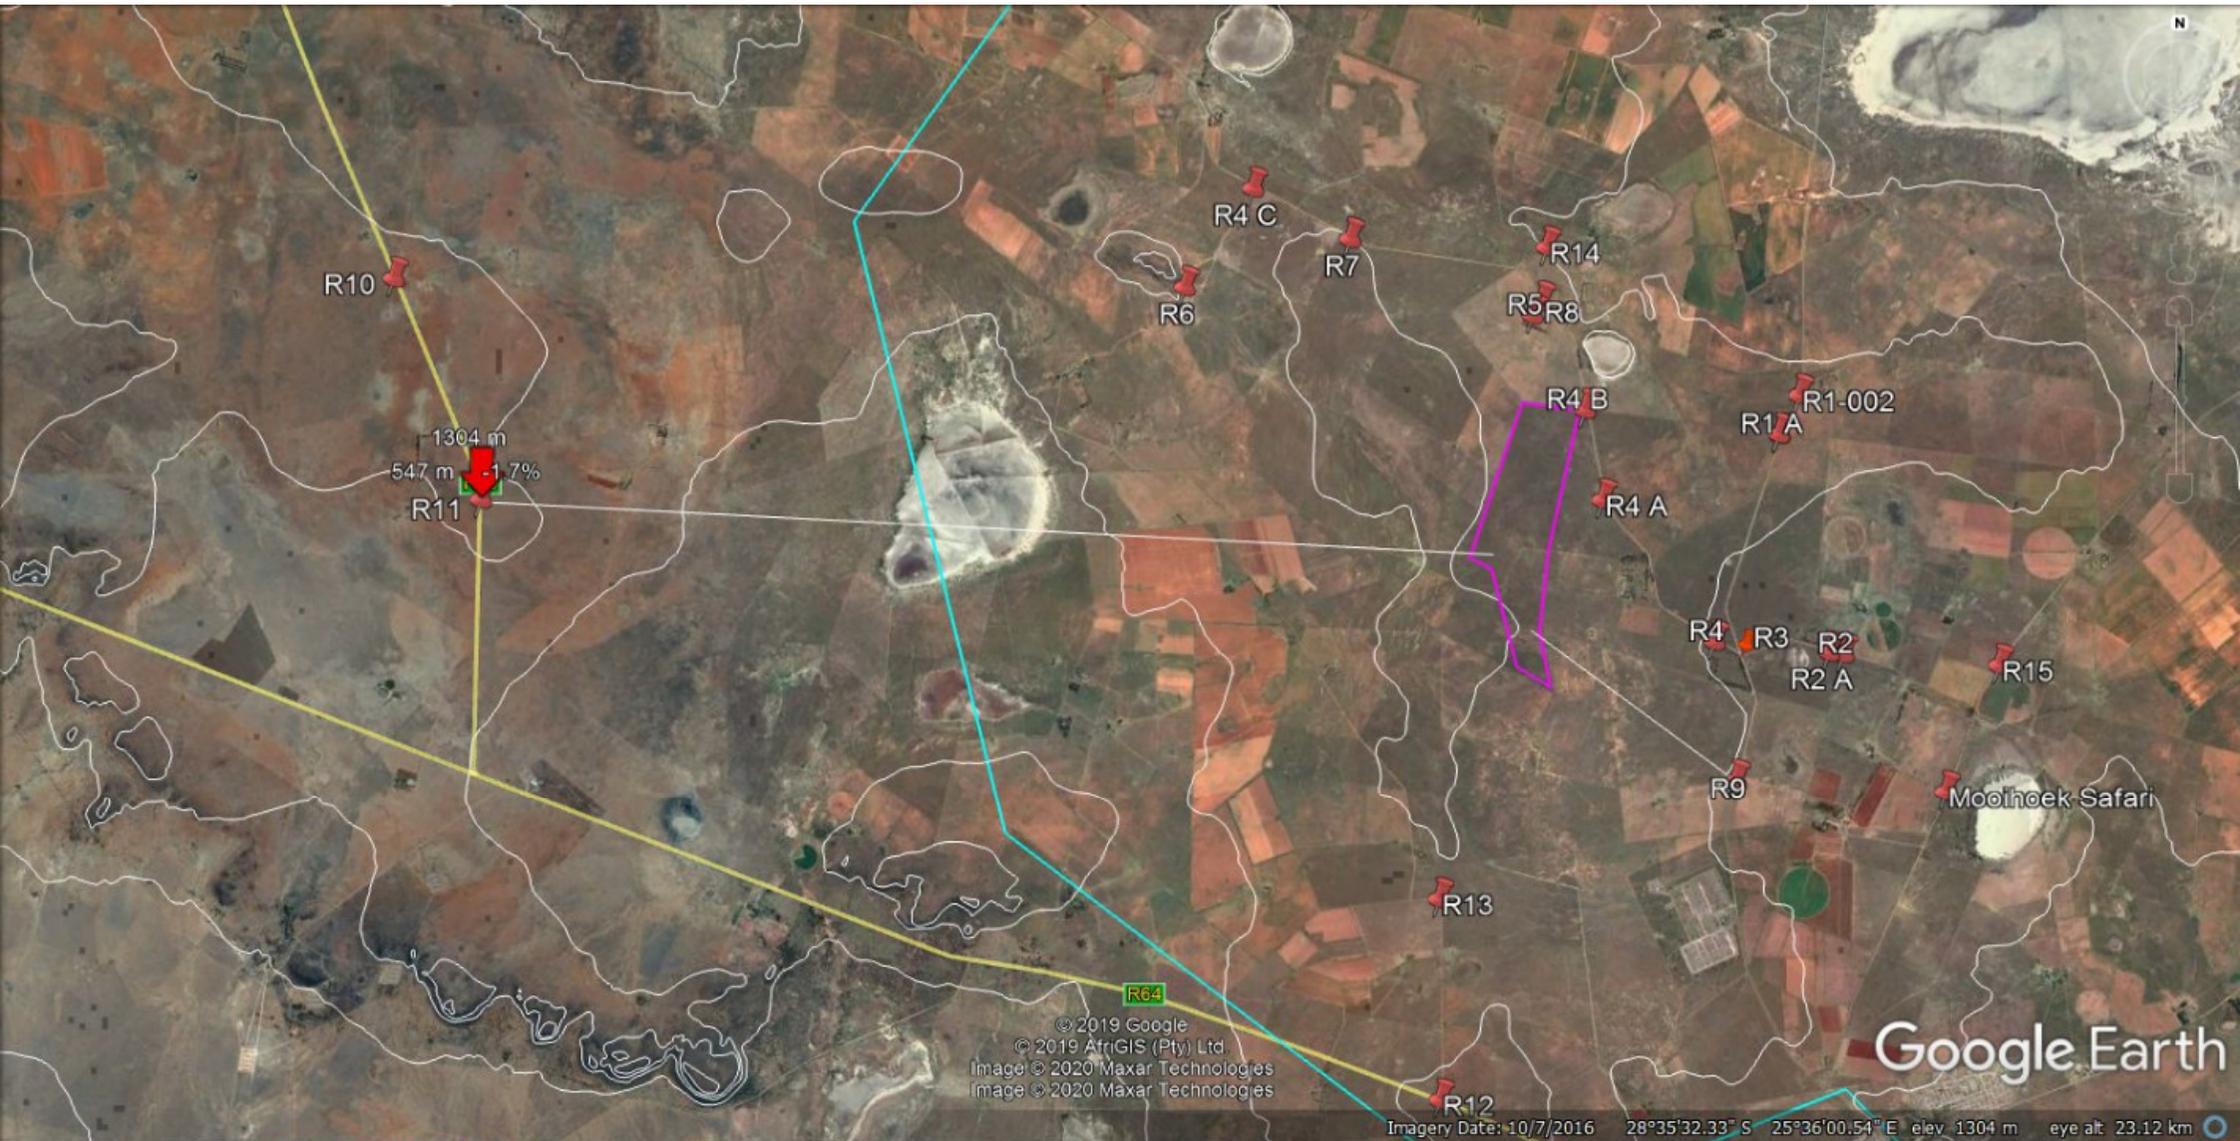
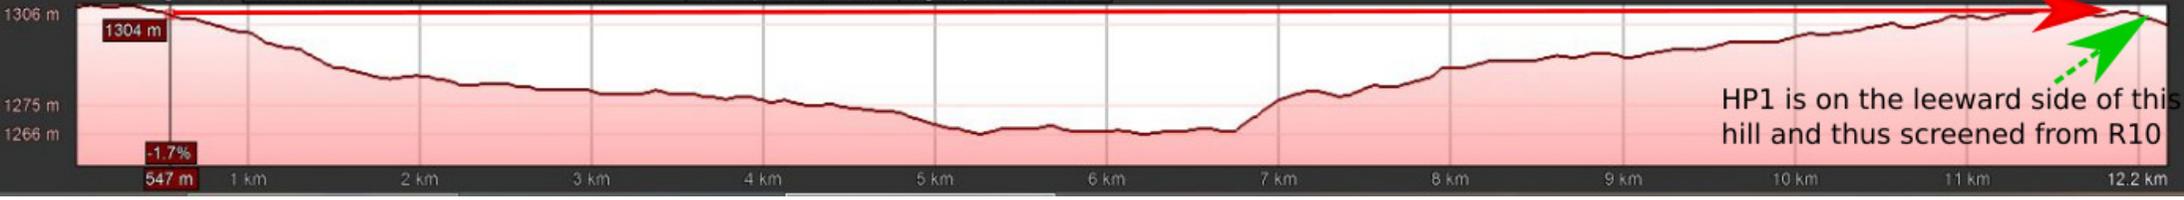
Graph: Min. Avg. Max Elevation: 1266, 1286, 1306 m
Range Totals: Distance: 12.2 km Elev Gain/Loss: 59.1 m -64.8 m Max Slope: 4.6%, -4.4% Avg Slope: 0.9%, -1.1%

HP1 is on the leeward side of this hill and thus screened from R10

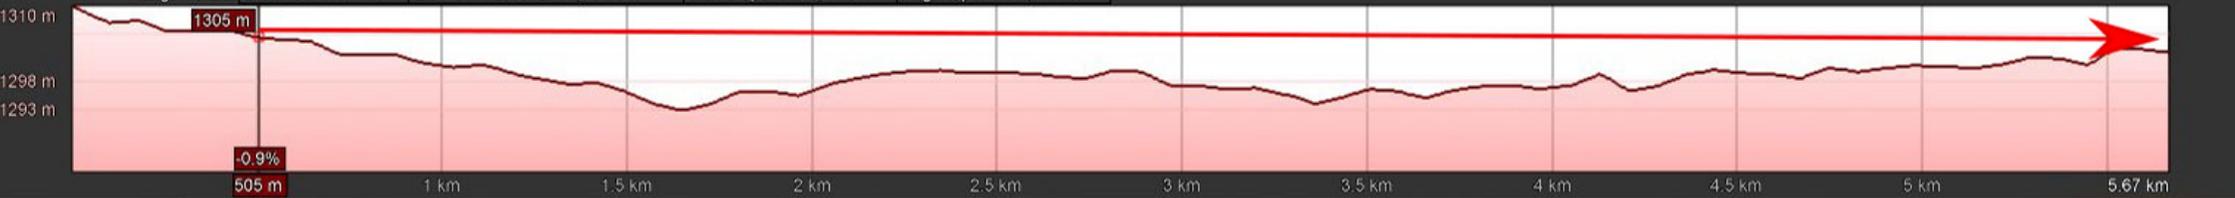
Graph: Min, Avg, Max Elevation: 1293, 1299, 1310 m
Range Totals: Distance: 5.67 km Elev Gain/Loss: 27 m, -34.5 m Max Slope: 3.9%, -4.0% Avg Slope: 1.0%, -1.1%

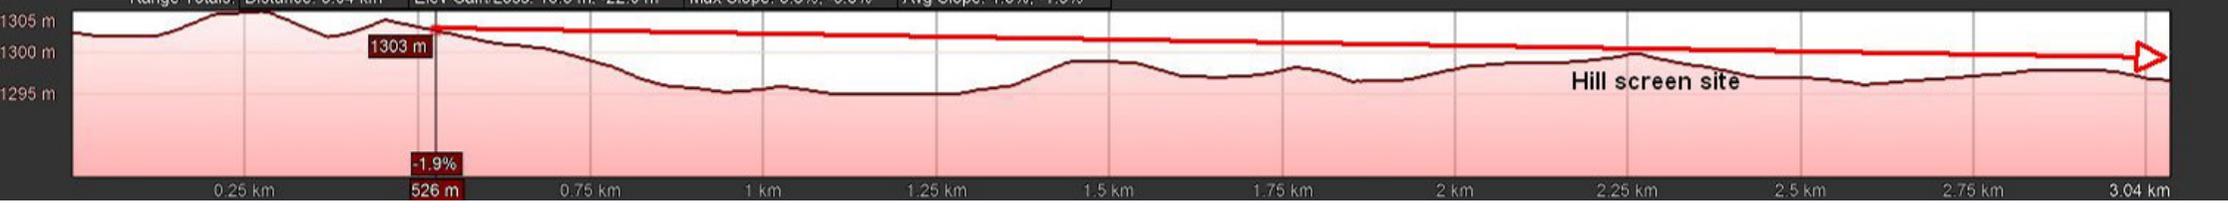
Graph: Min, Avg, Max Elevation: 1295, 1299, 1305 m
Range Totals: Distance: 3.04 km Elev Gain/Loss: 16.3 m, -22.0 m Max Slope: 3.8%, -3.8% Avg Slope: 1.0%, -1.5%

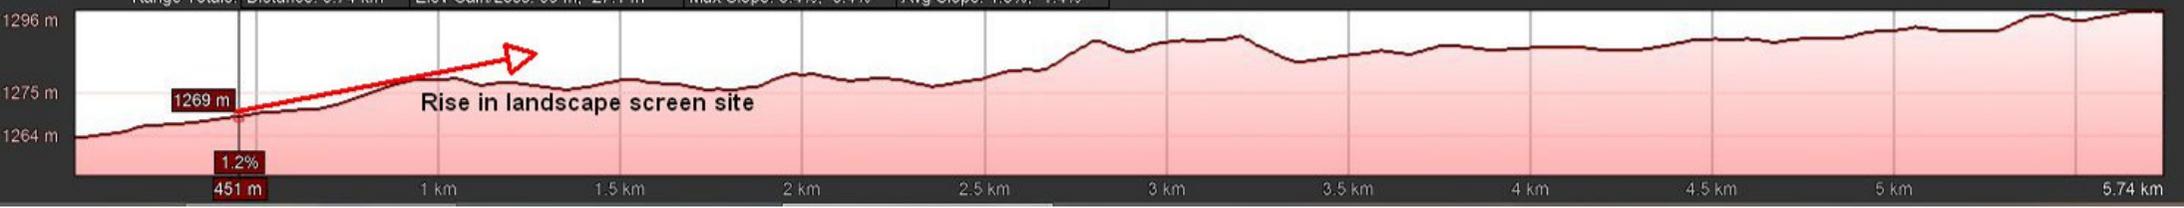
Graph: Min, Avg, Max Elevation: 1264, 1282, 1296 m
Range Totals: Distance: 5.74 km Elev Gain/Loss: 59 m, -27.1 m Max Slope: 6.4%, -5.4% Avg Slope: 1.5%, -1.4%

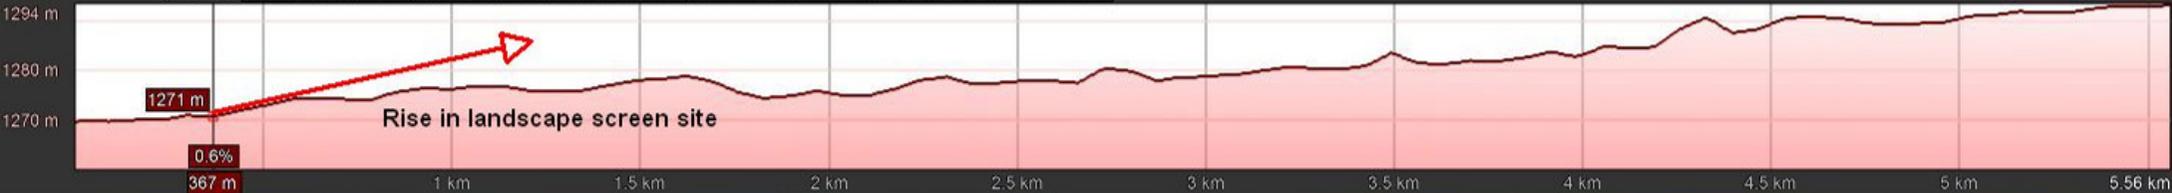
Graph: Min, Avg, Max Elevation: 1270, 1281, 1294 m
Range Totals: Distance: 5.56 km Elev Gain/Loss: 45.8 m, -21.6 m Max Slope: 5.5%, -4.7% Avg Slope: 1.2%, -1.1%

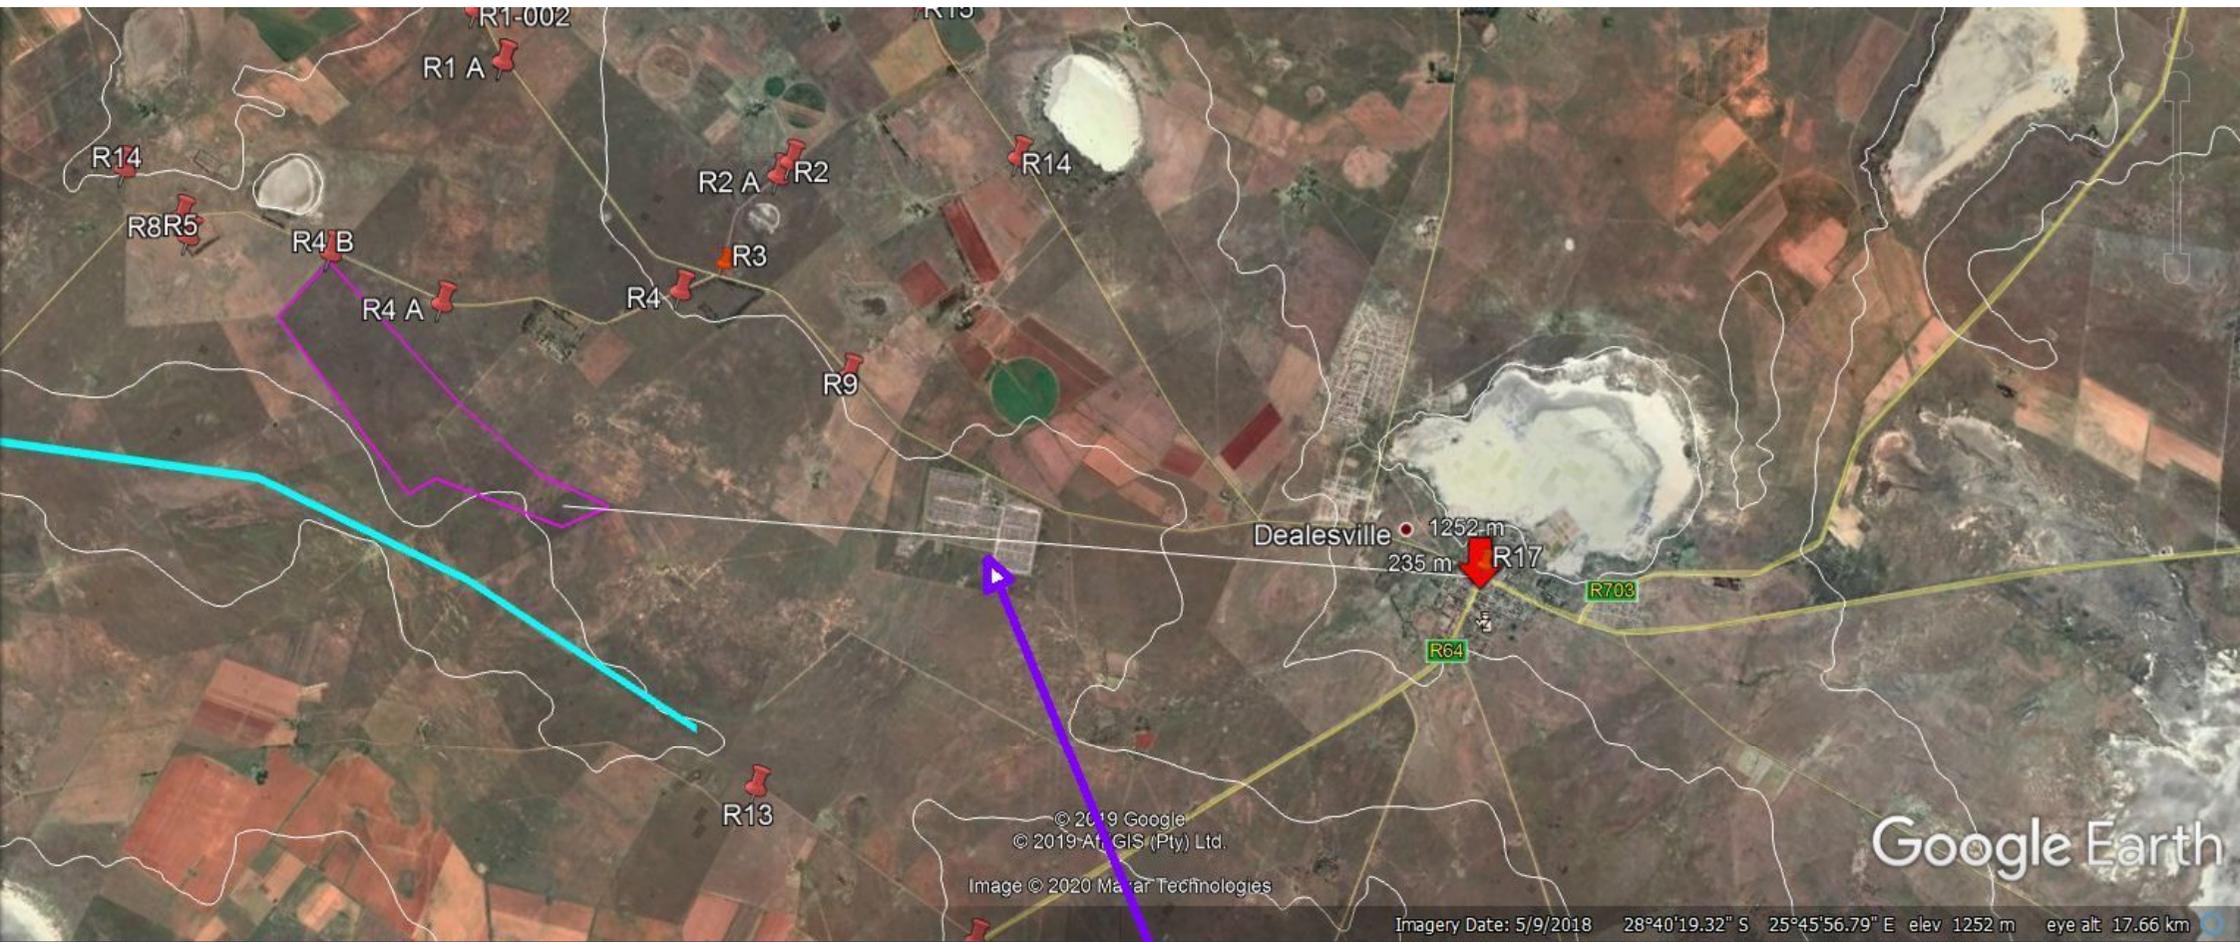
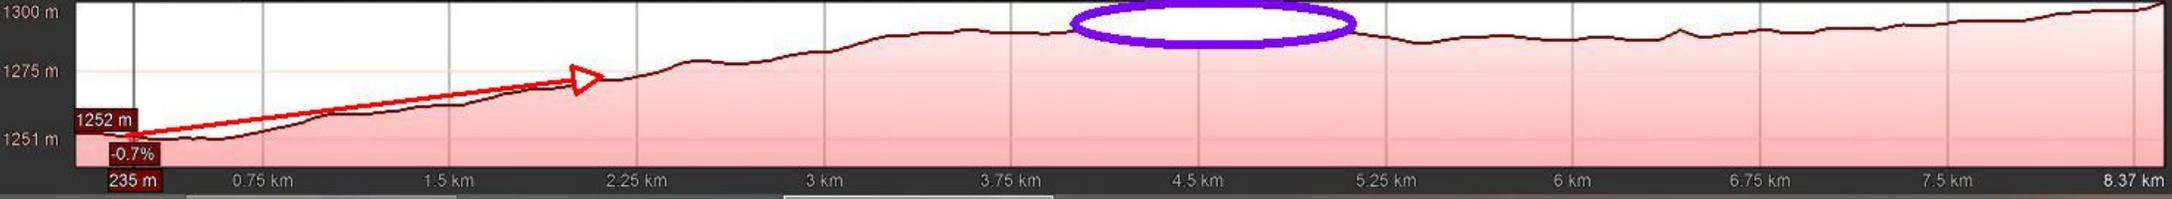
R17 Dealesville

Graph: Min, Avg, Max Elevation: 1251, 1261, 1300 m
Range Totals: Distance: 8.37 km Elev Gain/Loss: 72.3 m, -25.9 m Max Slope: 4.6%, -3.7% Avg Slope: 1.2%, -0.9%
