**Appendix G – Specialist Reports/Opinions:
G3c (Visual Impact Assessment)**

**VISSERSPAN PV FACILITY
PROJECT 1
FARM 40, DEALESVILLE, FREE STATE**

VISUAL ASSESSMENT

Final Report

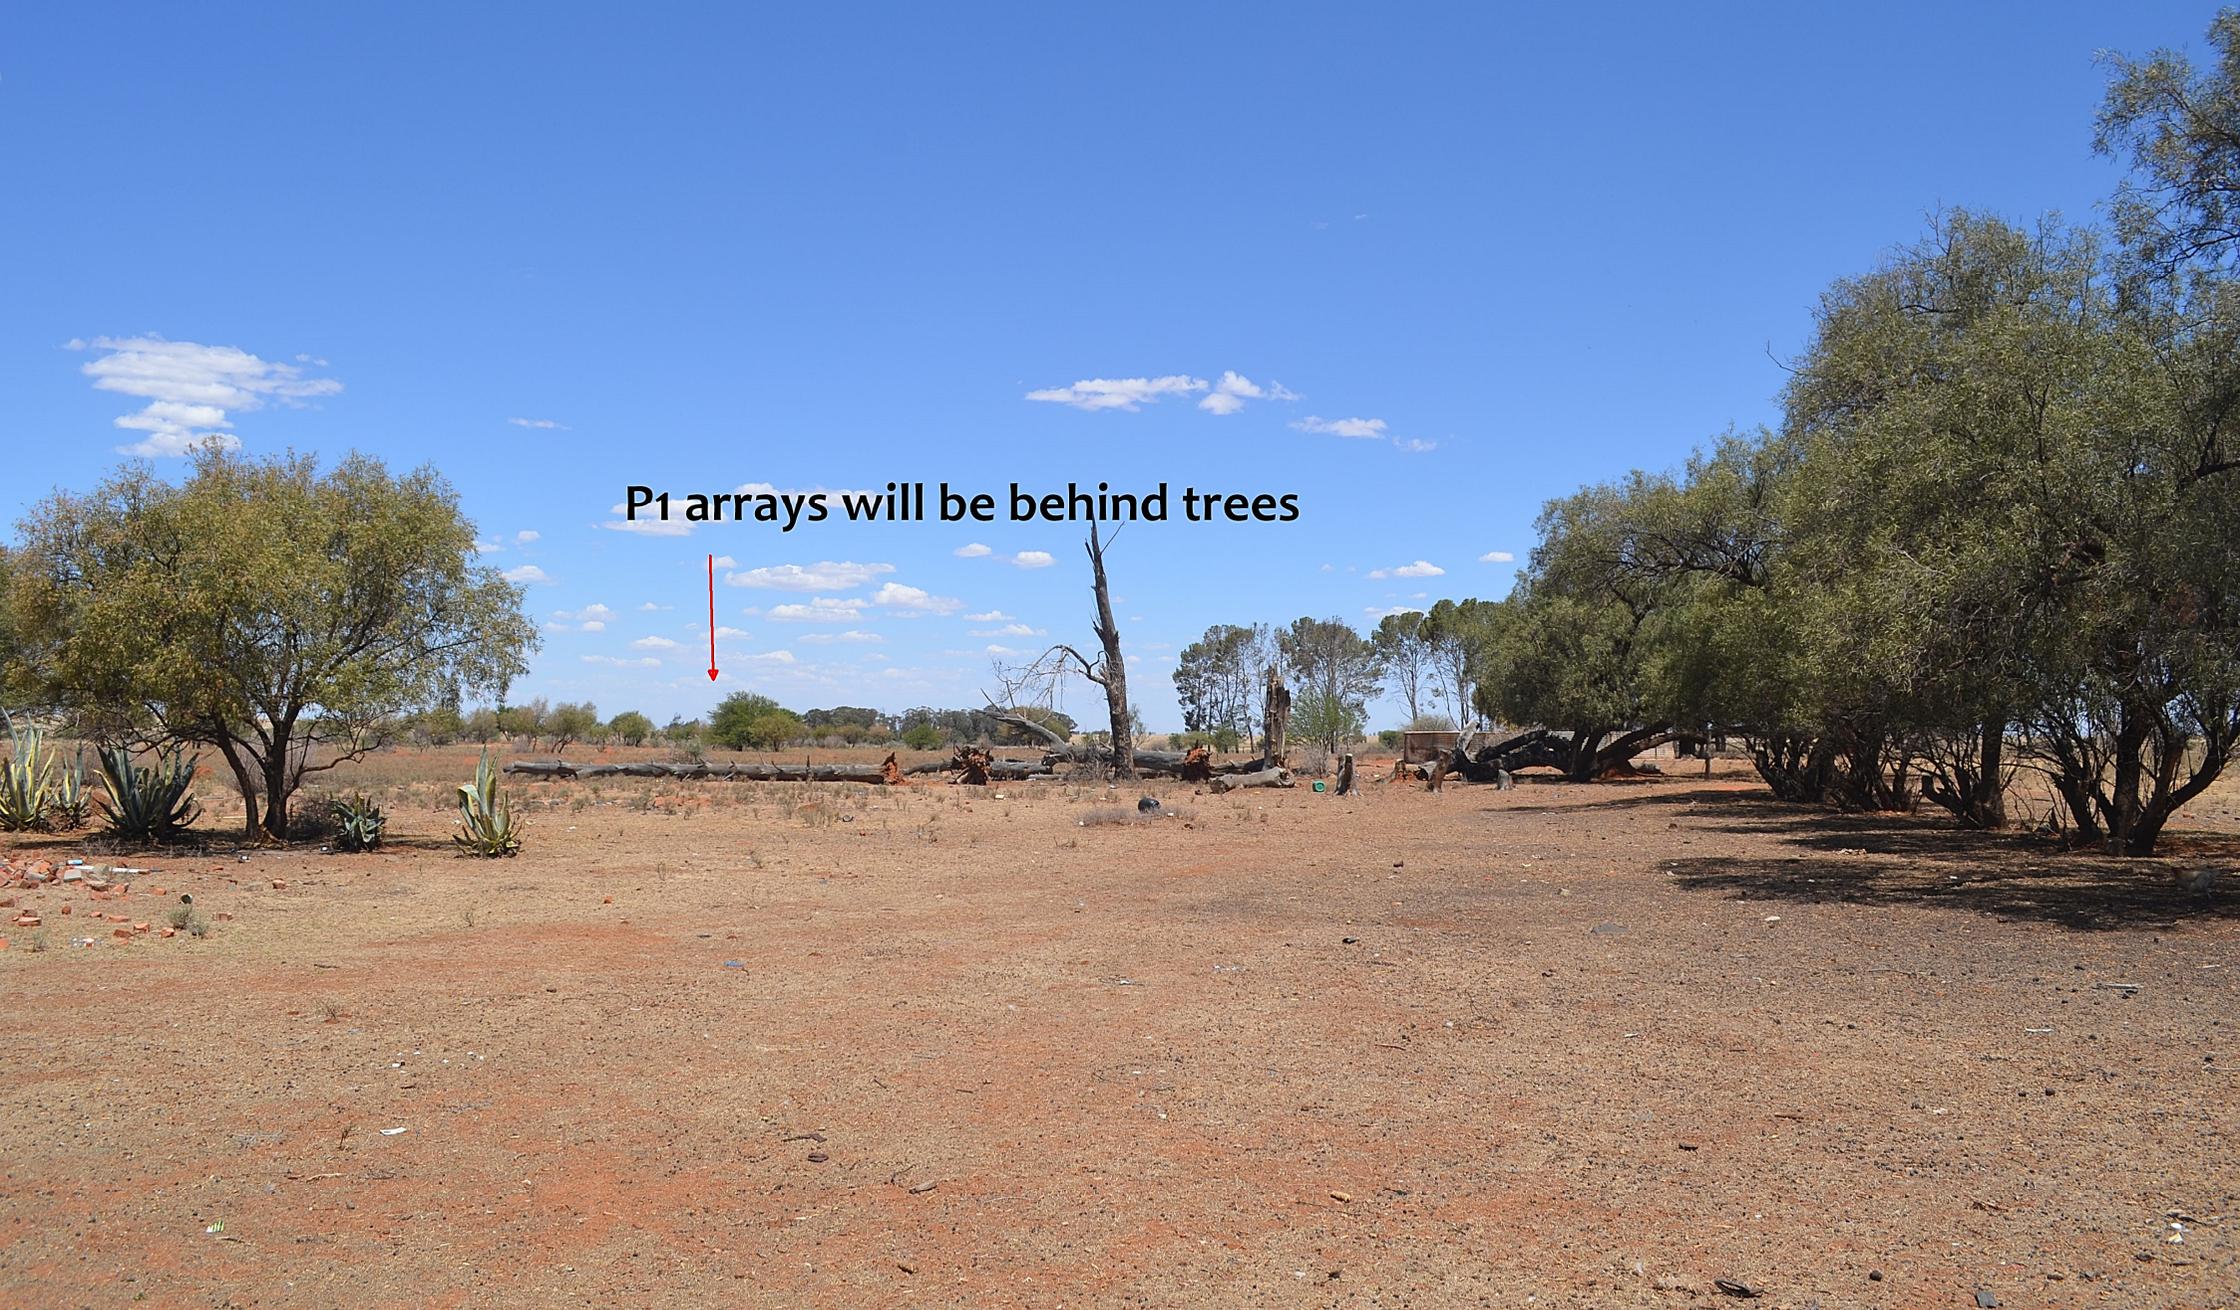
R5 Rooidam Homestead

P1 arrays will be behind trees

The Rooirand Homestead is situated adjacent the site. The homestead is however in a degraded state and only occupied by a farm worker family. The perimeter fence and the first row of PV arrays will be in clear site from the farm worker cottage. Trees on the Rooirand property however provide some screening. The overall visual significance is rated low due to the degraded state of the homestead and the screening provided by landscape elements which reduce the intrusive level of the facility

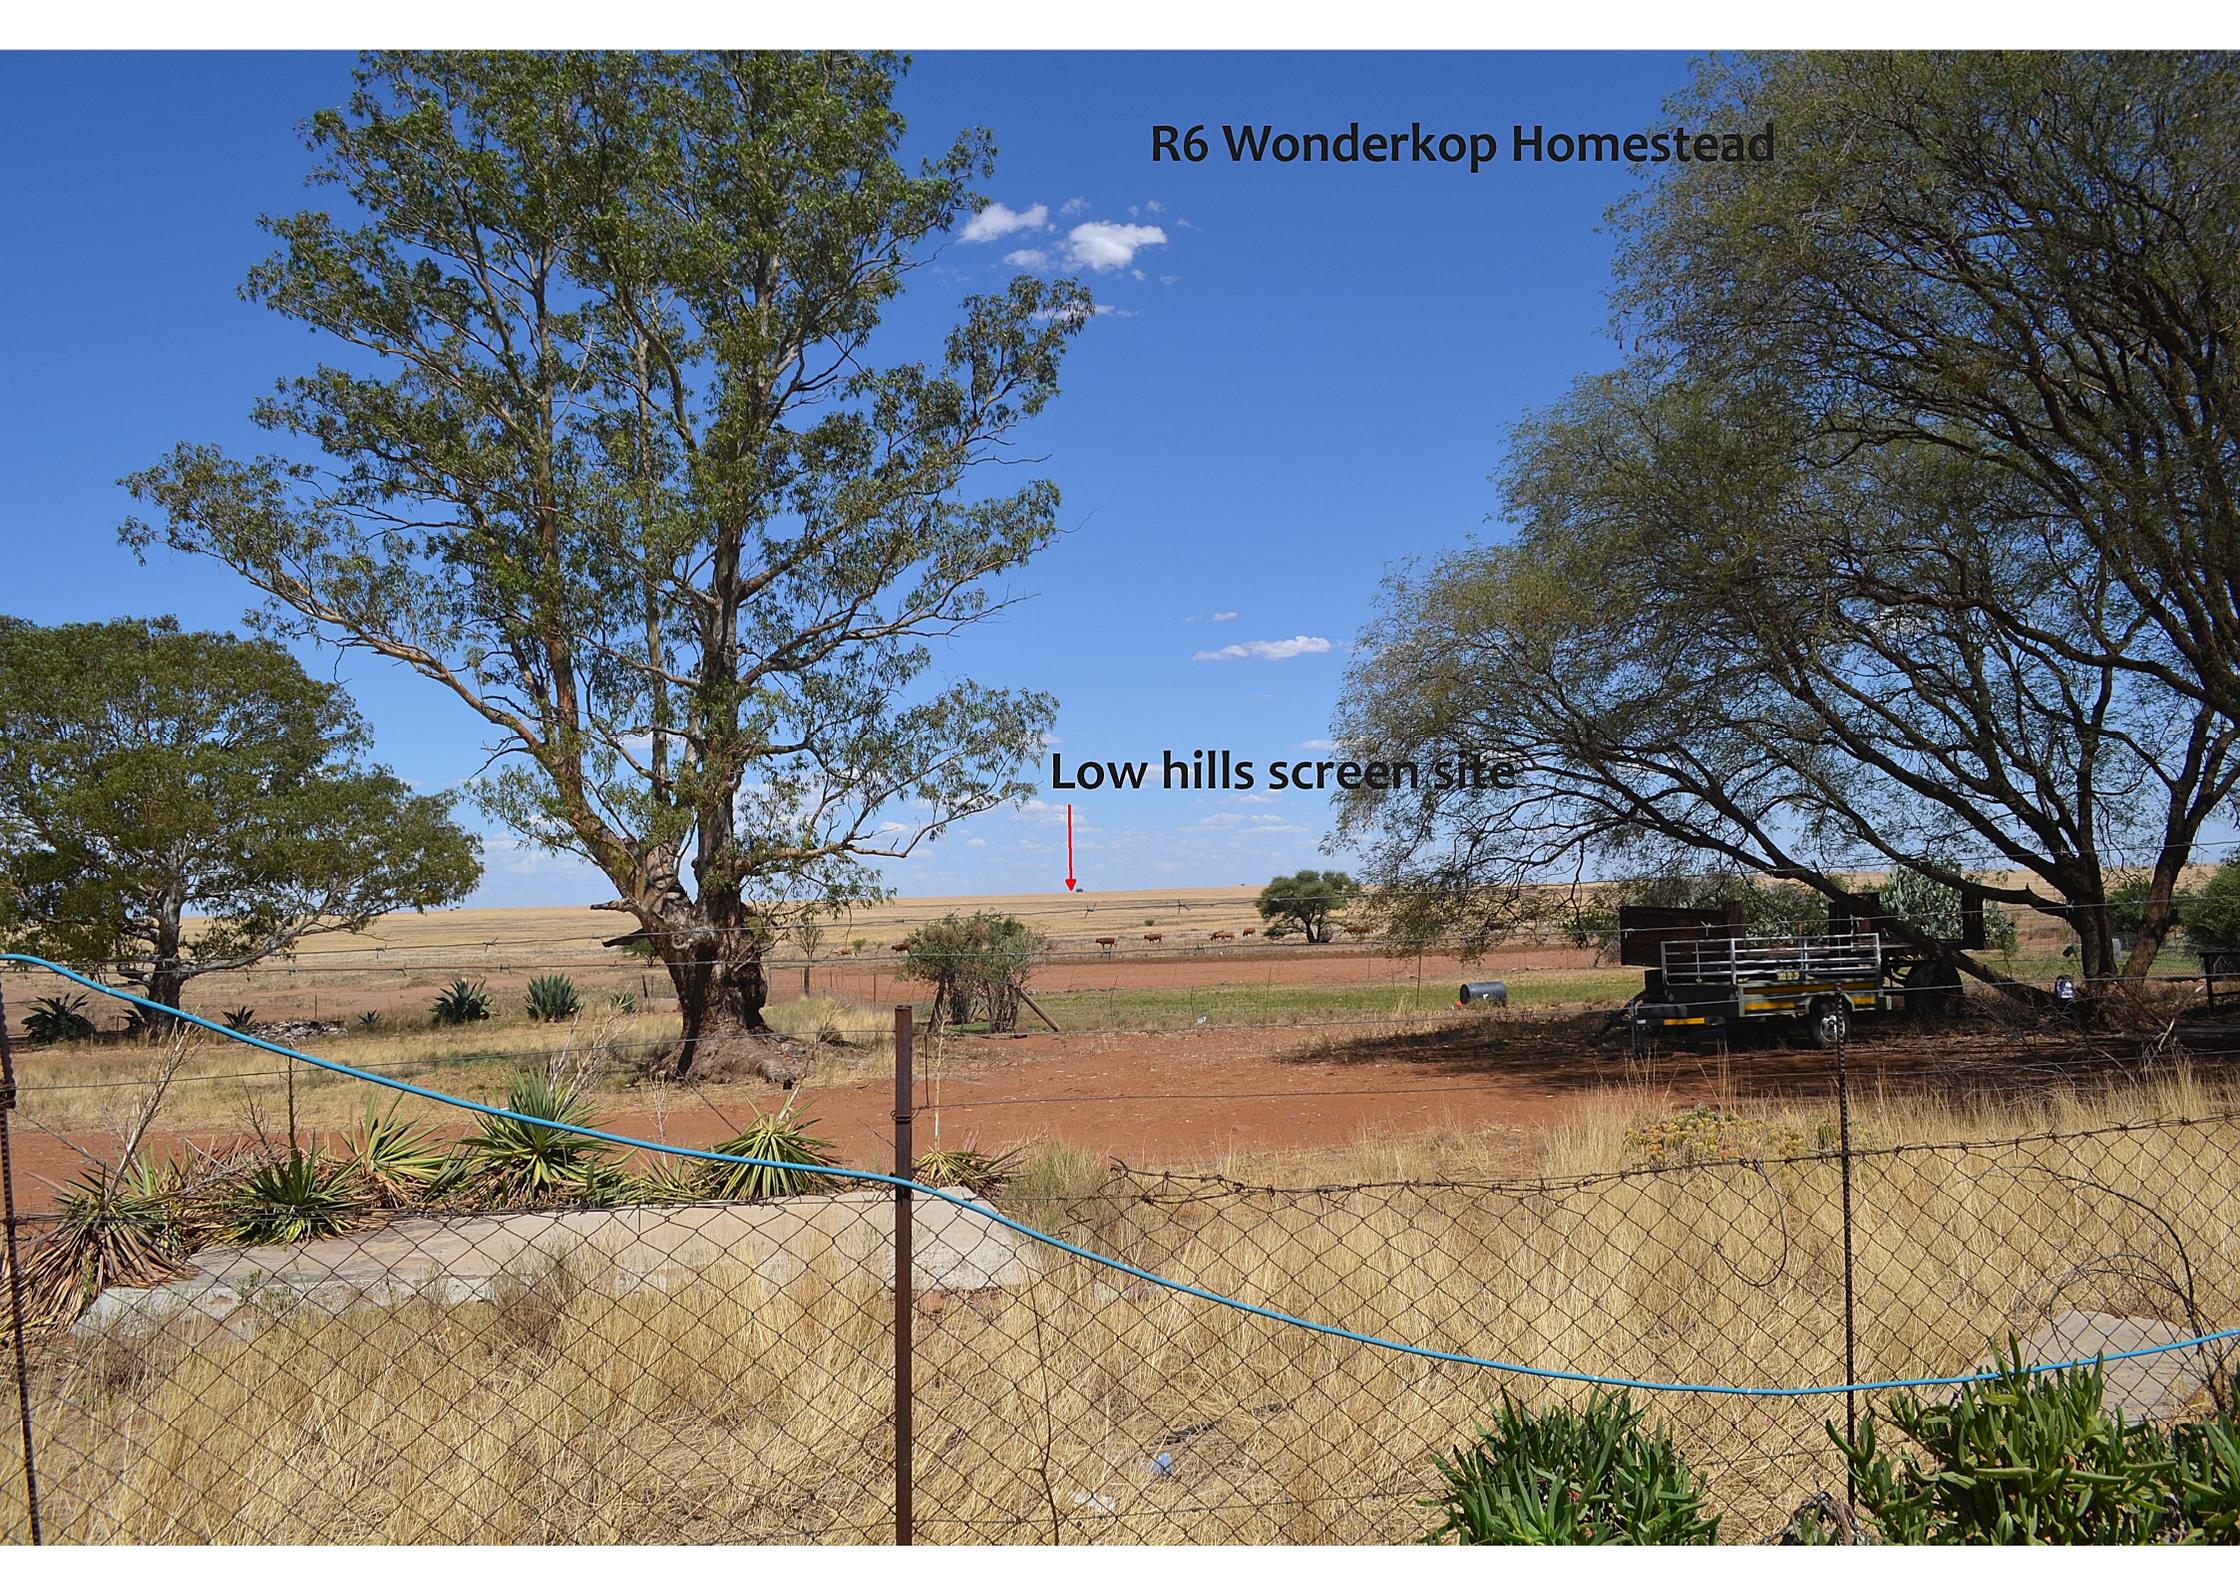
R6 Wonderkop Homestead

Low hills screen site

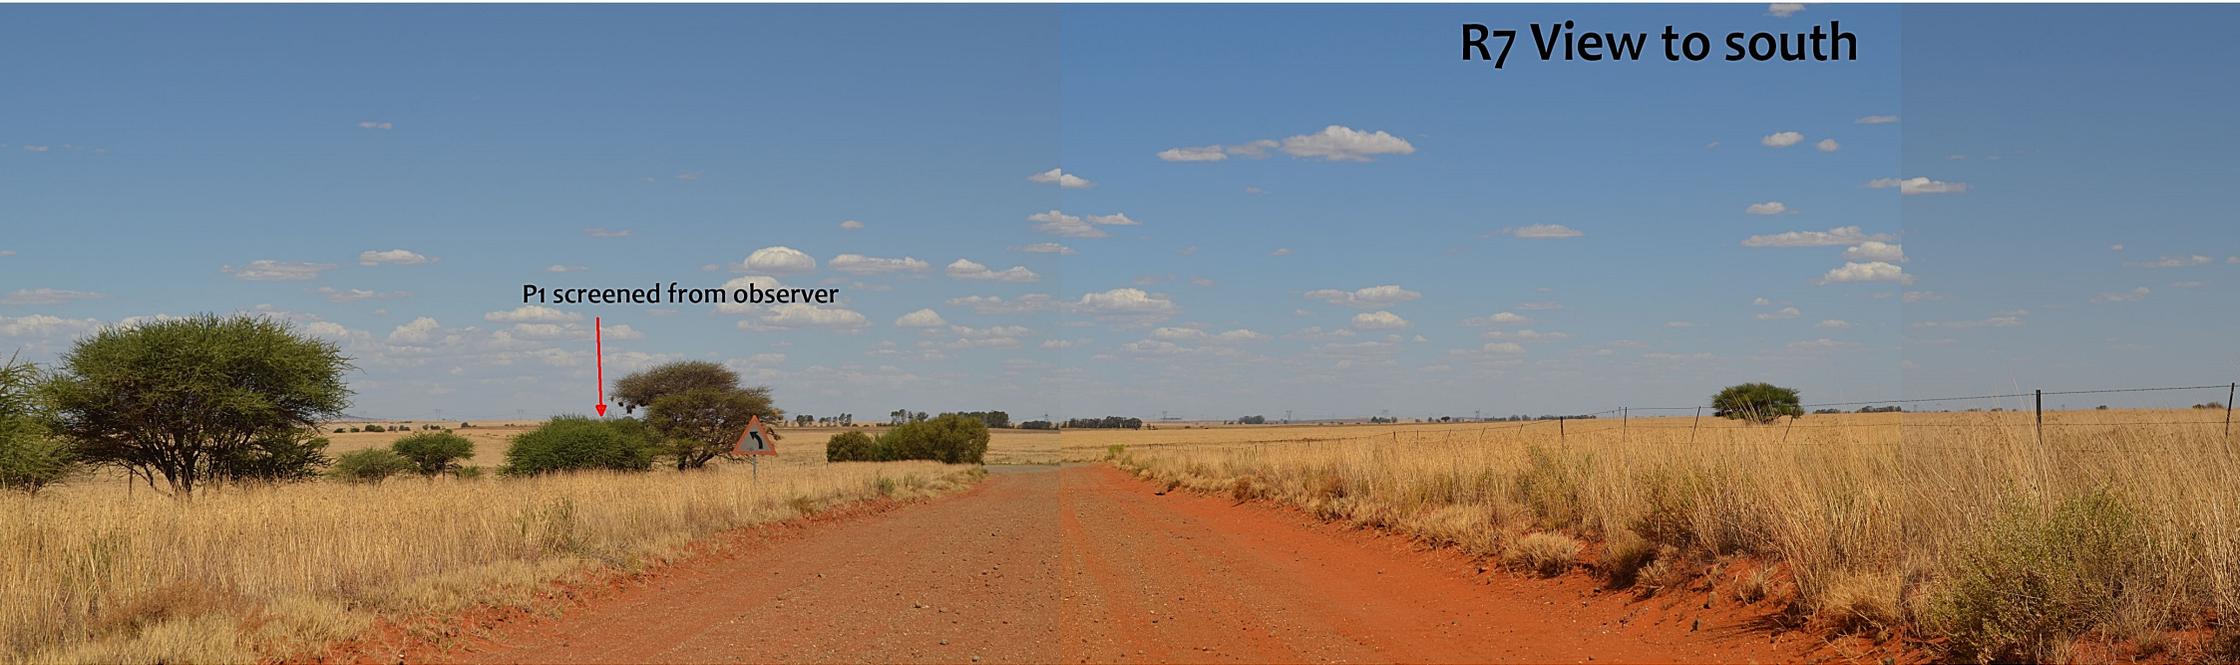
R7 View to south

P1 screened from observer

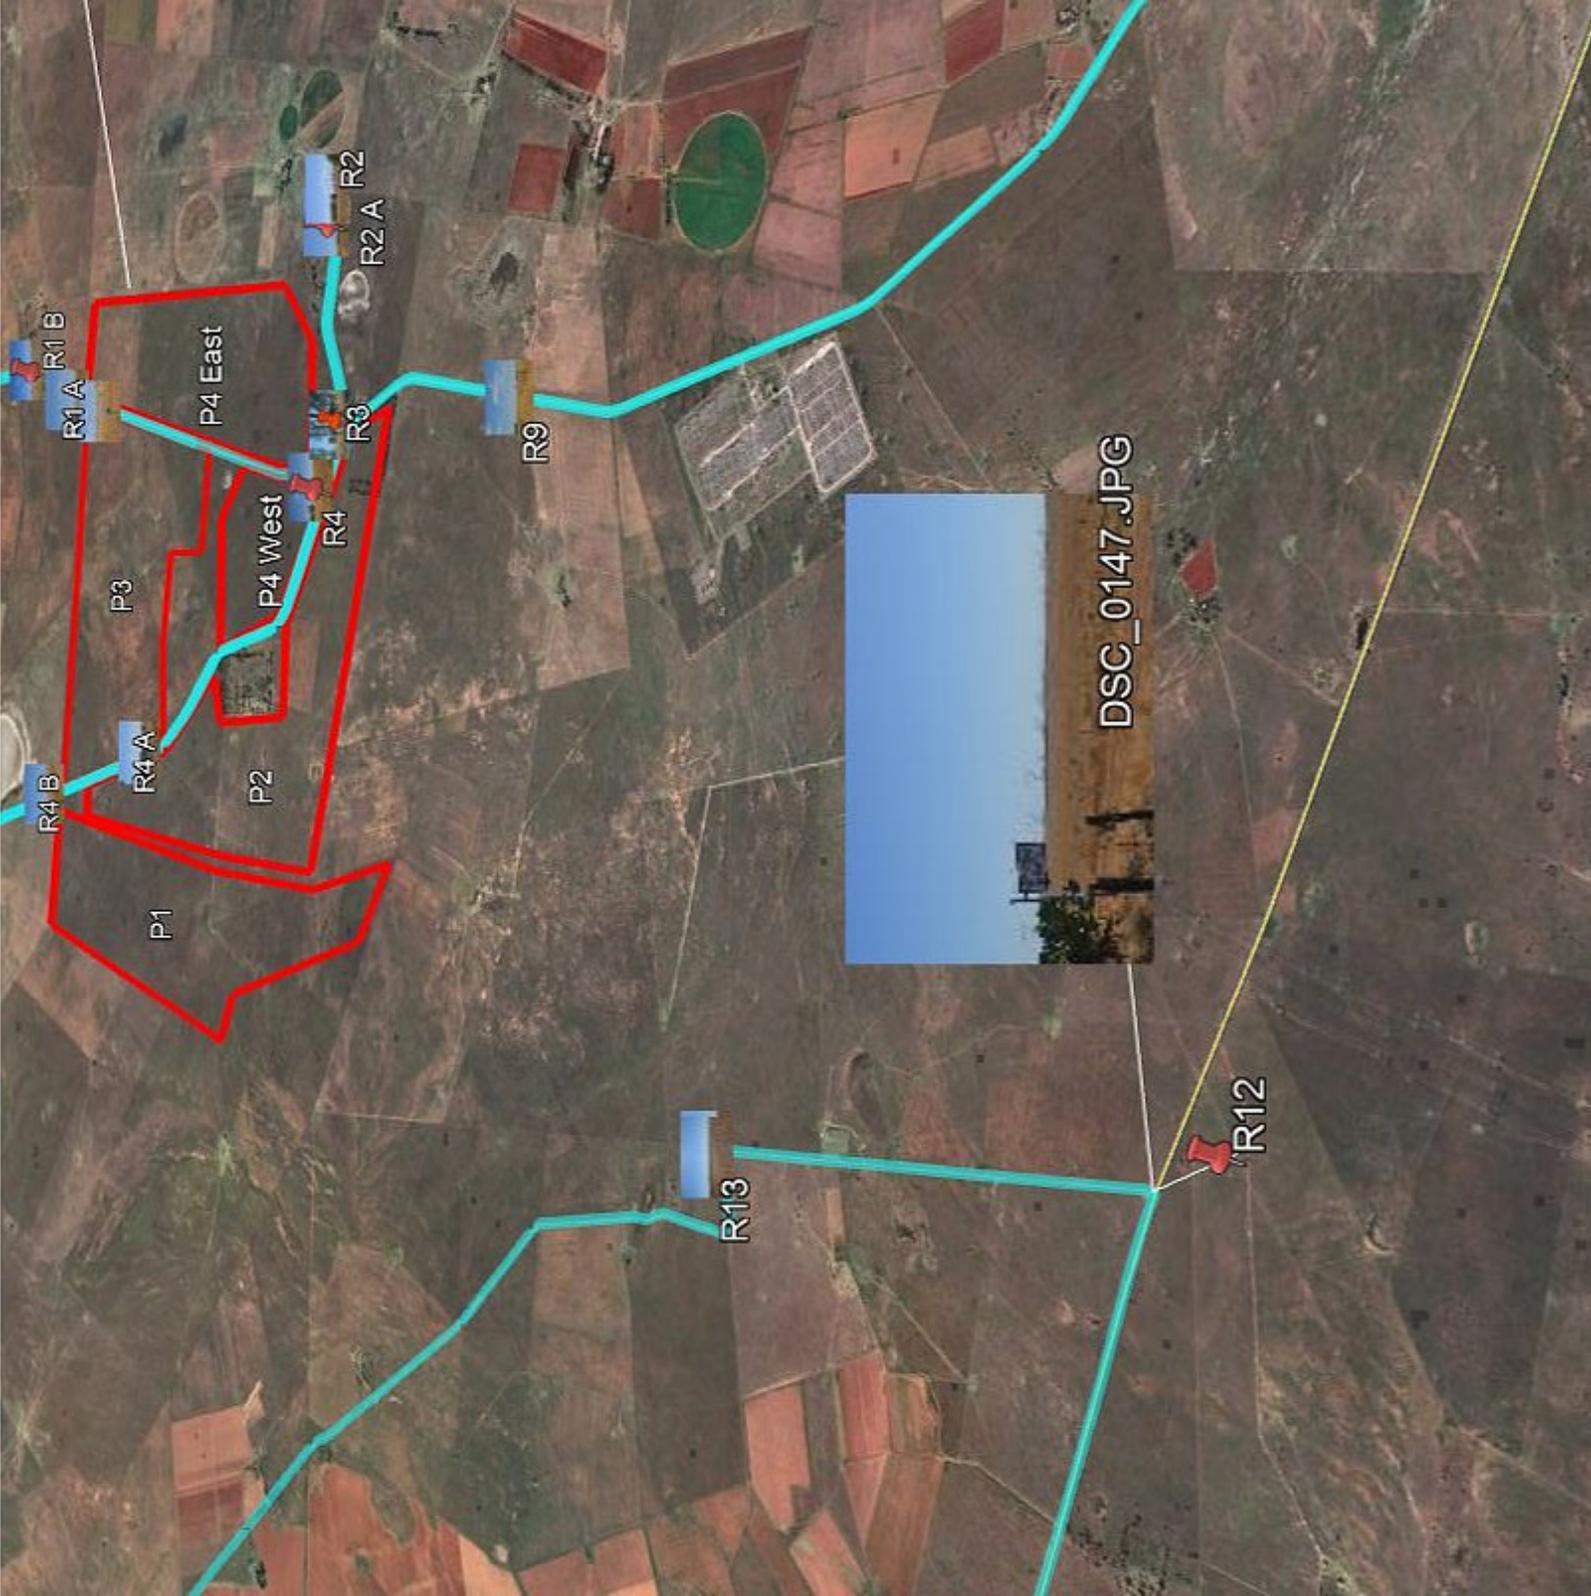
R9 Hertzogville Rd northward

P2 behind trees

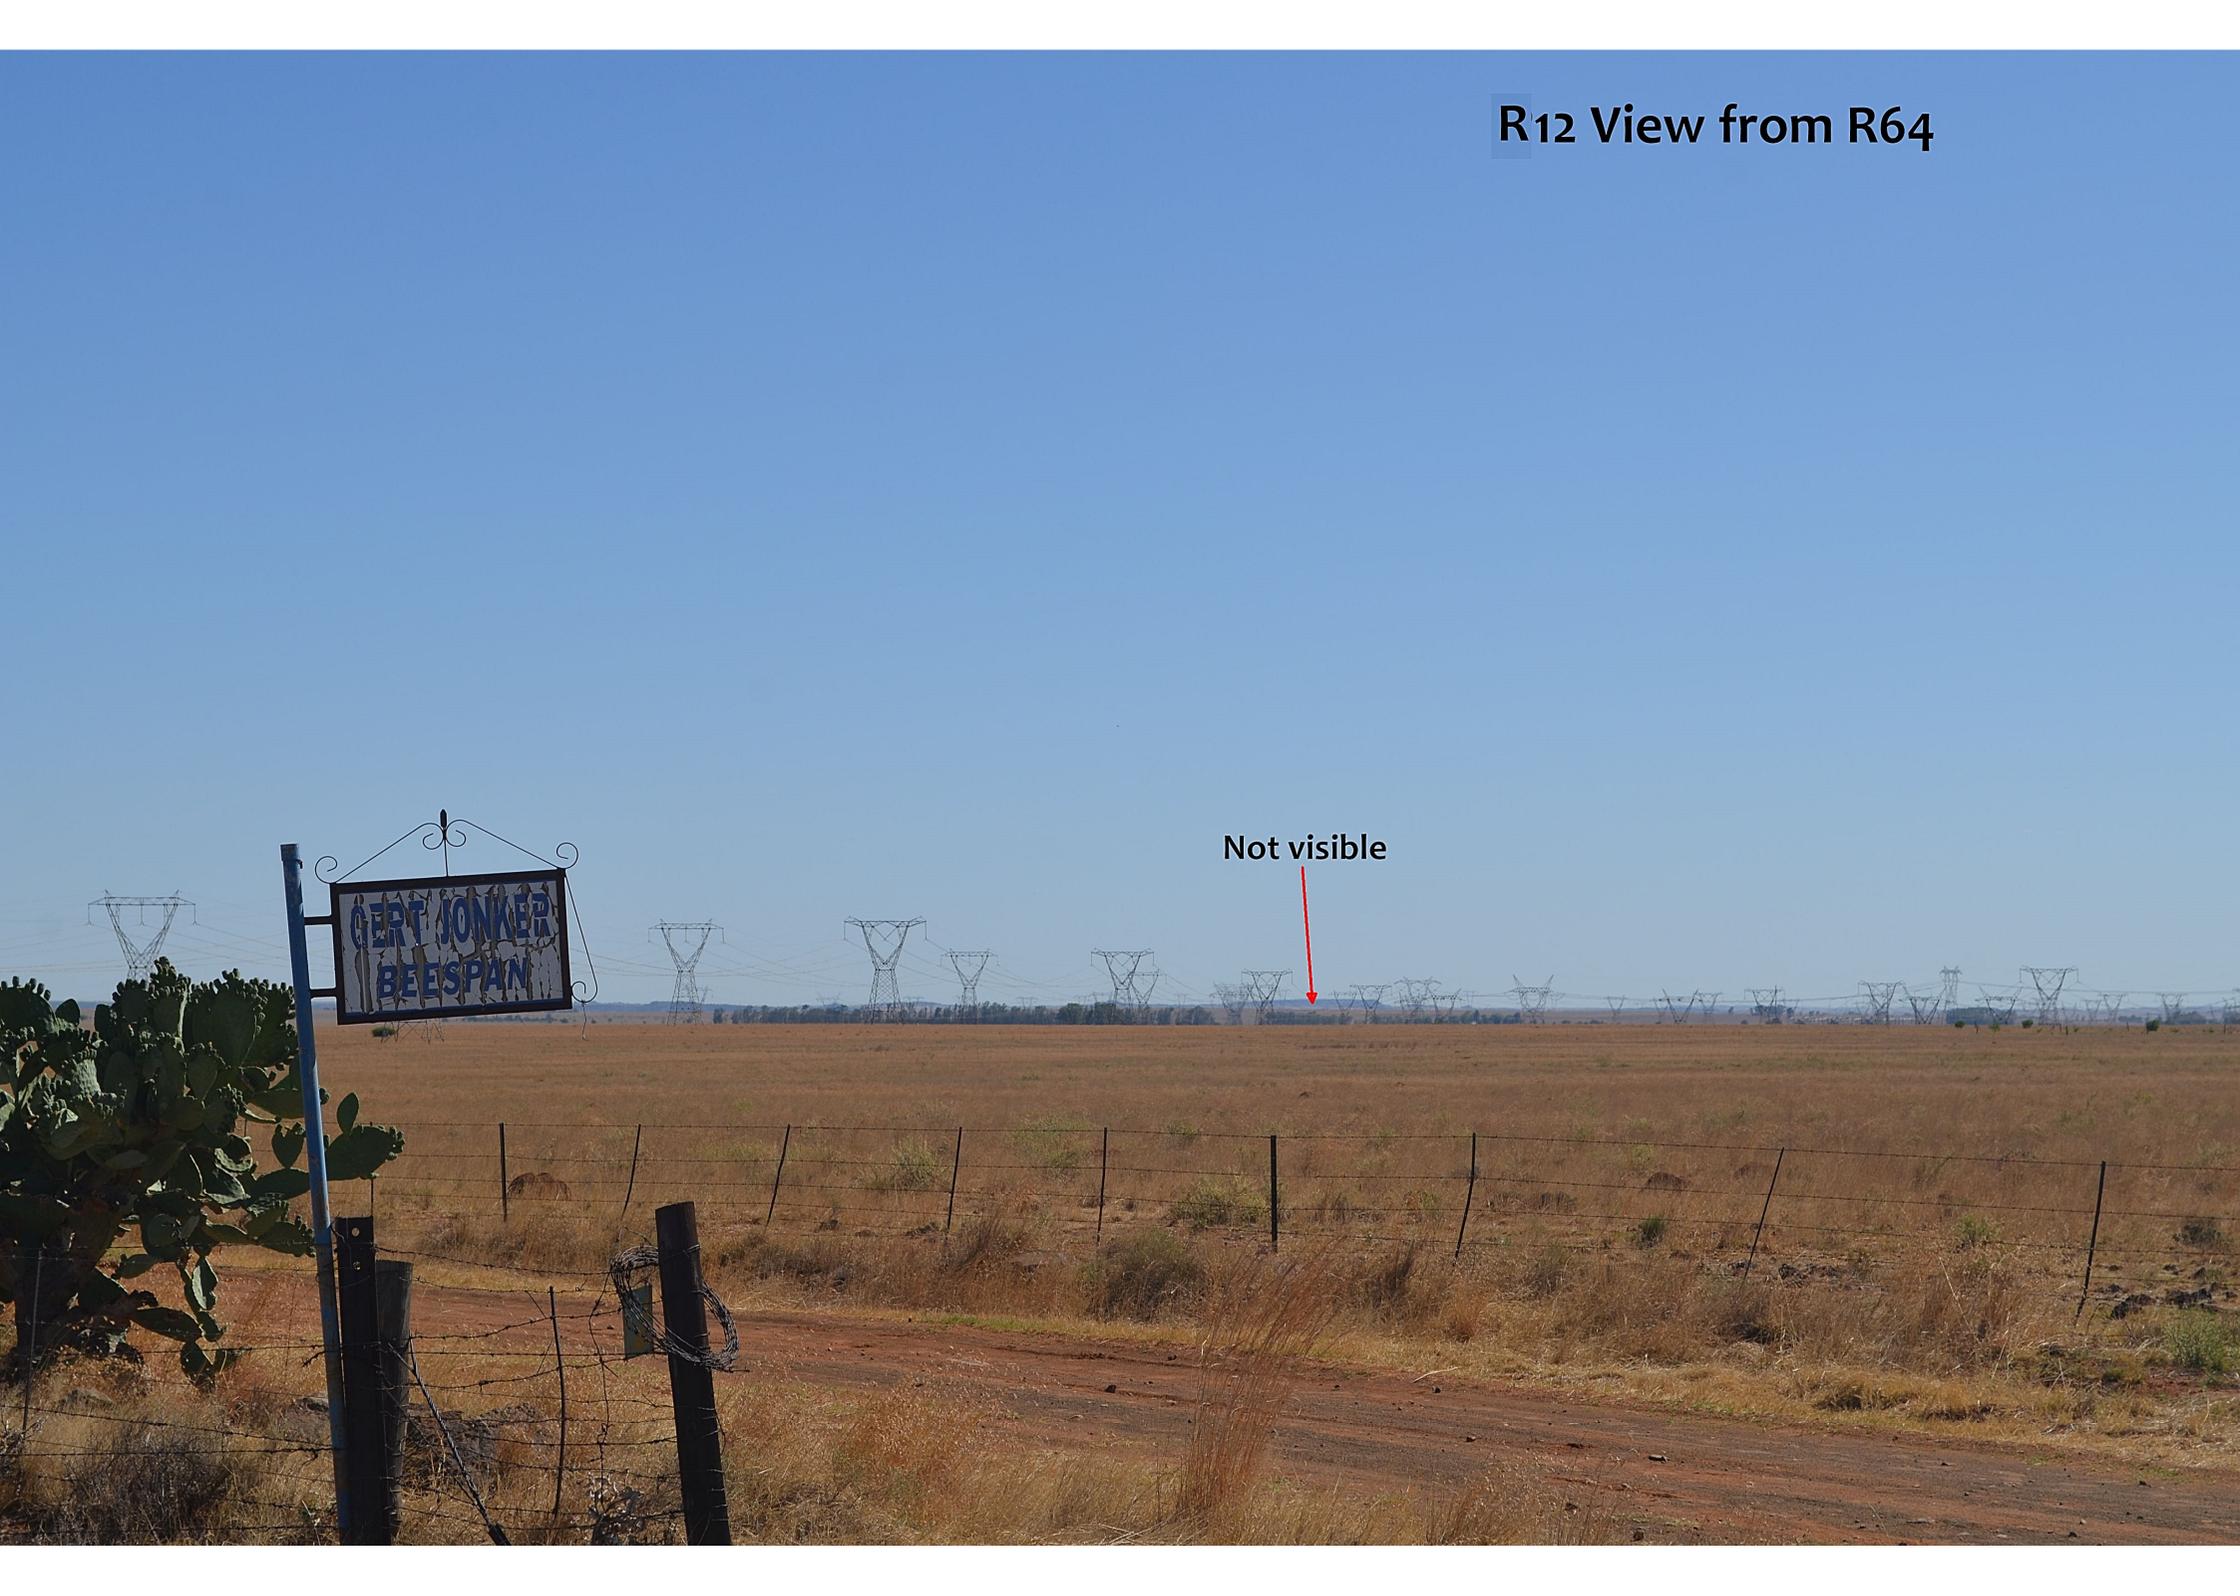
R12 View from R64

Not visible

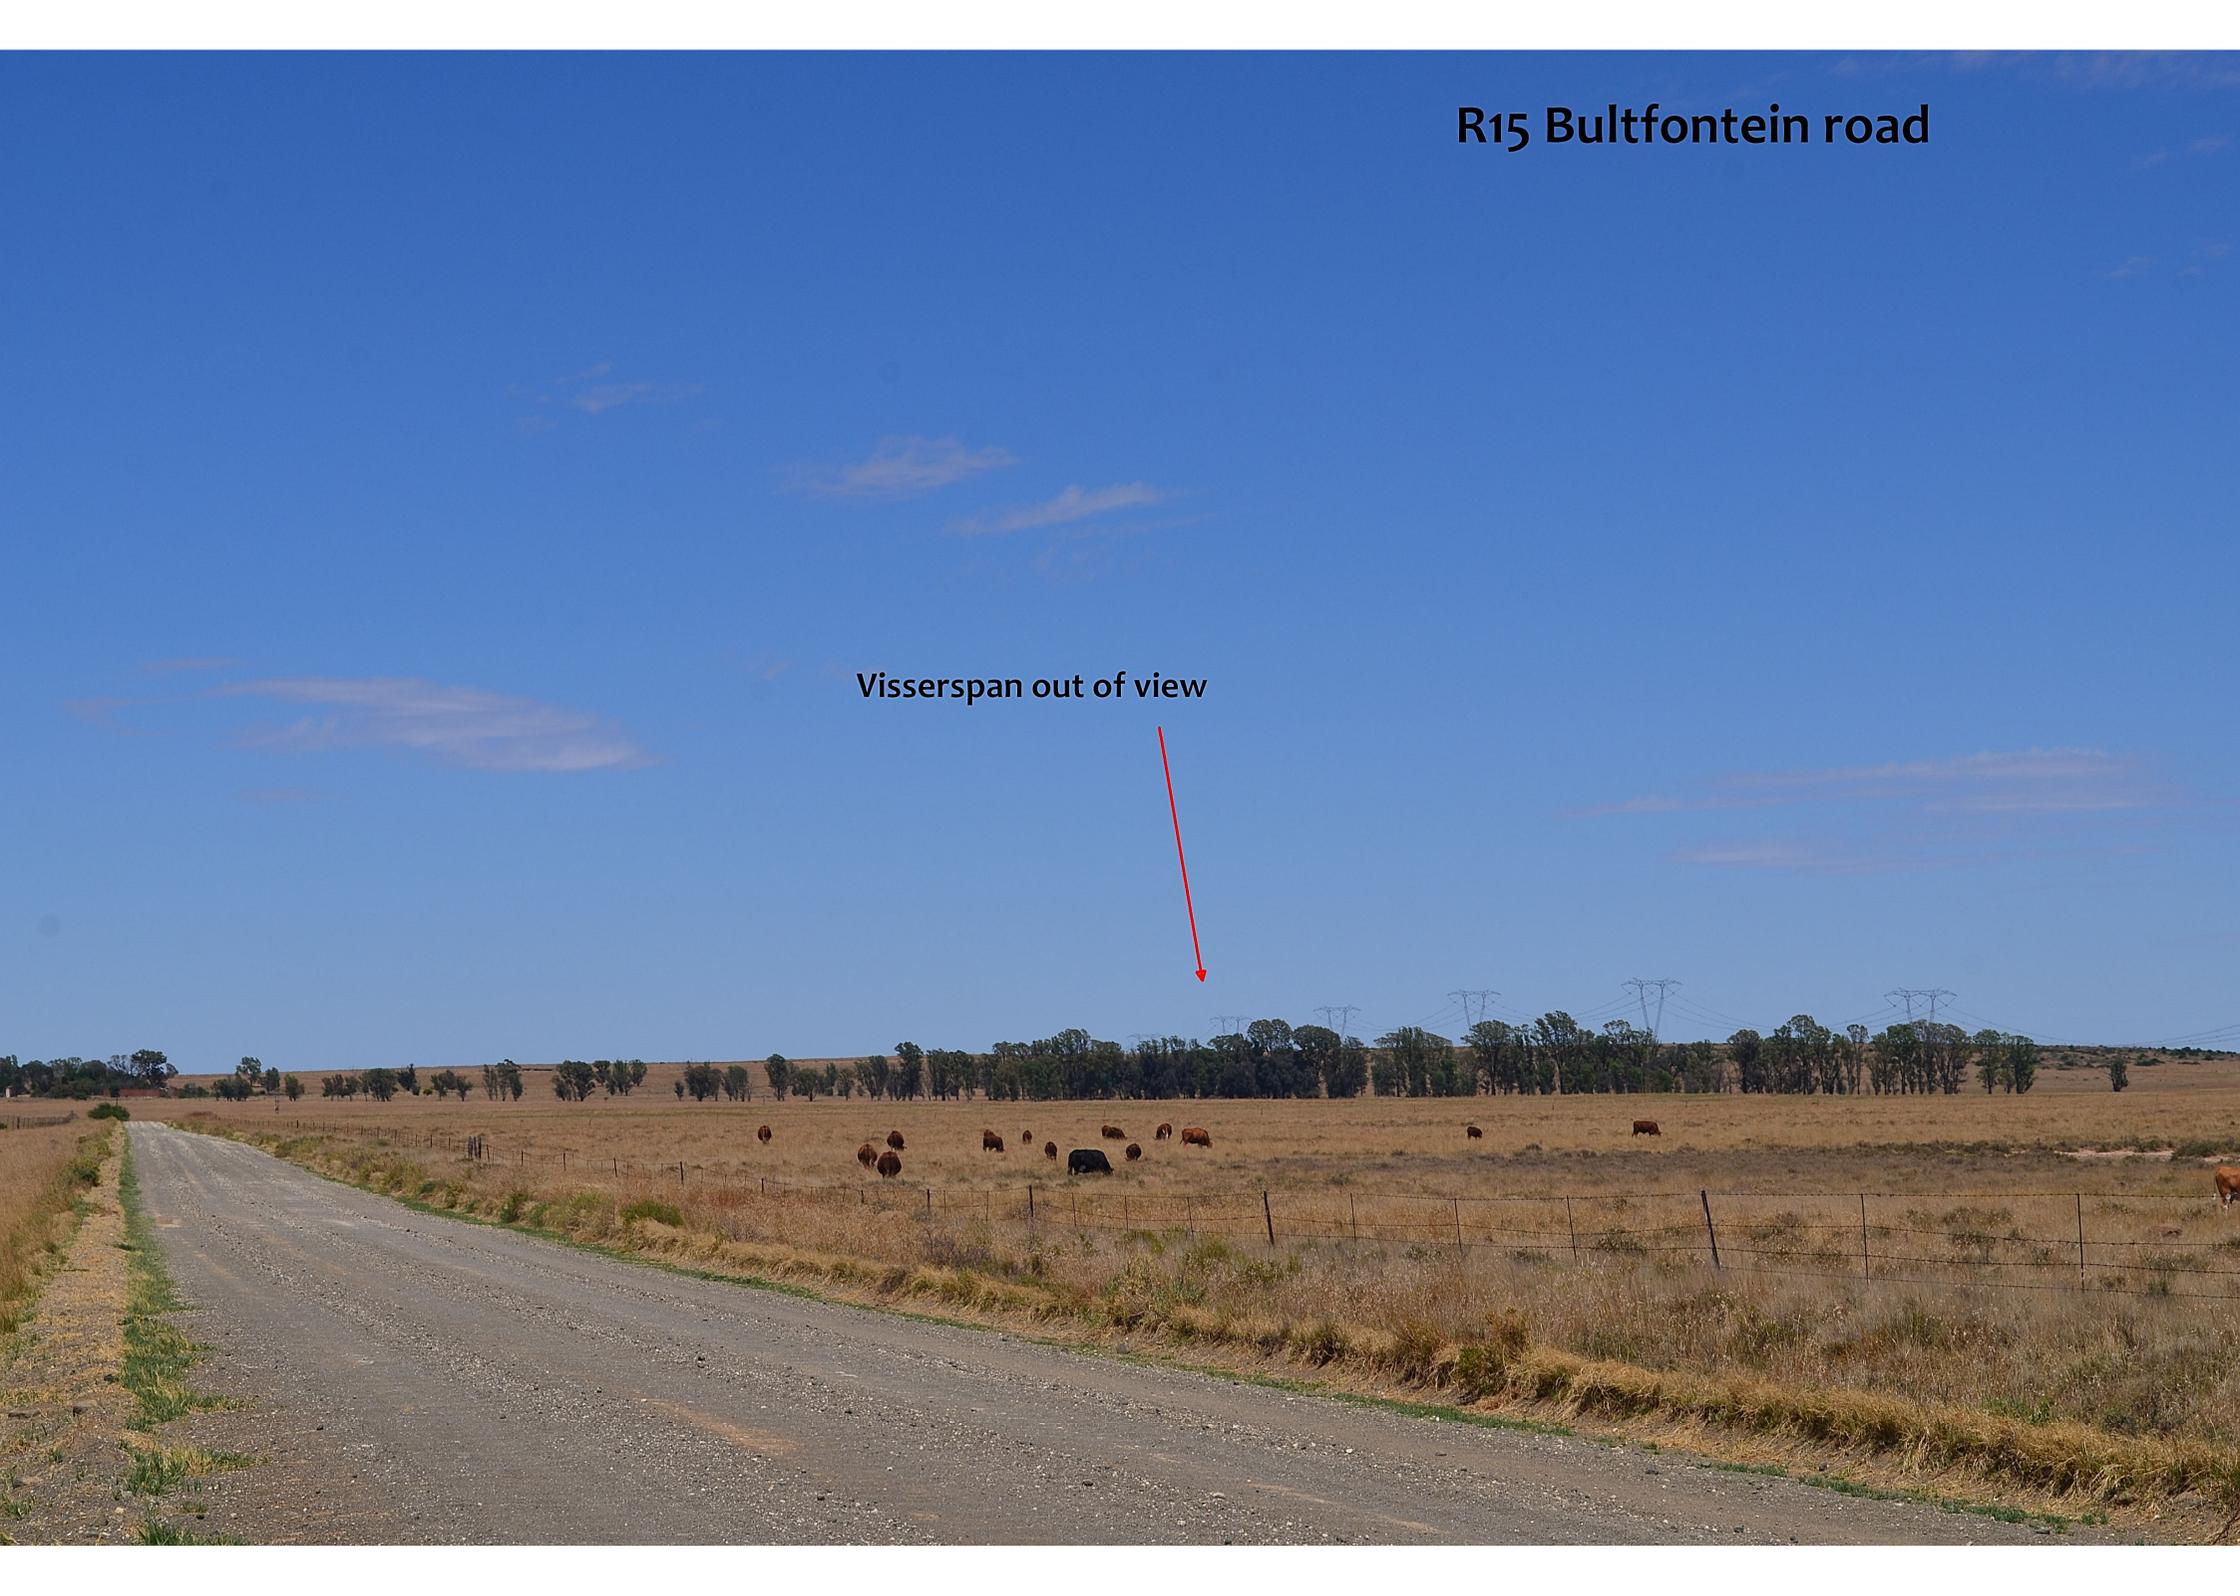
R15 Bultfontein road

Visserspan out of view

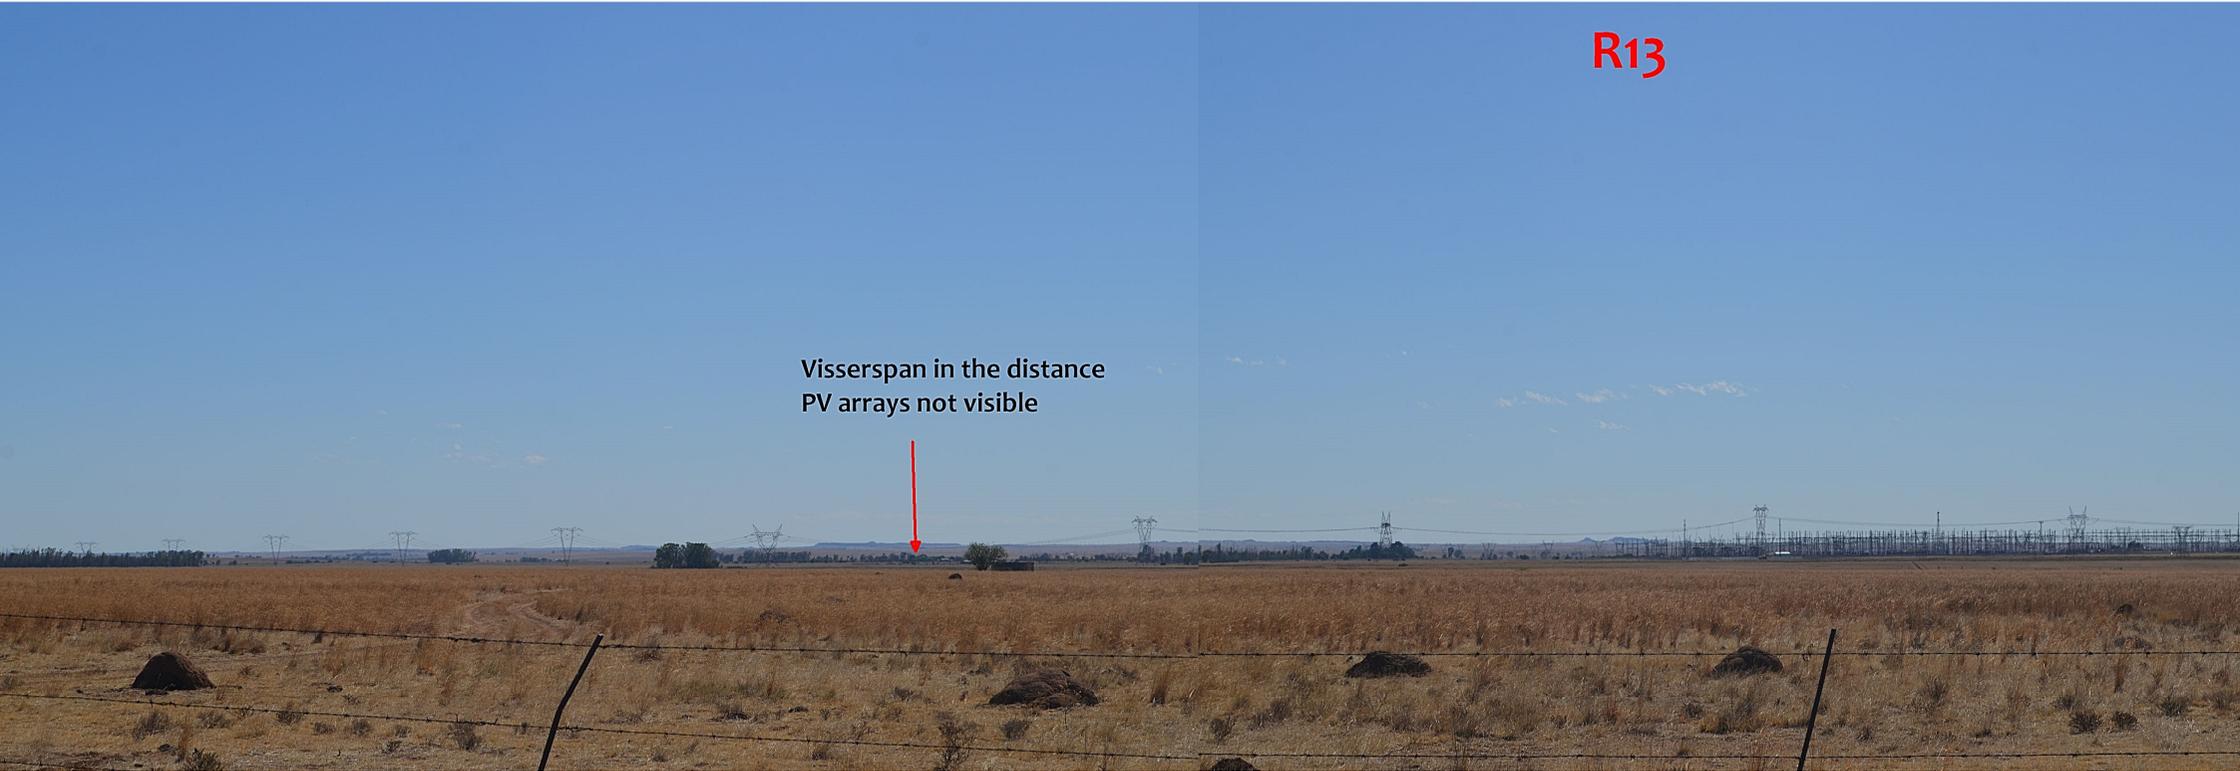
R13

Visserspan in the distance
PV arrays not visible

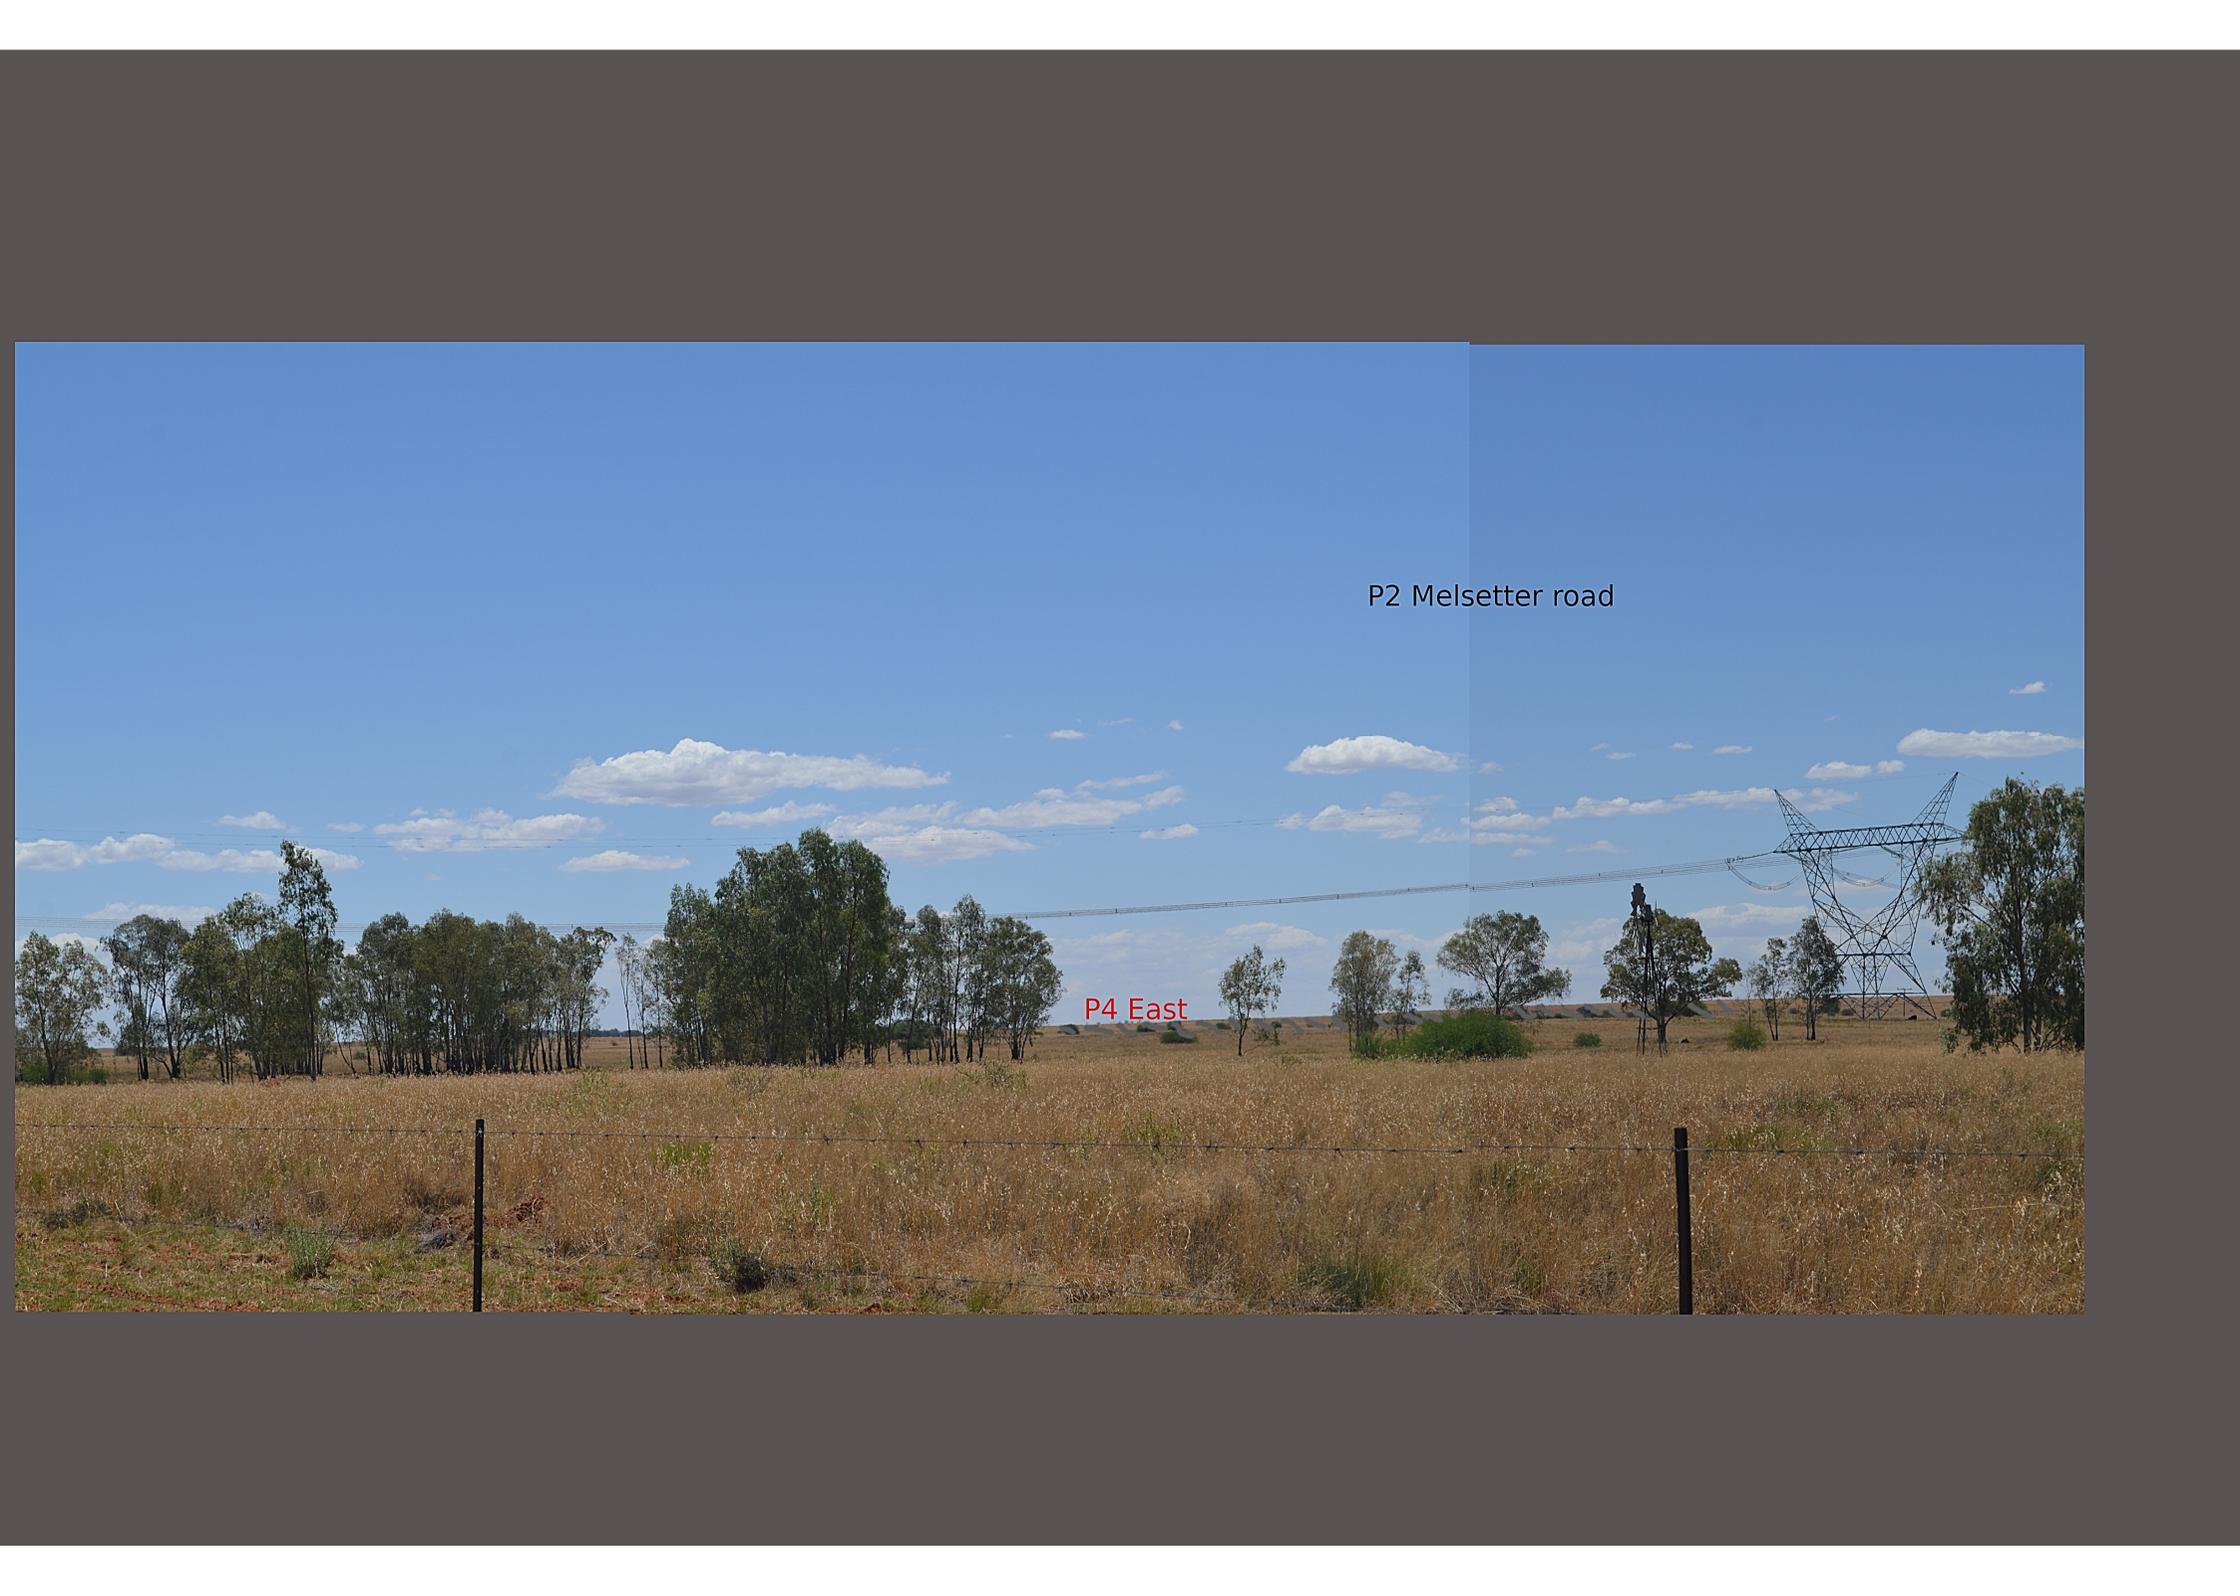
P2 Melsetter road

PV arrays behind trees with sideview to observer

HV Powerlines
