**Appendix G – Specialist Reports/Opinions:
G3c (Visual Impact Assessment)**

**VISSERSPAN PV FACILITY
PROJECT 1
FARM 40, DEALESVILLE, FREE STATE**

VISUAL ASSESSMENT

Final Report

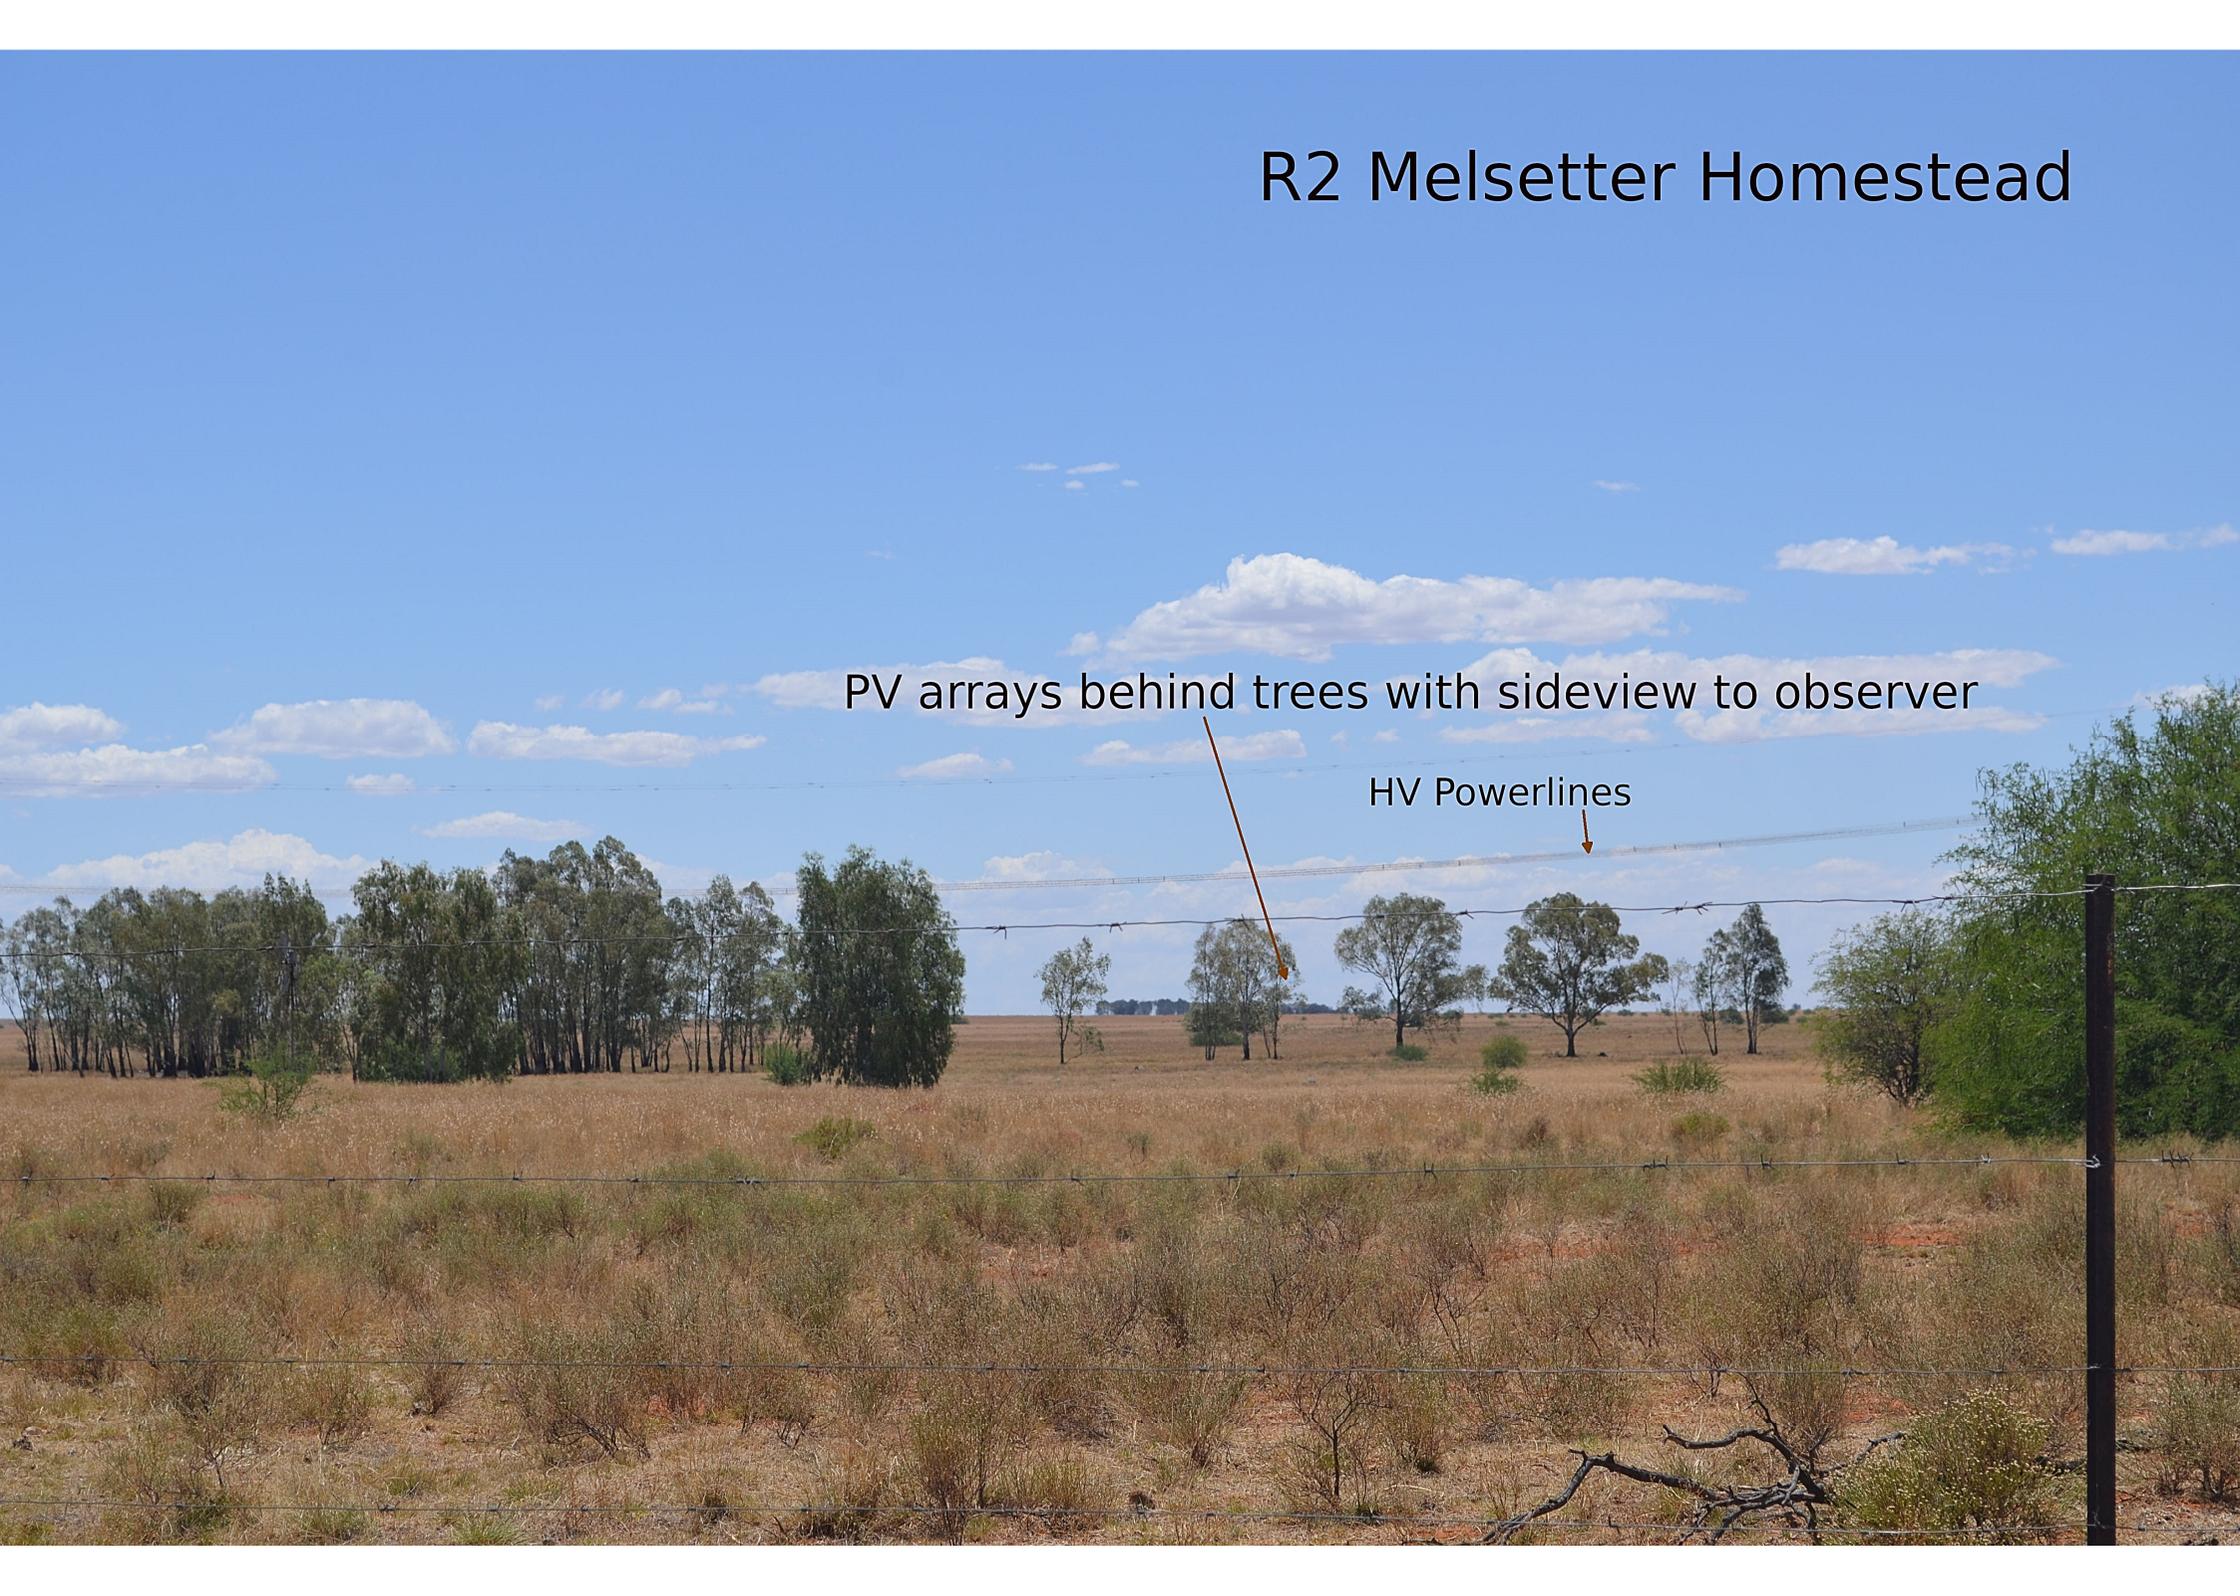
PV arrays behind trees with sideview to observer

HV Powerlines

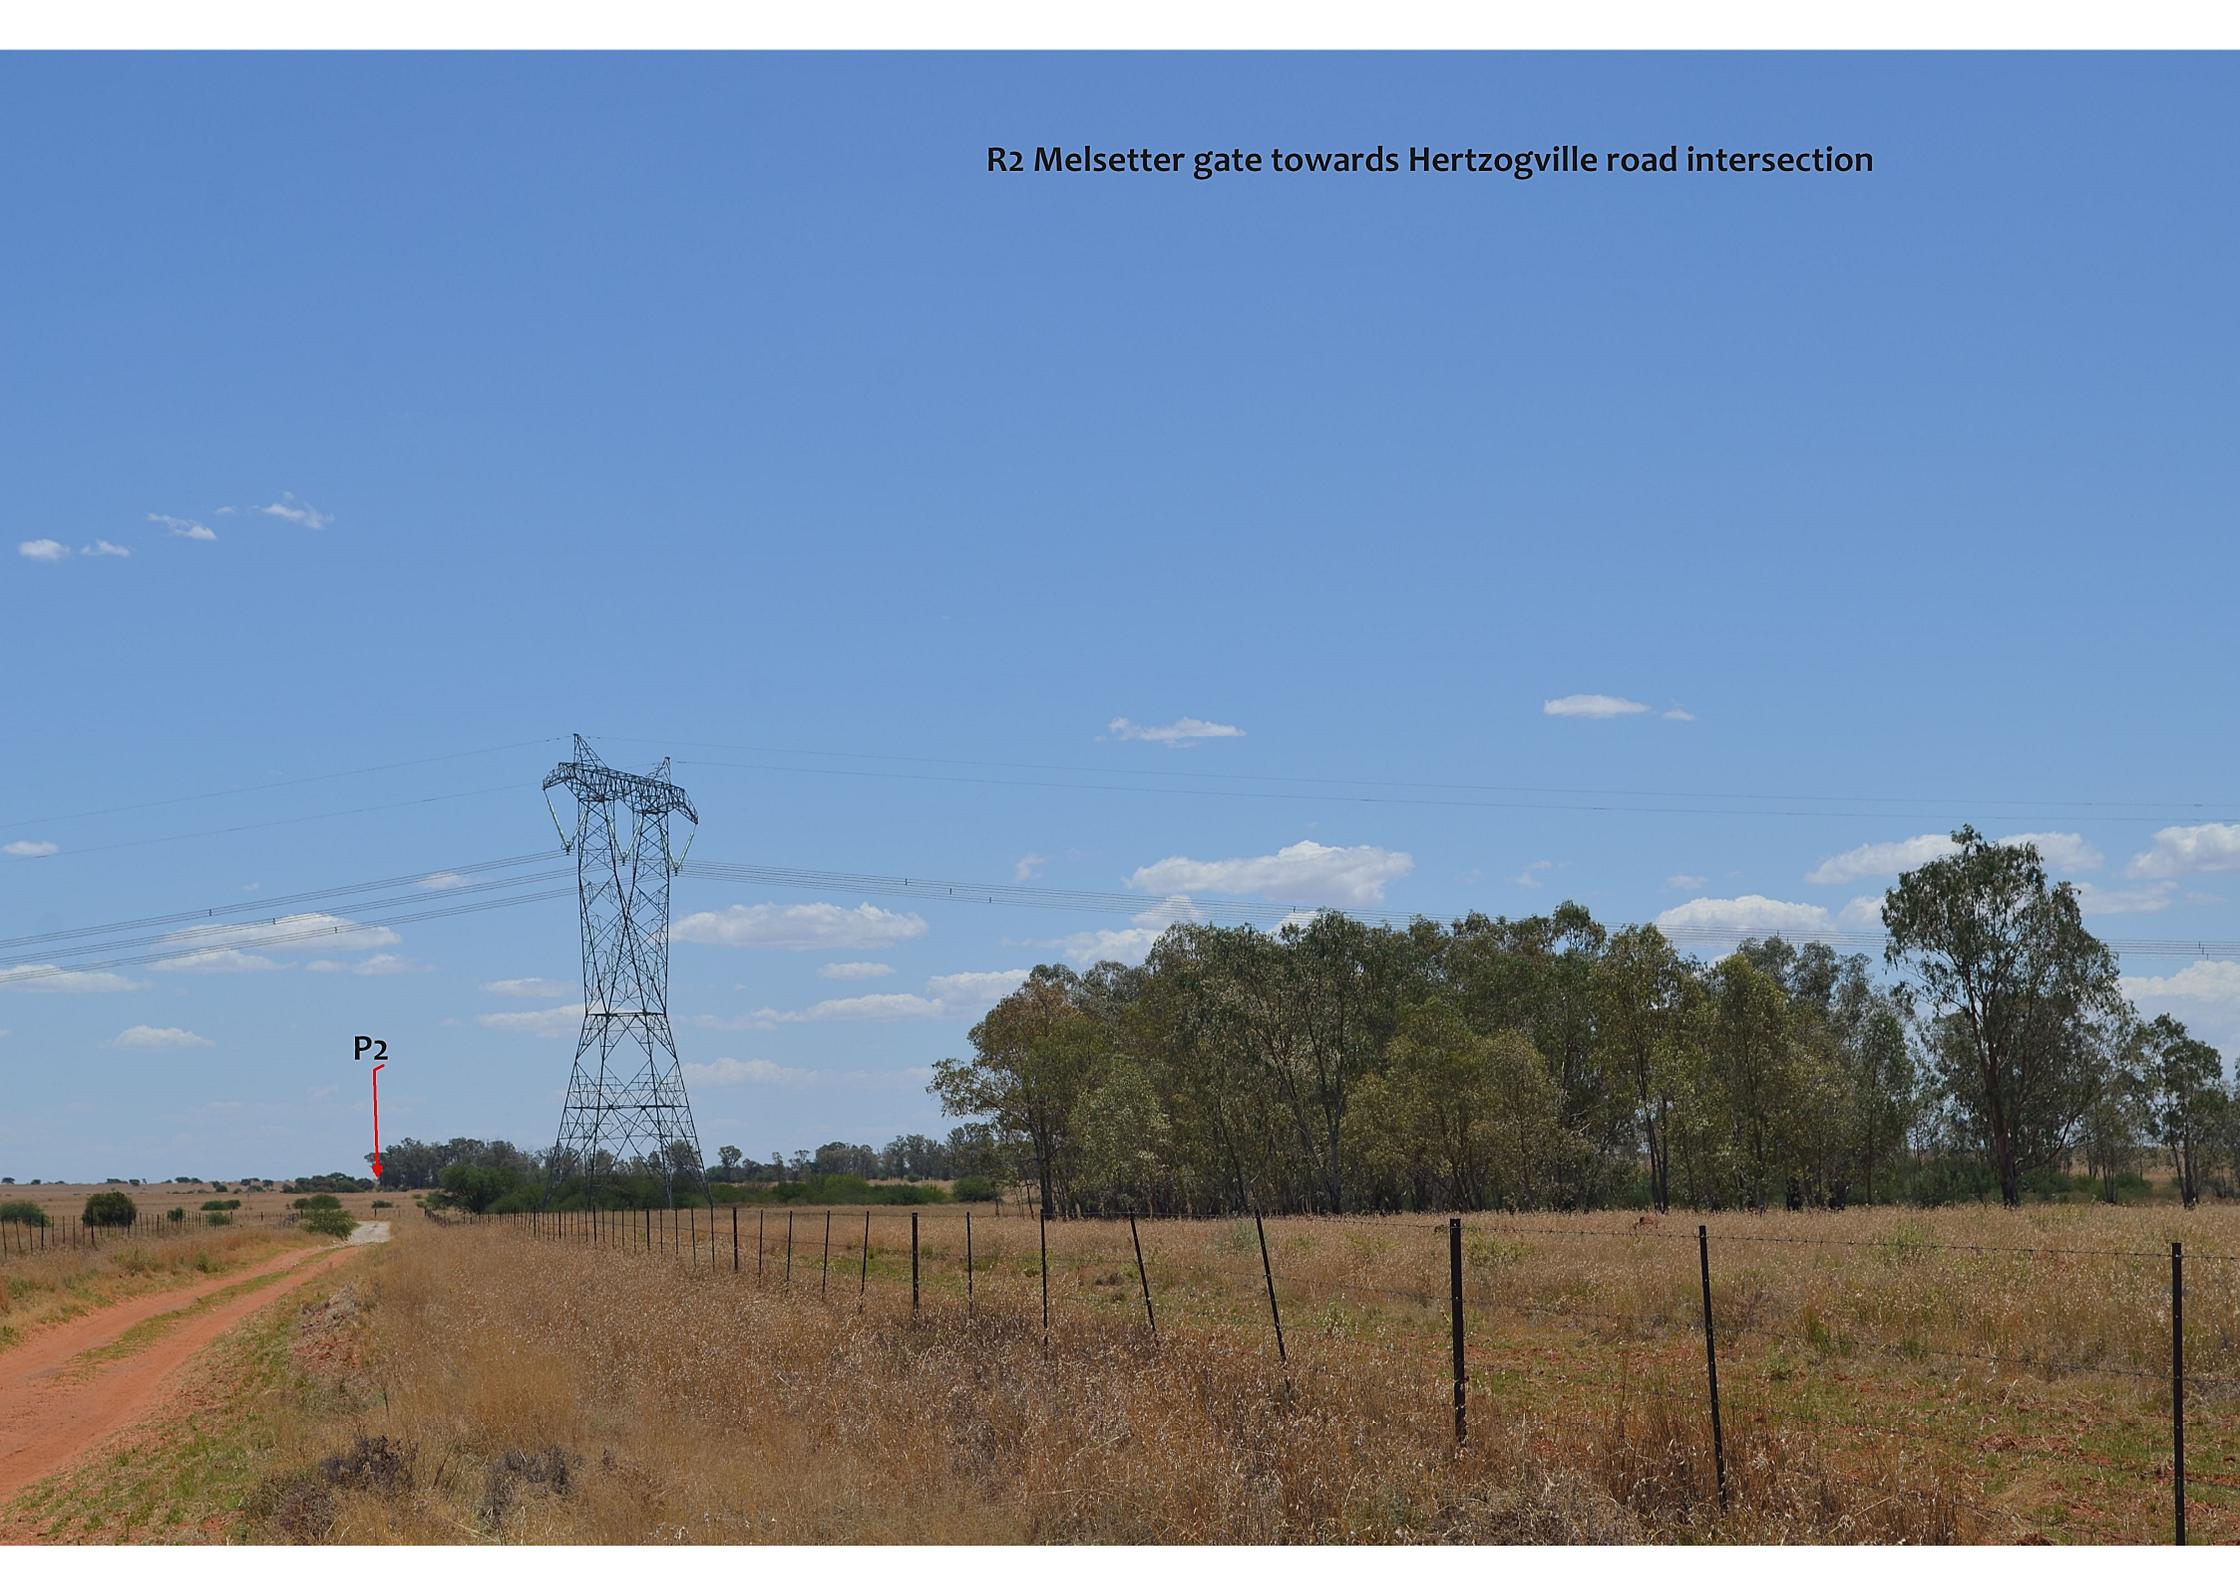
R2 Melsetter gate towards Hertzogville road intersection

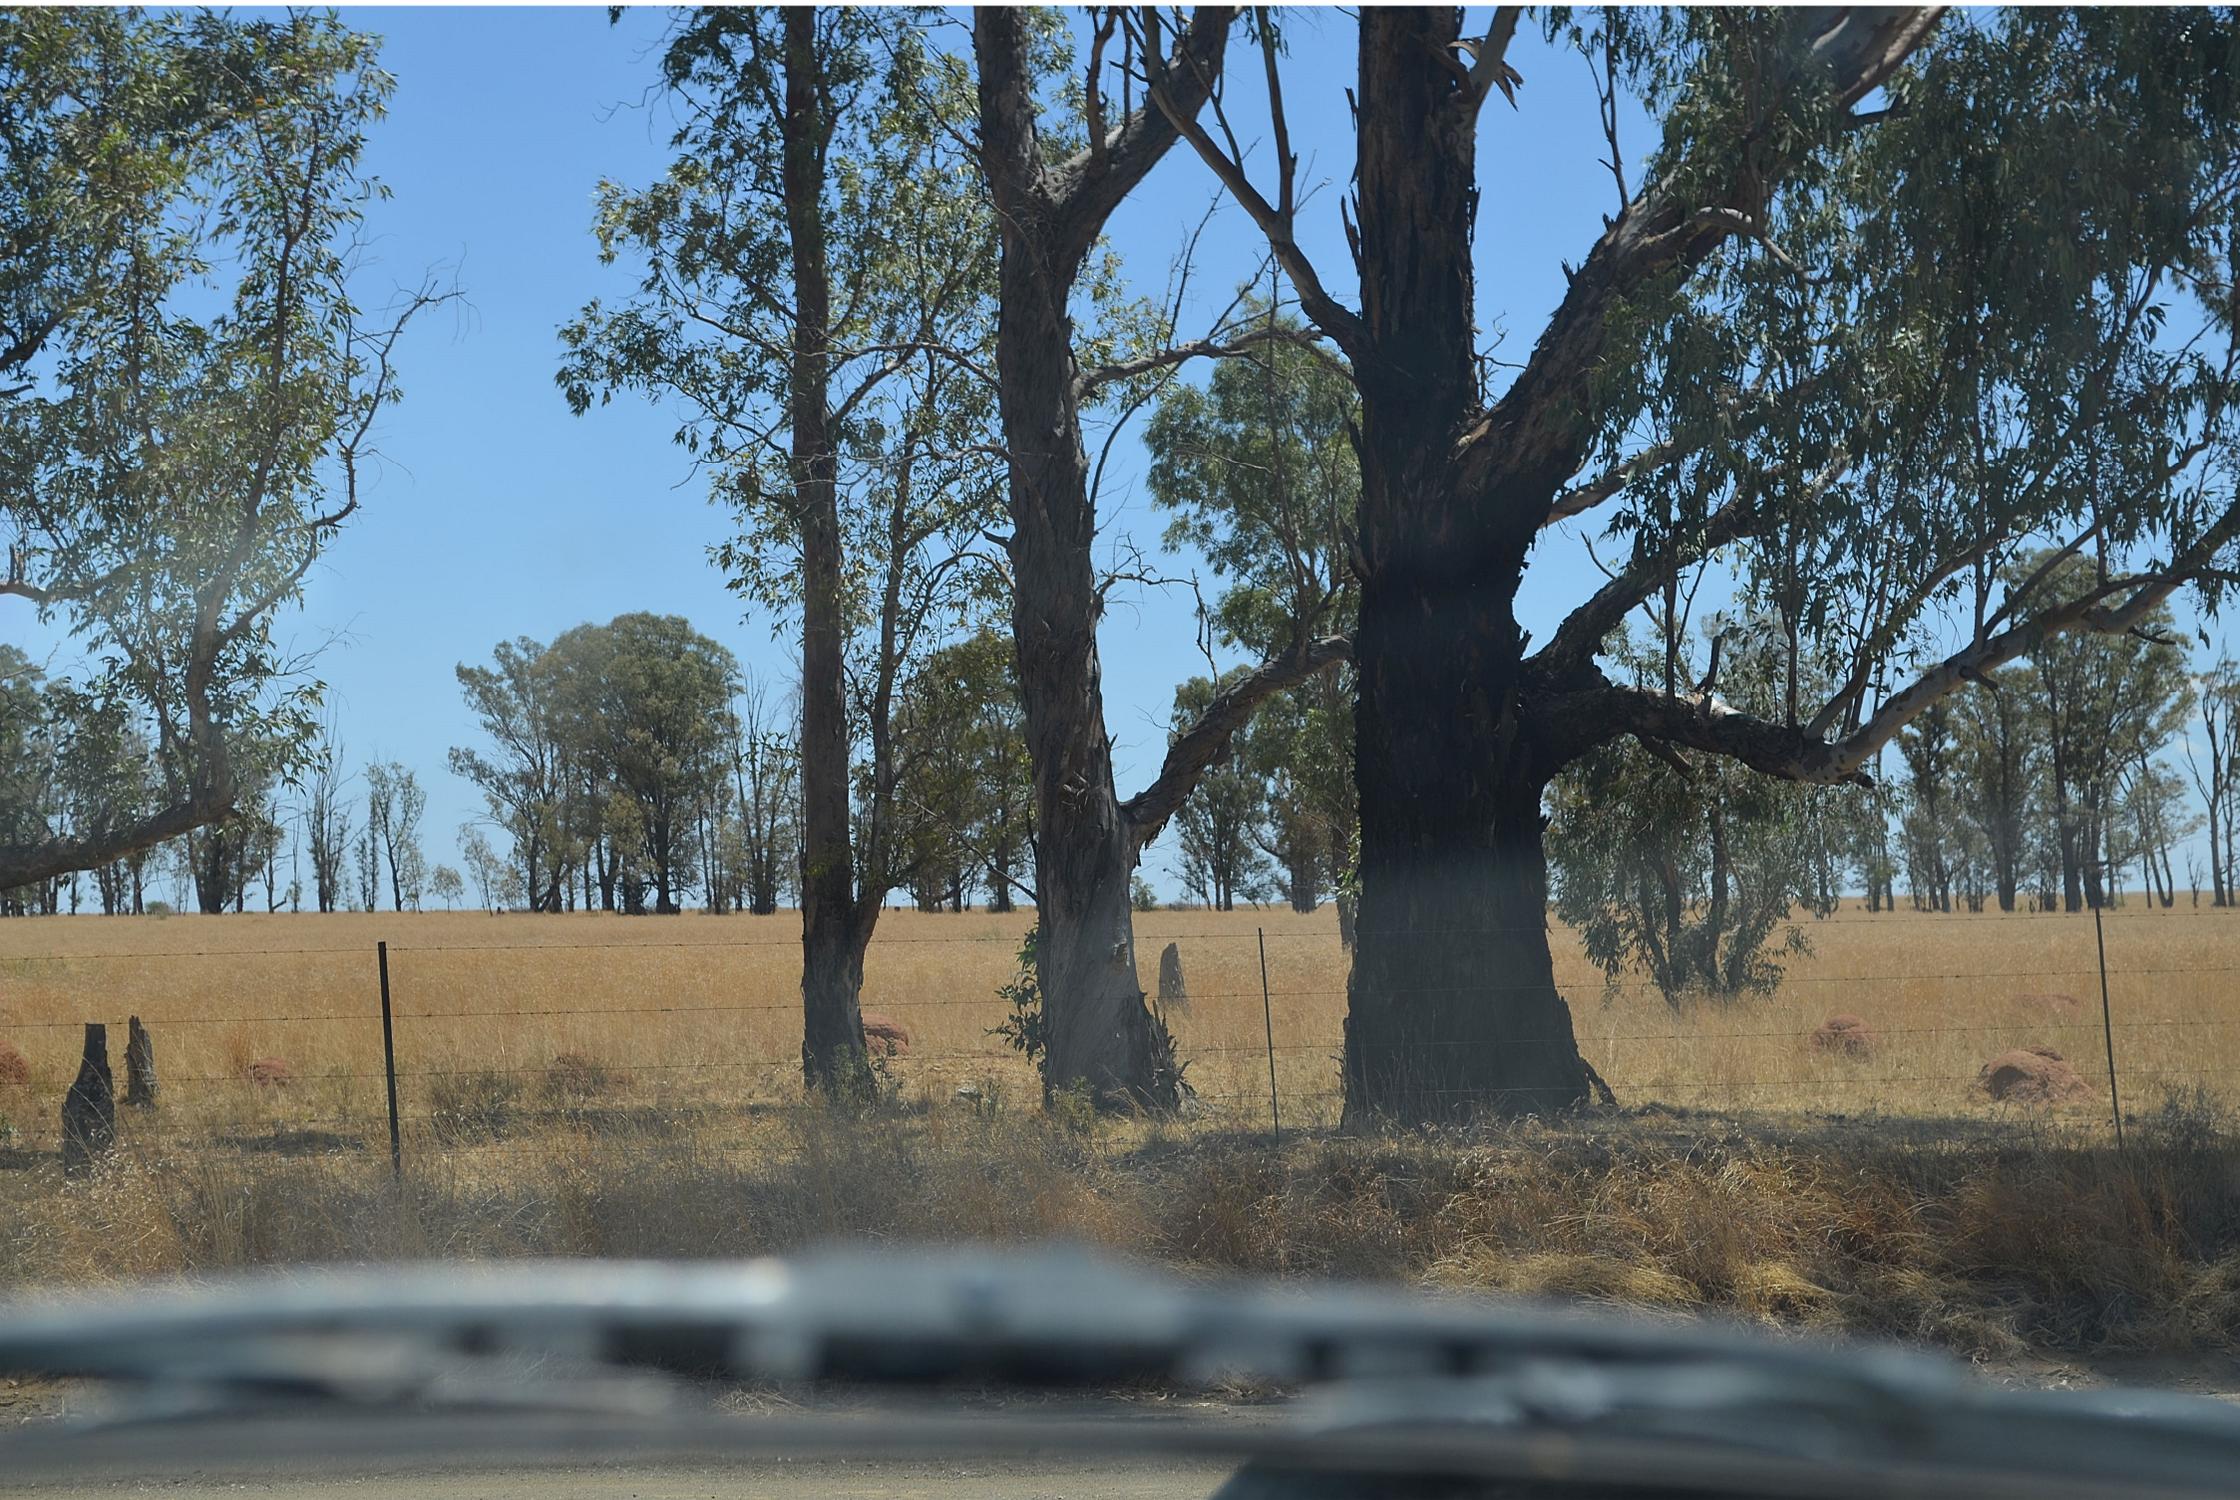
R3 Melsetter intersection with Hertzogville Rd

Trees to be removed

Sideview of arrays

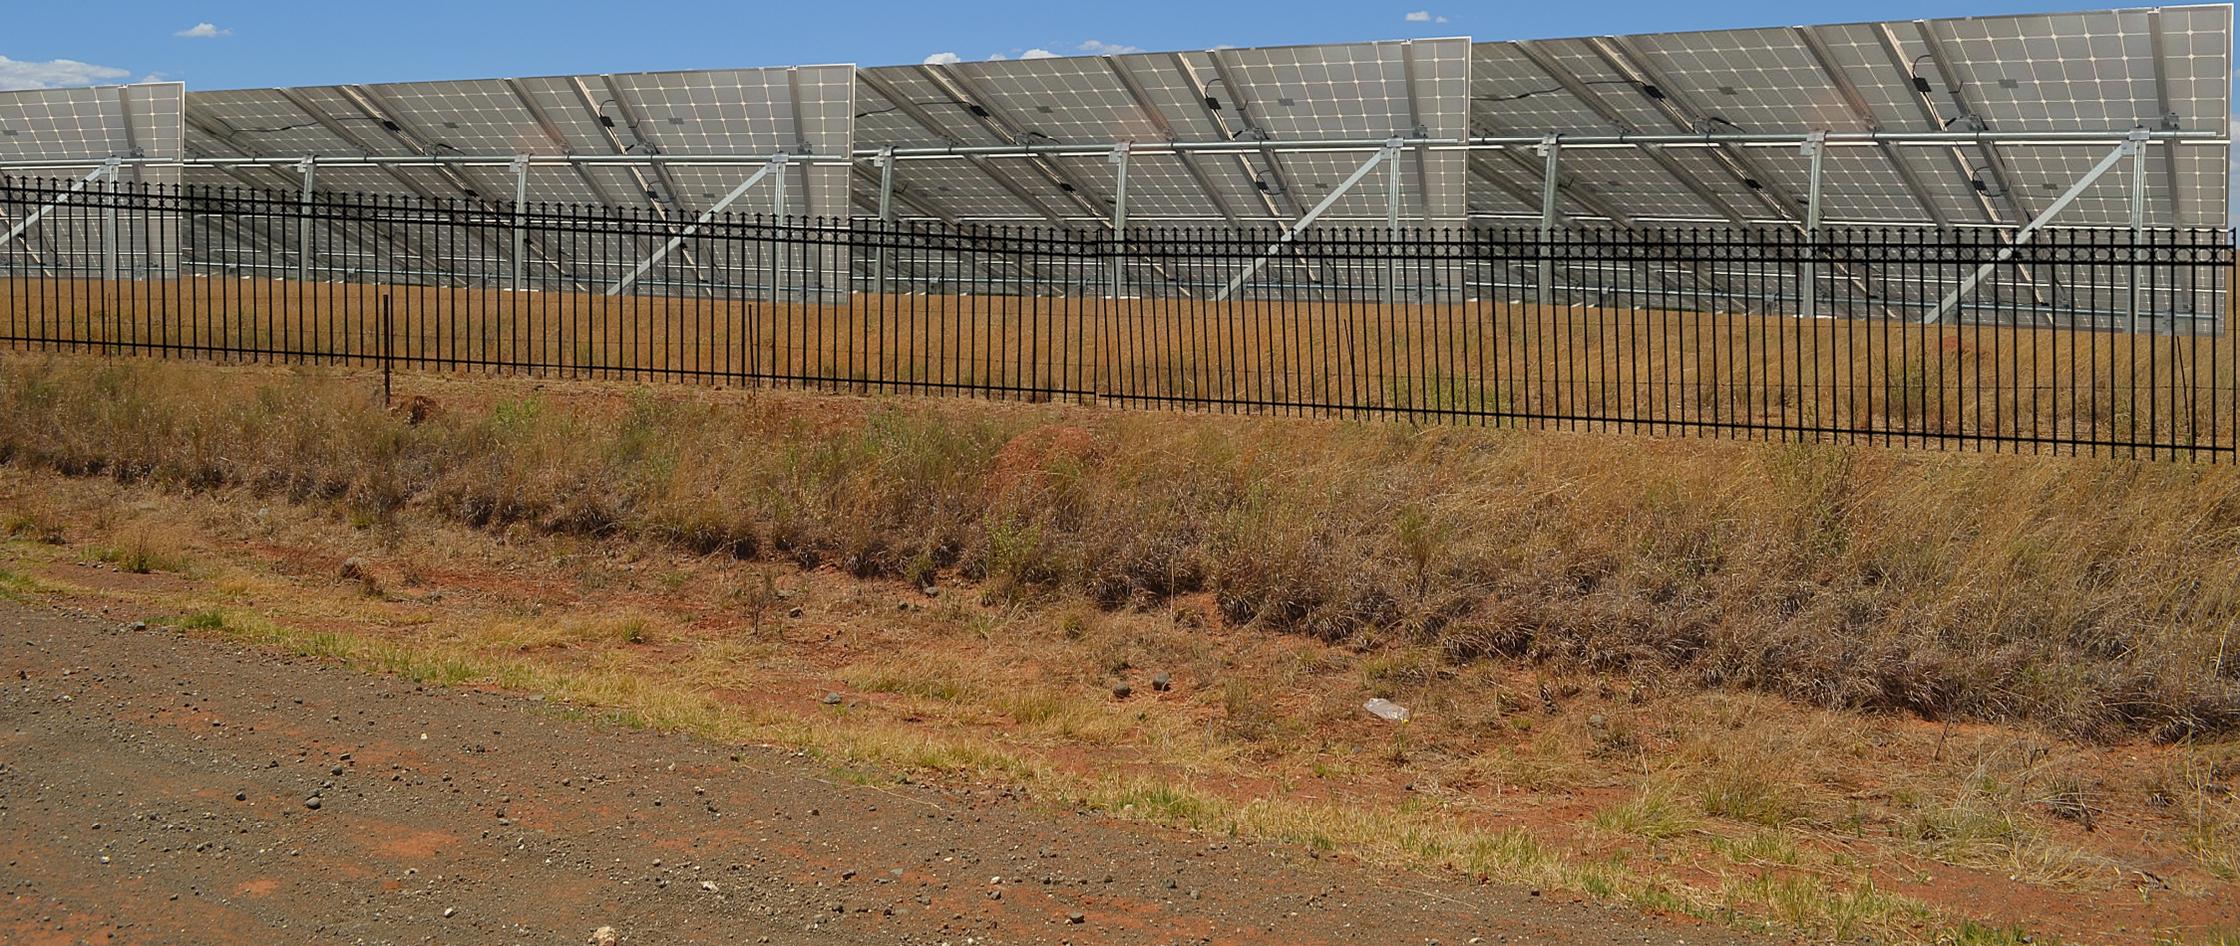
R4 Northview from Hertzogville Rd, West loop
