**GEOTECHNICAL CONDITIONS ON PORTION 16 OF
THE FARM BOEGOEBERG SETTLEMENT 48: A
REPORT FOR THE EXPANSION AND
FORMALISATION OF GROBLERSHOOP COMMUNITY**

2020/J09/MCP_01

PREPARED BY : CEDARLAND GEOTECHNICAL
CONSULT (PTY) LTD

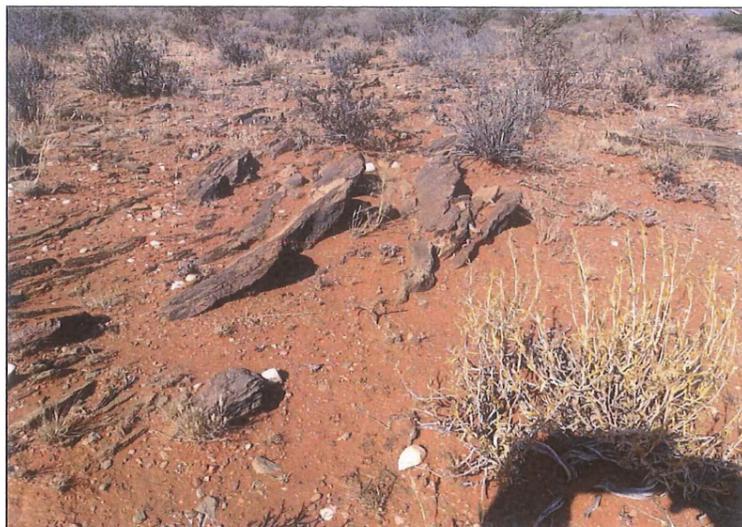
TILTED OUTCROPS OF QUARTZ-AMPHIBOLE SCHIST THROUGH AEOLIAN SAND

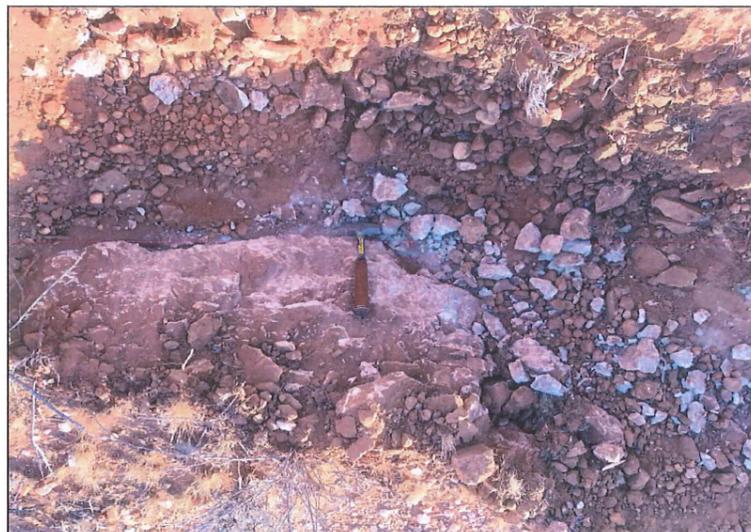
CONDITIONS OF HARD EXCAVATION IN CALCRETE

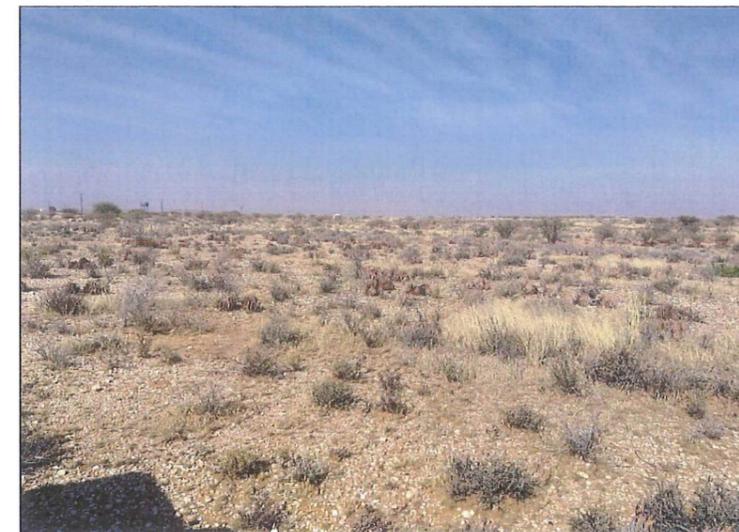
CONDITIONS IN UNDISTURBED VELD

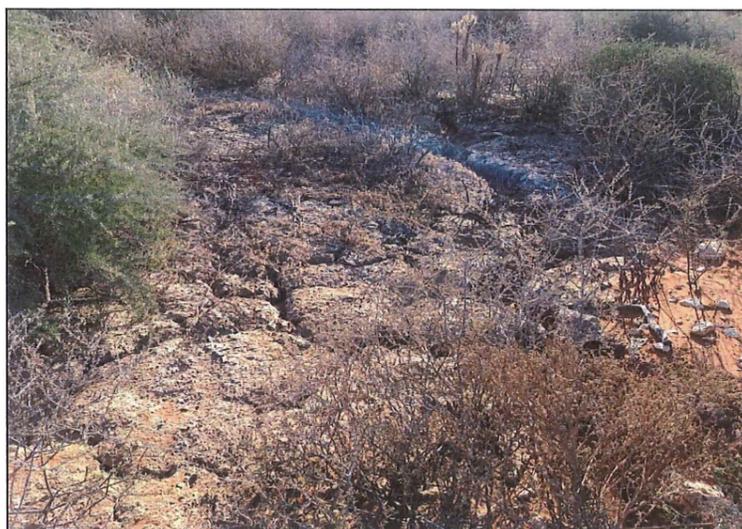
DRIED SPILL OF SEWER WASTE

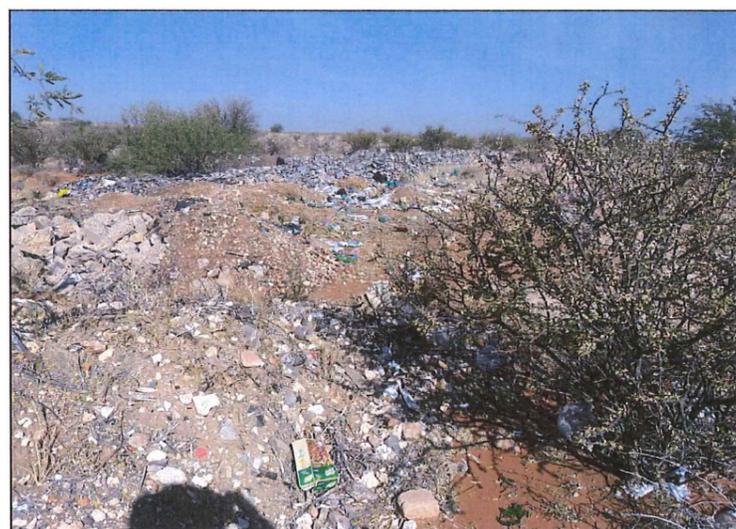
STOCKPILES OF MIXED WASTE MATERIAL

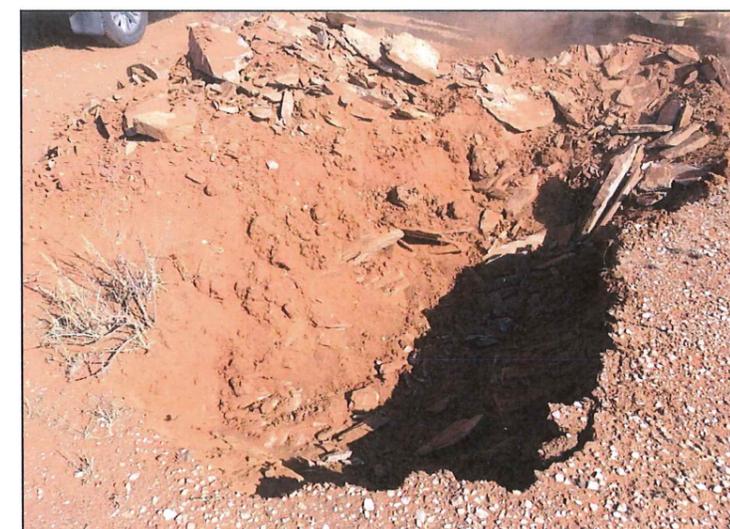
CONDITIONS OF HARD EXCAVATION IN QUARTZ-AMPHIBOLE SCHIST

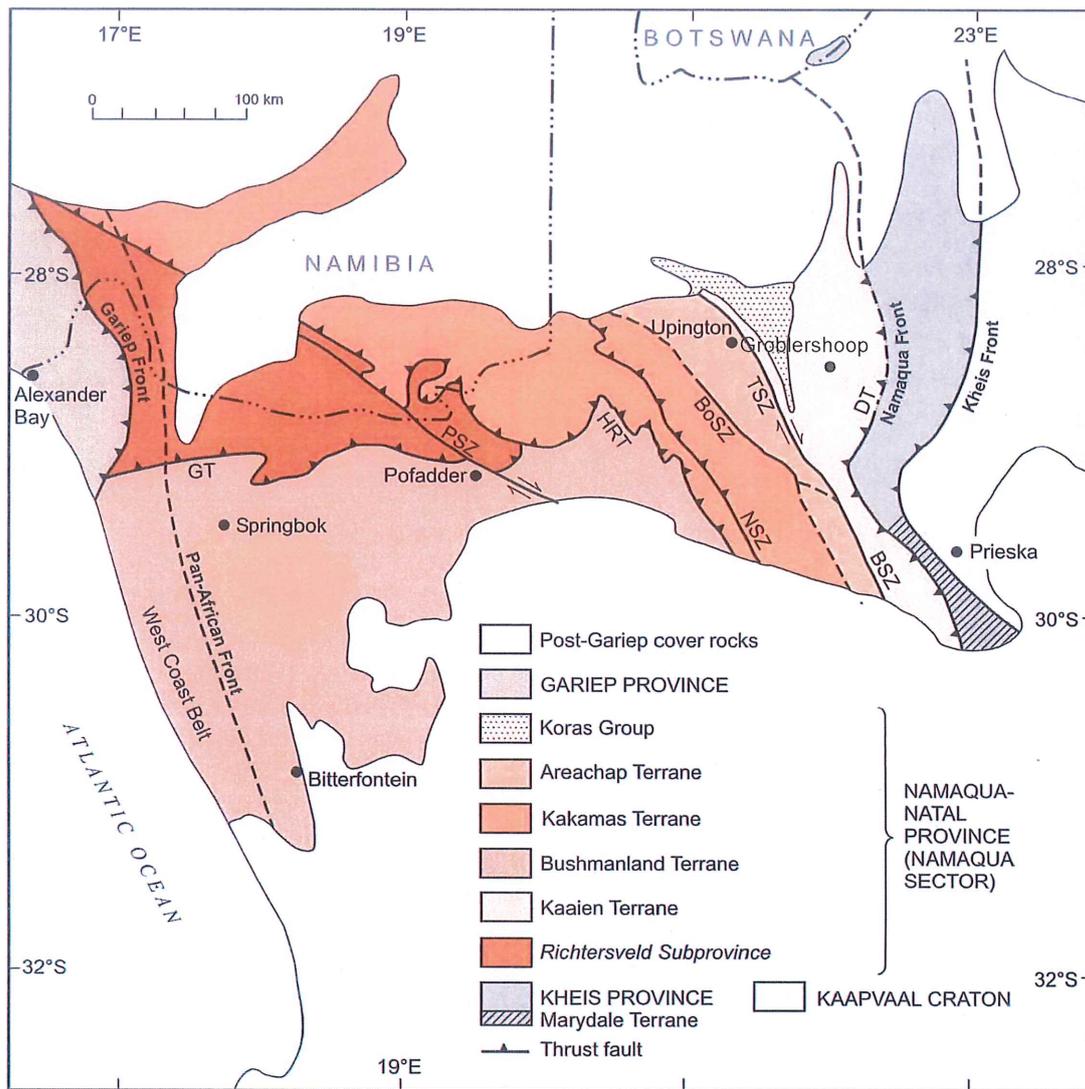
FIGURE 3 : TECTONIC SUBDIVISION OF THE NAMAQUA SECTOR

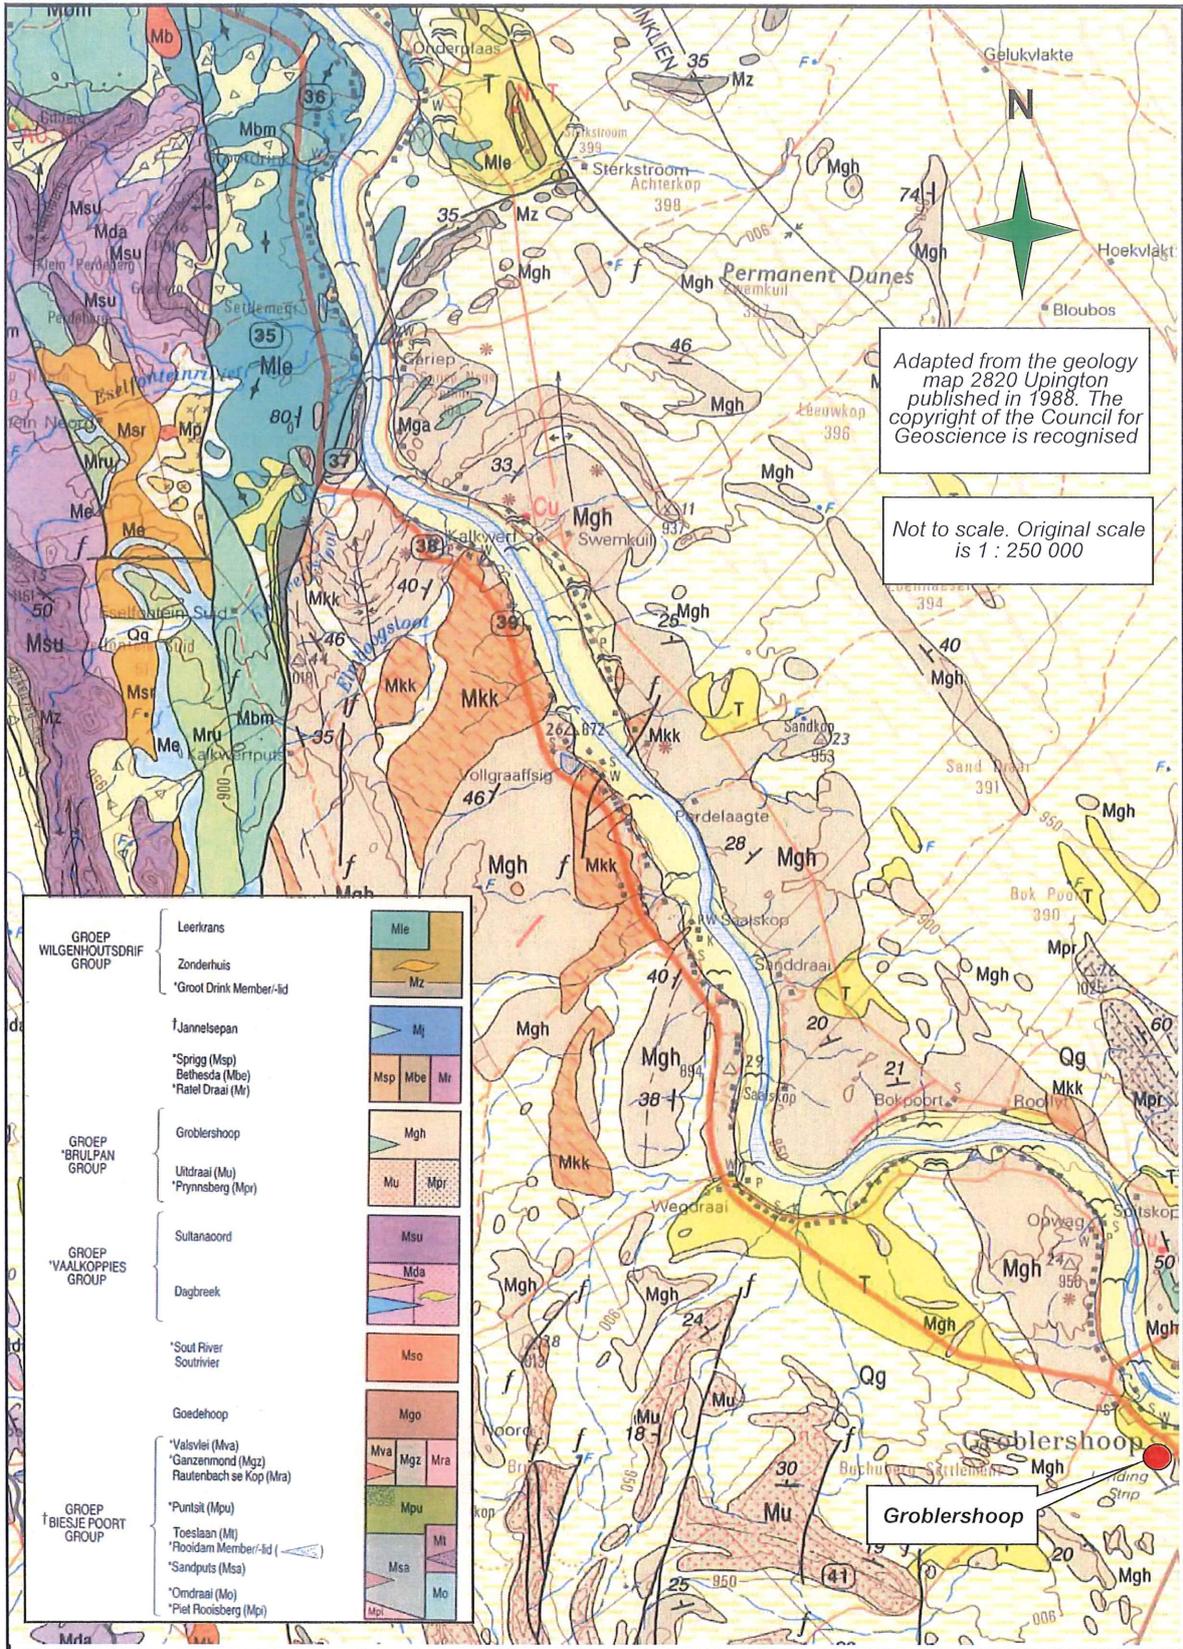
FIGURE 4

GROBLERSHOOP : REGIONAL GEOLOGY

The regional geology is indicated on Figure 4 : Regional Geology.

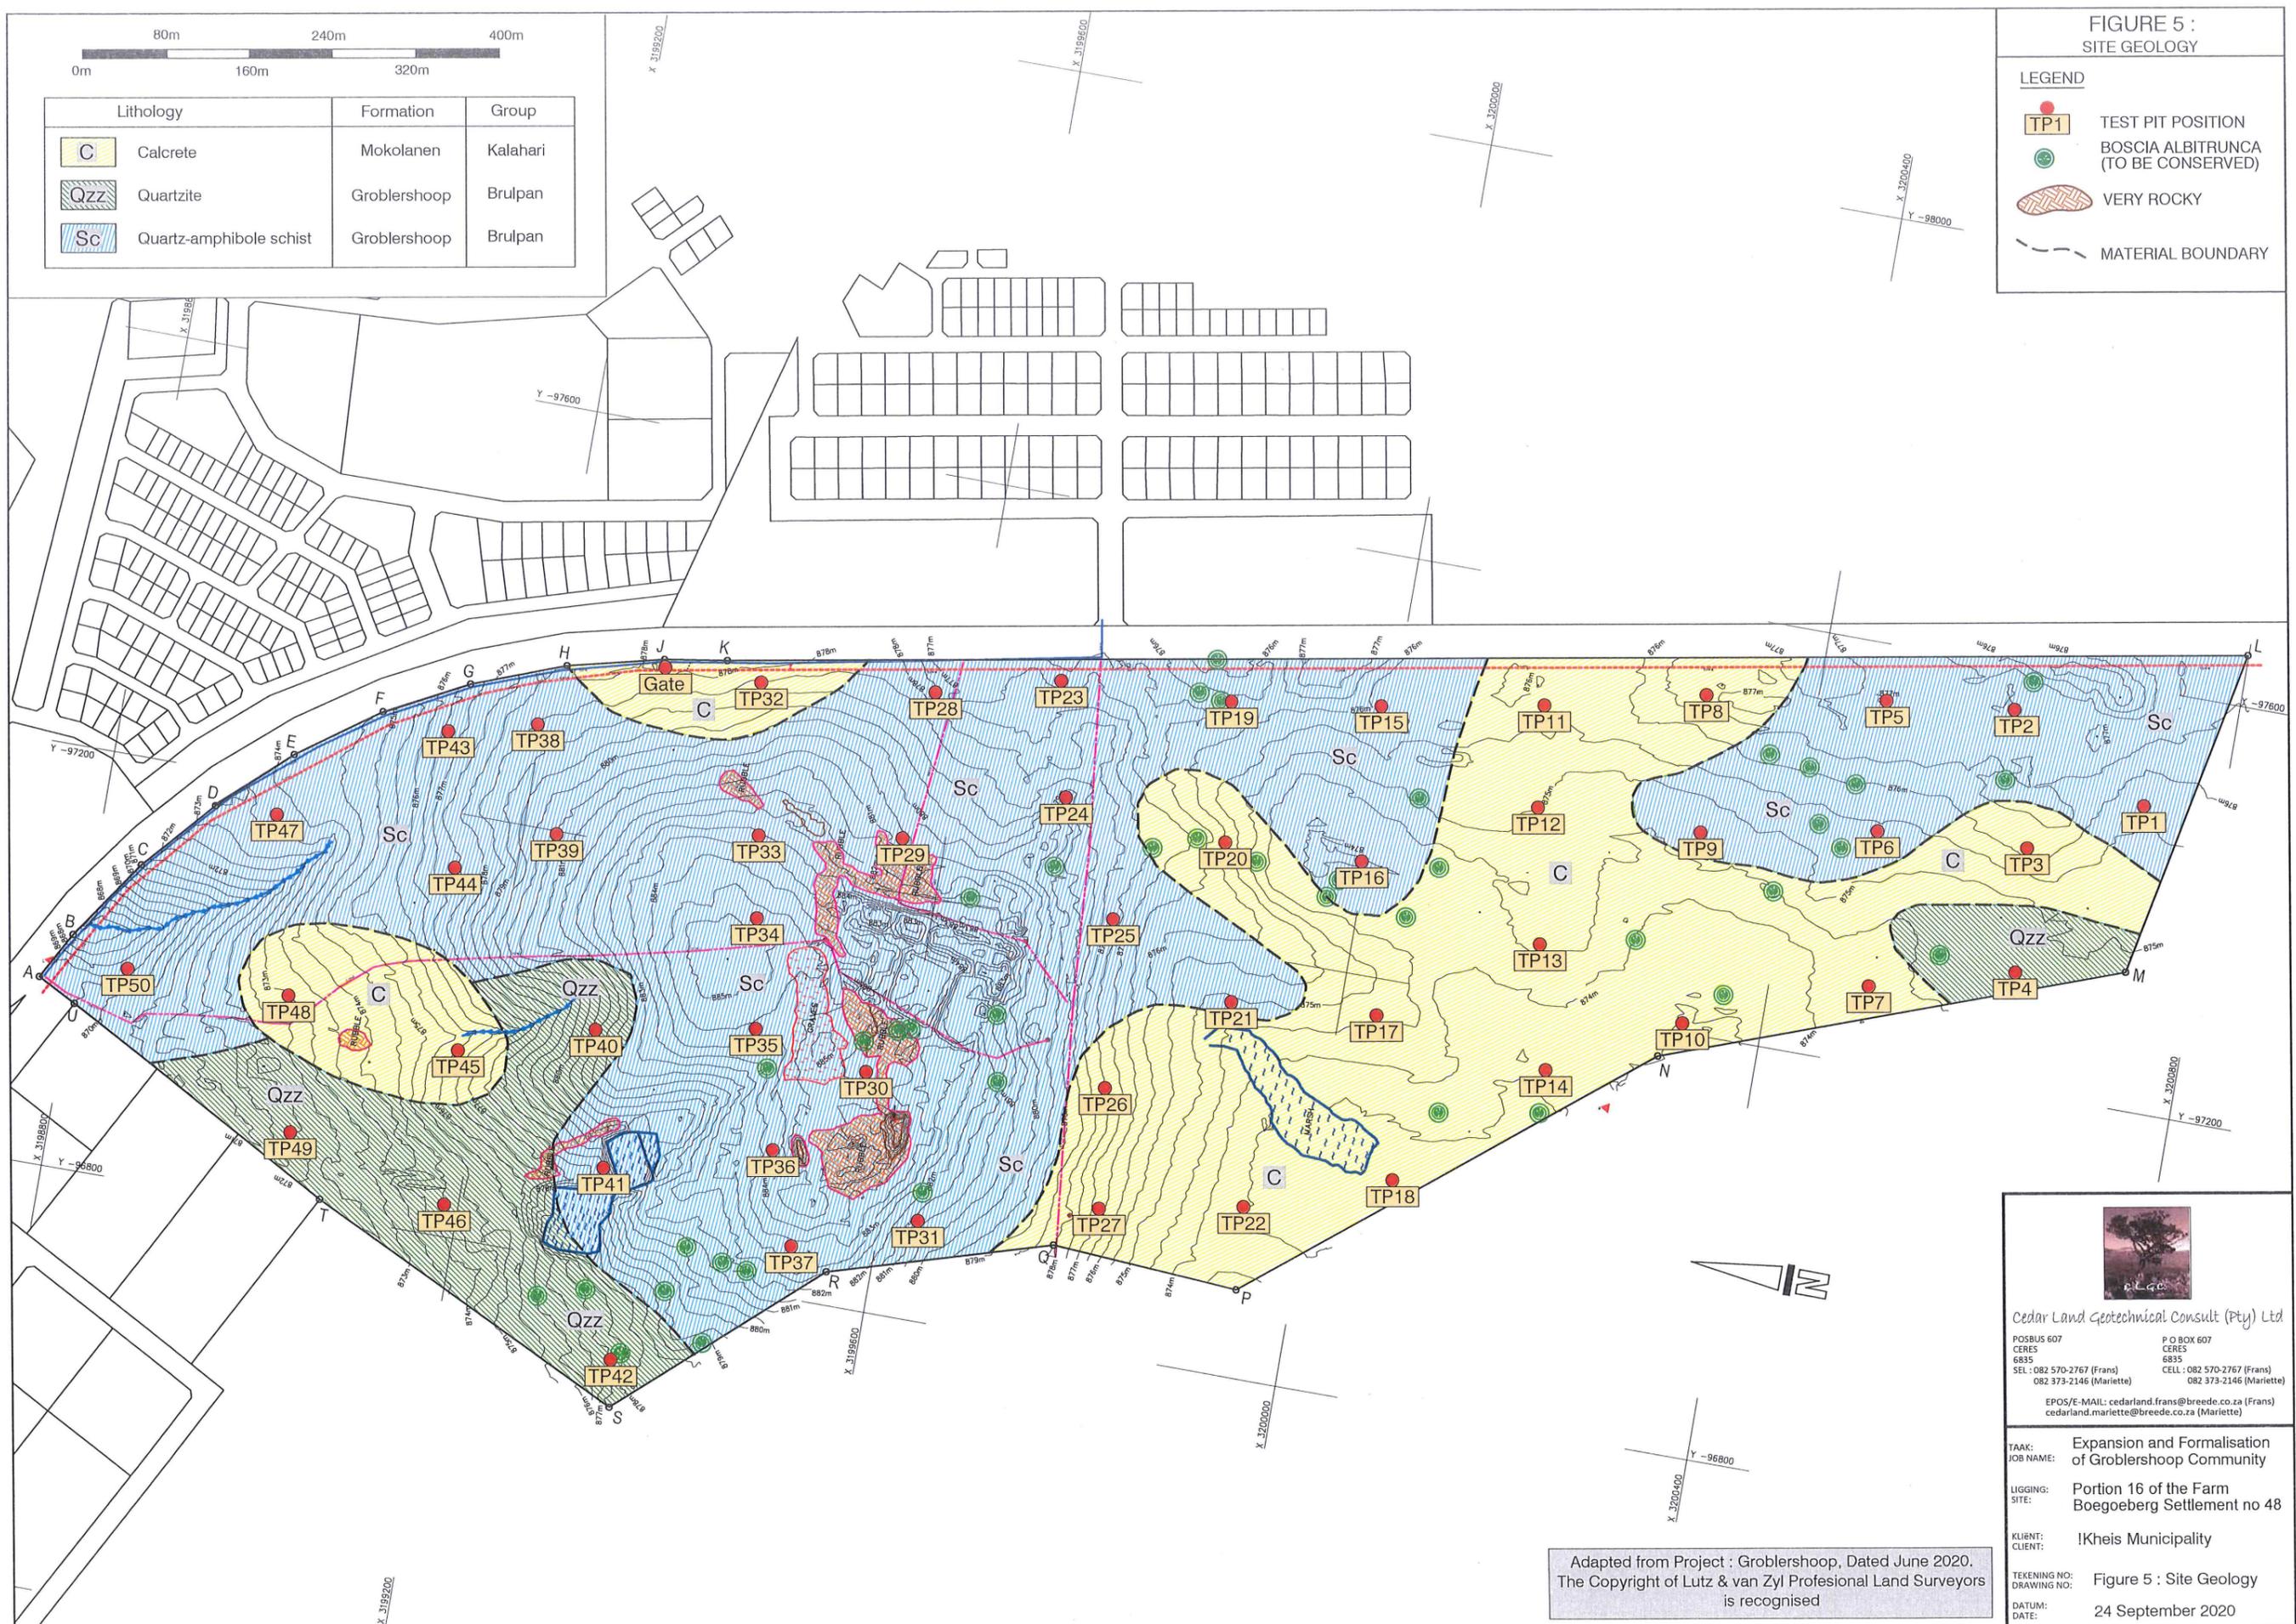
- TP1 TEST PIT POSITION
- BOSCIA ALBITRUNCA (TO BE CONSERVED)
- VERY ROCKY
- MATERIAL BOUNDARY

Lithology	Formation	Group
C	Calcrete	Mokolanen Kalahari
QZZ	Quartzite	Groblershoop Brulpan
Sc	Quartz-amphibole schist	Groblershoop Brulpan

The site geology is illustrated on Figure 5. The soil and pedocretes are present as a very dense barrier over bedrock with exposures in areas of thin and less dense pedocrete deposits.

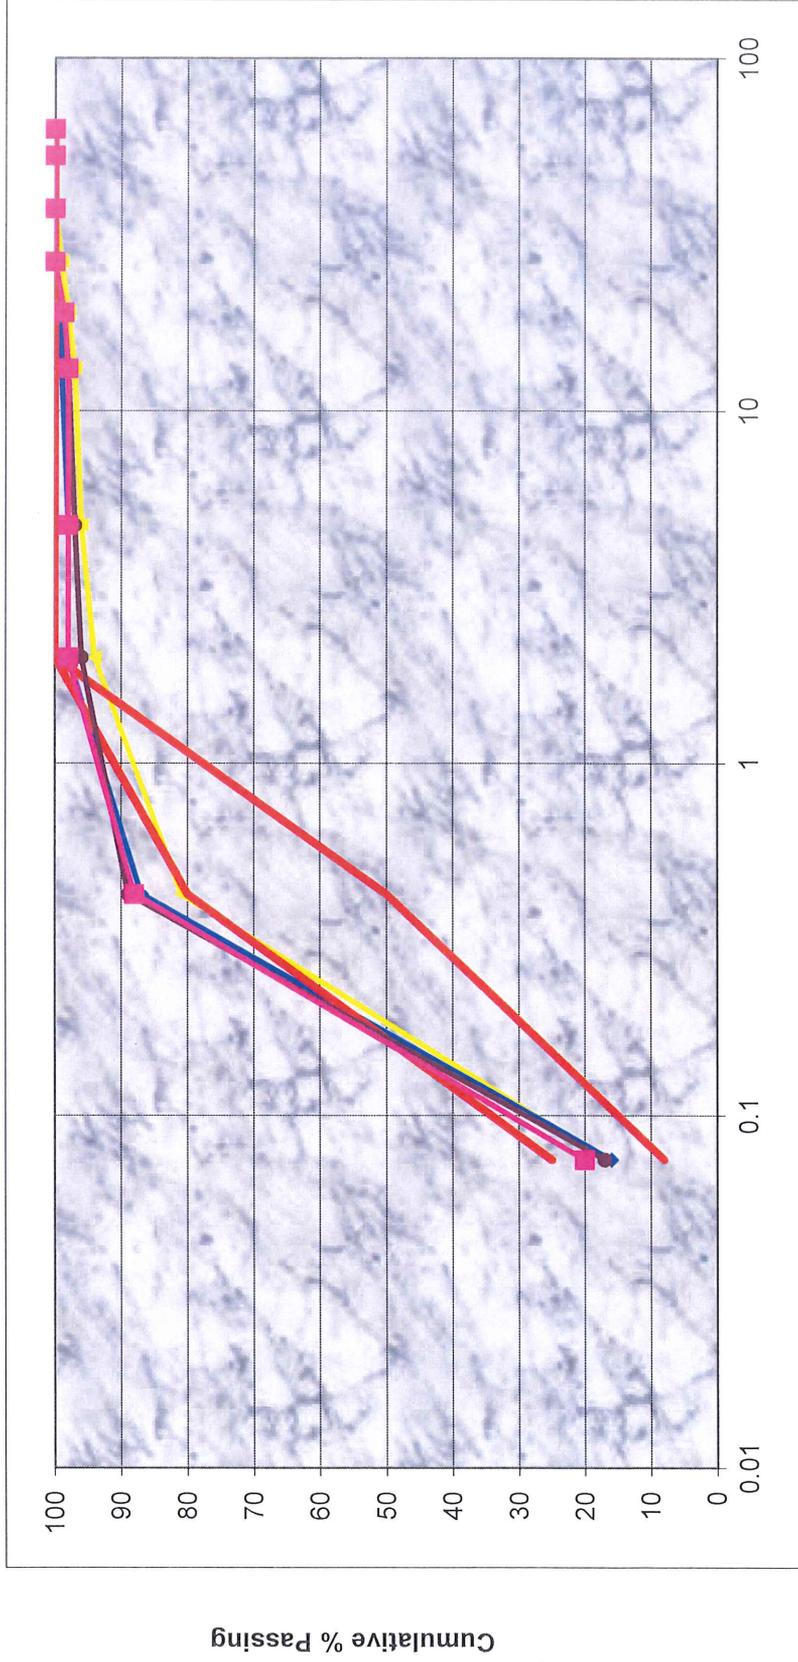
Sieve sizes (To Log Scale)

- Errera envelope
- Sample U9305
- Sample U9303
- Sample U9298
- Sample U9295

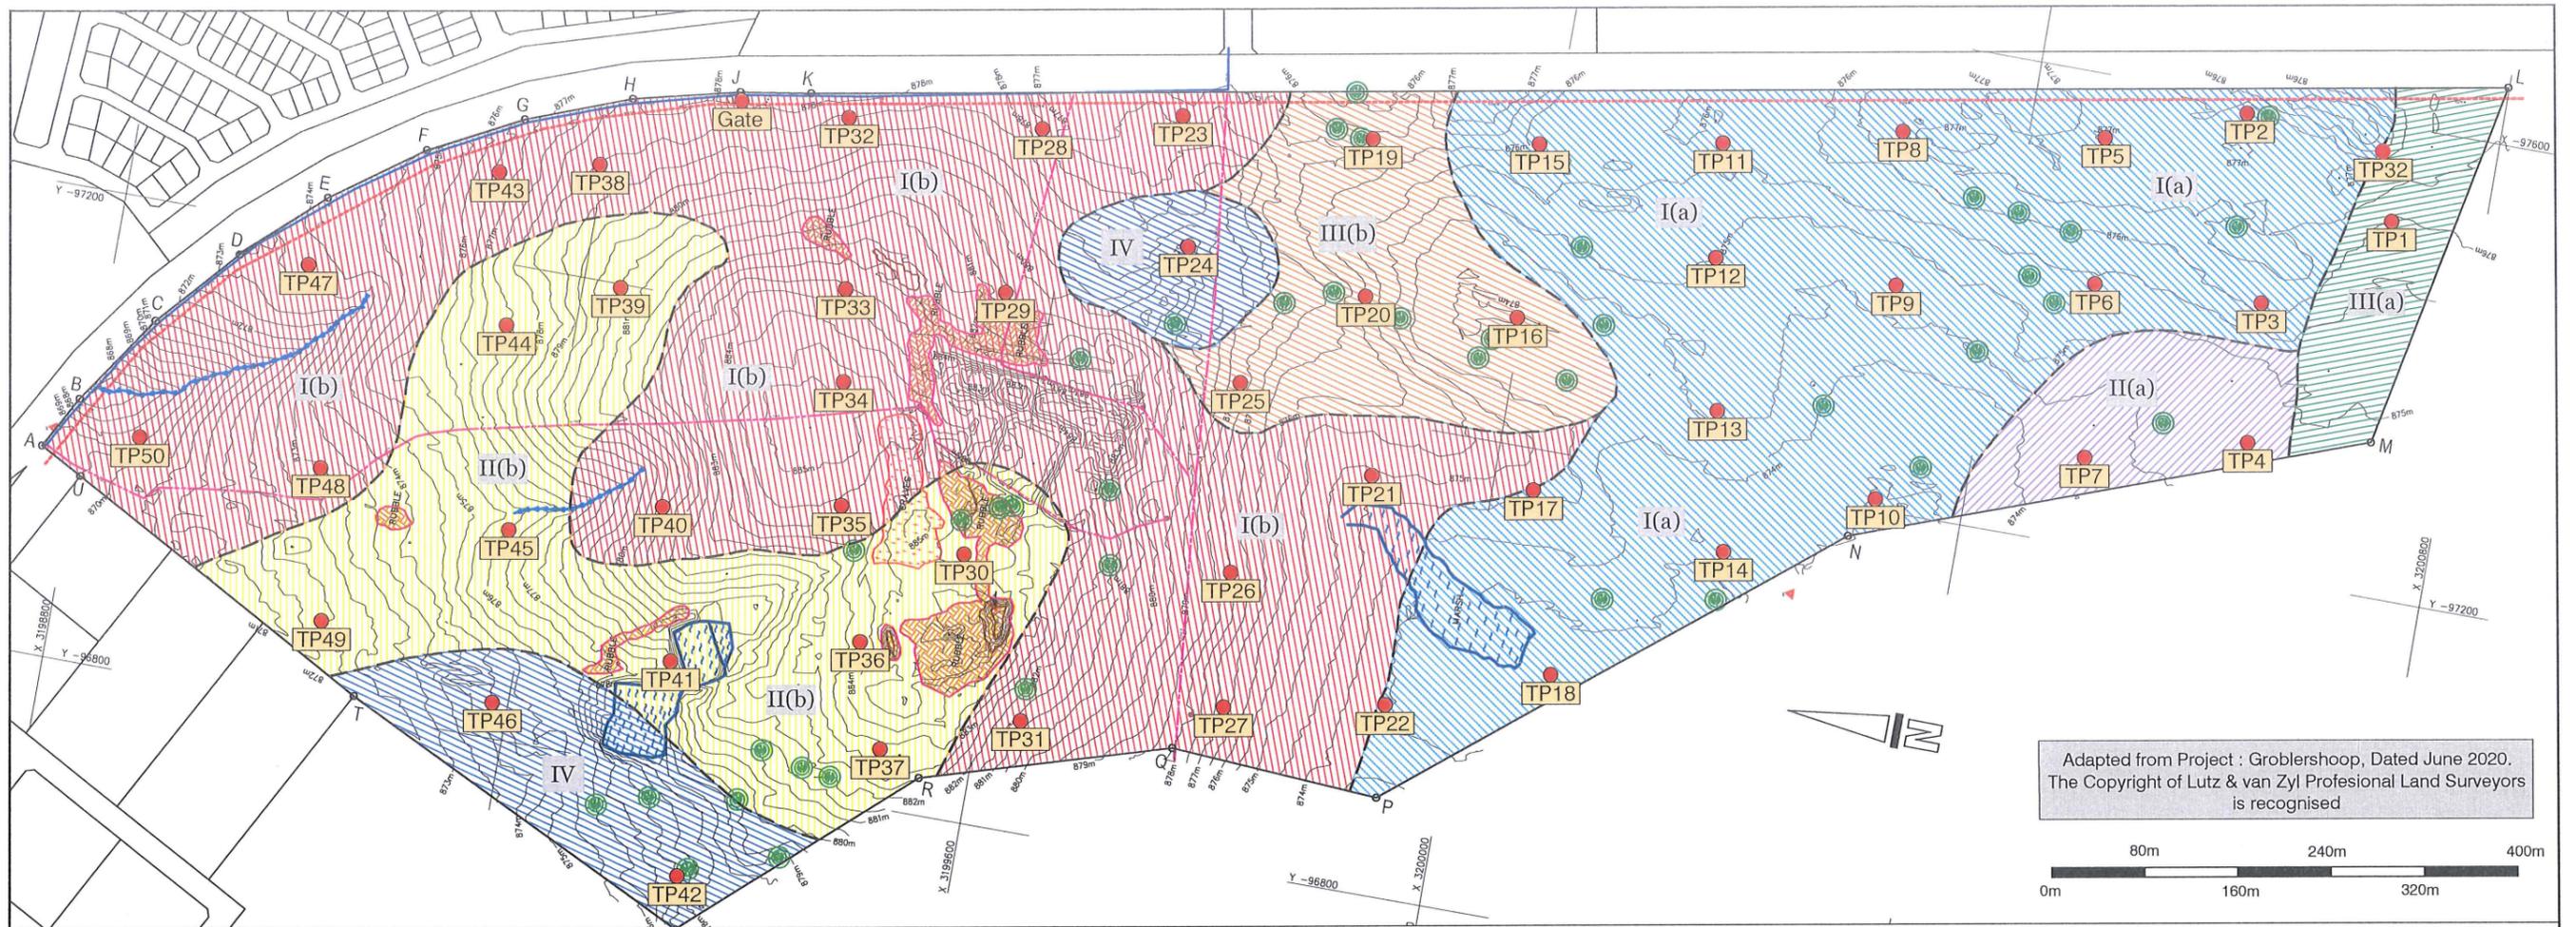
FOUNDATION DESIGN, BUILDING PROCEDURES AND PRECAUTIONARY MEASURES

AREA	AREA OF PROPERTY (%)	GEOTECHNICAL CLASS	ESTIMATED SOIL MOVEMENT(mm)	SOIL PROFILE	CONSTRUCTION TYPE	FOUNDATION DESIGN	ASSOCIATED PROBLEMS	DEVELOPMENT POTENTIAL	FIGURE 7 : SITE CLASS DESIGNATION
I(a)	27,54	R	Negligible	Less than 400mm of colluvium and residual soil overlying bedrock and pedogenic deposits	Normal	Normal construction (strip footing or slab-on-the-ground) foundation. Founding to take place on very dense pedocretes or bedrock	Conditions of hard rock excavation. Landslope less than 2% favours slab-on-the-ground foundations	Intermediate	LEGEND TEST PIT POSITION BOSCIA ALBITRUNCA (TO BE CONSERVED) VERY ROCKY MATERIAL BOUNDARY Cedar Land Geotechnical Consult (Pty) Ltd POSBUS 607 CERES 6835 SEL : 082 570-2767 (Frans) 082 373-2146 (Mariette) P O BOX 607 CERES 6835 CELL : 082 570-2767 (Frans) 082 373-2146 (Mariette) EPOS/E-MAIL: cedarland.frans@breede.co.za (Frans) cedarland.mariette@breede.co.za (Mariette)
