**GEOTECHNICAL CONDITIONS ON ERF 131
GROOTDRINK AND PLOT 2627 BOEGOEBERG
SETTLEMENT: A REPORT FOR THE EXPANSION
AND FORMALISATION OF GROOTDRINK
COMMUNITY**

2020/J09/MCP_01

PREPARED BY : CEDARLAND GEOTECHNICAL
CONSULT (PTY) LTD

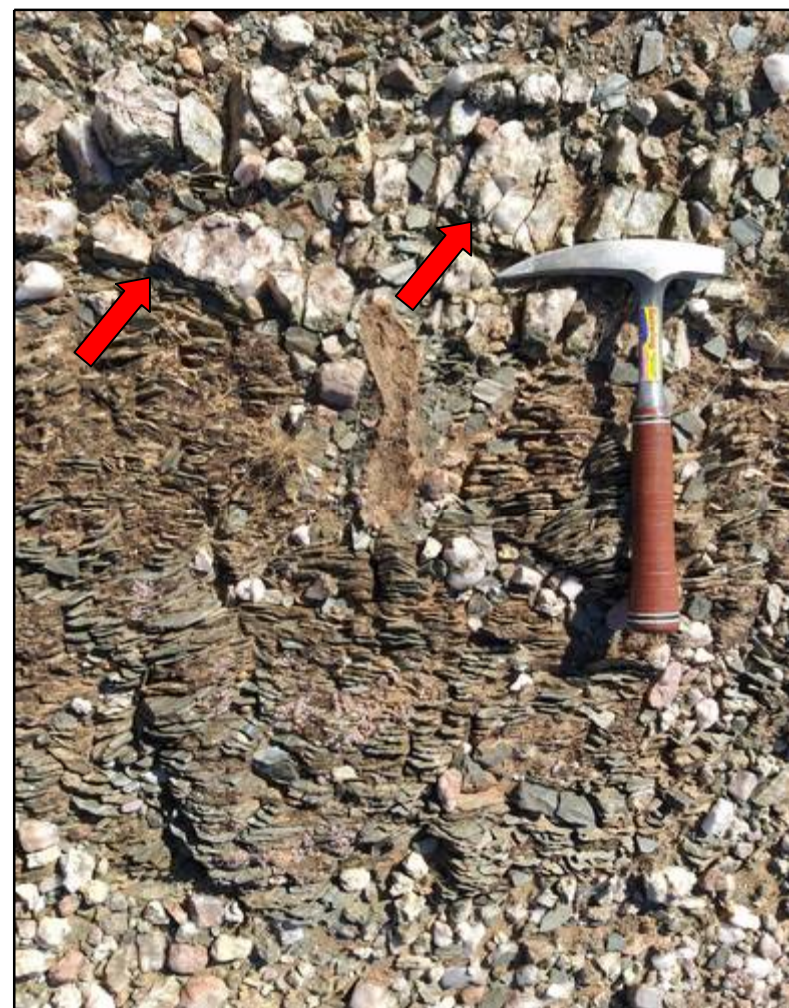
TYPICAL OUTCROPS OF GREENSCHIST -
NOTE LENSES OF QUARTZ (arrowed)

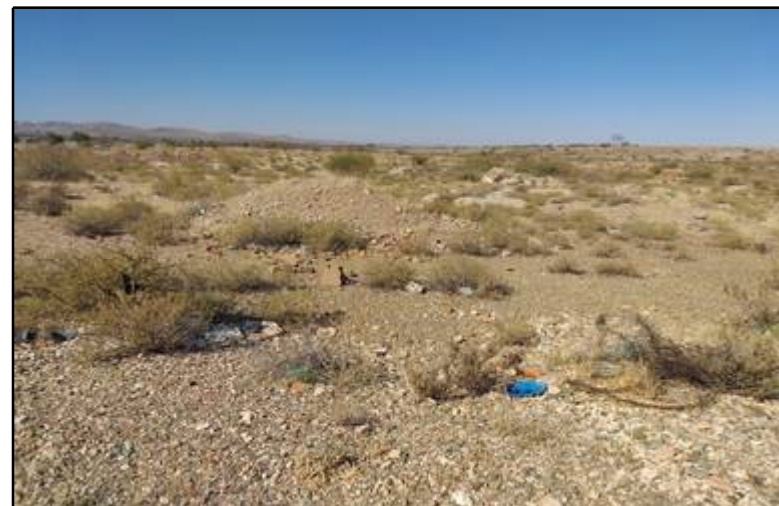
WASTE DUMPS OF CALCRETE, CONCRETE
ROCK AND SANDY MATERIAL

- The presence of hard rock and very dense hardpan calcrete close to the surface. The presence thereof will result in conditions of hard excavation.
- The limited slope of less than 2% in geotechnical zone II will have a detrimental influence on the design of stormwater disposal systems and sewerage reticulation.
- The presence of waste material need to be addressed.

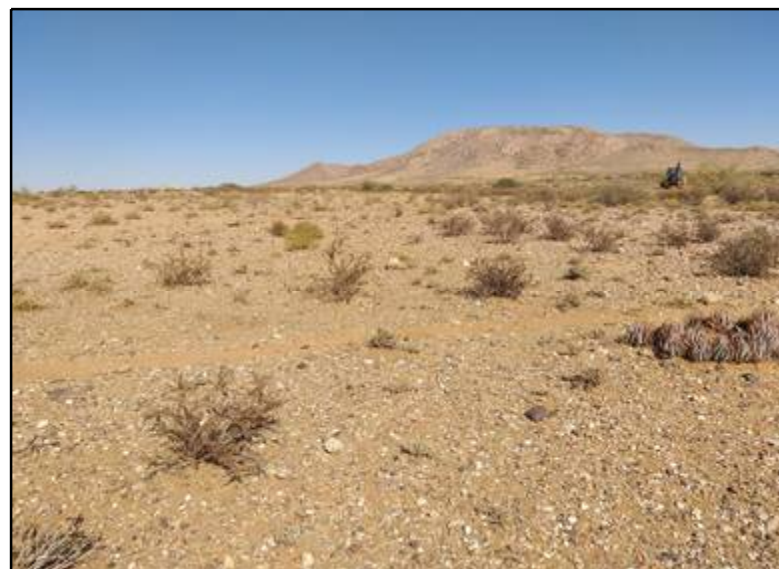
SITE CONDITIONS IN OPEN VELD. NOTE
COLLUVIAL DEPOSITS OF WHITE QUARTZ
GRAVELS

On site colluvium as surface deposit was found in all the test pits except TP's 4, 14, 15, 20, 21, 25, 27 and 28. The horizon of colluvium was between 100mm and 900mm thick in the test pits. Colluvium consists of pegmatitic gravels, weather resistant scree of quartz and quartzite fragments contained in a sandy matrix. Nodules of calcrete may be contained in the colluvium. The consistency of the colluvium varies between loose and medium dense.

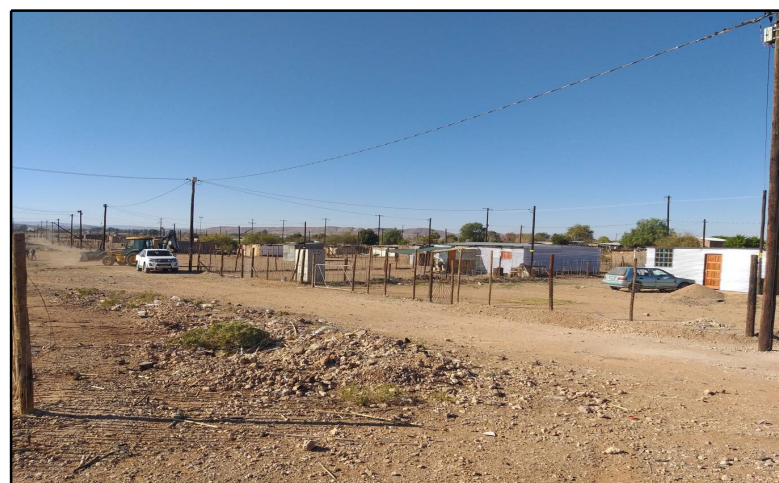
CONDITIONS IN GROOTDRINK VILLAGE

Site conditions are illustrated on Photo 1 : Site Conditions. The area can be divided into two zones as follows :

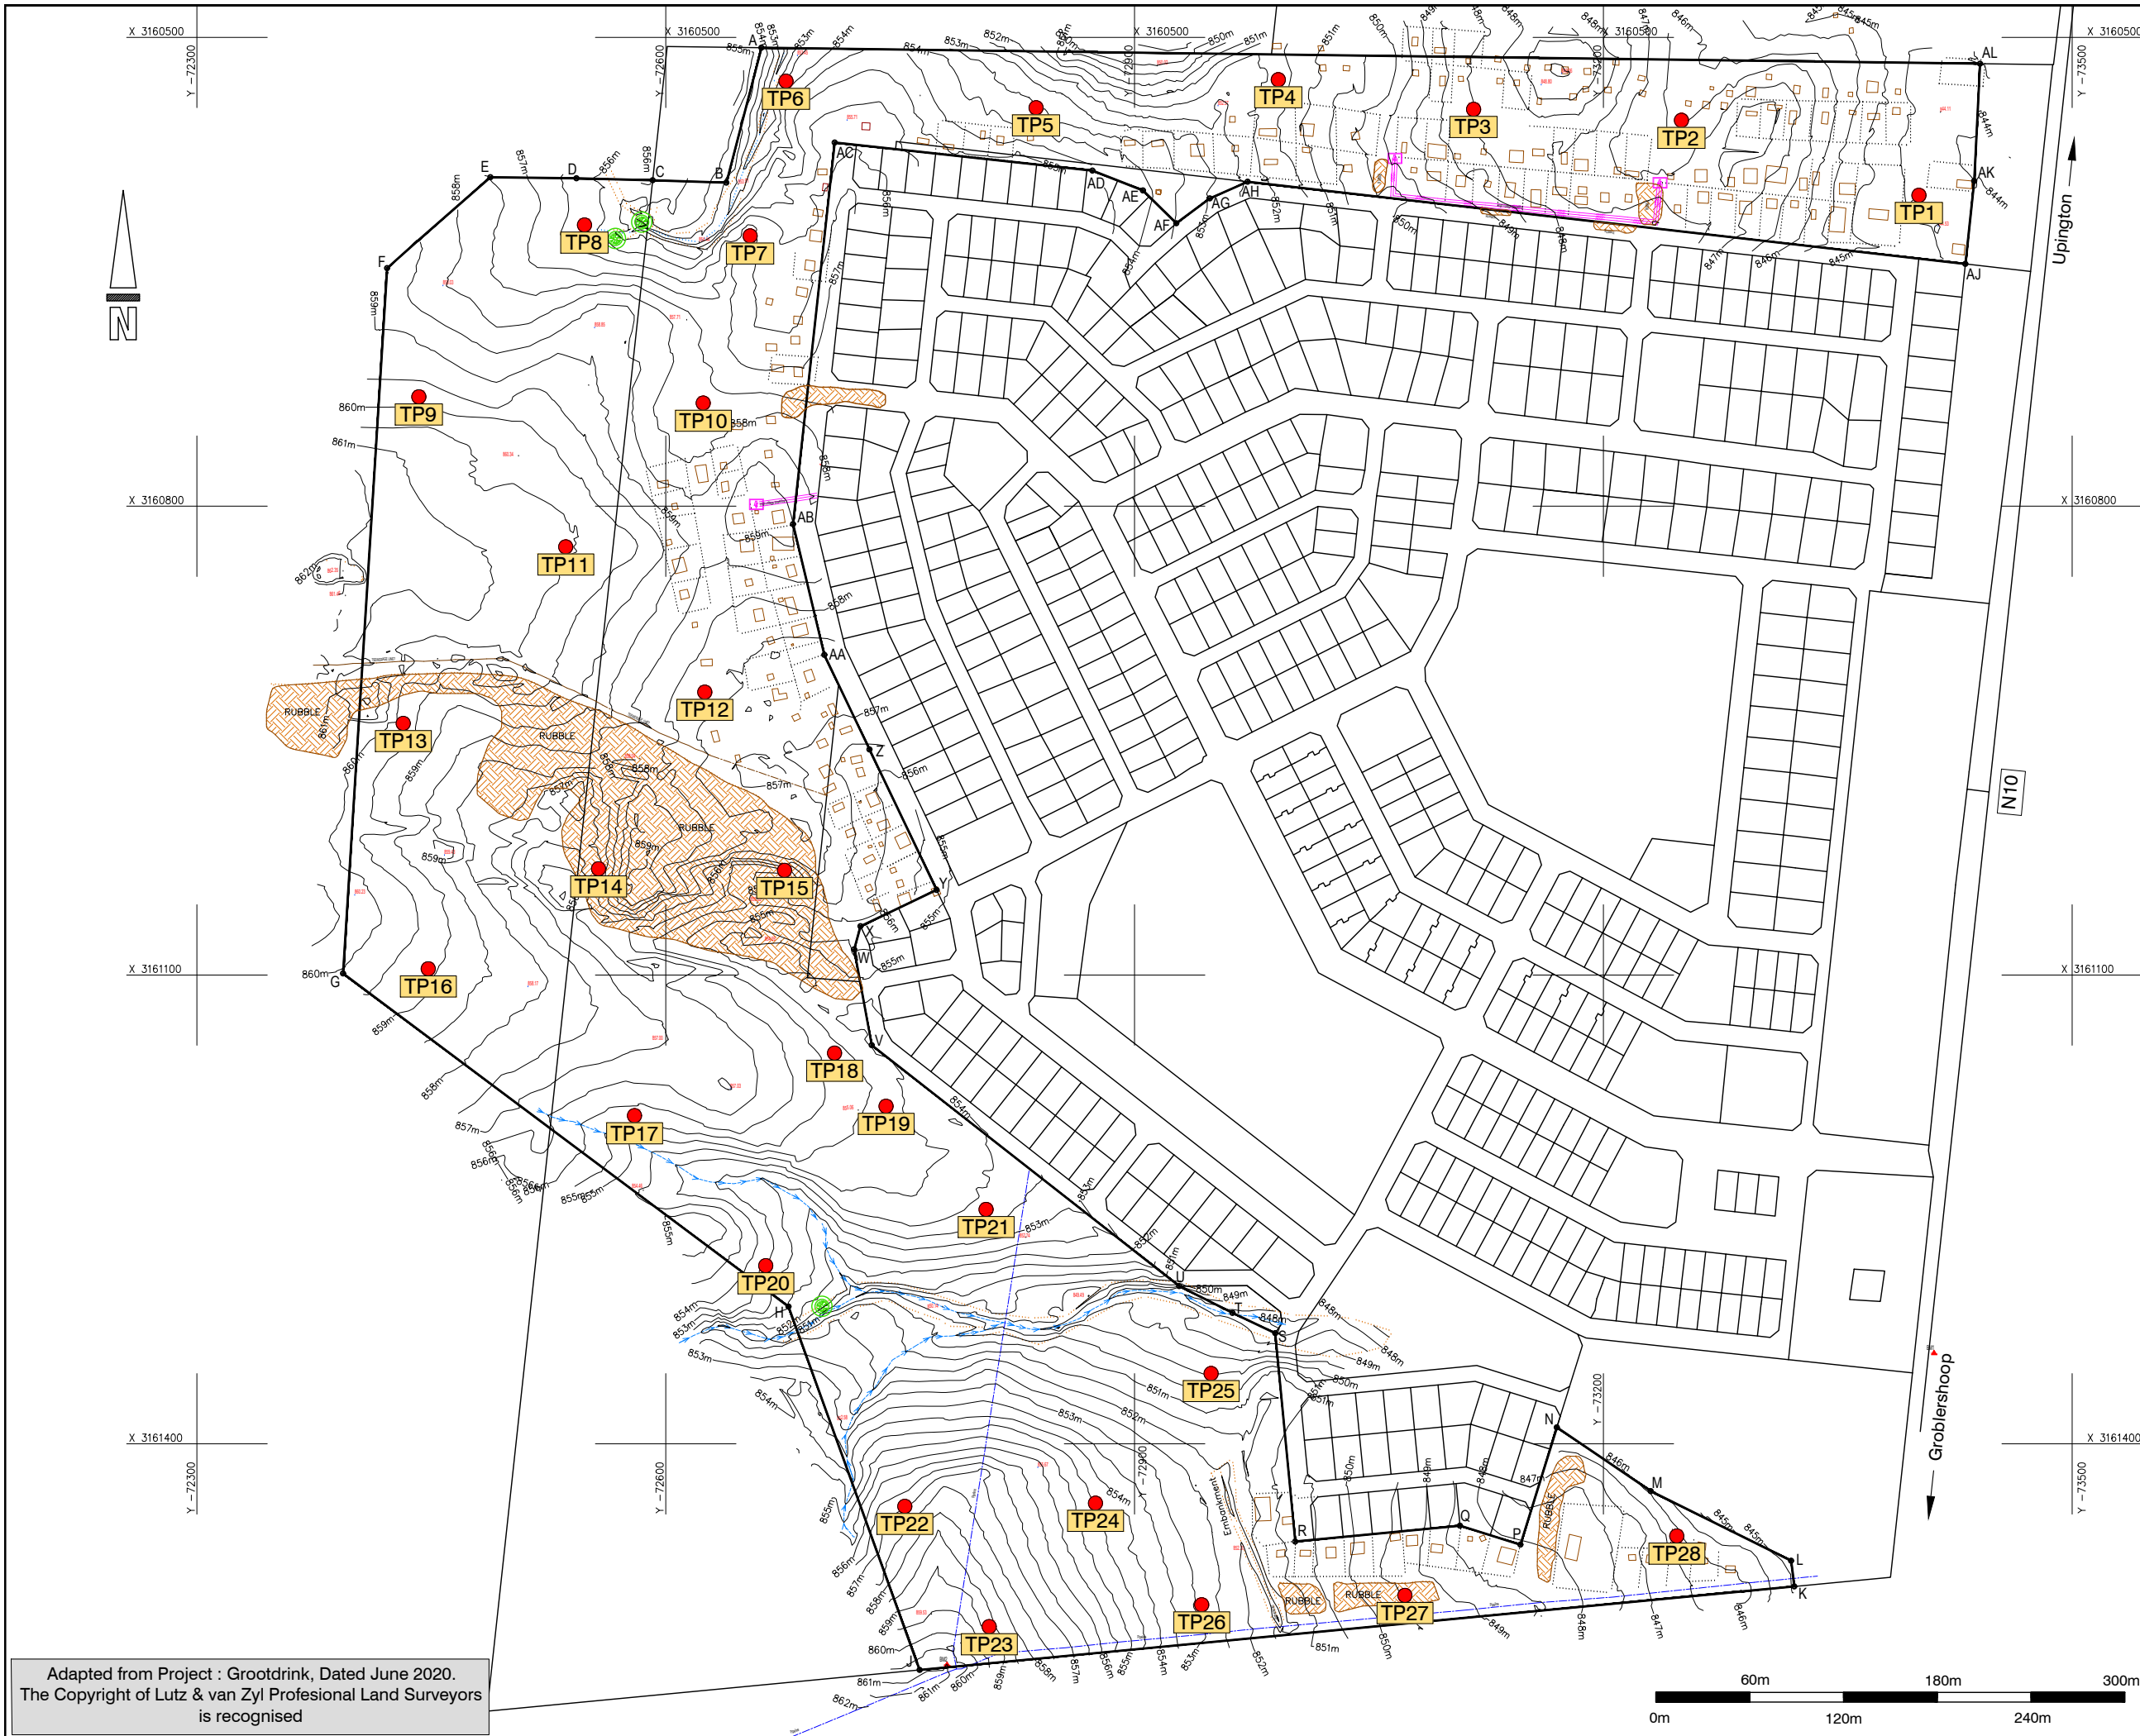
FIGURE 2 :
SITE PLAN

The test pits were profiled by a professionally registered geotechnical engineer. For the benefit of the non-geotechnical reader of this document, the guidelines for test pit profiling are summarized in the attached Table 1 : Soil Profiling Parameters. The profiles of the test pits may be found in Addendum A to this report. The positions of the test pits are indicated on the attached Figure 2 : Site Plan. Provisional co-ordinates for property beacons A to AL are indicated on this figure.

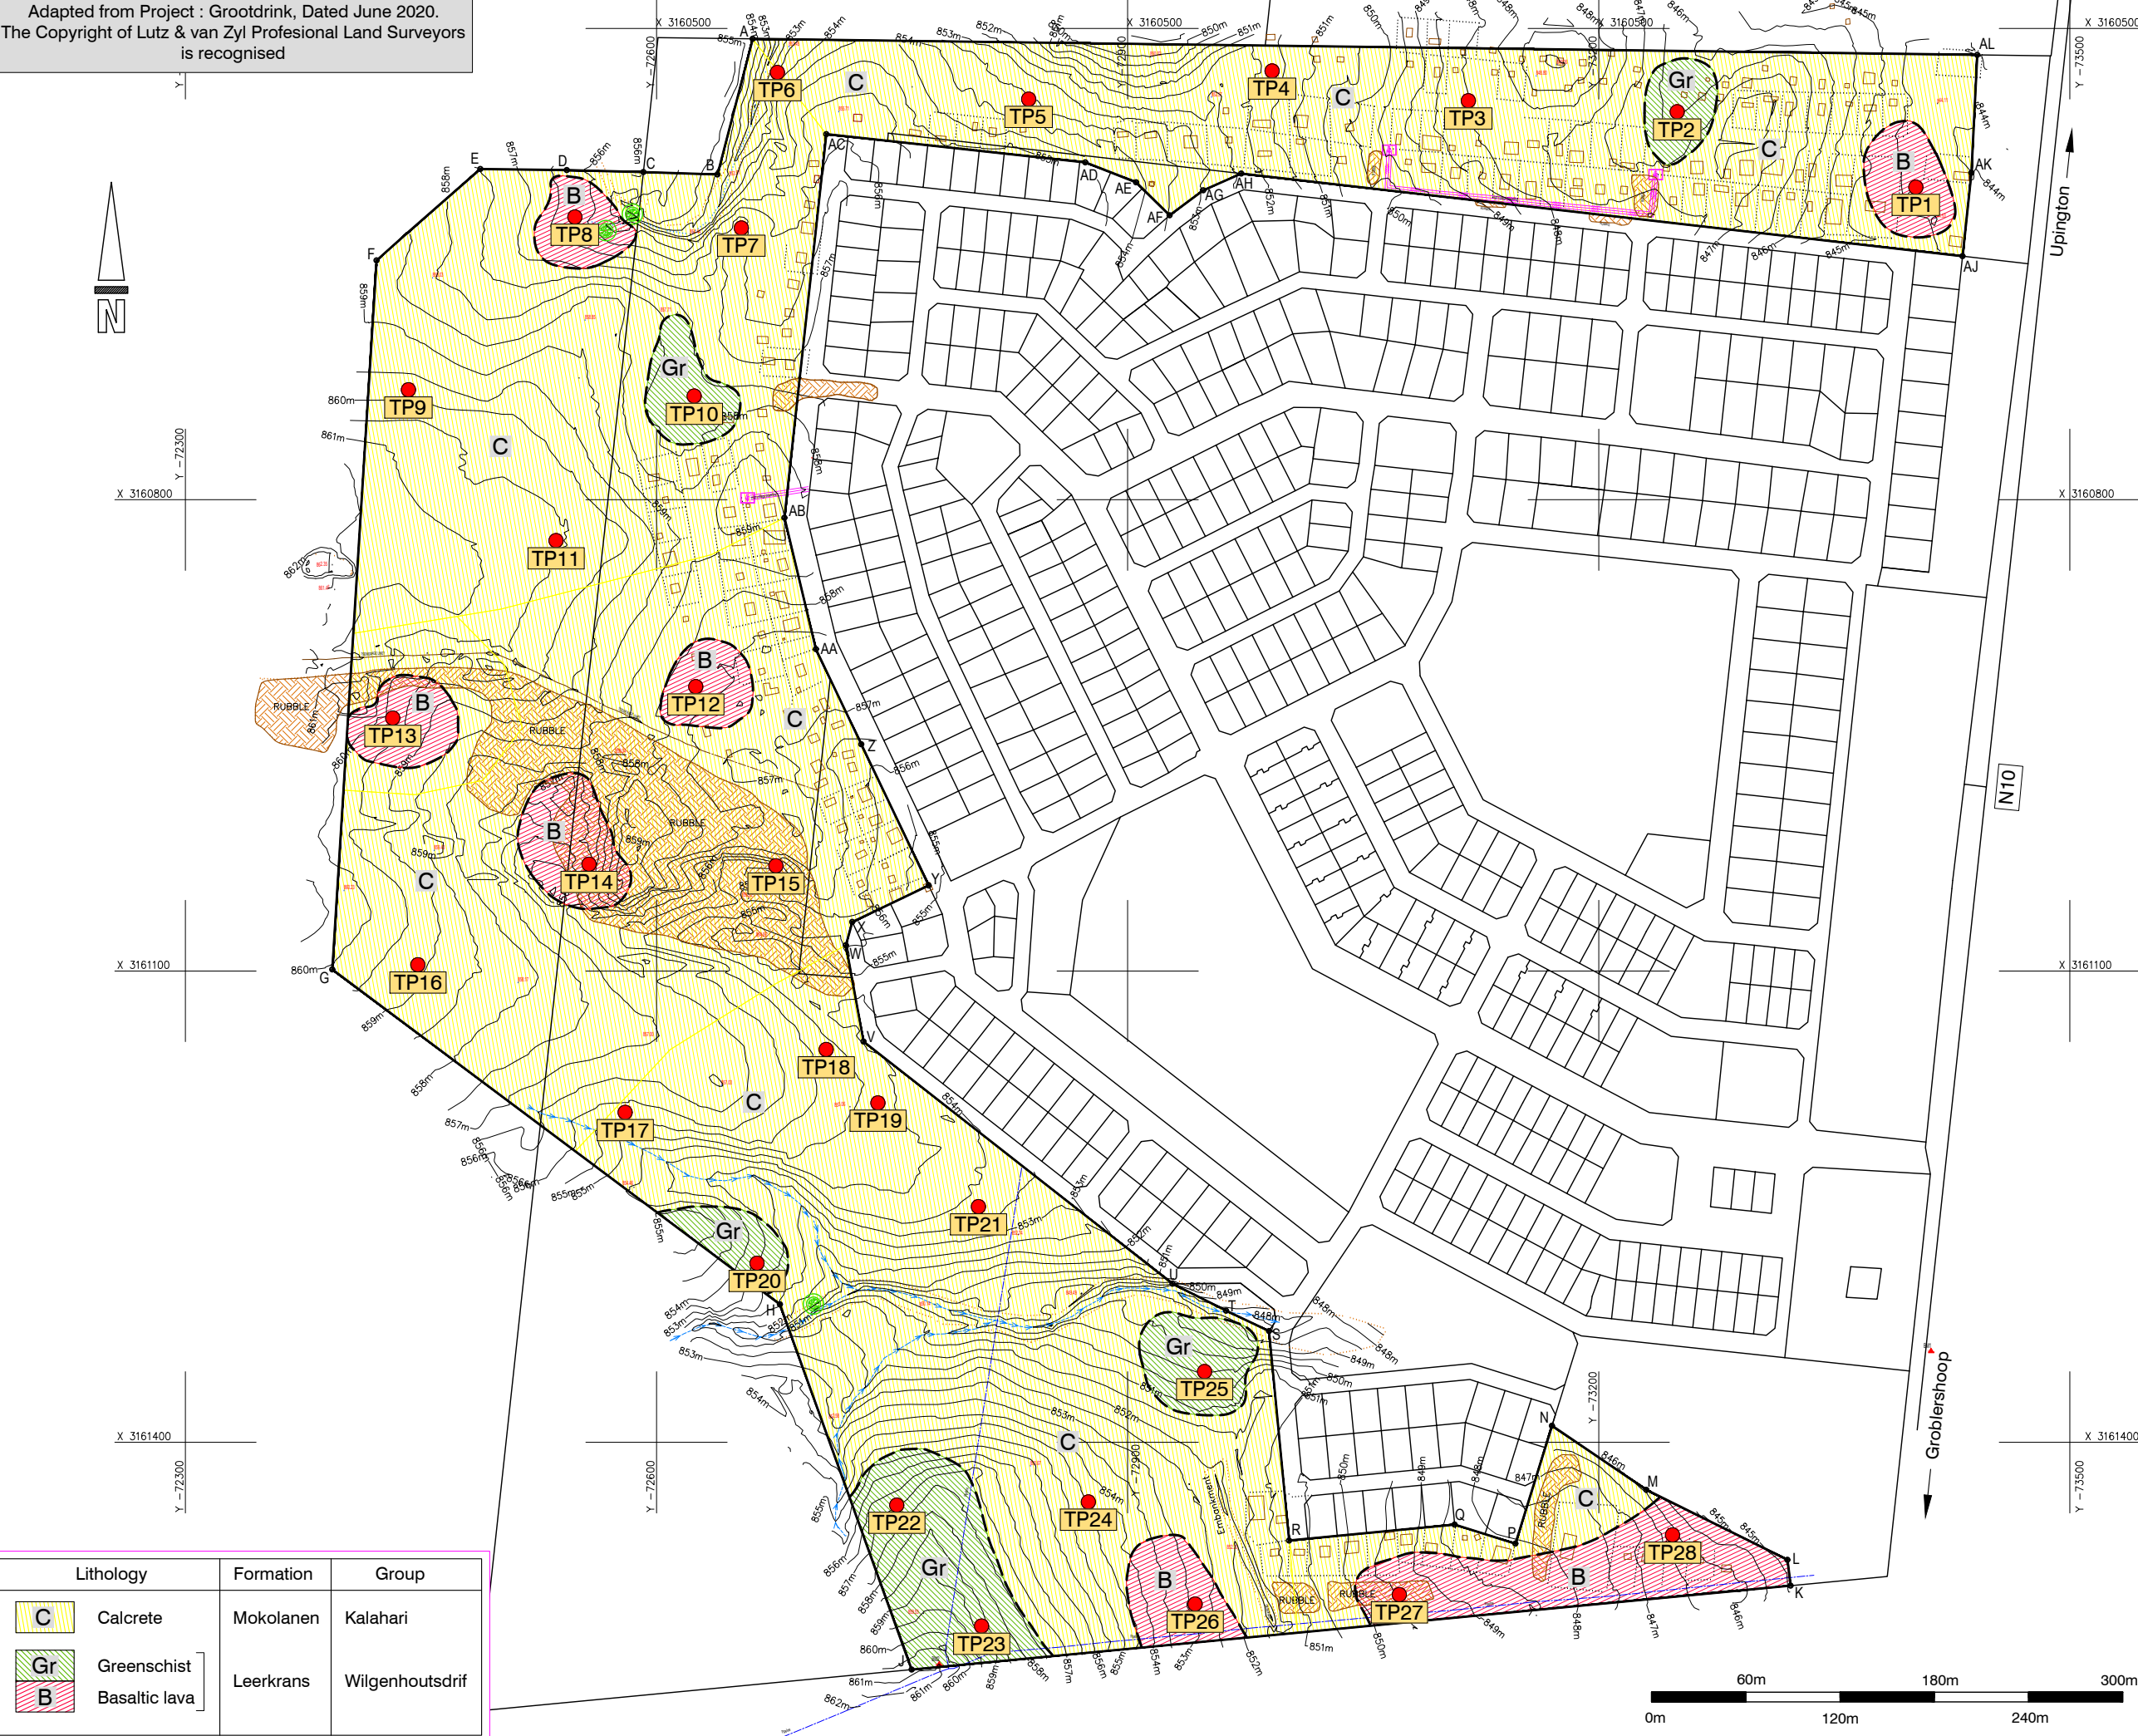
FIGURE 5 :
SITE GEOLOGY

The site geology is illustrated on Figure 5. The soil and pedocretes cover all contacts of various rock types, thus hampering field investigations. The inferred material boundaries must be accepted as indicative of the actual conditions only.

Lithology	Formation	Group
C	Calcrete	Mokolanen
Gr	Greenschist	Leerkran
B	Basaltic lava	Wilgenhoutsdrif

The basalt is described as dark grey, very closely jointed, very fine grained, very hard rock. Discontinuities in the basalt are open and filled with sand. The presence of basalt was recorded in TP's 1, 8, 12 to 14 and 26. Green-schist was encountered in TP's 2, 10, 20, 22, 23, 25, 27 and 28. It is described as light grey green to dark grey, very closely jointed and very intensely laminated, very fine grained, hard rock. Discontinuities are closed, smooth and clean. The dip of the laminations is variable, but mostly orientated at 90° with the horizontal and striking parallel with the Brakbosch fault zone, that is approximately north-south.

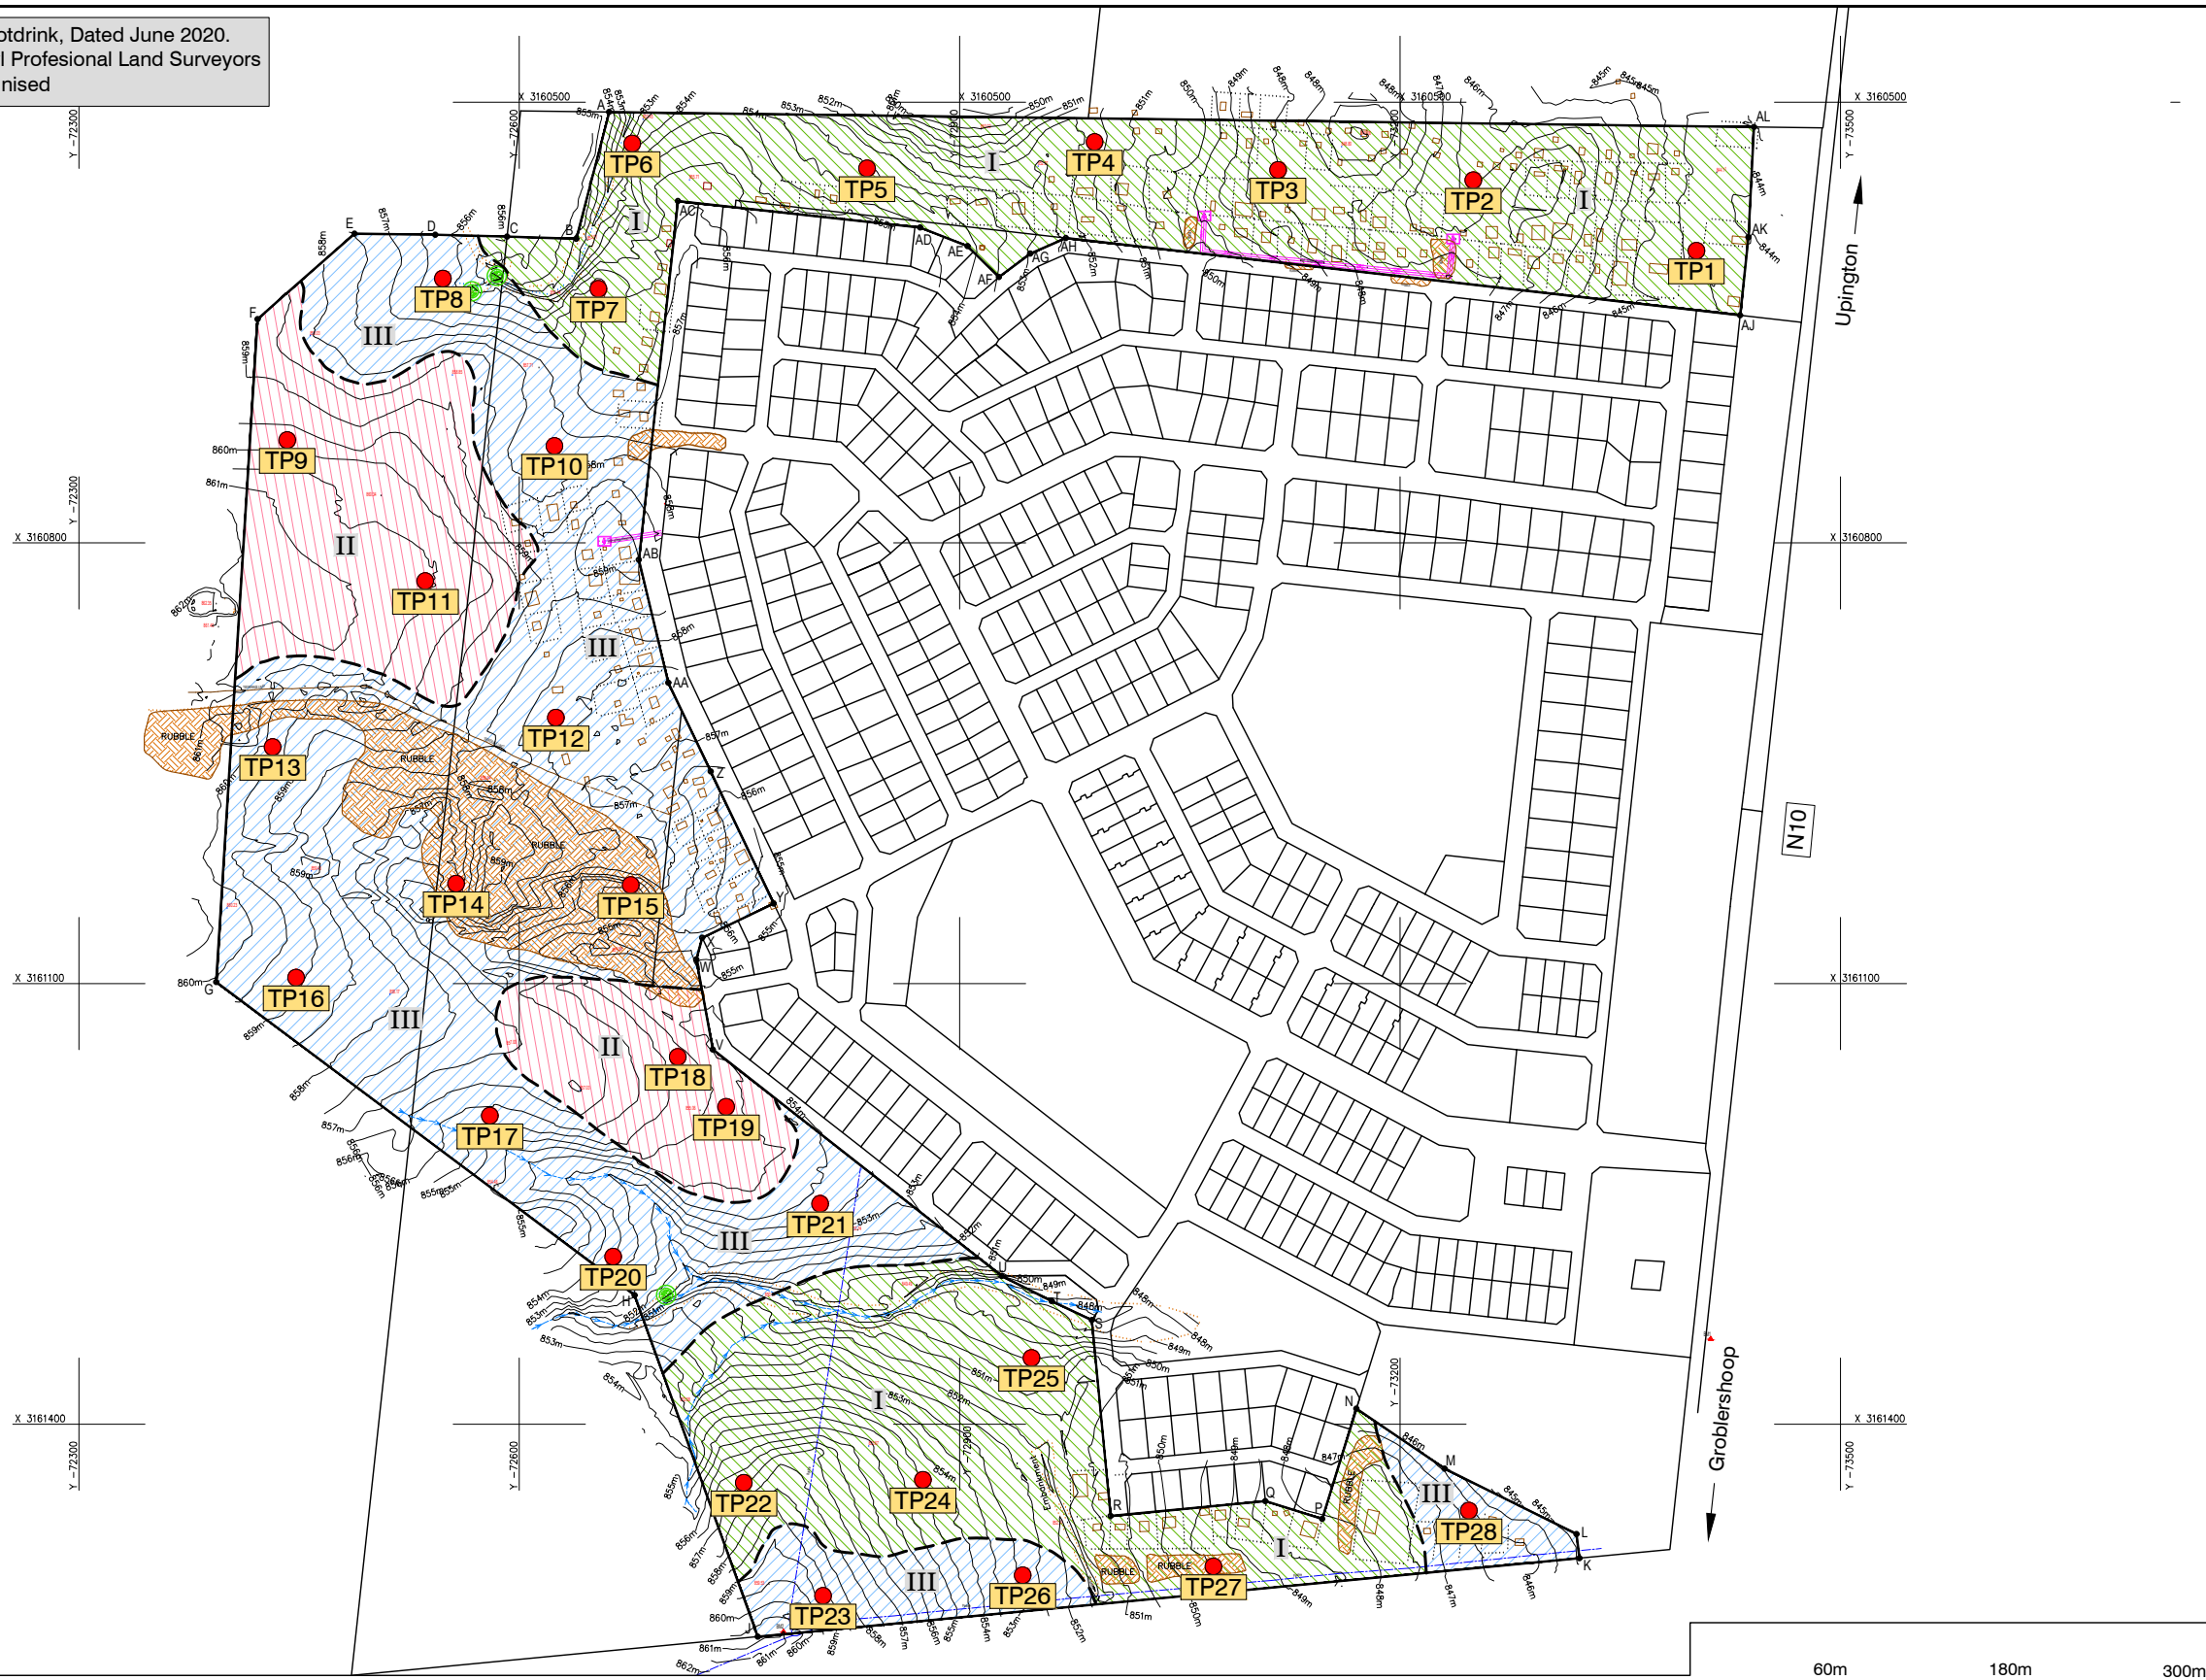
**FIGURE 6 :
SITE CLASS DESIGNATION**

This zone comprises 16% of the area investigated. It is characterized by the materials profiles of TP's 9, 11, 18 and 19. It is present in two separate areas on site. It consists of a superficial horizon less than 400mm thick comprising of colluvium and residual soil overlying very dense calcrete. Several outcrops of calcrete occur in the area. Slope across the land is

The zone is classed as R, meaning that the proposed horizon for founding is stable and negligible soil movement is expected. Slope across the land is approximately between 2% and 6%. Two foundation design alternatives are applicable to the zone, namely conventional strip foundations or slab-on-the-ground foundations placed directly on bedrock or very dense pedocrete.

The zone is classed as R, meaning that the proposed horizon for founding is stable and negligible soil movement is expected. Slope across the land is less than 2%. Considering the limited slope and the favourable geotechnical site classification, two foundation design alternatives are applicable to the zone, namely conventional strip foundations or slab-on-the-ground foundations placed directly on bedrock or very dense pedocrete.

The zone is classed as S, meaning that the proposed horizon for founding is slightly compressible and rapid settlement less than 10mm is expected. Slope across the land is between 2% and 6%.
