**GEOTECHNICAL CONDITIONS ON ERVEN 1, 16 AND  
87 SAALSKOP (TOPLINE); AND PLOT 2777  
BOEGOEBERG SETTLEMENT: A REPORT FOR THE  
EXPANSION AND FORMALISATION OF THE TOPLINE  
COMMUNITY**

2020/J09/MCP\_01

PREPARED BY : CEDARLAND GEOTECHNICAL  
CONSULT (PTY) LTD

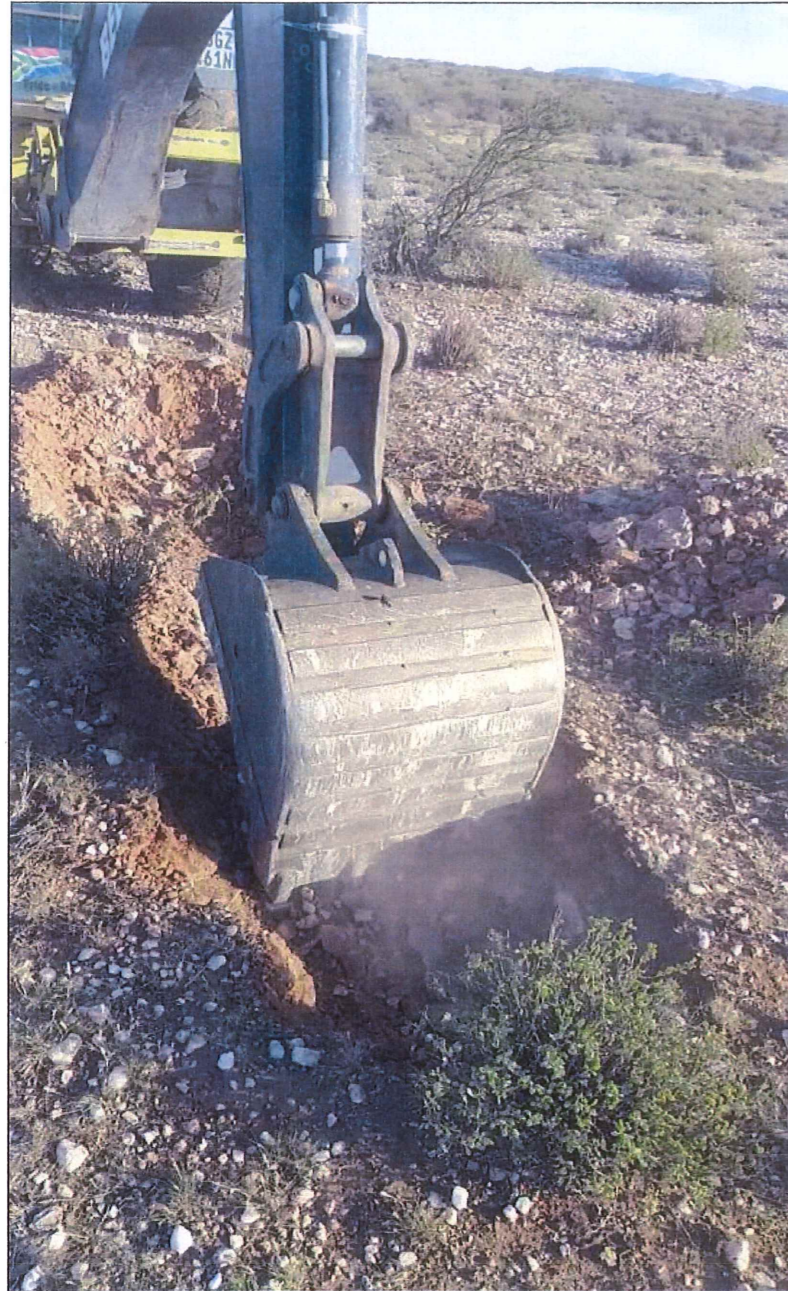
CONDITIONS OF REFUSAL OF EXCAVATION IN HARDPAN CALCRETE

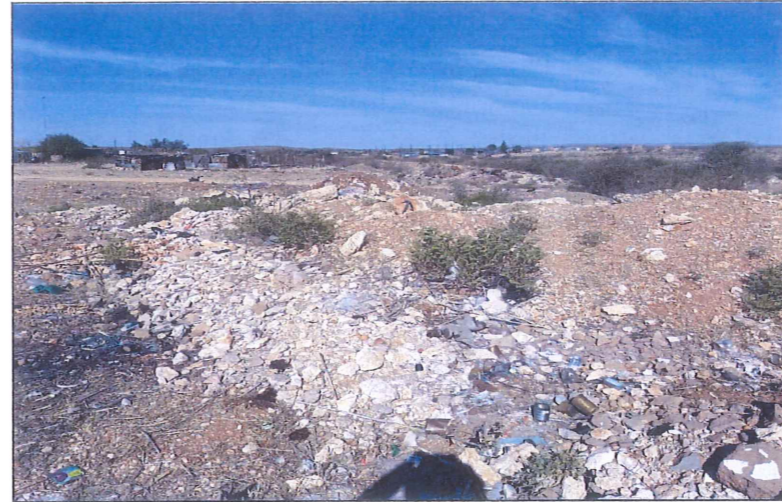
WASTE DUMPS OF CALCRETE, CONCRETE  
ROCK AND SANDY MATERIAL

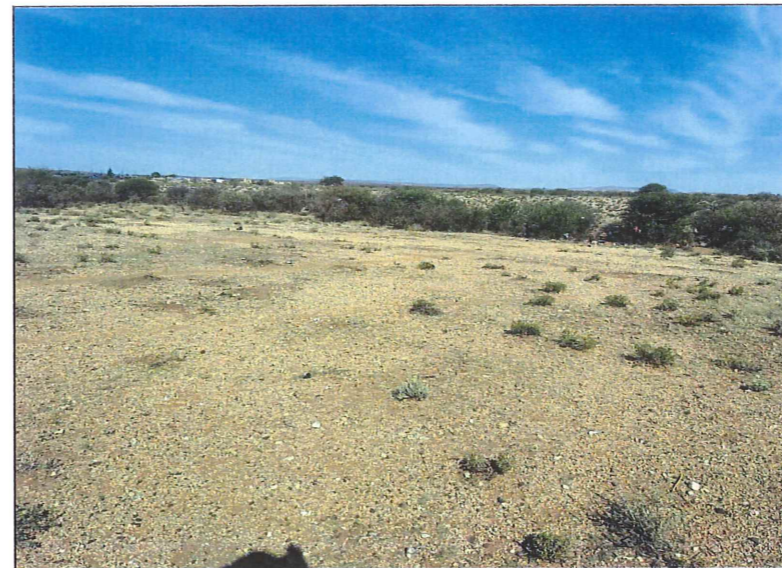
SITE CONDITIONS IN OPEN VELD. NOTE  
COLLUVIAL DEPOSITS OF WHITE QUARTZ  
GRAVELS

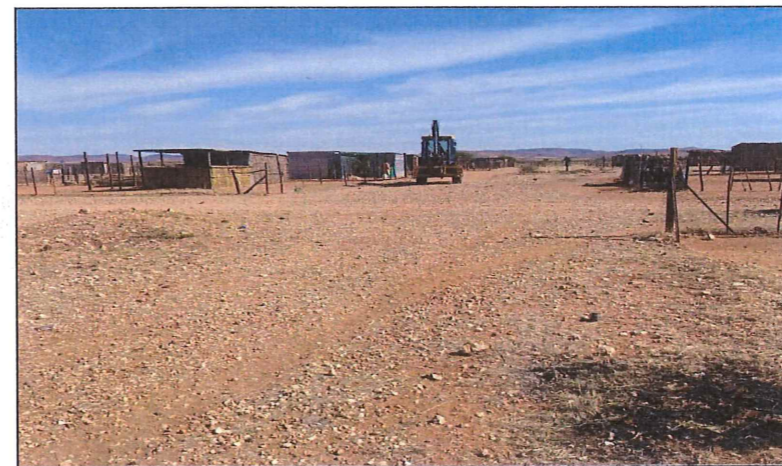
CONDITIONS IN TOPLINE VILLAGE
