# GEOTECHNICAL CONDITIONS ON ERVEN 1, 45 AND 47 OF WEGDRAAI: A REPORT FOR THE EXPANSION AND FORMALISATION OF WEGDRAAI COMMUNITY

2020/J09/MCP\_01

ON BEHALF OF : MACROPLAN

PREPARED BY : CEDARLAND GEOTECHNICAL  
CONSULT (PTY) LTD

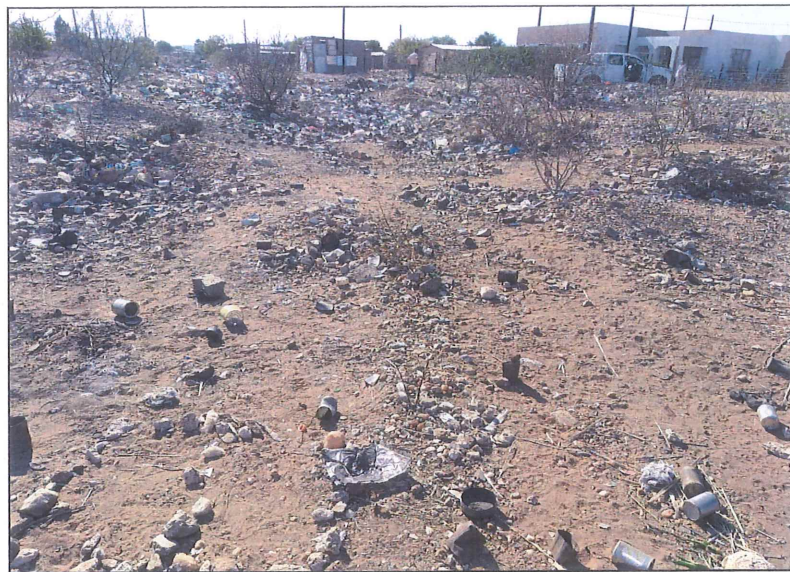
HOUSEHOLD WASTE IN THE VILLAGE

Site conditions are illustrated on Photo 1 : Site Conditions. The area is characterized by the widespread presence of waste material, consisting of domestic waste, stockpiles of gravels and human waste. An excavation to dispose of waste is present in the western part of the site, but it is not used. Numerous trenches, presumably to obtain calcrete gravels for construction, are present in the northern parts of the site.

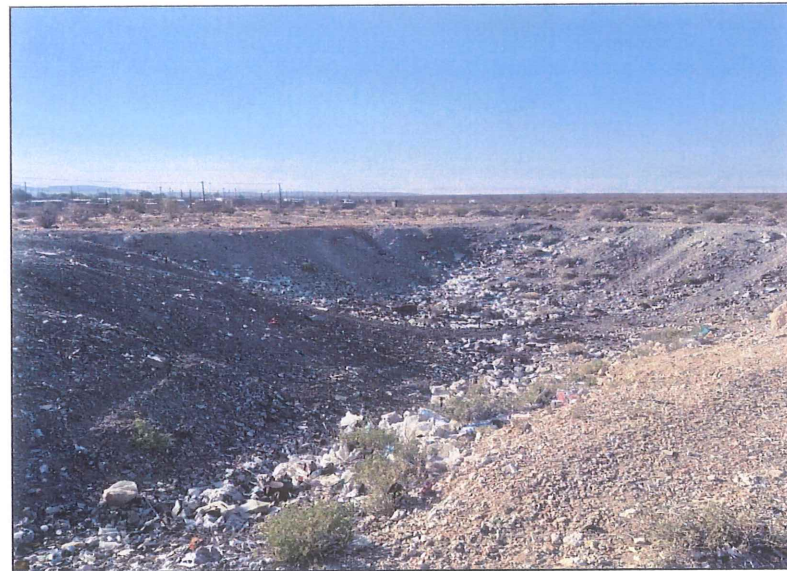
UNUSED EXCAVATION FOR WASTE DISPOSAL

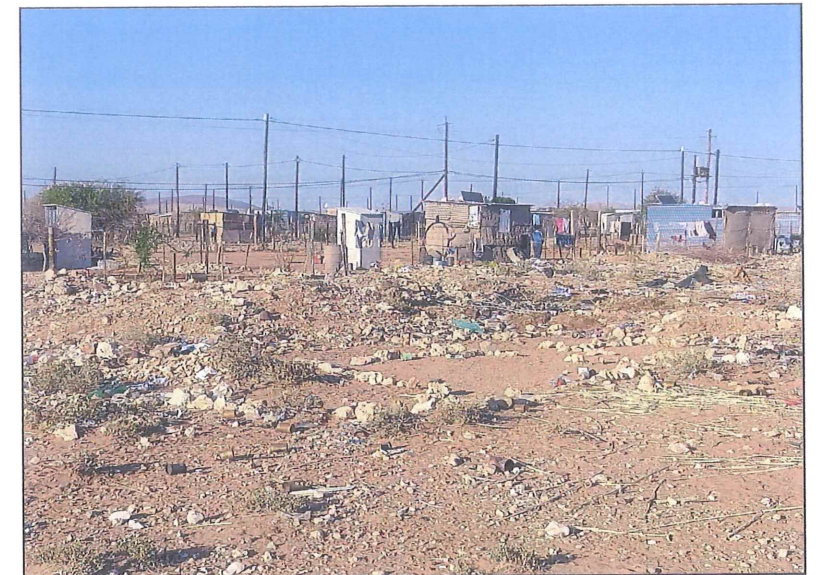
CONDITIONS IN THE VILLAGE

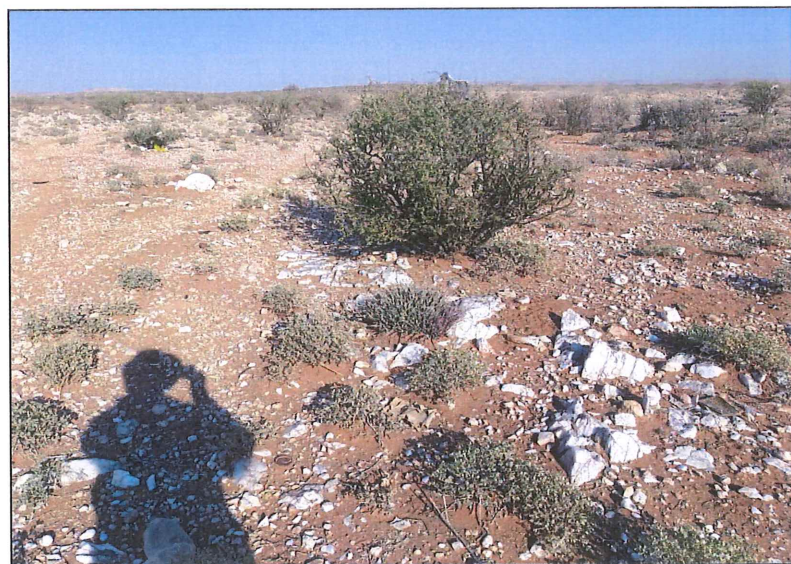
COLLUVIAL DEPOSITS OF COARSE GRAVELS AND COBBLES

On site colluvium as surface deposit was found in all the test pits except TP's 12, 24, 27 and 31. The colluvium is not a homogenous material on site due to a variable gravel content thereof. The matrix of the colluvium consists light brown fine sand and clasts of gravels and cobbles of quartz and some calcrete. With an increase in clasts from matrix supported to clast supported the consistency of the colluvium improves from loose to medium dense. The matrix of the colluvium remains intact throughout. The horizon of colluvium was between 100mm and 600mm thick in the test pits.

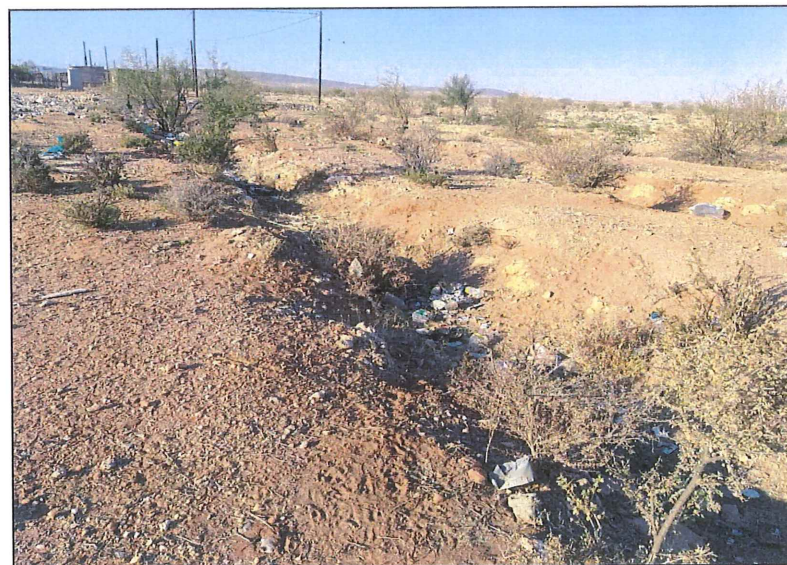
ABANDONED TRENCH EXCAVATIONS

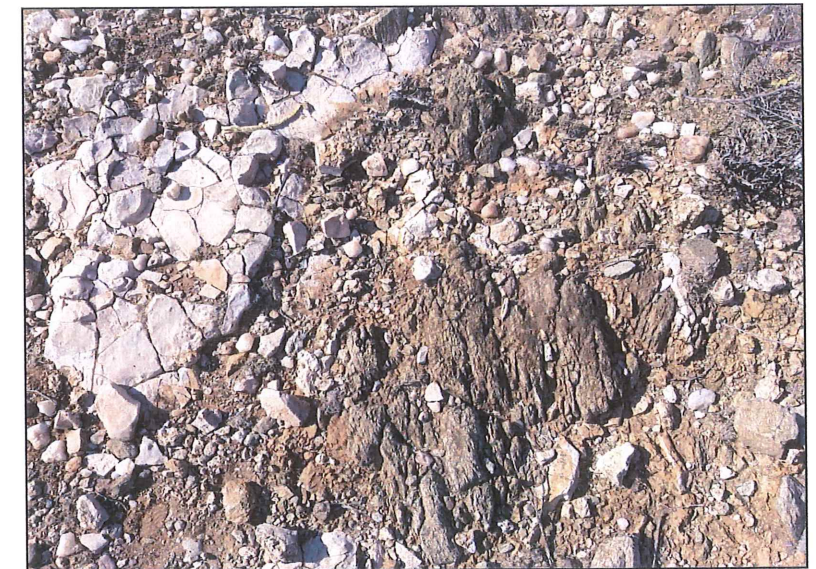
QUARTZ-MUSCOVITE SCHIST OUTCROPS THROUGH SURFACE CALCRETE

Bedrock on site occurs as quartz-muscovite schist of the Groblershoop Formation, Brulpan Group. The strata of the Groblershoop Formation are intensely foliated on site, dipping between zero and 45°, striking randomly. On site the quartz-muscovite schist was exposed in TP's 17 to 19, 21 and 22, but elsewhere covered by a very dense horizon of hardpan calcrete. The quartz-muscovite schist is described as pale white mottled light green, intensely laminated, closely jointed, soft rock becoming hard rock with depth. While the laminations are generally closed smooth and clean ; the condition of the joints may vary from closed, smooth and clean to open smooth and containing fine, white calcareous sand.

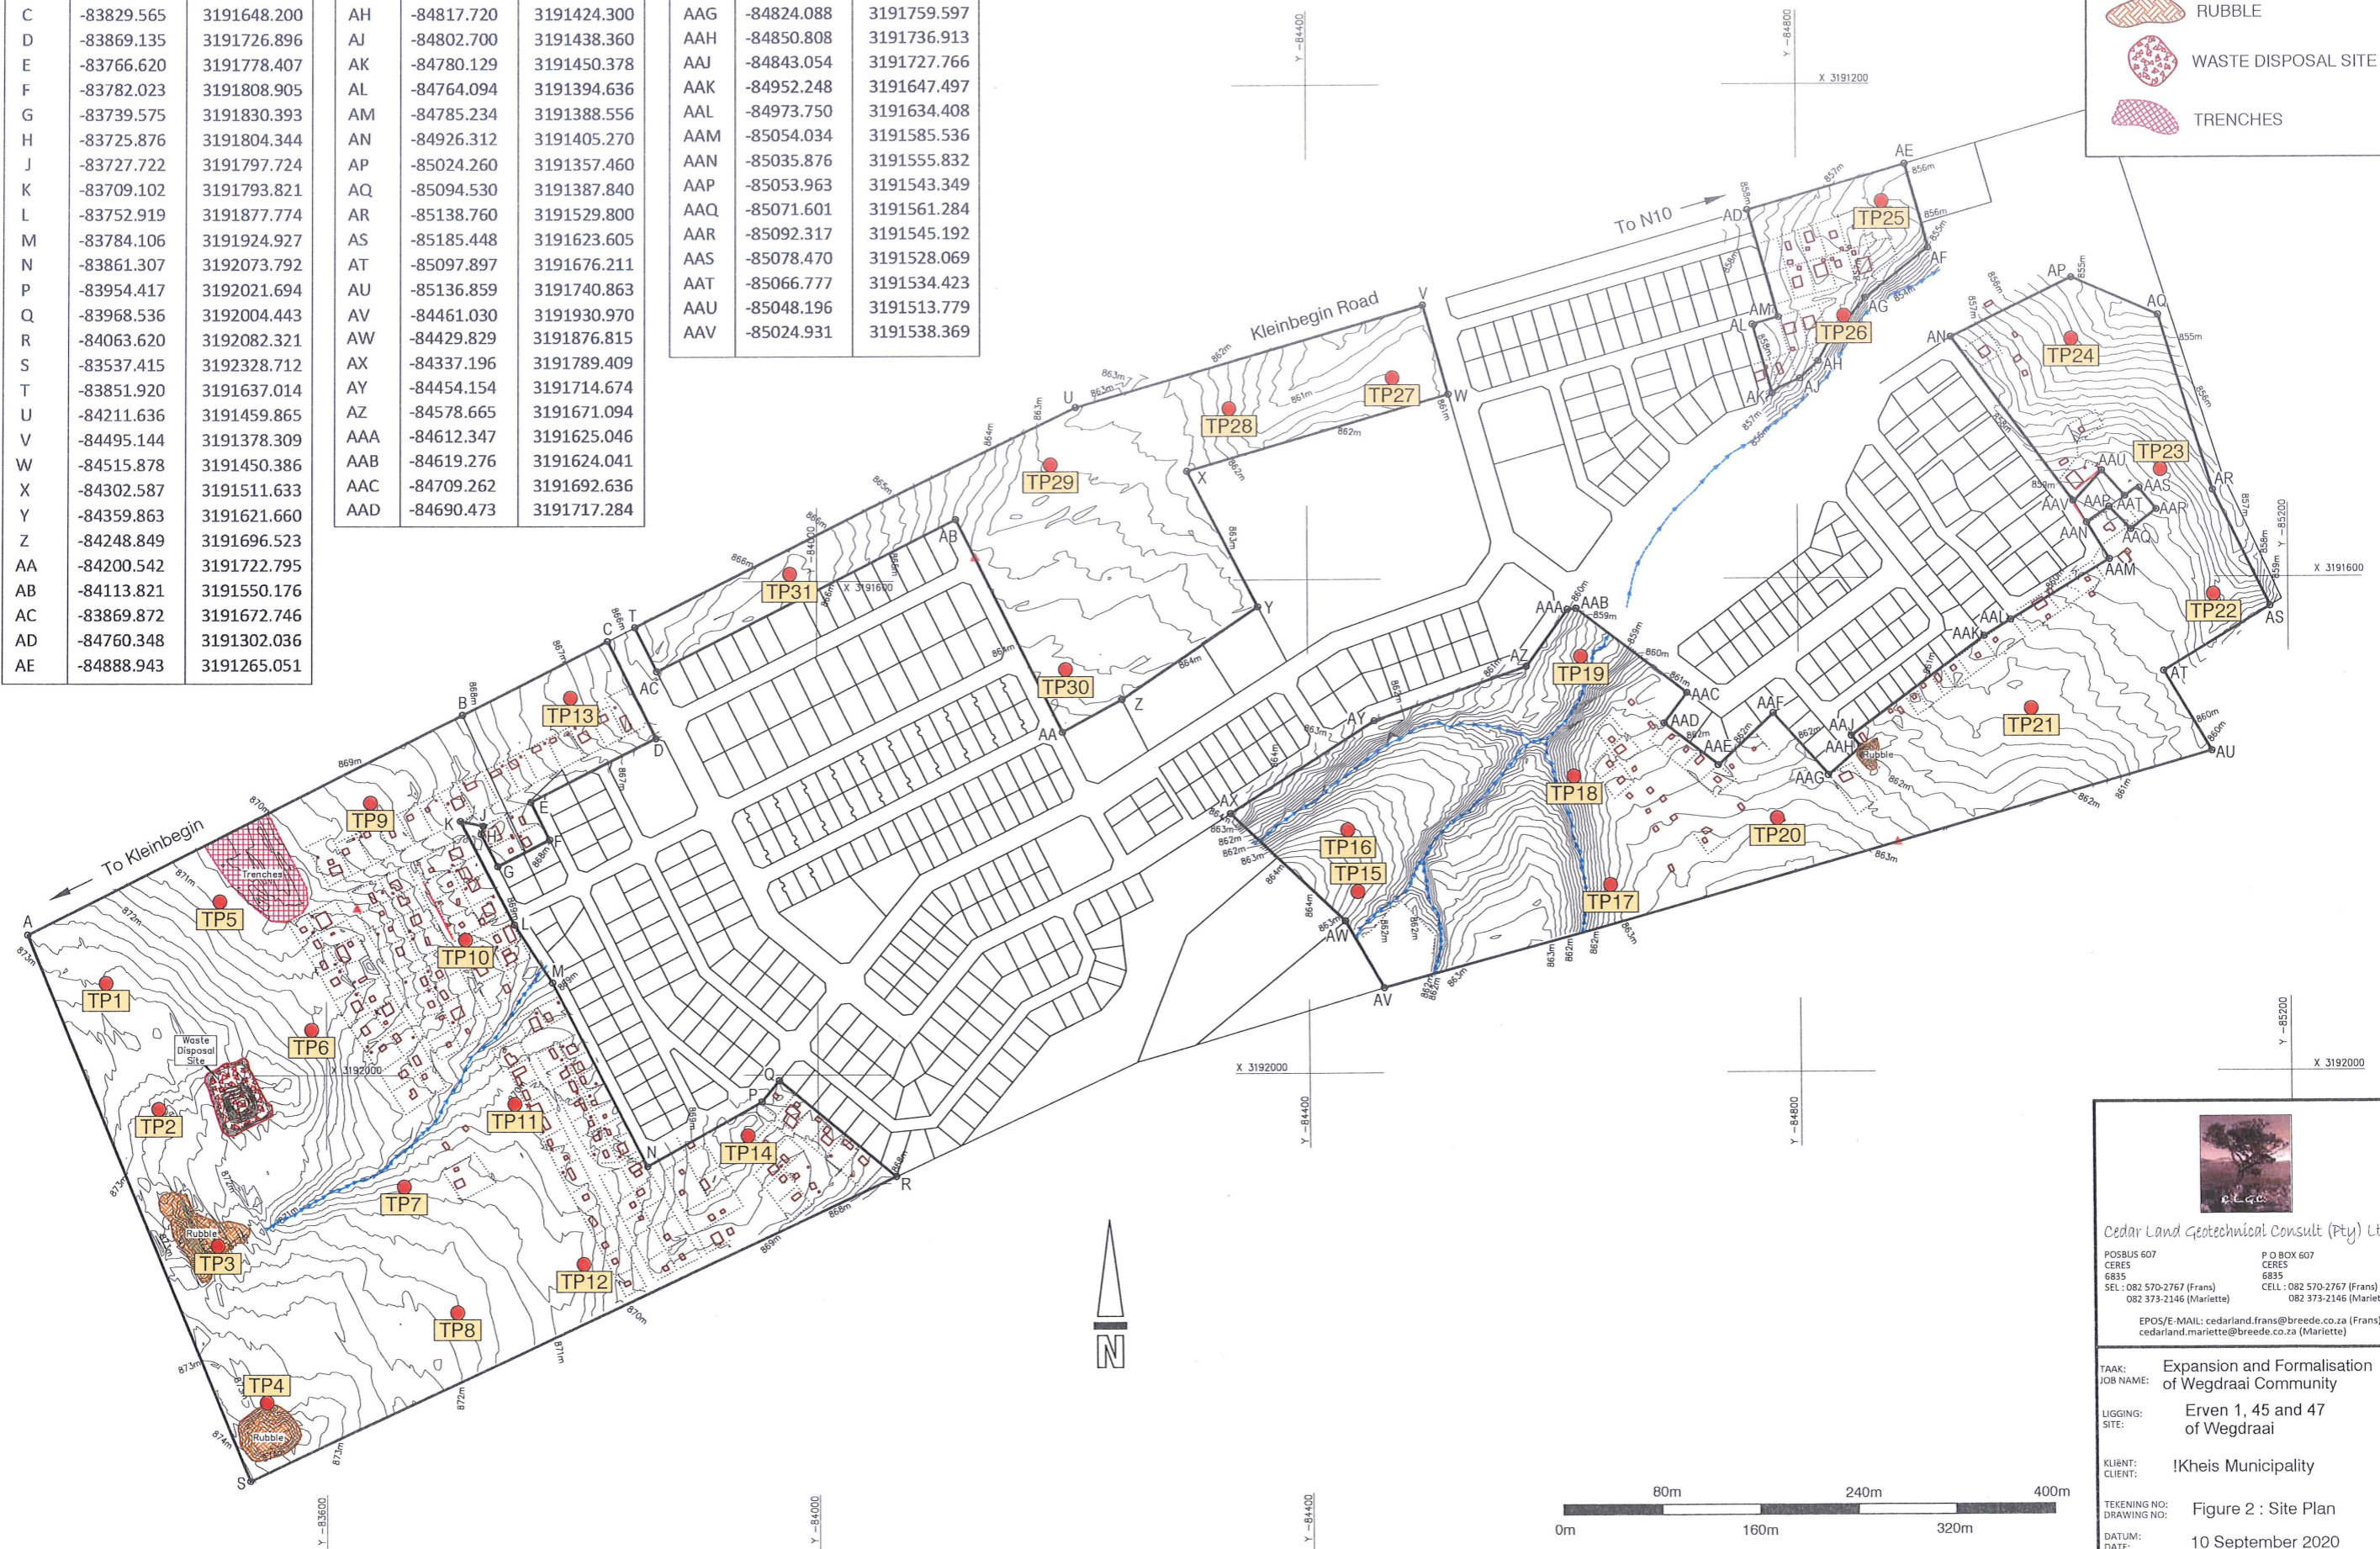
TAAK: Expansion and Formalisation of Wegdraai Community  
 IOB NAME: Erven 1, 45 and 47 of Wegdraai  
 KLIENT: IKheis Municipality  
 TEKENING NO: Figure 2 : Site Plan  
 DRAWING NO:  
 DATUM: 10 September 2020

-   TEST PIT POSITION
-   RUBBLE
-   WASTE DISPOSAL SITE
-   TRENCHES

west of the existing village. The most important of these stockpiles of waste are indicated on the site plans and illustrated on the photo sheet. However, large areas of the land was littered with waste consisting of quartz gravels, soil, all types of household waste and builders' rubble. Test pit 14 was excavated through such waste. The waste can be described as consisting of dry, light brown sand containing ash, paper, bones, glass, plastic and decaying household matter. The waste extended to a depth of 300mm in the test pit, prior to encountering colluvium.

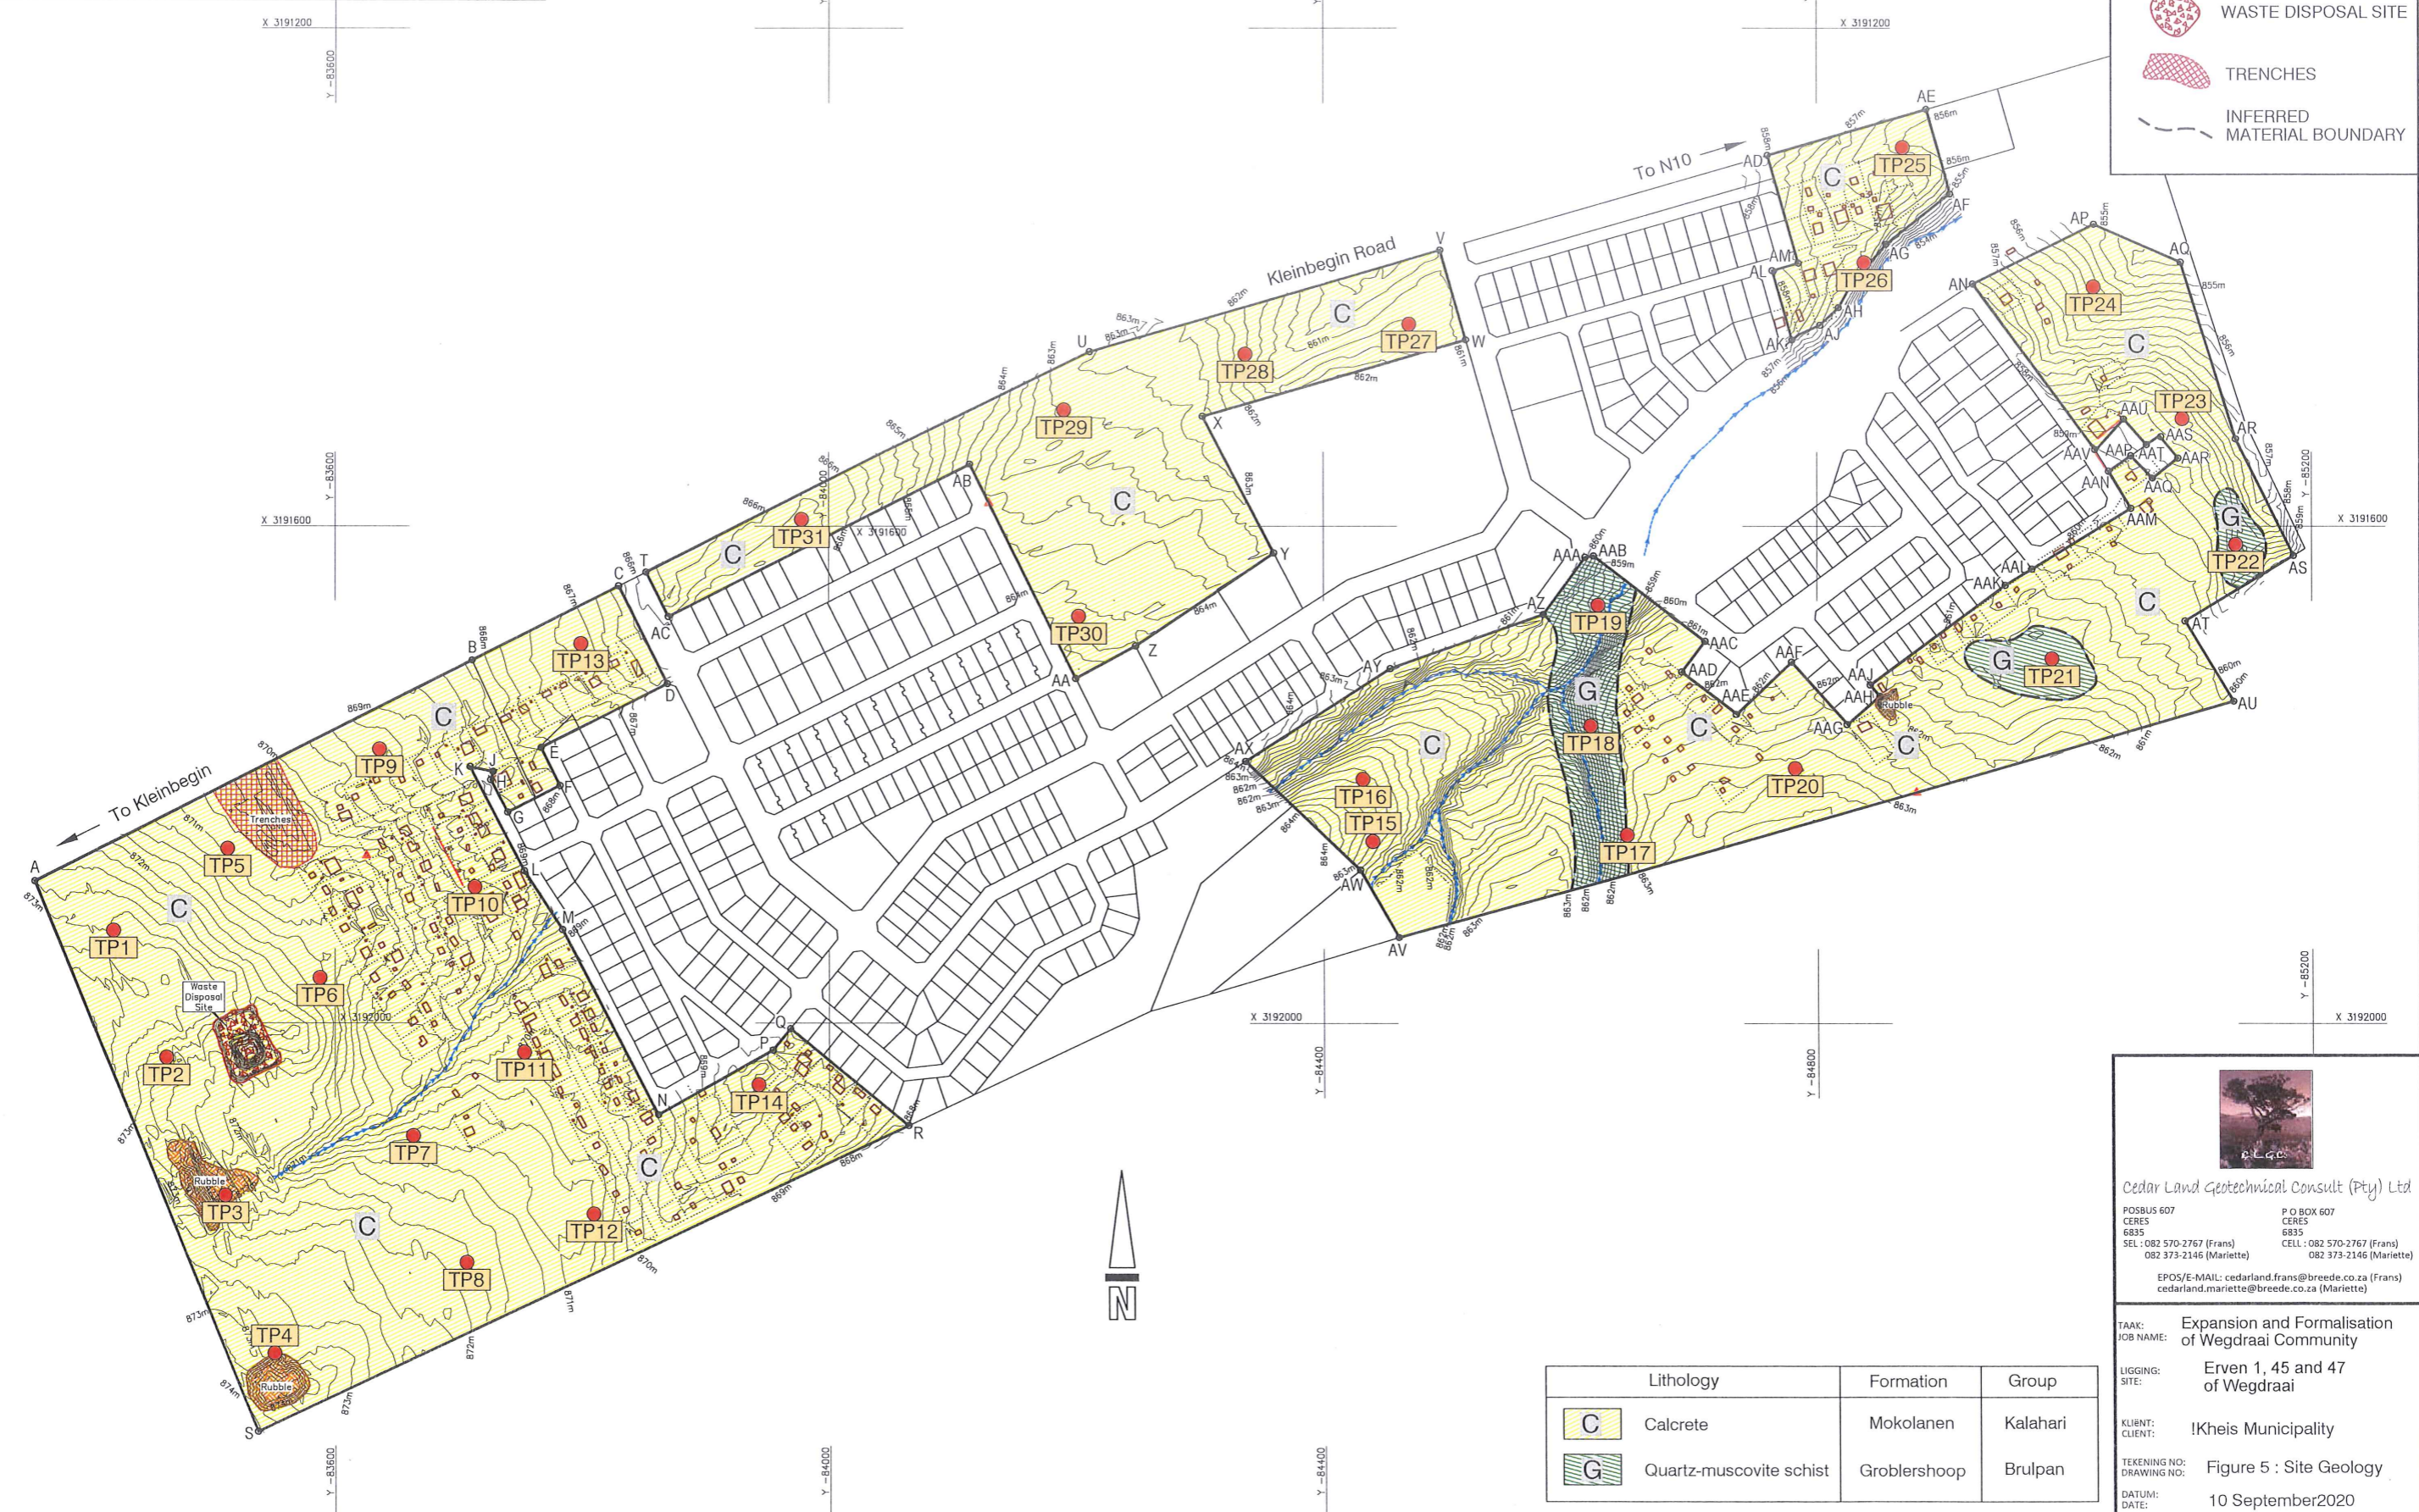
- TP1 TEST PIT POSITION
- RUBBLE
- WASTE DISPOSAL SITE
- TRENCHES
- INFERRED MATERIAL BOUNDARY

Lithology	Formation	Group
C Calcrete	Mokolanen	Kalahari
G Quartz-muscovite schist	Groblersthoop	Brulpan

The site geology is illustrated on Figure 5. The soil, but especially the pedocretes form an ubiquitous and well developed cover over bedrock with only localized exposures in areas of thin and less dense pedocretic cover, thus hampering field investigations. The inferred material boundaries must be accepted as indicative of the actual conditions only.

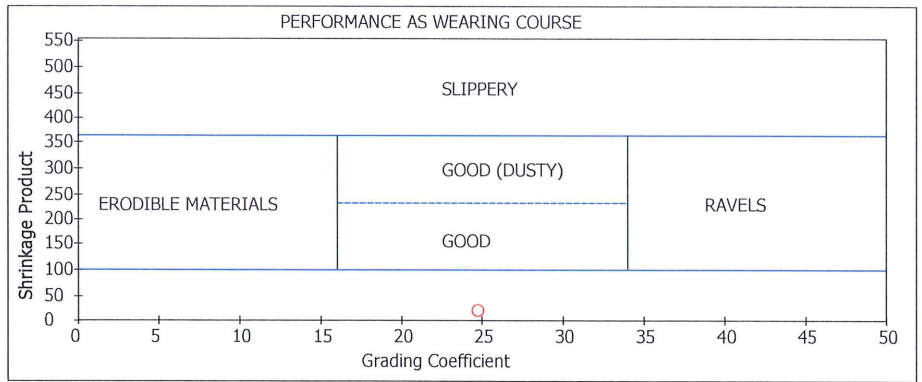
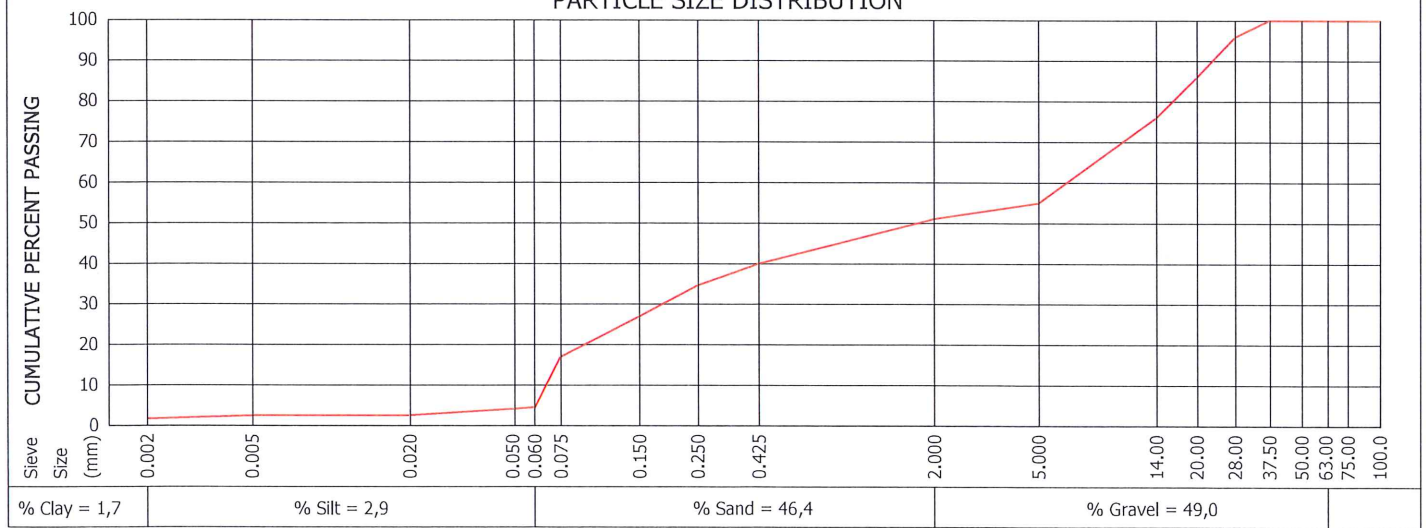
Sample No.	: U9267
Position	: TP 1
Layer Type	: 0-300mm
Sample Colour	: Orange Brown Gravel
Sample Type	: Mix Quartzstone

D10= 0,067 D30= 0,189 D60= 7,143

PARTICLE SIZE DISTRIBUTION

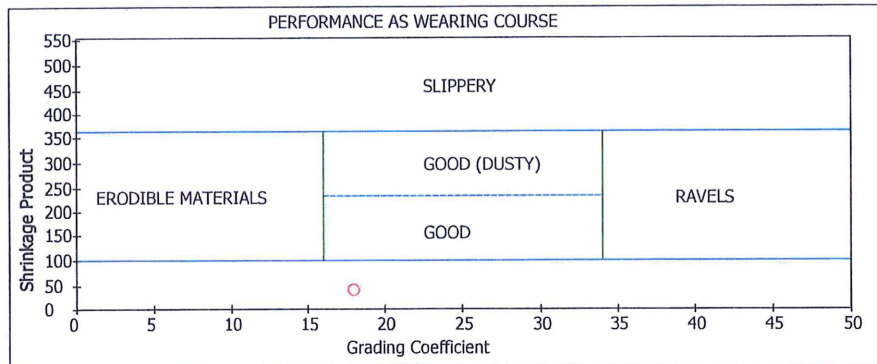
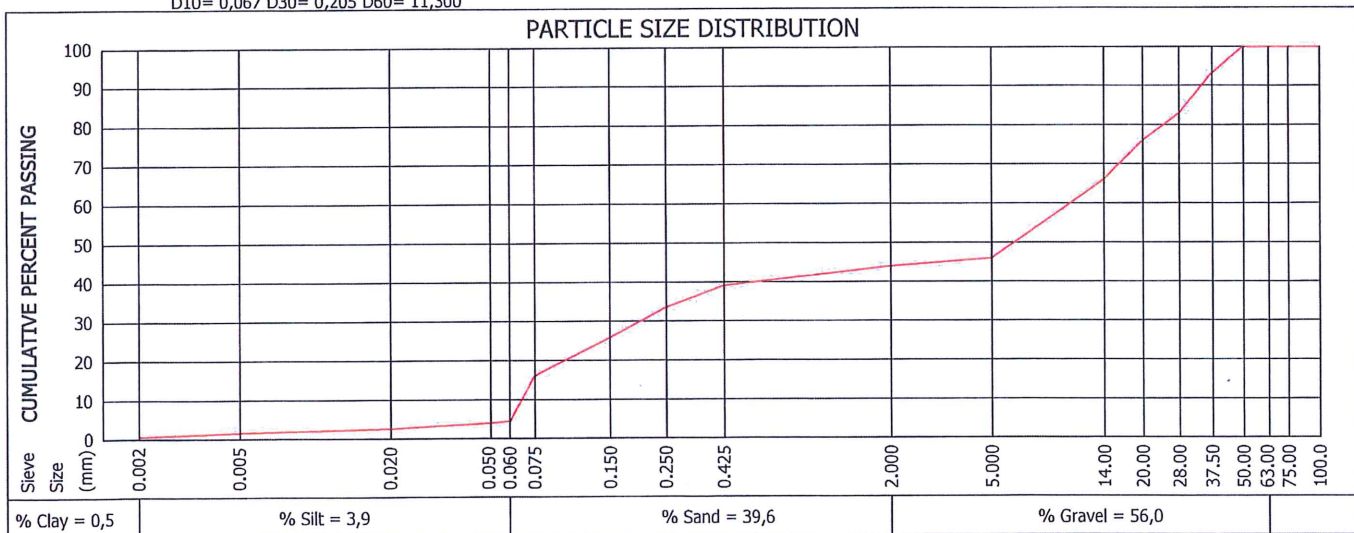
Sample No.	: U9268
Position	: TP 6
Layer Type	: 0-400mm
Sample Colour	: Orange Brown Gravel
Sample Type	: Mix Calcrete + Quart

D10= 0,067 D30= 0,205 D60= 11,300

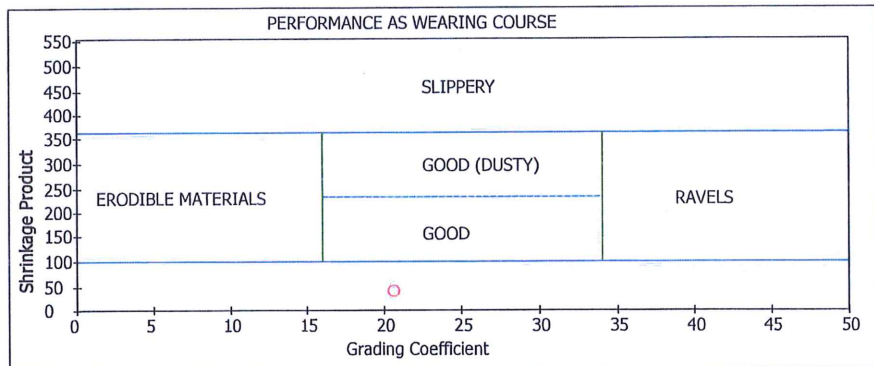
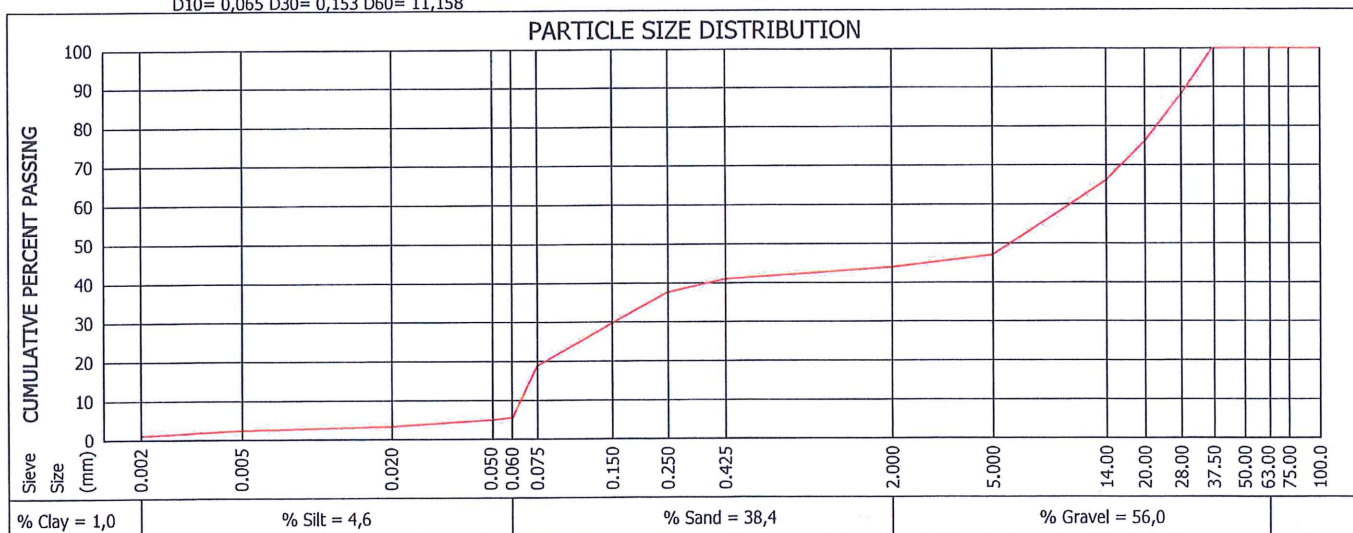
Sample No.	: U9270
Position	: TP 16
Layer Type	: 0-300mm
Sample Colour	: Light Red & Brown
Sample Type	: Fine Sand & Calcrete

D10= 0,065 D30= 0,153 D60= 11,158

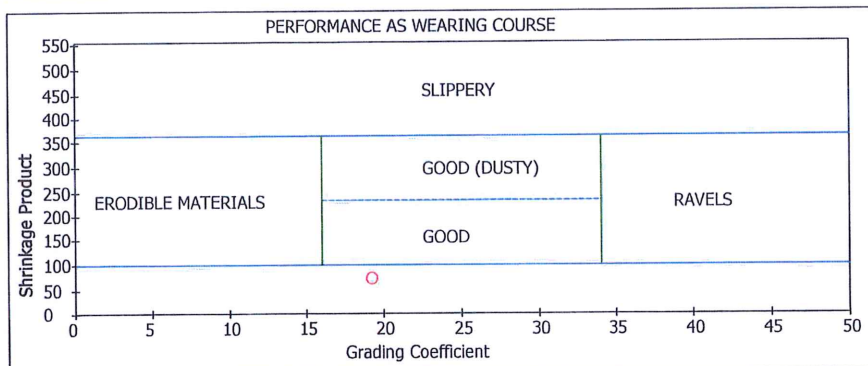
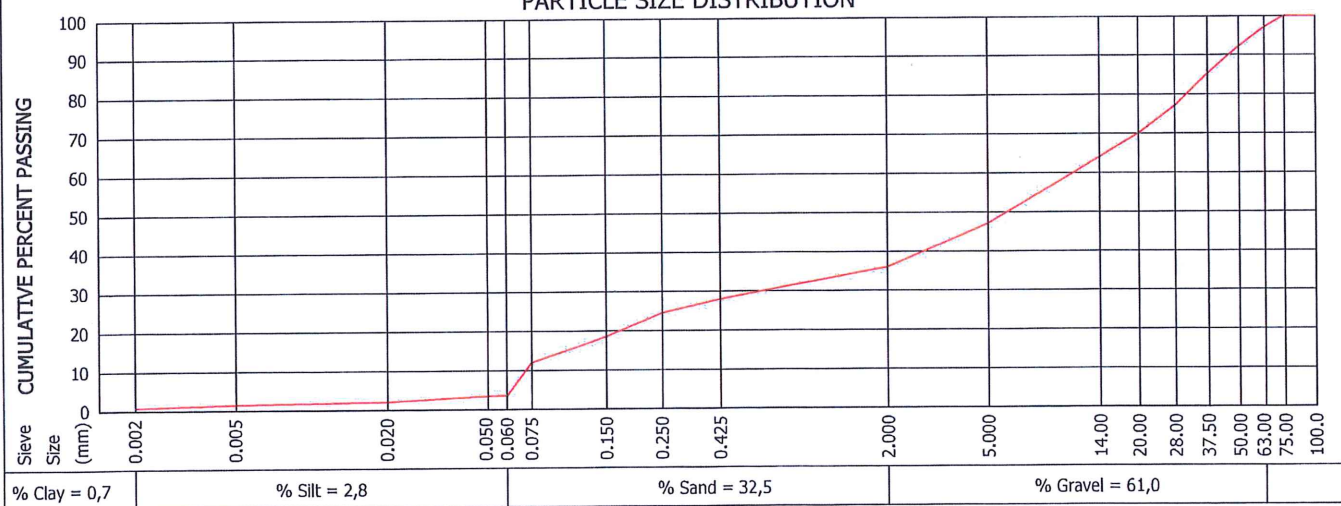
Sample No.	: U9271
Position	: TP 17
Layer Type	: 500-900mm
Sample Colour	: Light Brown
Sample Type	: Mix Weathered Quartz

D10= 0,071 D30= 0,819 D60= 11,882

PARTICLE SIZE DISTRIBUTION

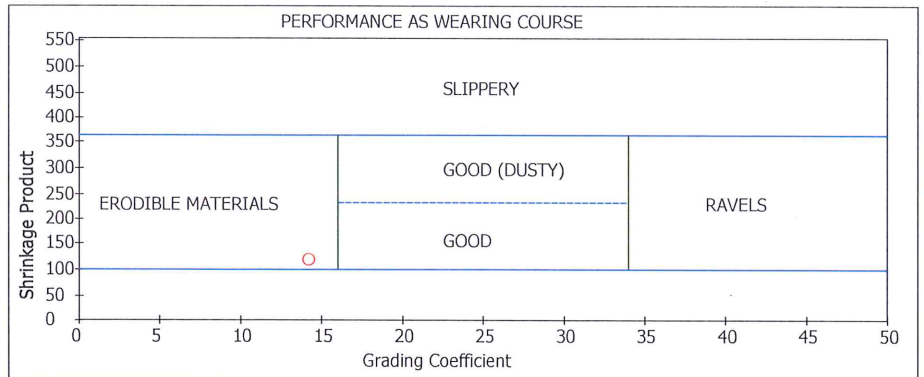
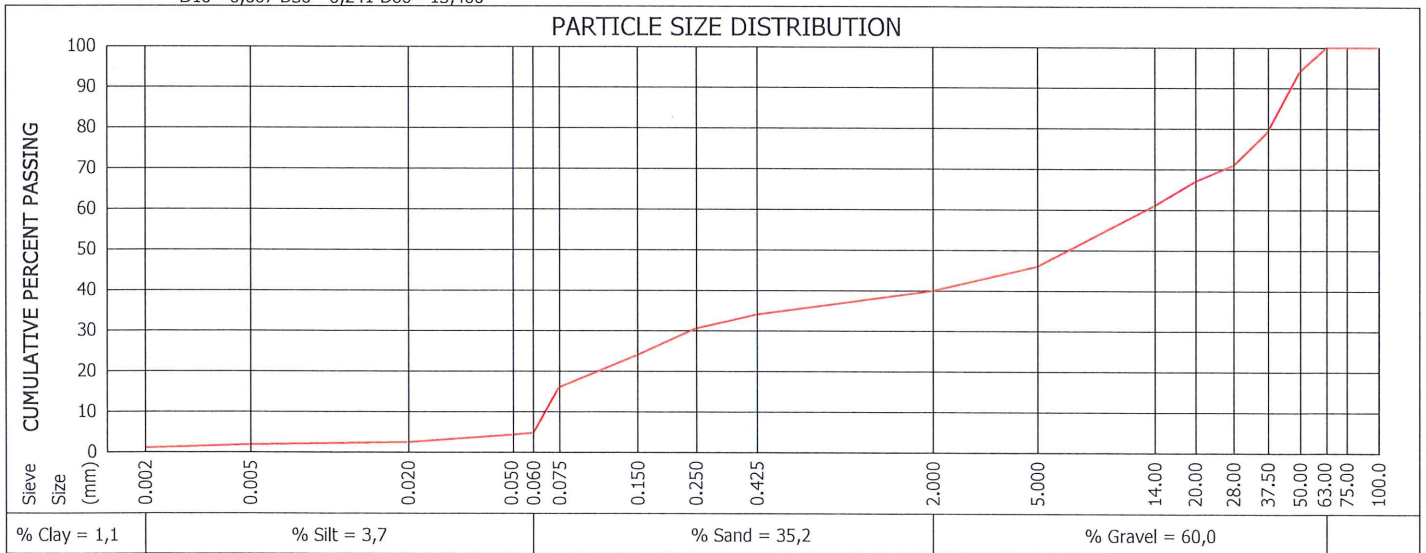
Sample No.	: U9273
Position	: TP 23
Layer Type	: 100-400mm
Sample Colour	: Brown Gravel
Sample Type	: Mix Calcrete+Quartz

D10= 0,067 D30= 0,241 D60= 13,400

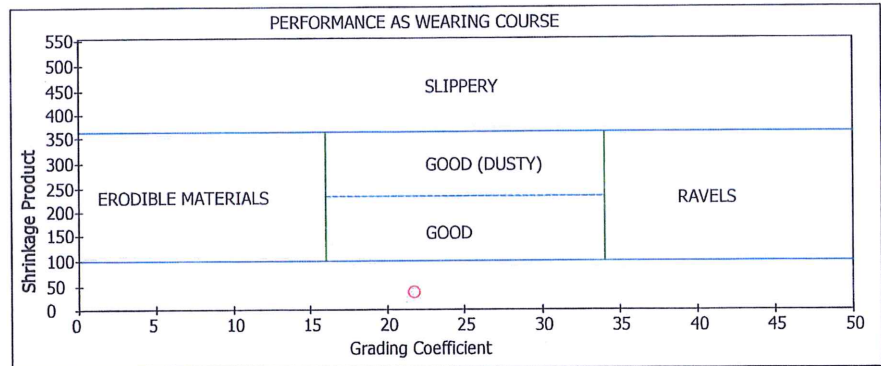
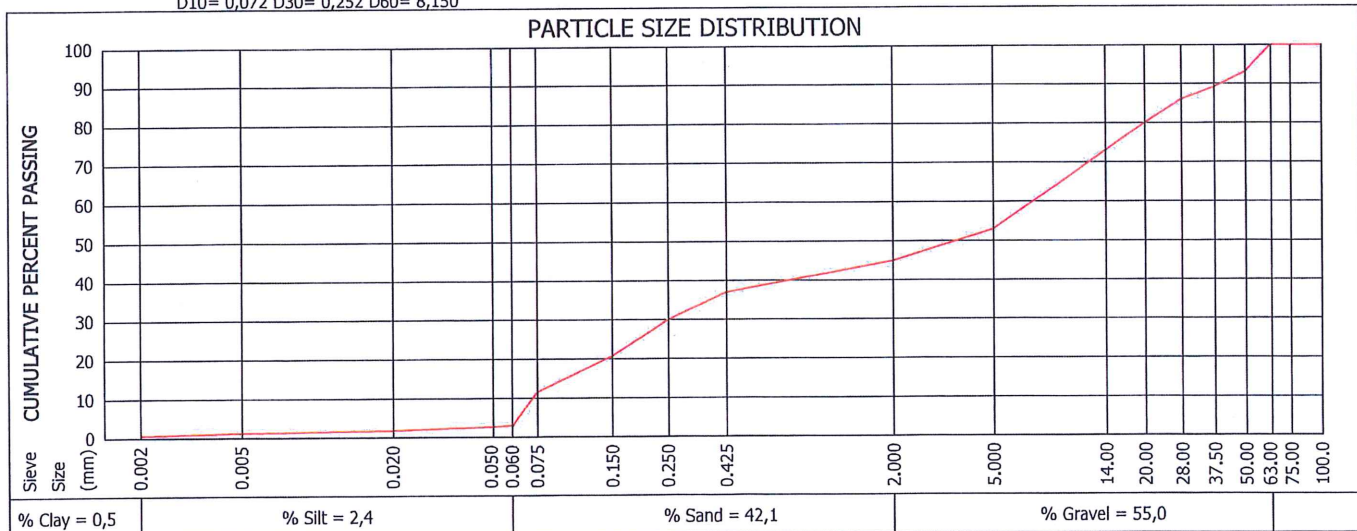
Sample No.	: U9274
Position	: TP 26
Layer Type	: 200-600mm
Sample Colour	: Brown Gravel
Sample Type	: Mix Calcrete+Quartz

D10= 0,072 D30= 0,252 D60= 8,150

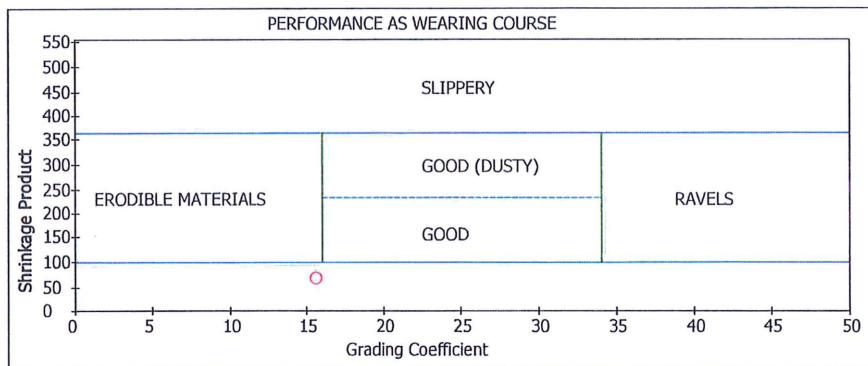
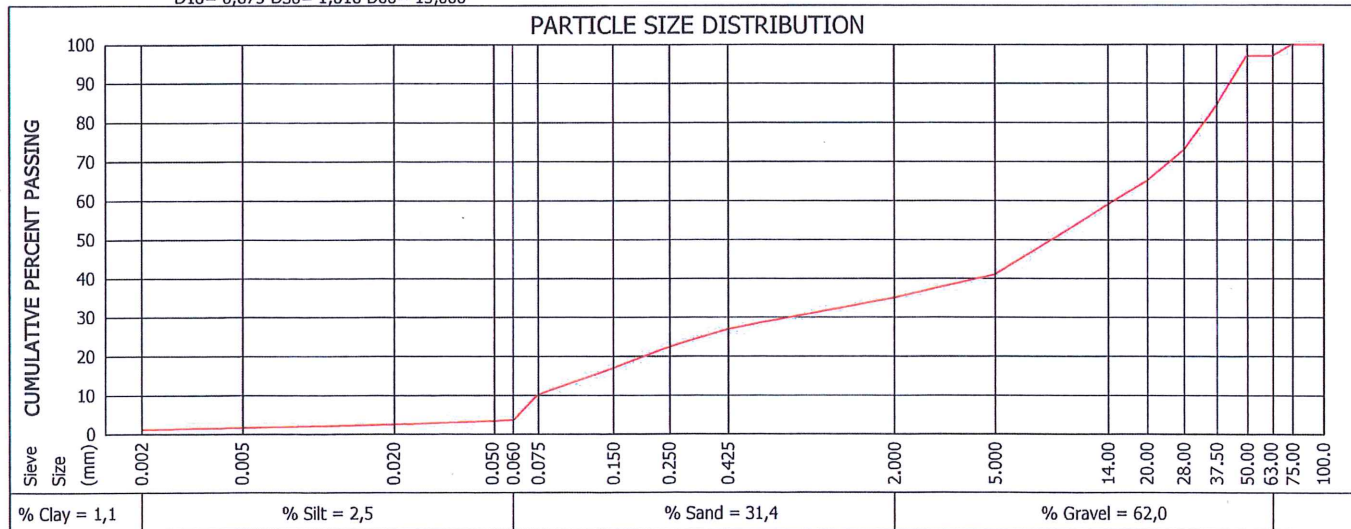
Sample No.	: U9275
Position	: TP 30
Layer Type	: 200-1000mm
Sample Colour	: Brown Gravel
Sample Type	: Mix Calcrete+Quartz

D10= 0,075 D30= 1,016 D60= 15,000

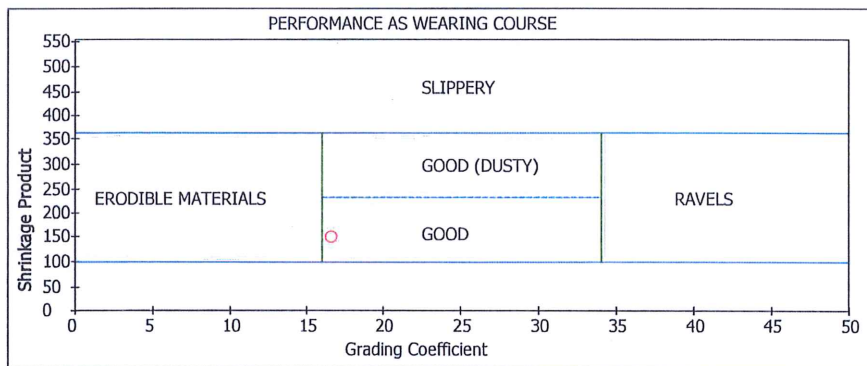
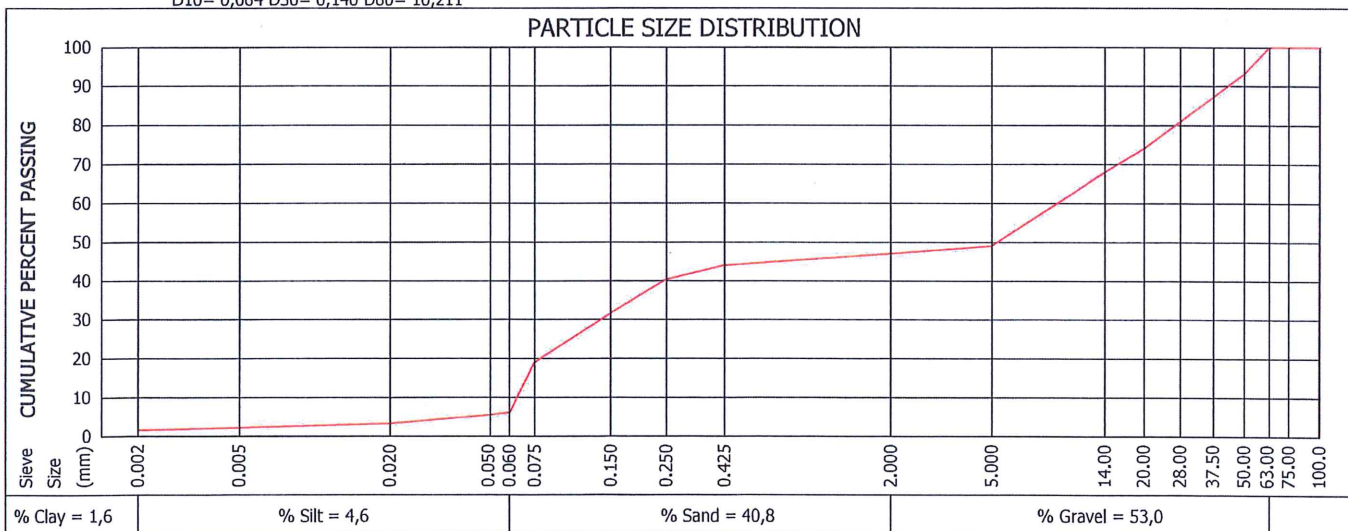
Sample No.	: U9276
Position	: TP 31
Layer Type	: 0-300mm
Sample Colour	: Light Reddish Brown
Sample Type	: Calcrete & Kalahari

D10= 0,064 D30= 0,140 D60= 10,211
