**GEOTECHNICAL CONDITIONS ON PLOT 1890
BOEGOEBERG SETTLEMENT AND THE
REMAINDERS OF FARMS 142 AND 144: A REPORT
FOR THE EXPANSION AND FORMALISATION OF
BOEGOEBERG COMMUNITY**

2020/J09/MCP_01

PREPARED BY : CEDARLAND GEOTECHNICAL
CONSULT (PTY) LTD

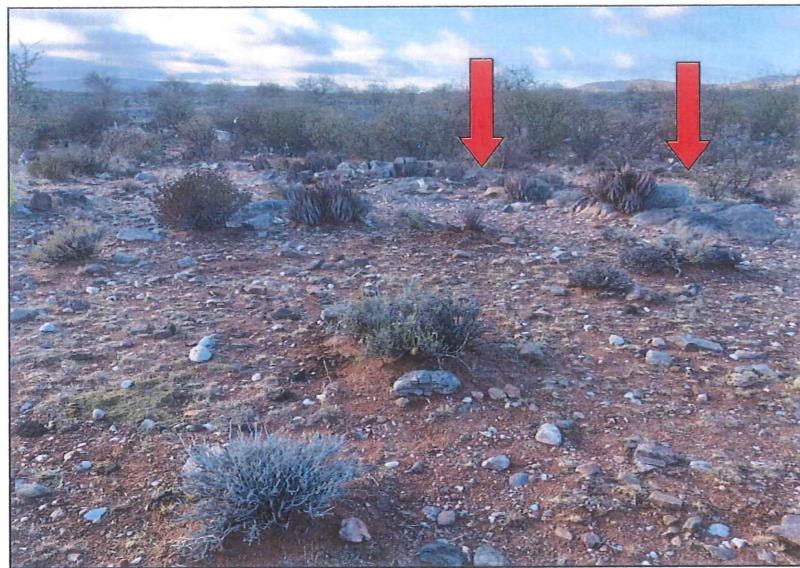
OUTCROPS OF VERY HARD ROCK, QUARTZITE

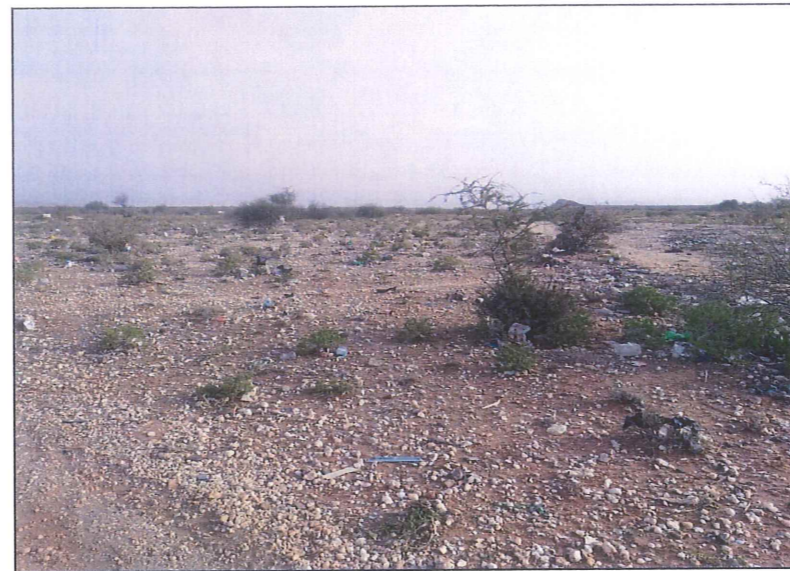
NATURAL CONDITIONS NORTHWEST OF THE VILLAGE

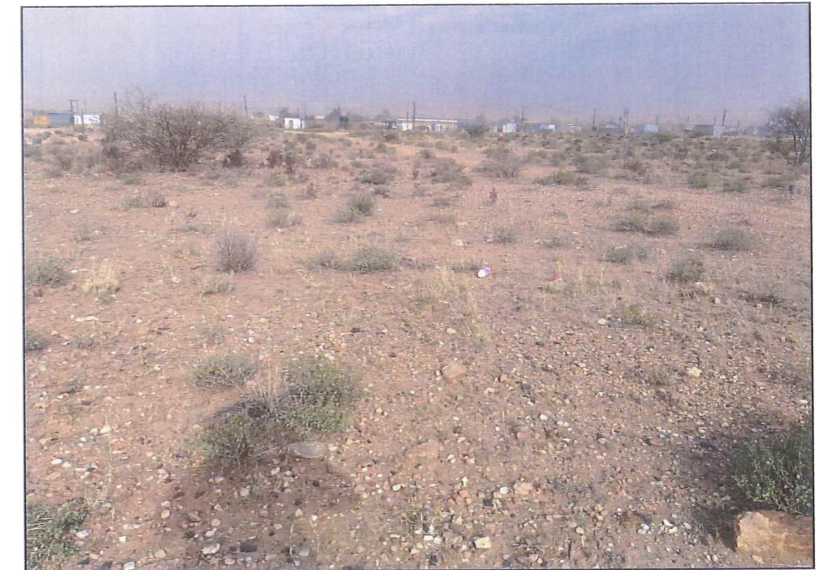
GULLY TO THE NORTHWEST OF THE VILLAGE

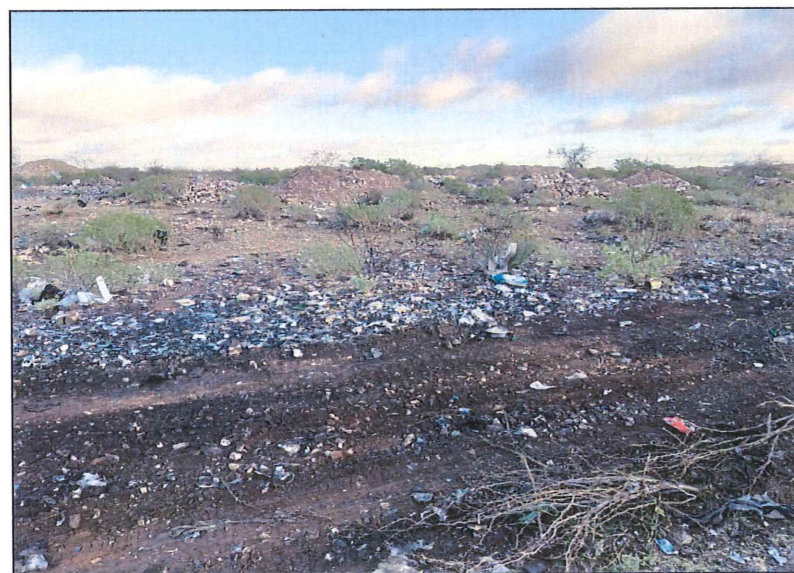
STOCKPILES OF WASTE CALCRETE AND HOUSEHOLD WASTE

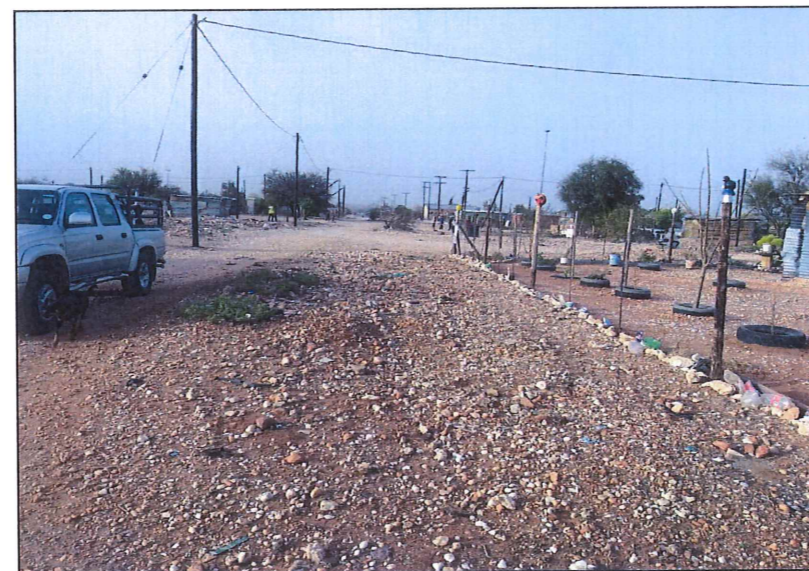
CONDITIONS IN THE VILLAGE

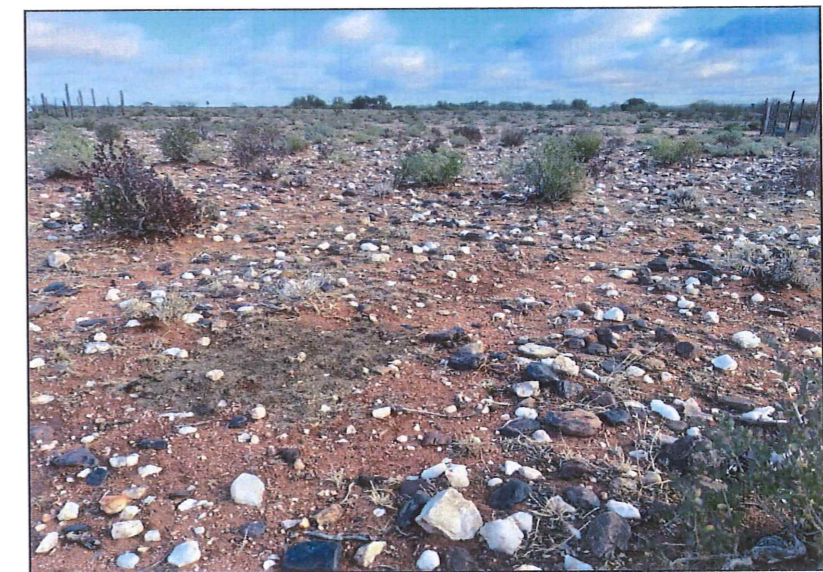
WELL DEVELOPED TERRACE GRAVELS OF QUARTZ AND BANDED IRONSTONE

Site conditions are illustrated on Photo 1 : Site Conditions. Water purification works are present on the southeastern perimeter of the site. An underground pipeline originating from the facility follows a course due west through the area of investigation. An unused, non-functional oxidation pond is present on the western perimeter of the site. Localized stockpiles of waste material, consisting of domestic waste, stockpiles of gravels and human waste are present close to the water purification works. Electricity is provided by an overhead reticulation system via overhead lines.

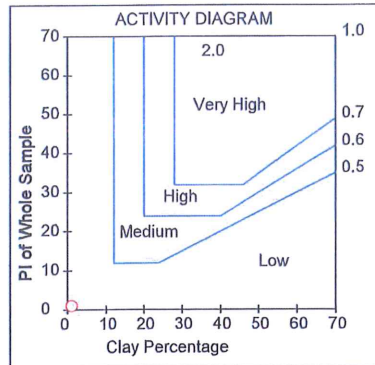
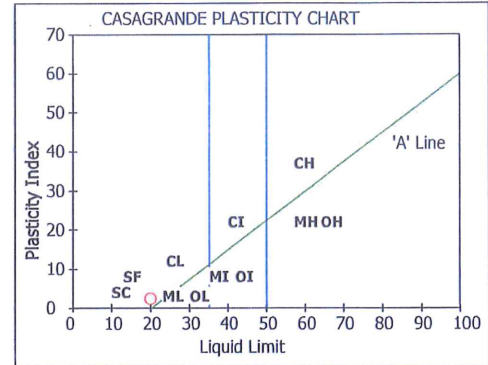
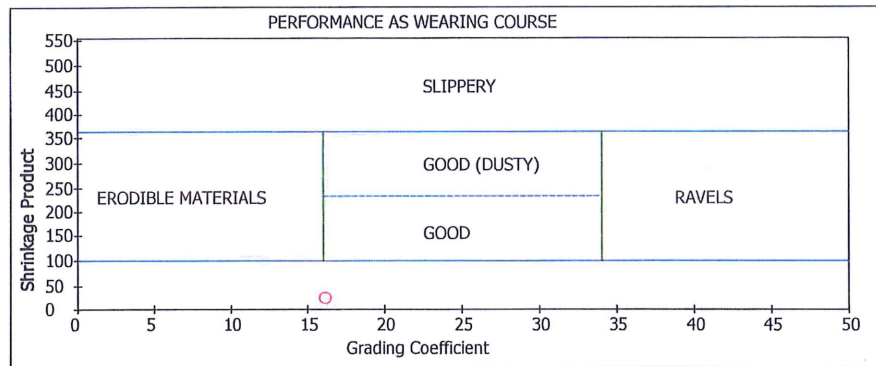
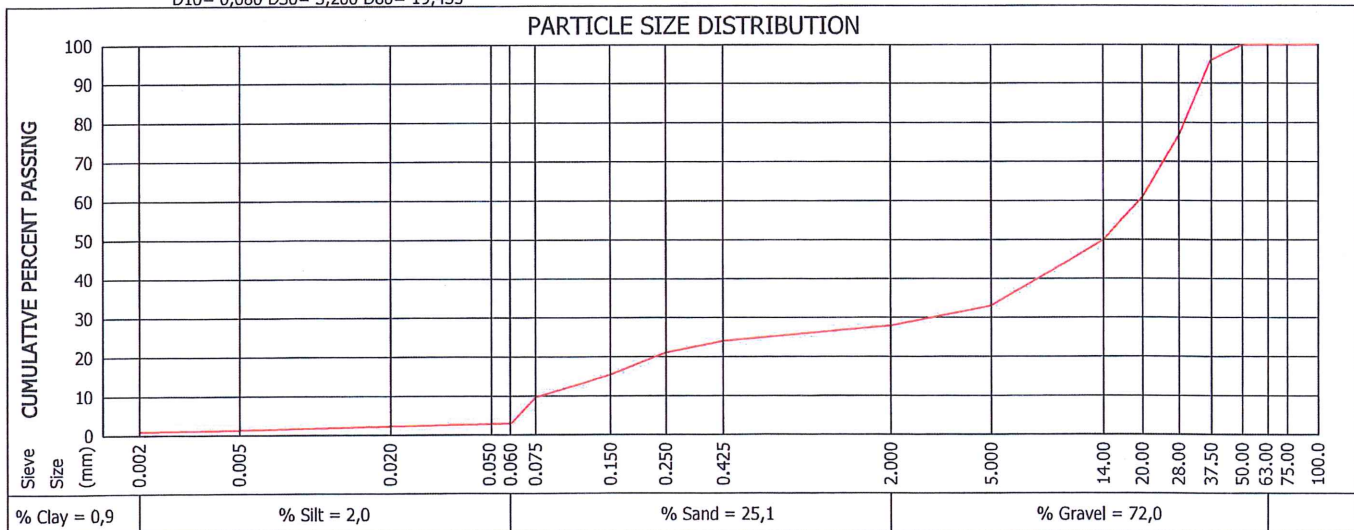
Sample No.	: U9316
Position	: TP 1
Layer Type	: 200-400mm
Sample Colour	: Brown Gravel
Sample Type	: Mix Cal+Quartz+OCC I

Sieve Size(mm)	% Passing	Soil Mortar		
100.0	100	2.000 - 0.425	15	
75.00	100	0.425 - 0.250	11	
63.00	100	0.250 - 0.150	20	
50.00	100	0.150 - 0.075	19	
37.50	96	< 0.075	36	
28.00	77	Effective Size	0,080	
20.00	61	Uniformity Coefficient	243,2	
14.00	50	Curvature Coefficient	6,6	
5.000	33	Oversize Index	4,0	
2.000	28	Shrinkage Product	24,0	
0.425	24	Grading Coefficient	16,2	
0.250	21	Grading Modulus	2,40	
0.150	15	Atterberg Limits	Liquid Limit	20
0.075	9,6		Plasticity Index	2,0
0.060	2,9		Linear Shrinkage	1,0
0.050	2,8		PI < 0.075	
0.020	2,2	Unified Soil Classification	GW-GC	
0.005	1,3	US Highway Classification	A-1-a(0)	
0.002	0,9			D10= 0,080 D30= 3,200 D60= 19,455

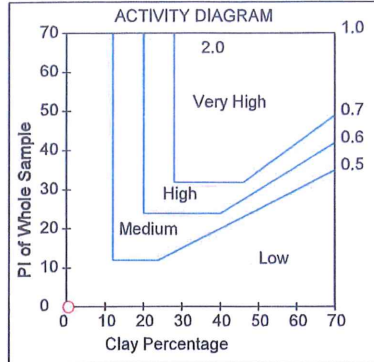
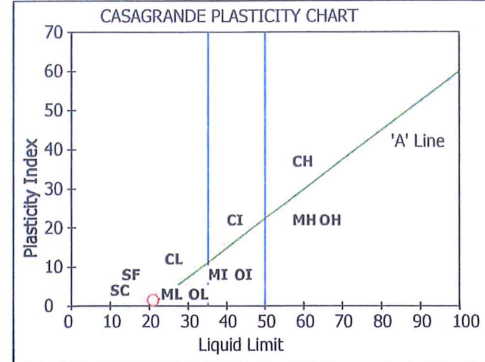
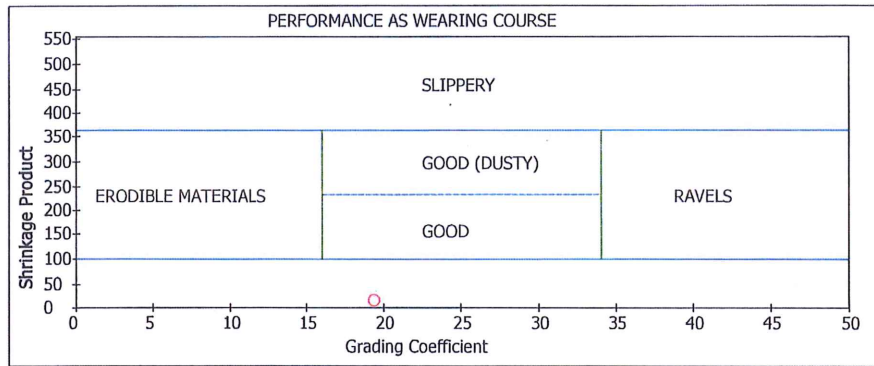
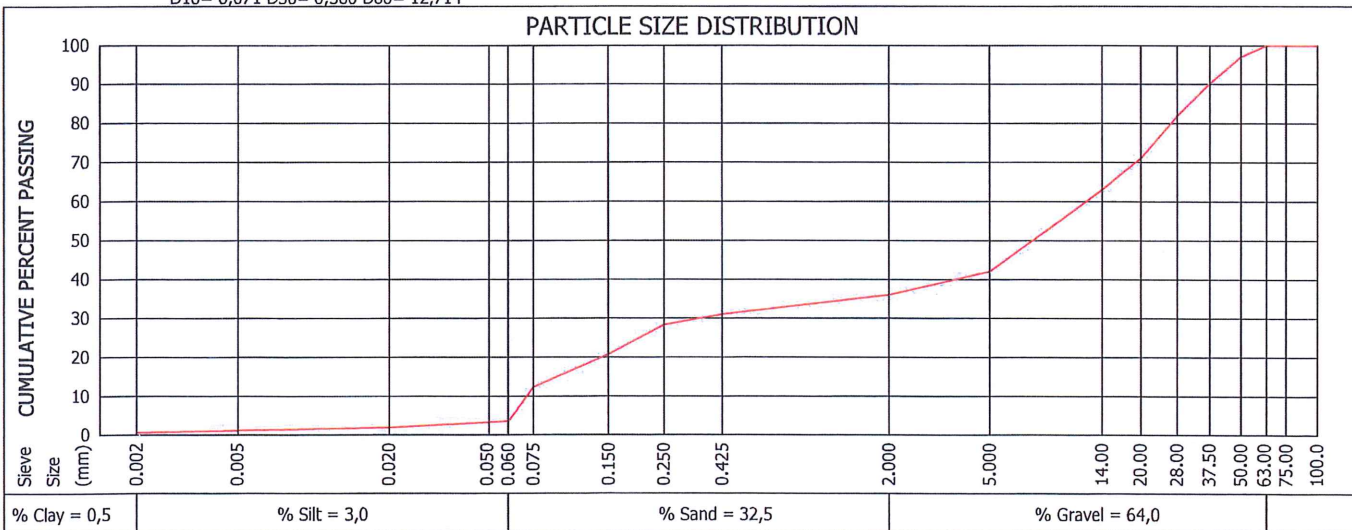
Sample No.	: U9317
Position	: TP 6
Layer Type	: 0-400mm
Sample Colour	: Light Brown Gravel
Sample Type	: Mix Calcrete+Quartz

Sieve Size (mm)	% Passing	Soil Mortar		
100.0	100	2.000 - 0.425	13	
75.00	100	0.425 - 0.250	8	
63.00	100	0.250 - 0.150	21	
50.00	97	0.150 - 0.075	24	
37.50	90	< 0.075	33	
28.00	82	Effective Size	0,071	
20.00	71	Uniformity Coefficient	179,1	
14.00	63	Curvature Coefficient	0,1	
5.000	42	Oversize Index	7,0	
2.000	36	Shrinkage Product	15,5	
0.425	31	Grading Coefficient	19,3	
0.250	28	Grading Modulus	2,20	
0.150	21	Atterberg Limits	Liquid Limit	21
0.075	12		Plasticity Index	1.0
0.060	3,5		Linear Shrinkage	0.5
0.050	3,2		PI < 0.075	
0.020	1,9	Unified Soil Classification	GC	
0.005	1,1	US Highway Classification	A-1-b(0)	
0.002	0,5

D10= 0,071 D30= 0,360 D60= 12,714

Deviation from Test Method :
 Remarks and Notes : Chemistry: pH = 7.78 [SANS 5854] & Conductivity = 0.13 S/m [SANS 6240]

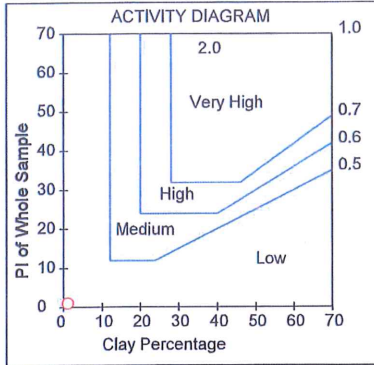
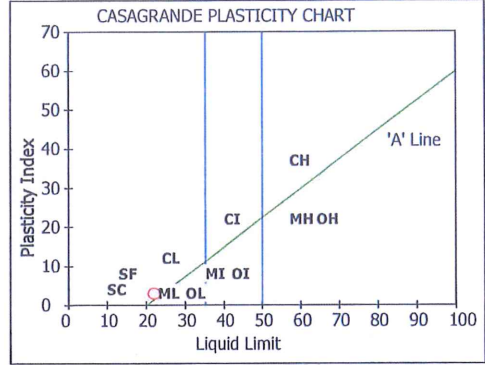
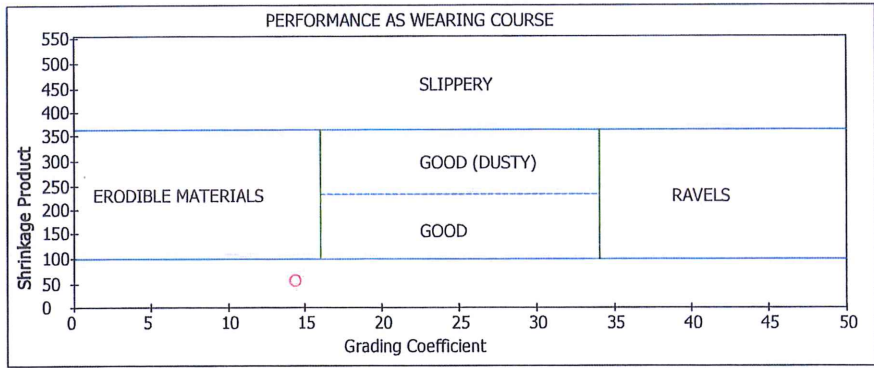
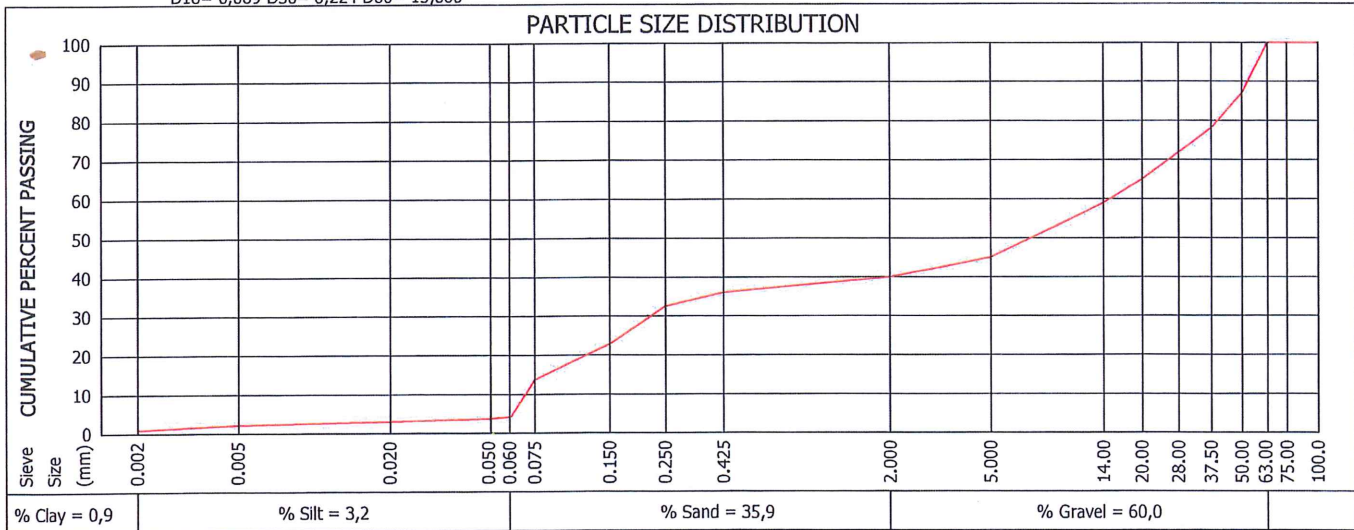
Sample No.	: U9318
Position	: TP 10
Layer Type	: 100-500mm
Sample Colour	: Brown Gravel
Sample Type	: Mix Calcrete + Quart

Sieve Size(mm)	% Passing	Soil Mortar		
100.0	100	2.000 - 0.425	10	
75.00	100	0.425 - 0.250	10	
63.00	100	0.250 - 0.150	24	
50.00	87	0.150 - 0.075	22	
37.50	78	< 0.075	35	
28.00	72	Effective Size	0,069	
20.00	65	Uniformity Coefficient	217,4	
14.00	59	Curvature Coefficient	0,0	
5.000	45	Oversize Index	9,0	
2.000	40	Shrinkage Product	54,0	
0.425	36	Grading Coefficient	14,4	
0.250	33	Grading Modulus	2,10	
0.150	23	Atterberg Limits	Liquid Limit	22
0.075	14		Plasticity Index	3.0
0.060	4,1		Linear Shrinkage	1.5
0.050	3,7		PI < 0.075	
0.020	3,0	Unified Soil Classification	GC	
0.005	2,1	US Highway Classification	A-1-b(0)	
0.002	0,9	D10= 0,069 D30= 0,224 D60= 15,000

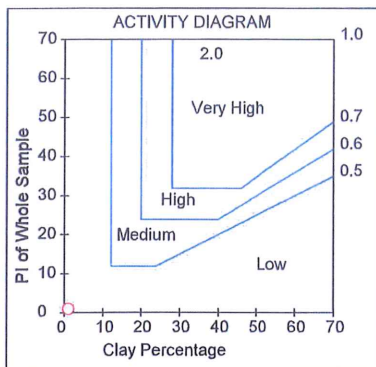
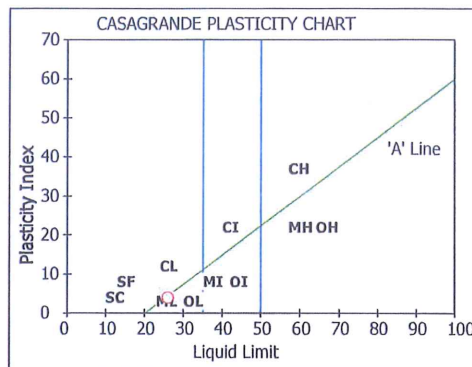
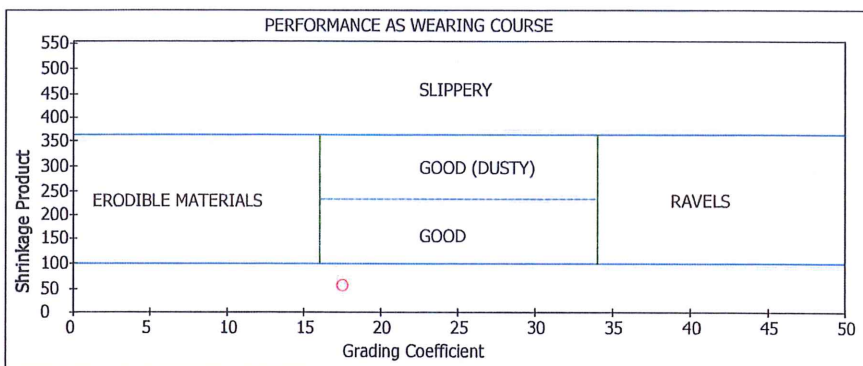
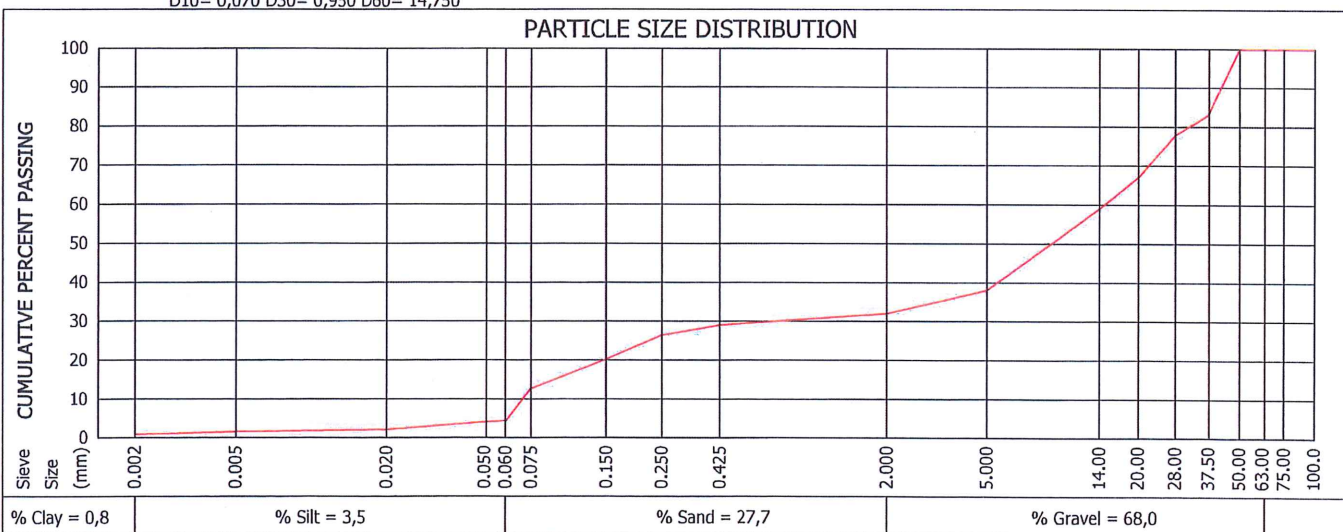
Sample No.	: U9315
Position	: TP 13
Layer Type	: 150-500mm
Sample Colour	: Brown Gravel
Sample Type	: Mix Calcrete + Quart

Sieve Size(mm)	% Passing	Soil Mortar	2.000 - 0.425	12
100.0	100		0.425 - 0.250	7
75.00	100		0.250 - 0.150	19
63.00	100		0.150 - 0.075	22
50.00	100		< 0.075	40
37.50	83	Effective Size		0,070
28.00	78	Uniformity Coefficient		210,7
20.00	67	Curvature Coefficient		0,9
14.00	59	Oversize Index		17,0
5.000	38	Shrinkage Product		58,0
2.000	32	Grading Coefficient		17,5
0.425	29	Grading Modulus		2,30
0.250	26	Atterberg Limits	Liquid Limit	26
0.150	20		Plasticity Index	4
0.075	13		Linear Shrinkage	2.0
0.060	4,3		PI < 0.075	
0.050	4,0	Unified Soil Classification		GM
0.020	2,0	US Highway Classification		A-1-a(0)
0.005	1,5			
0.002	0,8

D10= 0,070 D30= 0,950 D60= 14,750

Deviation from Test Method :
 Remarks and Notes : Chemistry: pH = 7.43 [SANS 5854] & Conductivity = 0.01 S/m [SANS 6240]

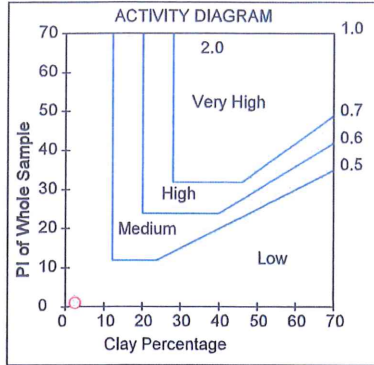
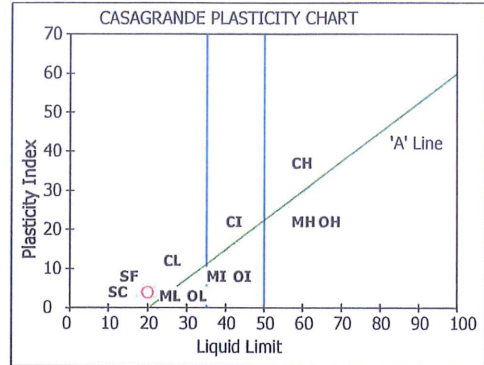
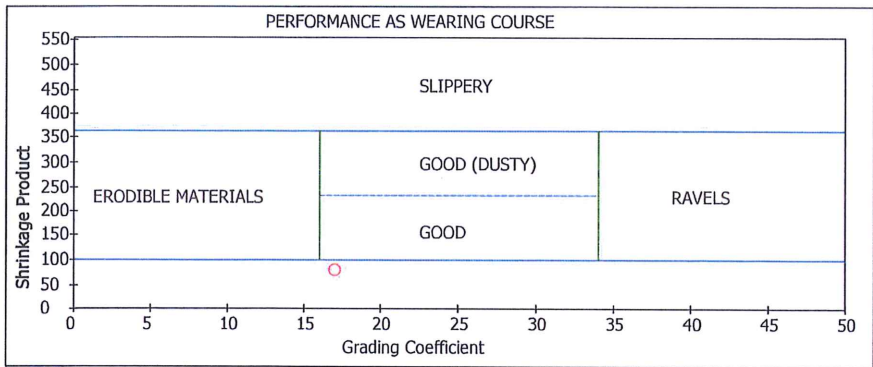
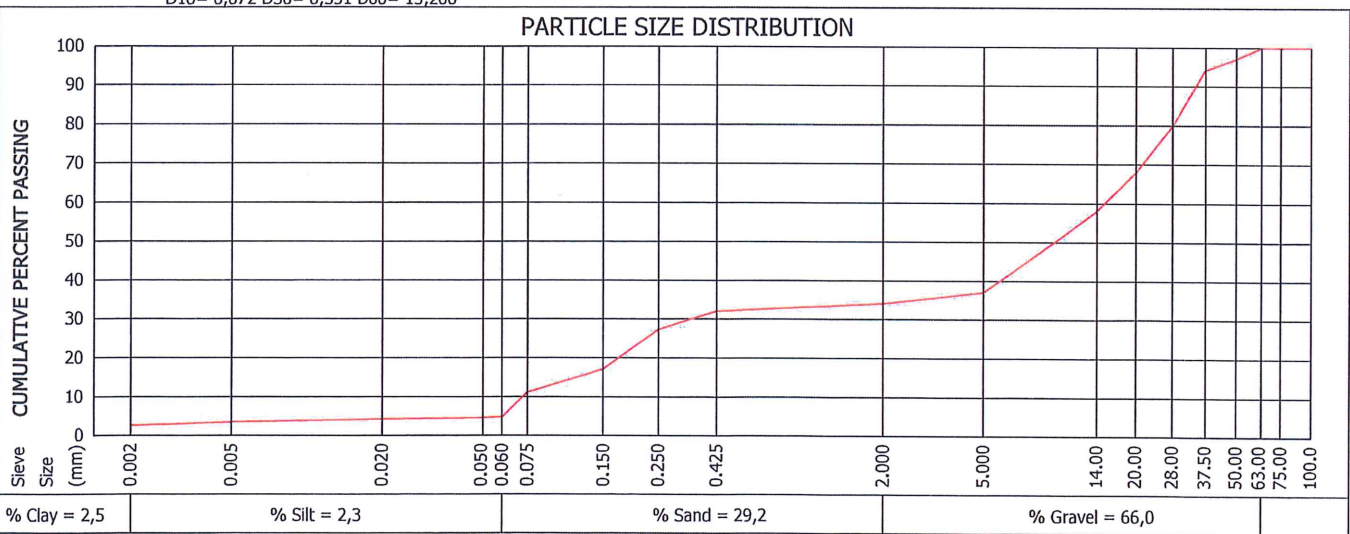
Sample No.	: U9314
Position	: TP 22
Layer Type	: 300-800mm
Sample Colour	: Reddish Brown Gravel
Sample Type	: Mix Ironstone

Sieve Size(mm)	% Passing	Soil Mortar		
100.0	100	2.000 - 0.425	6	
75.00	100	0.425 - 0.250	15	
63.00	100	0.250 - 0.150	30	
50.00	97	0.150 - 0.075	18	
37.50	94	< 0.075	32	
28.00	80	Effective Size	0,072	
20.00	68	Uniformity Coefficient	211,1	
14.00	58	Curvature Coefficient	0,1	
5.000	37	Oversize Index	3,0	
2.000	34	Shrinkage Product	80,0	
0.425	32	Grading Coefficient	17,0	
0.250	27	Grading Modulus	2,20	
0.150	17	Atterberg Limits	Liquid Limit	20
0.075	11		Plasticity Index	4.0
0.060	4,8		Linear Shrinkage	2.5
0.050	4,6		PI < 0.075	
0.020	4,1	Unified Soil Classification	GW-GM-GC	
0.005	3,4	US Highway Classification	A-1-b(0)	
0.002	2,5	D10= 0,072 D30= 0,351 D60= 15,200

Deviation from Test Method :
 Remarks and Notes : Chemistry: pH = 7.63 [SANS 5854] & Conductivity = 0.19 S/m [SANS 6240]

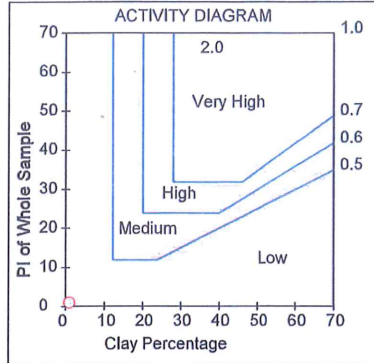
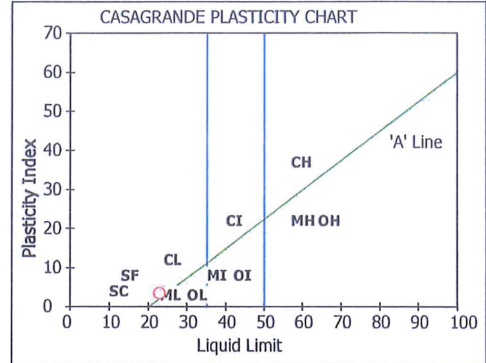
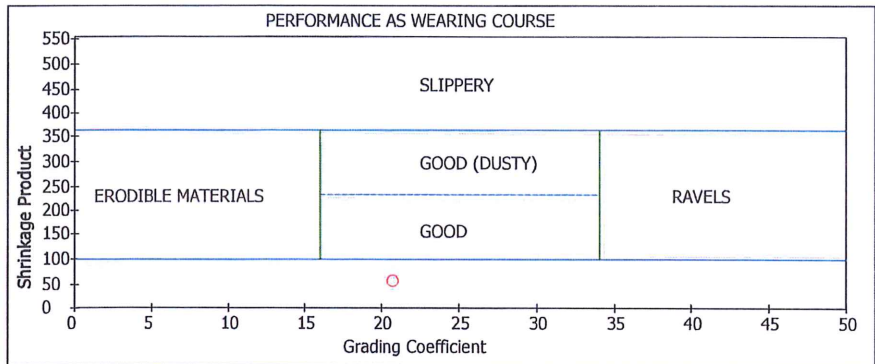
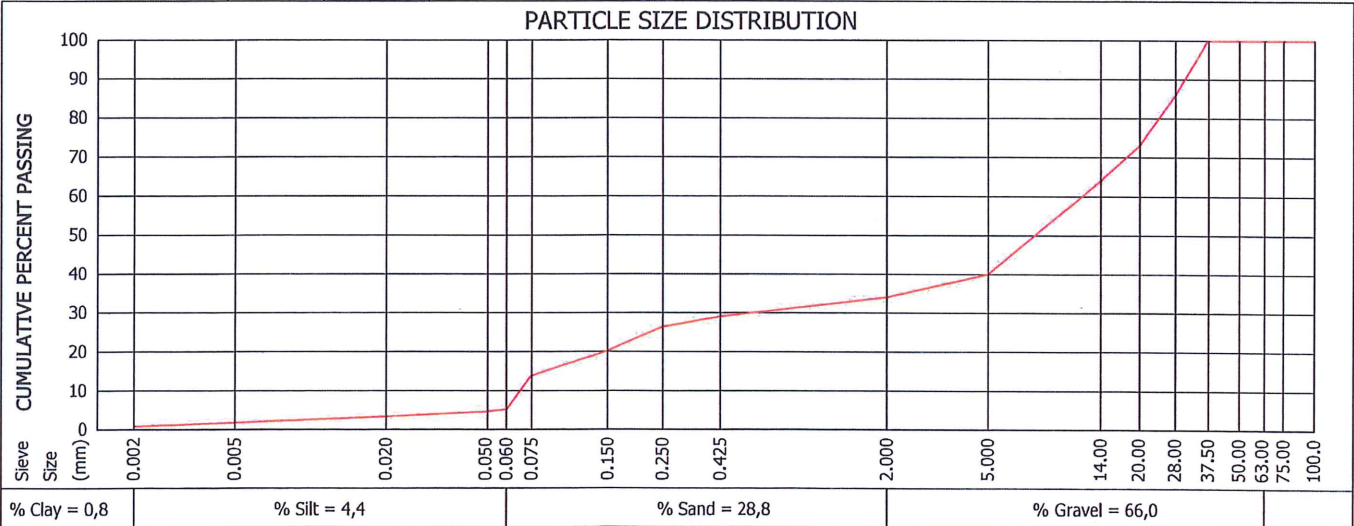
Sample No.	: U9312
Position	: TP 29
Layer Type	: 0-300mm
Sample Colour	: Brown Gravel
Sample Type	: Mix W.Cal + Quartz

Sieve Size (mm)	% Passing	Soil Mortar	2.000 - 0.425	13
100.0	100		0.425 - 0.250	8
75.00	100		0.250 - 0.150	18
63.00	100		0.150 - 0.075	19
50.00	100		< 0.075	42
37.50	100	Effective Size		0,068
28.00	86	Uniformity Coefficient		183,8
20.00	73	Curvature Coefficient		0,6
14.00	64	Oversize Index		0,0
5.000	40	Shrinkage Product		58,0
2.000	34	Grading Coefficient		20,8
0.425	29	Grading Modulus		2,20
0.250	26	Atterberg Limits	Liquid Limit	23
0.150	20		Plasticity Index	4,0
0.075	14		Linear Shrinkage	2,0
0.060	5,2		PI < 0.075	
0.060	5,2	Unified Soil Classification		GC
0.050	4,7	US Highway Classification		A-1-a(0)
0.020	3,3			
0.005	1,7			
0.002	0,8

D10= 0,068 D30= 0,740 D60= 12,500

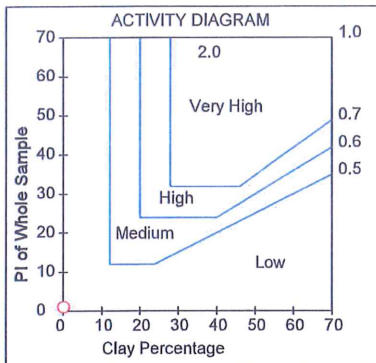
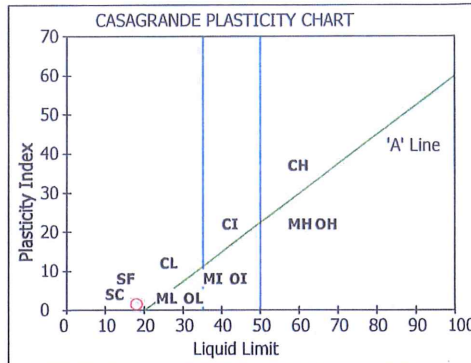
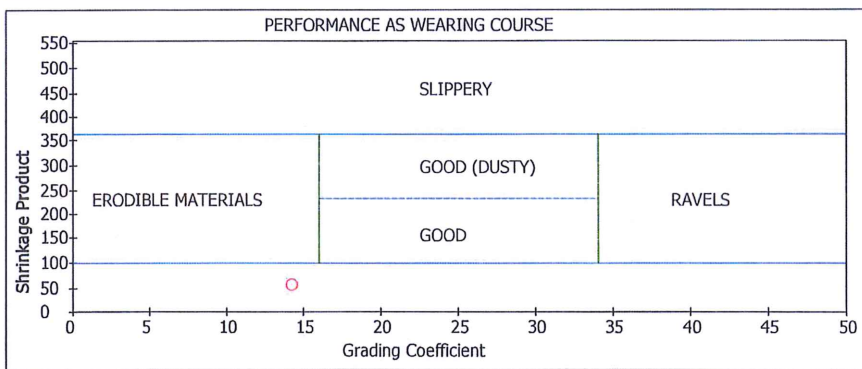
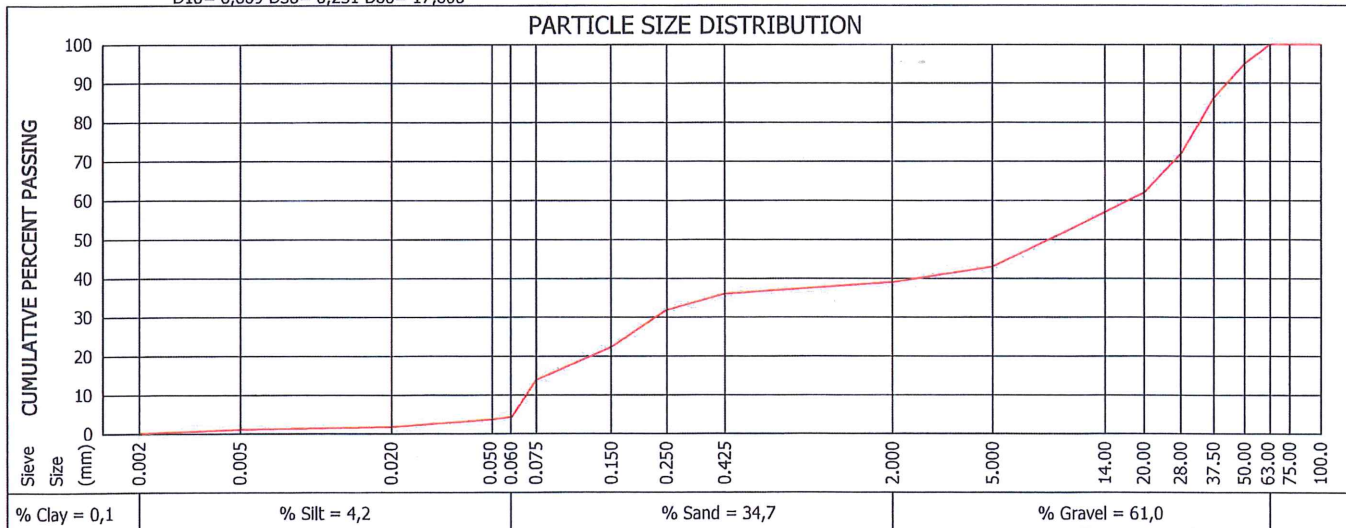
Sample No.	: U9311
Position	: TP 30
Layer Type	: 0-300mm
Sample Colour	: Brown Gravel
Sample Type	: Mix Calcrete + Quart

Sieve Size(mm)	% Passing	Soil Mortar	2.000 - 0.425	8
100.0	100		0.425 - 0.250	11
75.00	100		0.250 - 0.150	24
63.00	100		0.150 - 0.075	22
50.00	95		< 0.075	36
37.50	86	Effective Size		0,069
28.00	72	Uniformity Coefficient		255,1
20.00	62	Curvature Coefficient		0,0
14.00	57	Oversize Index		9,0
5.000	43	Shrinkage Product		54,0
2.000	39	Grading Coefficient		14,2
0.425	36	Grading Modulus		2,10
0.250	32	Atterberg Limits	Liquid Limit	18
0.150	22		Plasticity Index	2,0
0.075	14		Linear Shrinkage	1,5
0.060	4,3		PI < 0.075	
0.050	3,7	Unified Soil Classification		GC
0.020	1,8	US Highway Classification		A-1-b(0)
0.005	1,1			
0.002	0,1

D10= 0,069 D30= 0,231 D60= 17,600

Deviation from Test Method :
 Remarks and Notes : Chemistry: pH = 7.78 [SANS 5854] & Conductivity = 0.17 S/m [SANS 6240]
